VEHICLE INSPECTION REPORT

LN11VYA

Mercedes-Benz E Class E250 CDI BlueEFFICIENCY Avantgarde 5dr Tip Auto

nama
GRADE
3

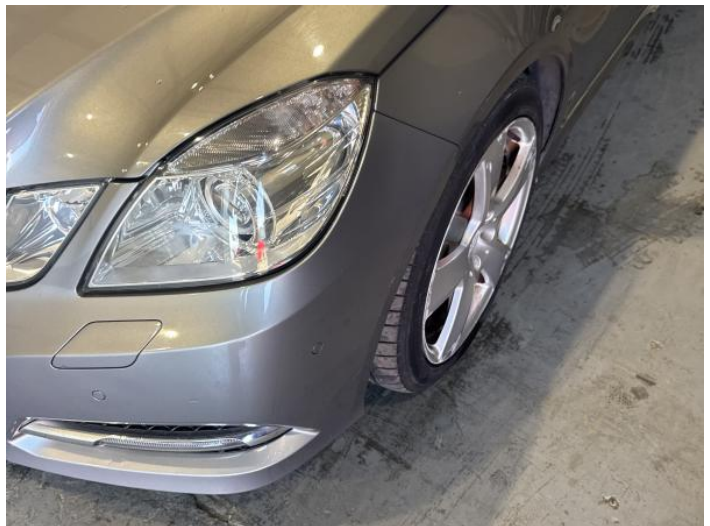
2: Bumper Front
Scratched
25 to 100mm Thru Paint

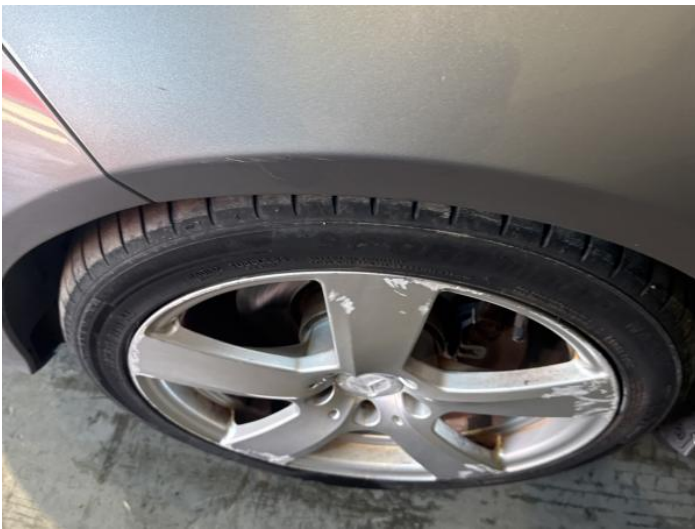
5: Wing nsf
Scratched
Over 25mm Thru Paint

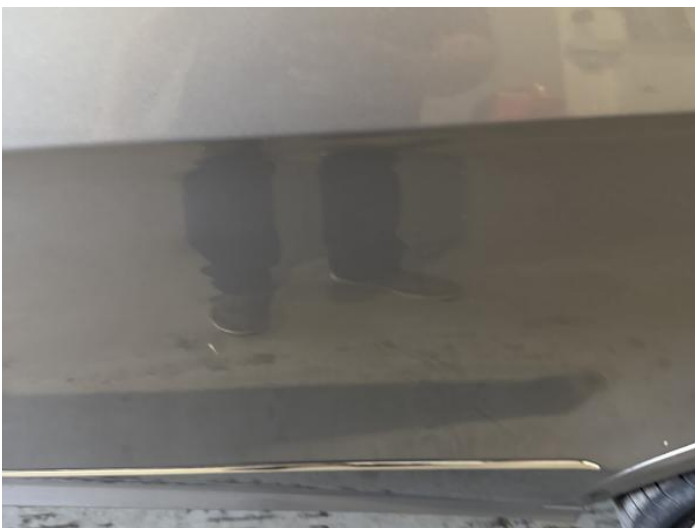
7: Door nsr
Chipped
1 To 5

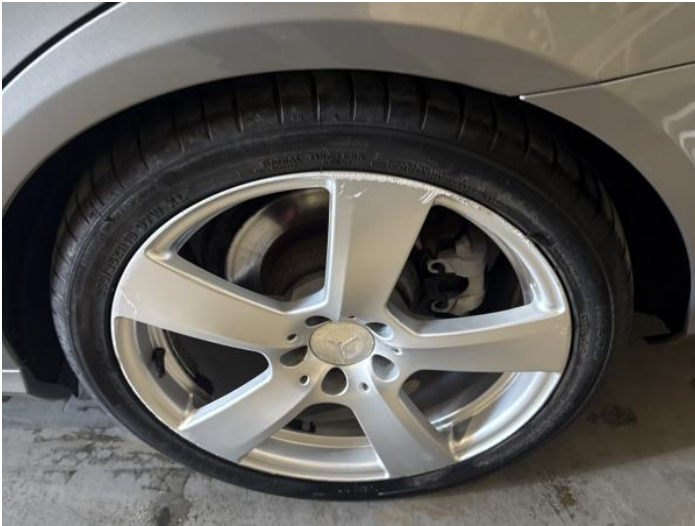
9: Wheel nsr
Scratched
Over 50mm

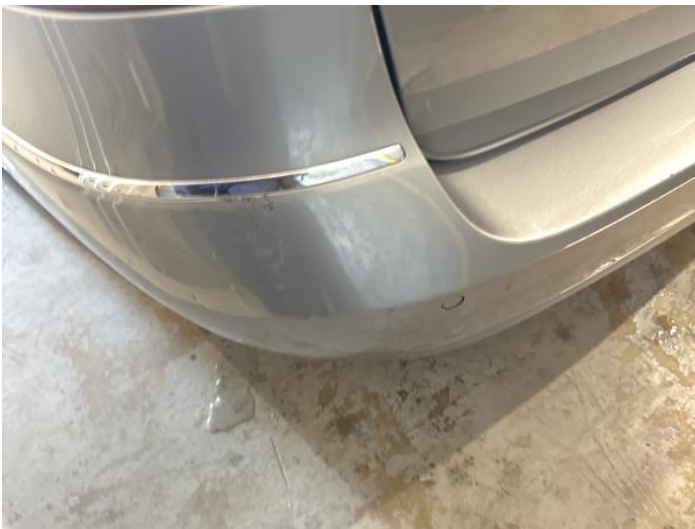
11: Bumper Rear
Scratched
Over 100mm Thru Paint

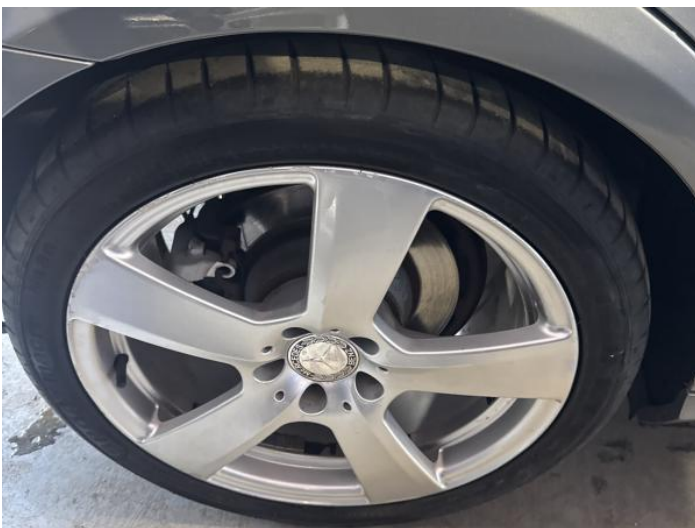
13: Wheel osr
Scratched
Up To 50mm

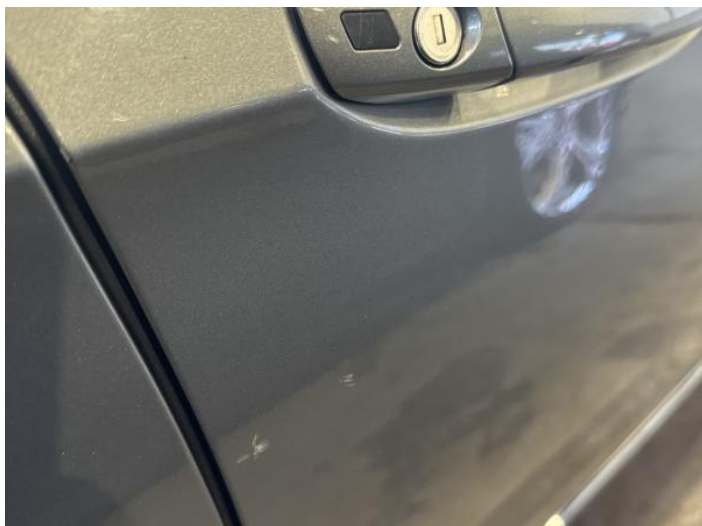
15: Door osf
Chipped
1 To 5

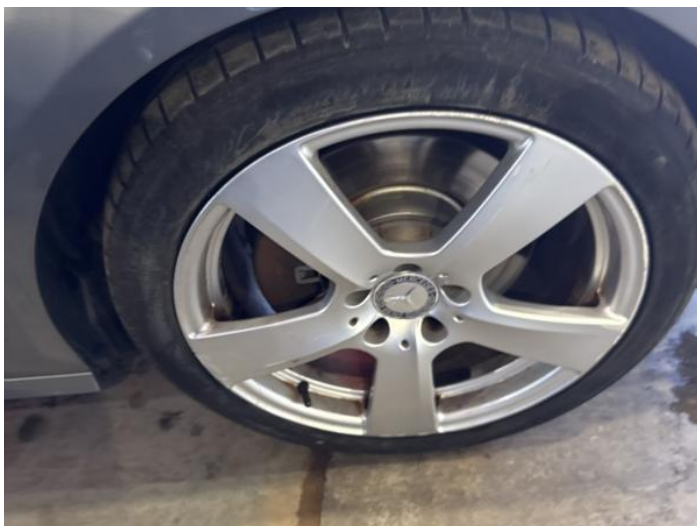
16: Wheel osf
Scratched
Over 50mm

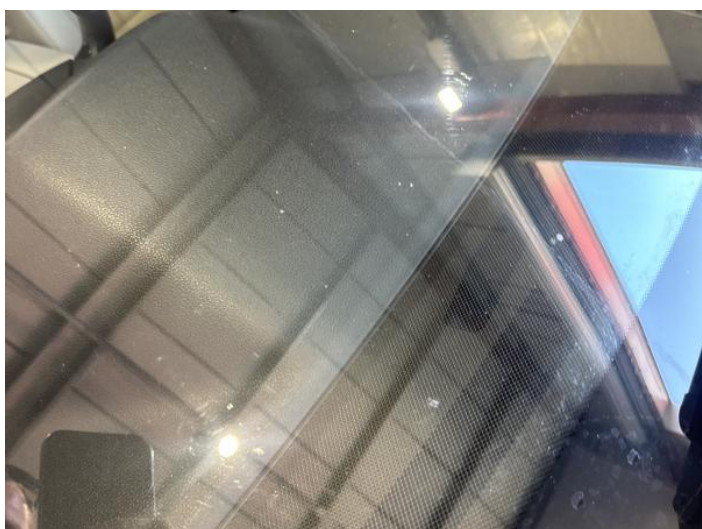
17: Screen Front
Chipped
UpTo 10mm
