## **VEHICLE INSPECTION REPORT**

LG16ZRF

## Ford Ranger Limited 4x4 Dcb Td - 2198cc

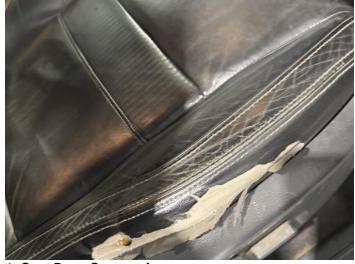
1: Seat Base Cover osf Torn Over 3mm

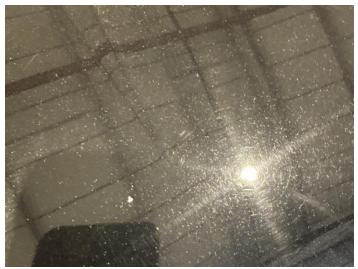
2: Bonnet Chipped 1 To 5

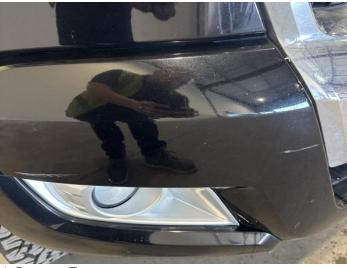
4: Bumper Front Scratched Over 100mm Thru Paint

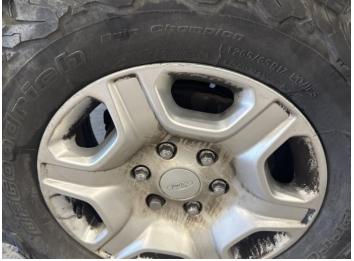
5: Wheel nsf Corroded Light

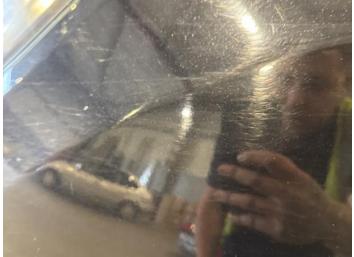
6: Wing nsf Chipped Multiple Chips

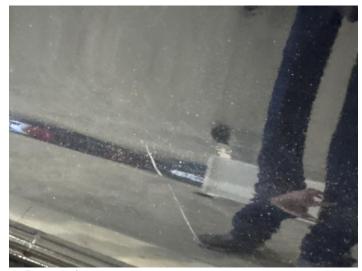
7: Door nsf Scratched Over 25mm Thru Paint

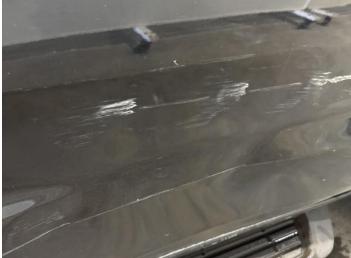
8: Door nsr Dented With Paint Damage

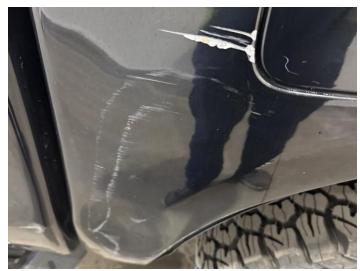
9: Qtr Panel nsr Dented With Paint Damage

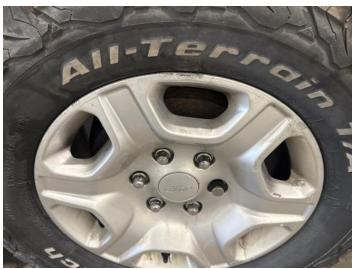
10: Wheel nsf Scratched Over 50mm

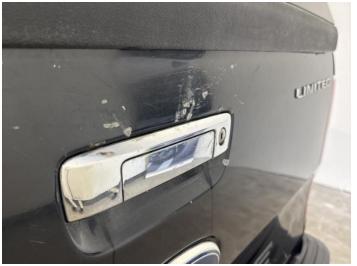
11: Boot Lid Dented With Paint Damage

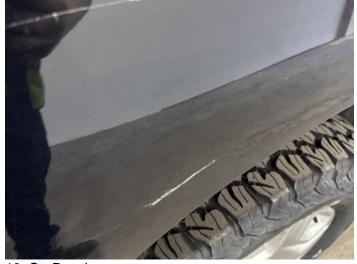
13: Qtr Panel osr Dented With Paint Damage

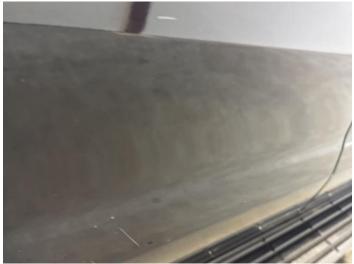
14: Door osr Dented With Paint Damage

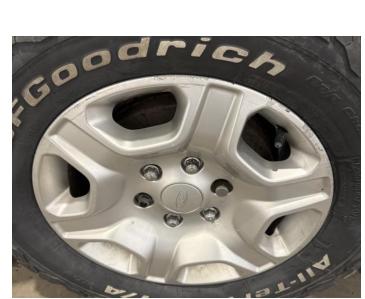
15: Wheel osr Scratched Over 50mm

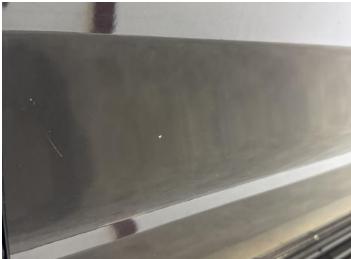
16: Door osr Chipped 1 To 5

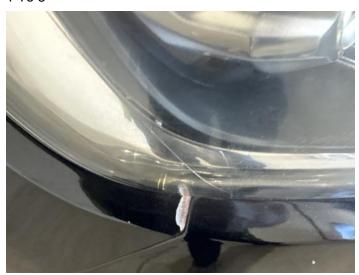
18: Wing osf Rusted Over 5mm

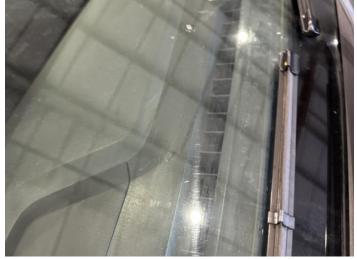
19: Screen Front Chipped UpTo 10mm

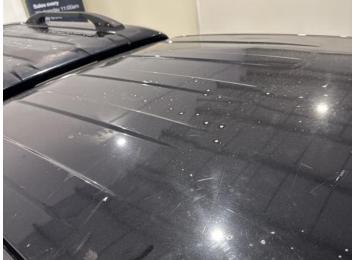
20: Roof Chipped Multiple Chips
