VEHICLE INSPECTION REPORT

AF60YFM

nama
GRADE
4

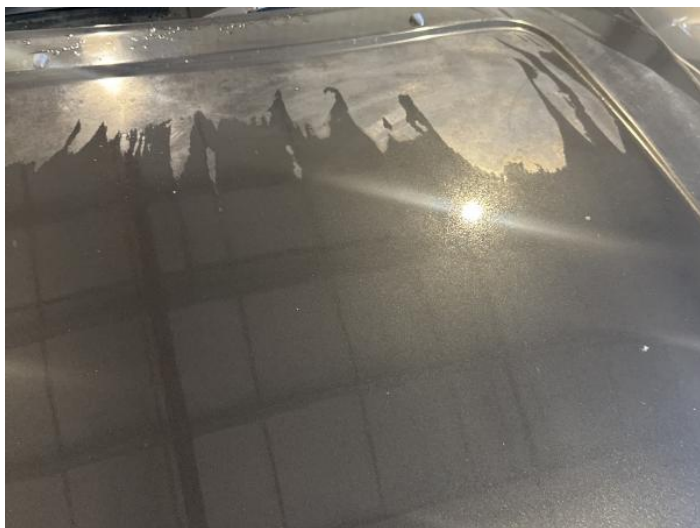
1: Bonnet
Poor Previous Repair
Poor Paint

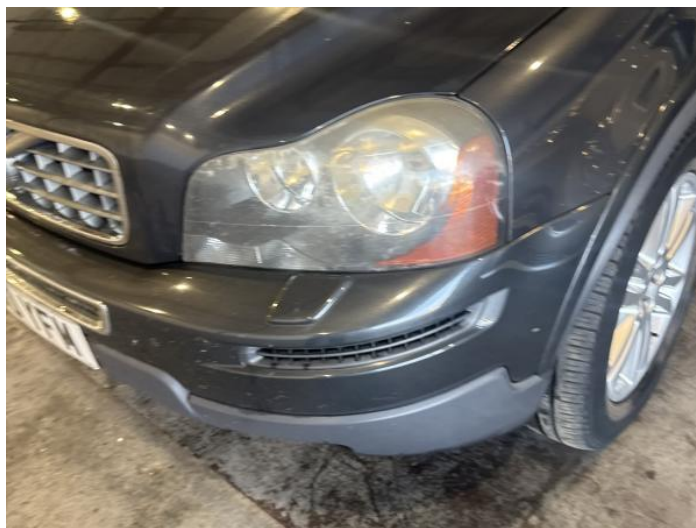
2: Bumper Front
Scratched
25 to 100mm Thru Paint

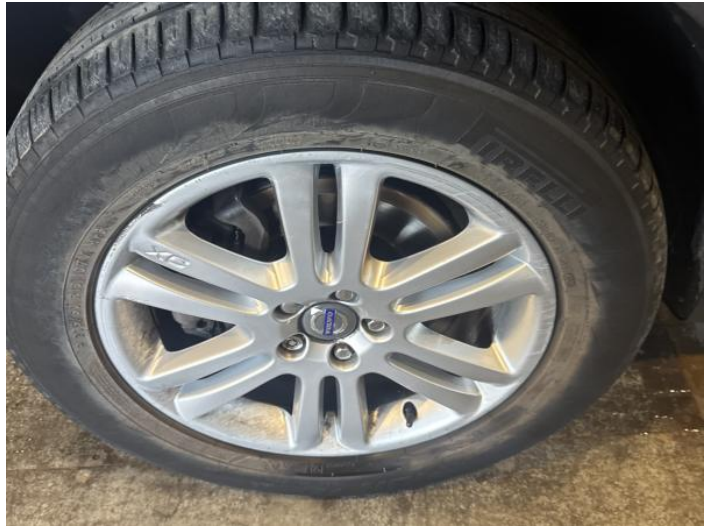
4: Wheel nsf
Scratched
Up To 50mm

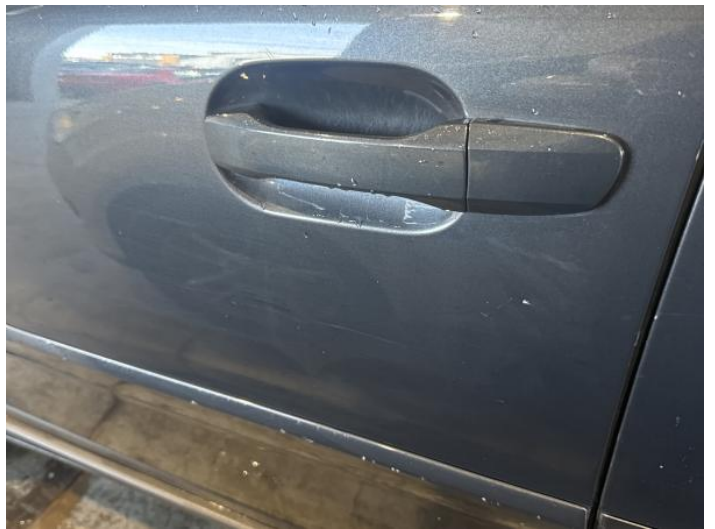
6: Door nsf
Dented
Over 2 UpTo 10mm

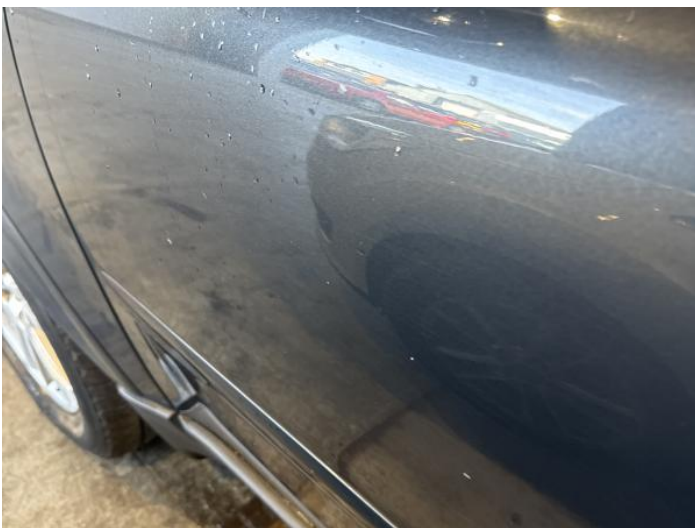
7: Door nsf
Chipped
1 To 5

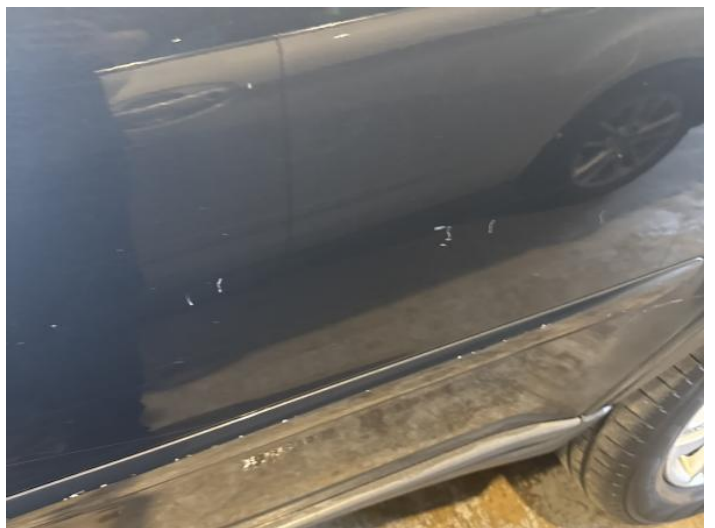
8: Door nsr
Dented
With Paint Damage

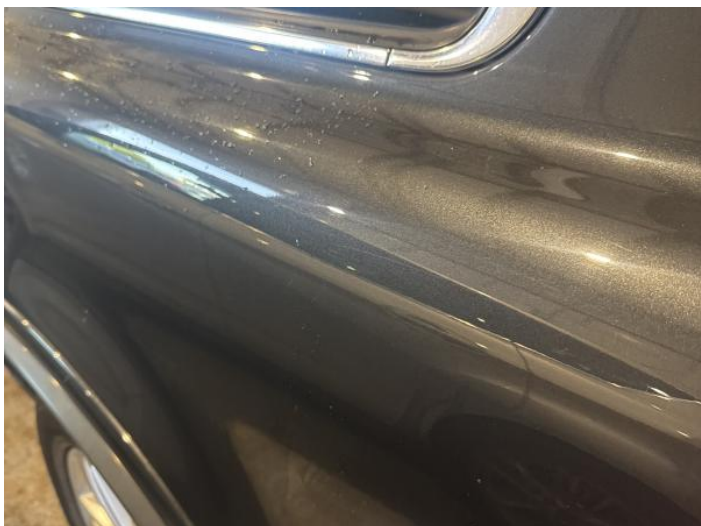
9: Qtr Panel nsr
Chipped
1 To 5

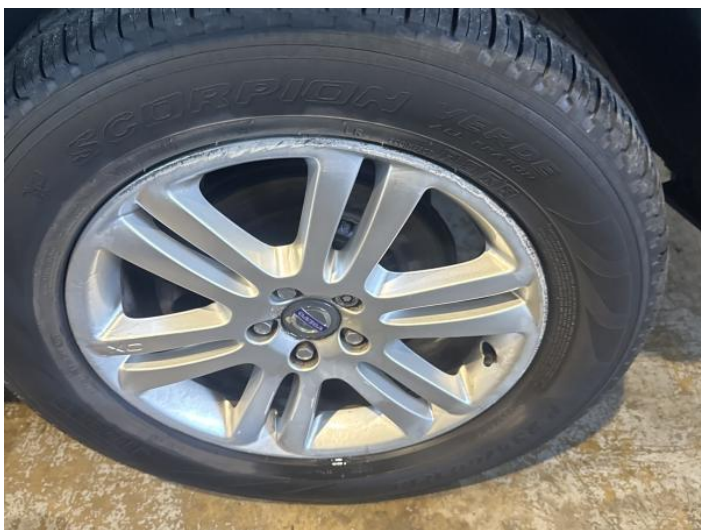
11: Wheel nsr
Scratched
Over 50mm

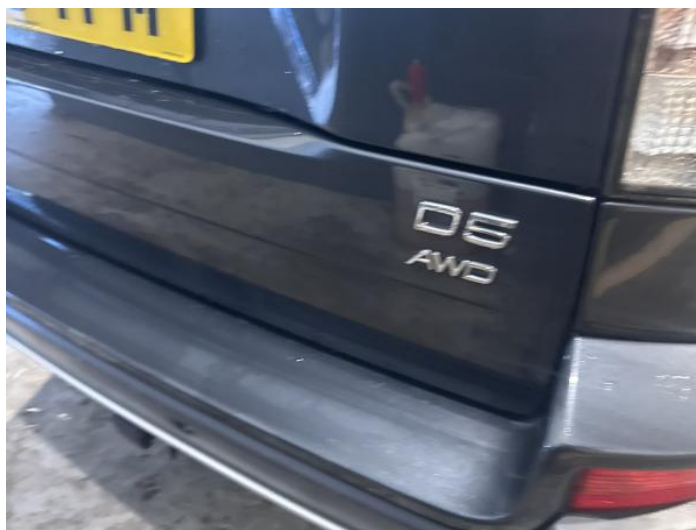
12: Bumper Rear
Scratched
25 to 100mm Thru Paint

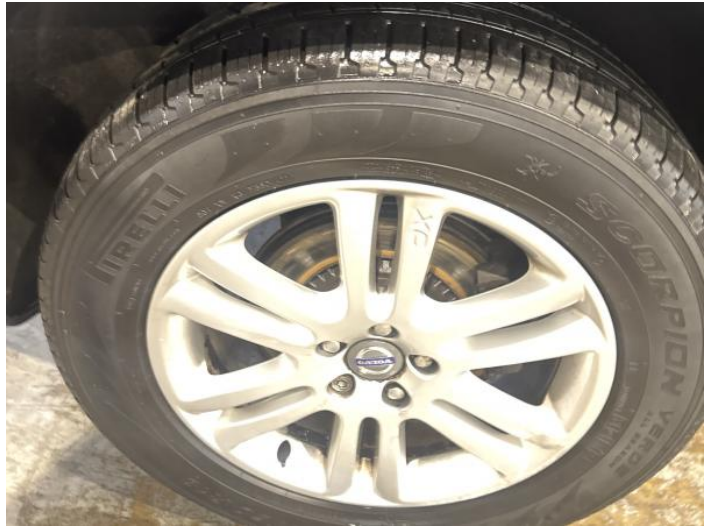
16: Wheel osr
Scratched
Up To 50mm

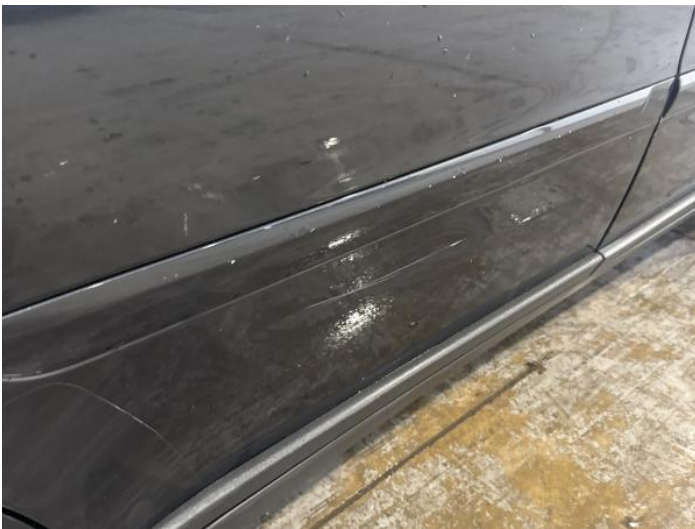
17: Door osr
Dented
With Paint Damage

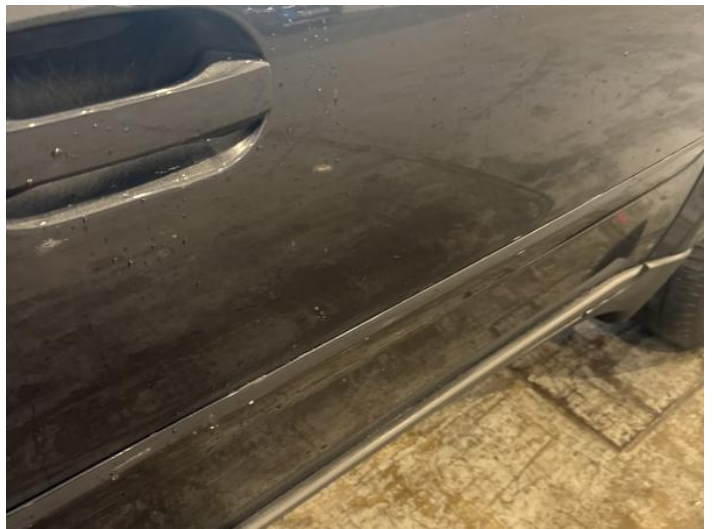
18: Door osf
Chipped
1 To 5

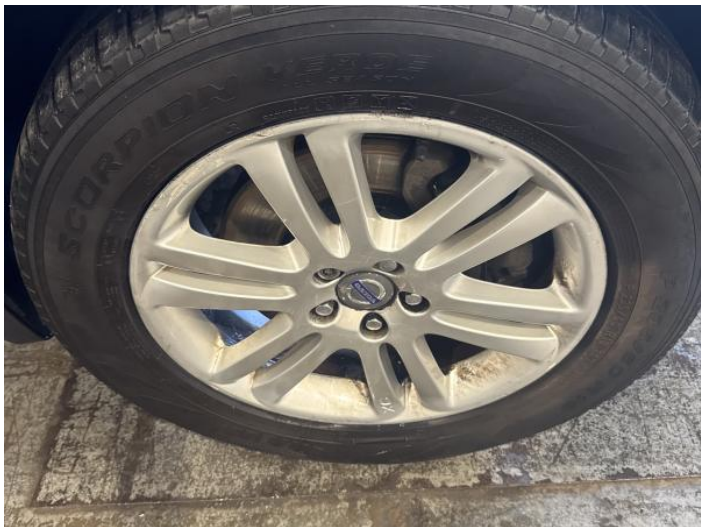
21: Wheel osf
Scratched
Over 50mm

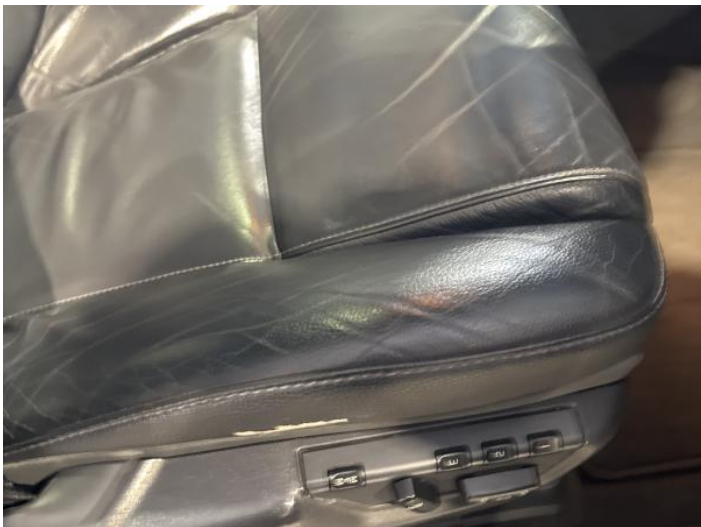
22: Seat Base Cover osf
Torn
Over 3mm
