VEHICLE INSPECTION REPORT

OU13CJZ

Honda Accord 2.4 i-VTEC EX 4dr

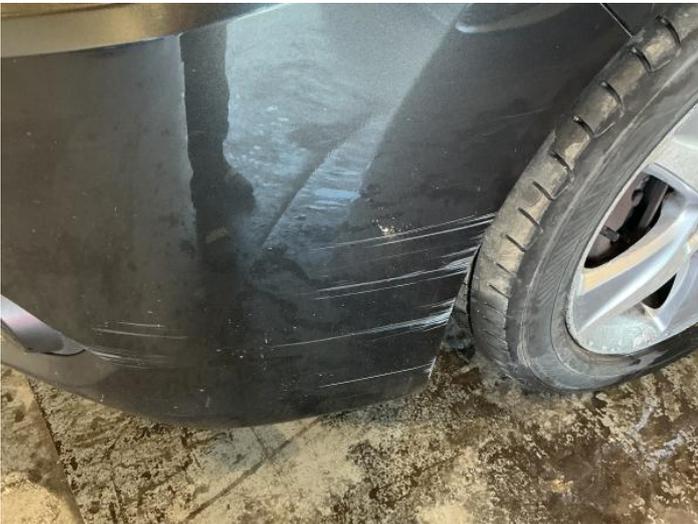
1: Bumper Front
Scratched
Over 100mm Thru Paint

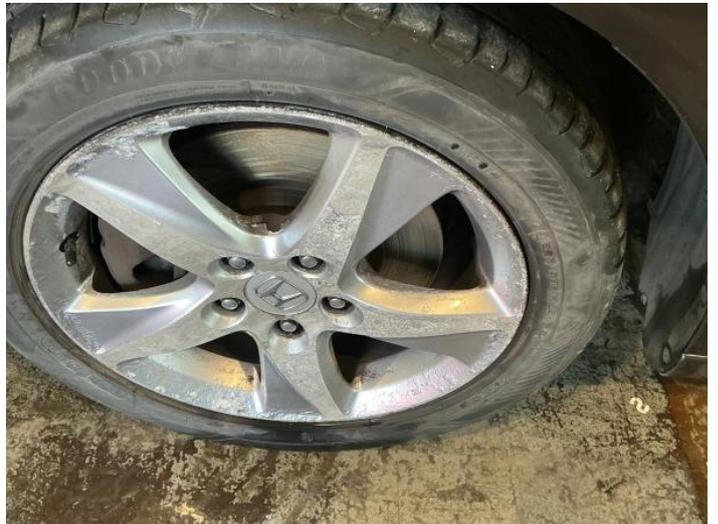
2: Wheel of
Corroded
Light

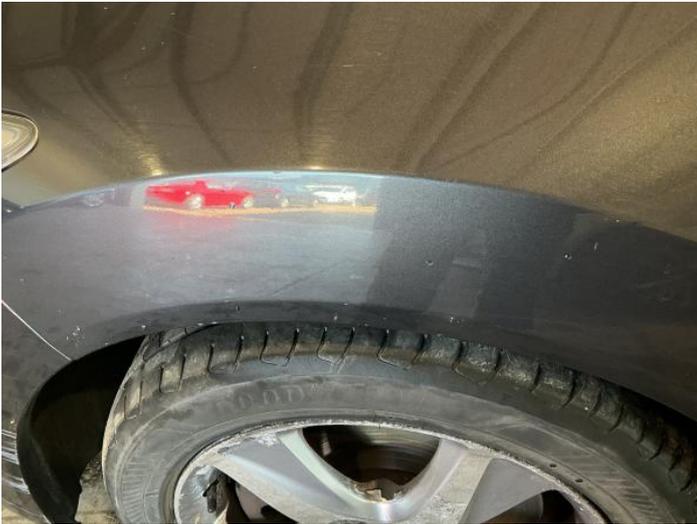
3: Wing nsf
Chipped
Multiple Chips

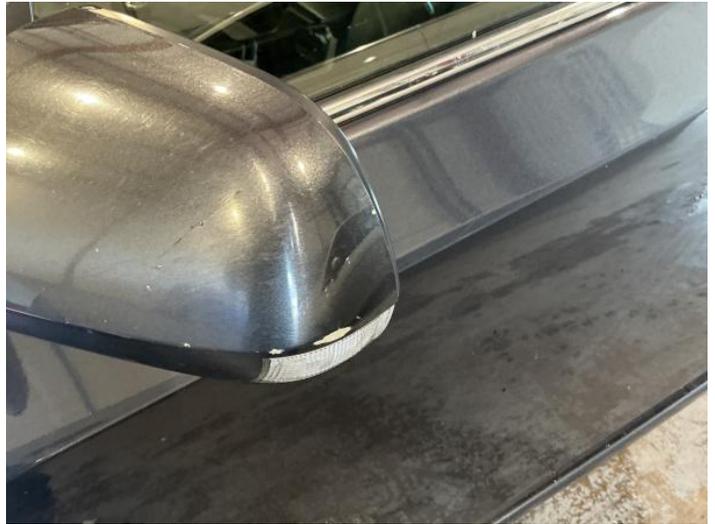
4: Door Mirror Assy nsf
Scratched (Painted)
UpTo 25mm Thru Paint

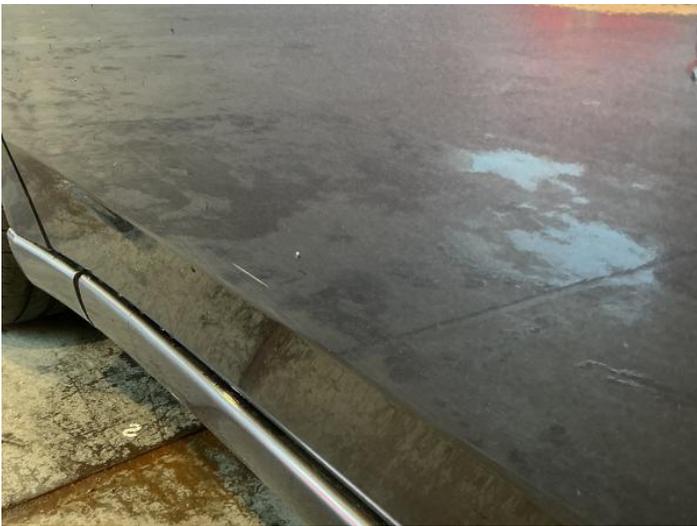
5: Door nsf
Scratched
Over 25mm Thru Paint

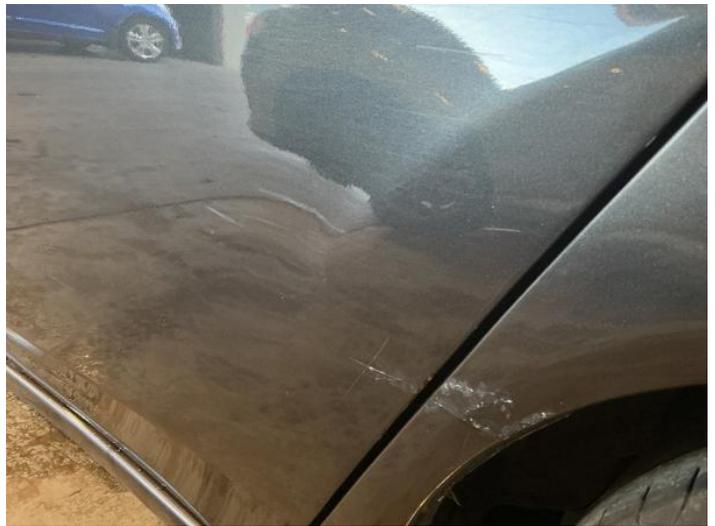
6: Door nsr
Scratched
Over 25mm Thru Paint

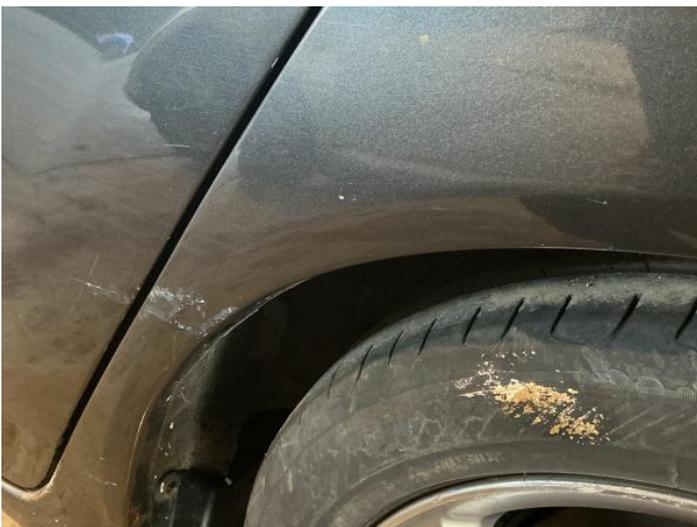
7: Qtr Panel nsr
Dented
With Paint Damage

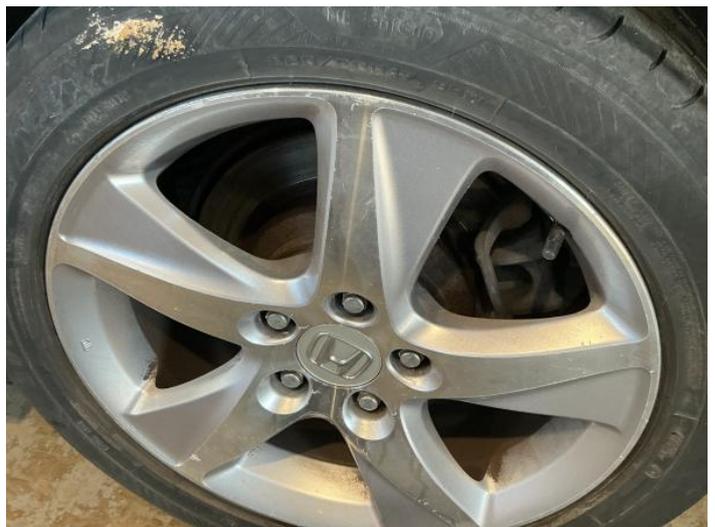
8: Wheel nsr
Scratched
Over 50mm

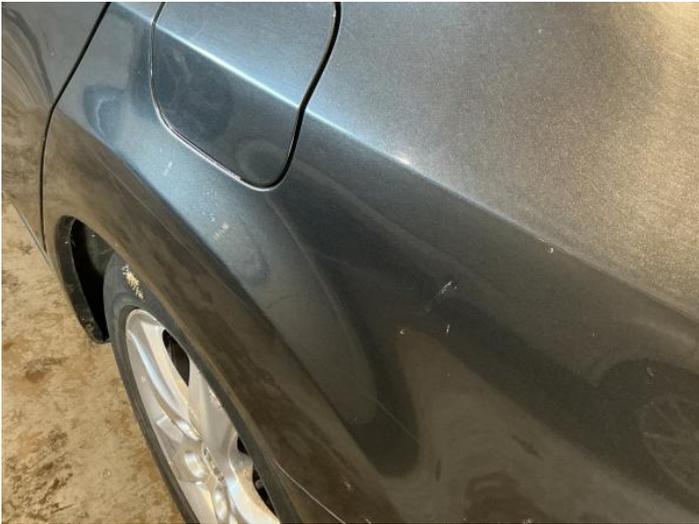
9: Qtr Panel nsr
Dented
Between 10mm + 30mm

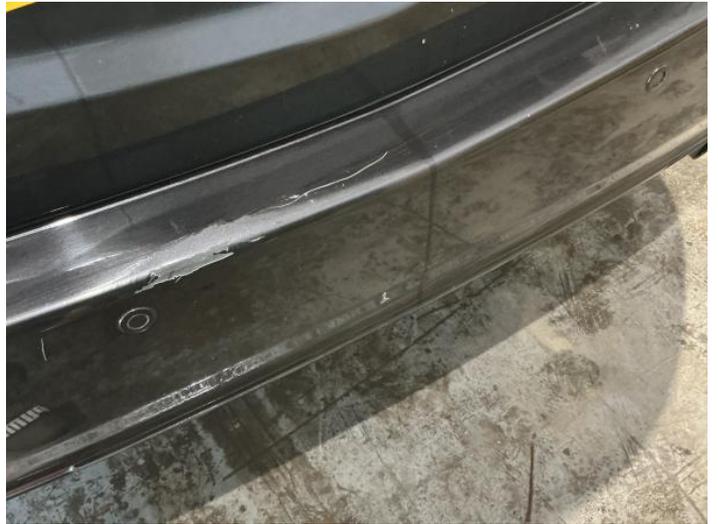
10: Bumper Rear
Dented
With Paint Damage

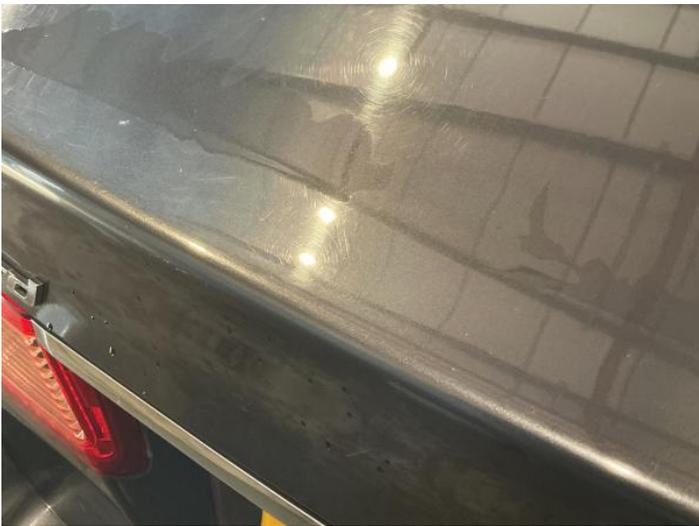
11: Tailgate
Scratched
UpTo 25mm Thru Paint

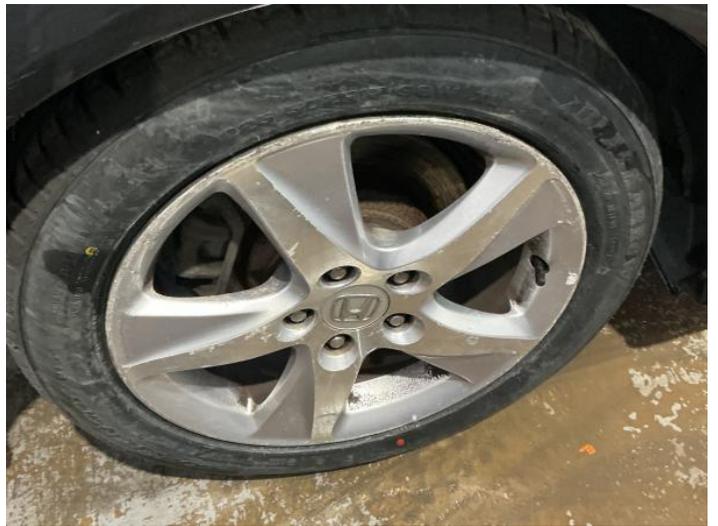
12: Wheel nsr
Scratched
Over 50mm

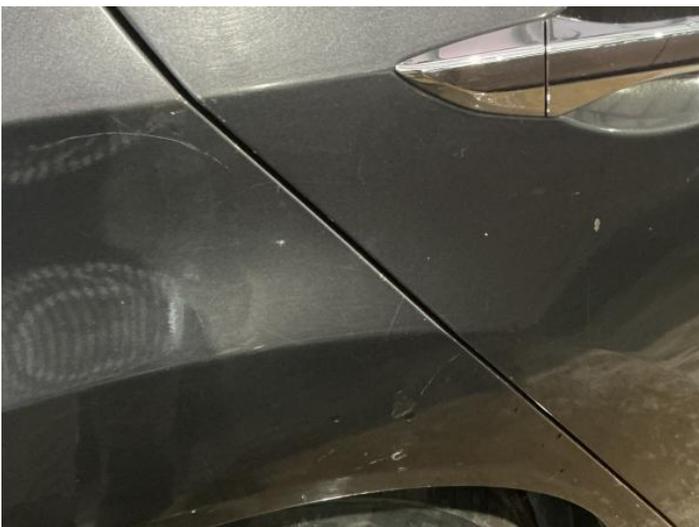
13: Qtr Panel osr
Scratched
Over 25mm Thru Paint

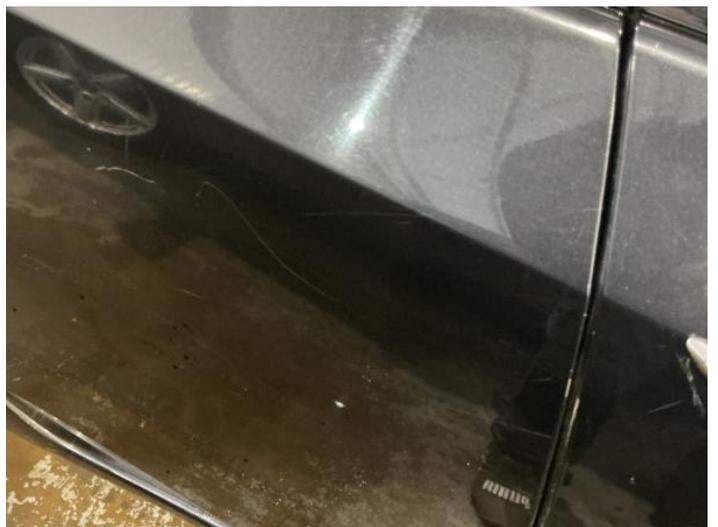
14: Door osr
Scratched
Over 25mm Thru Paint

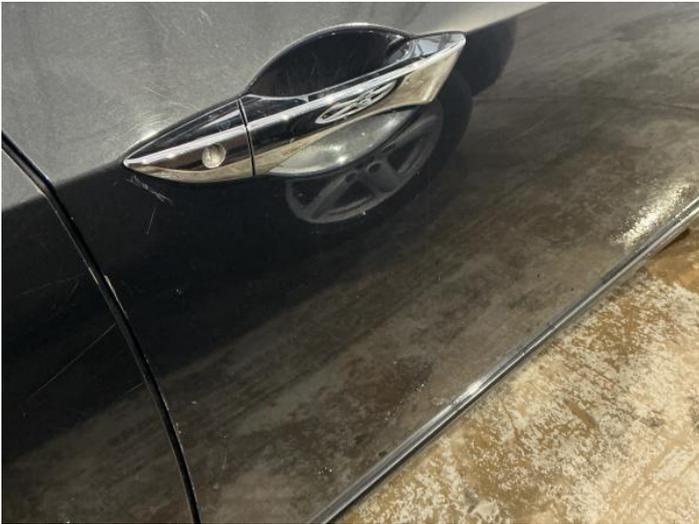
15: Door nsf
Scratched
Over 25mm Thru Paint

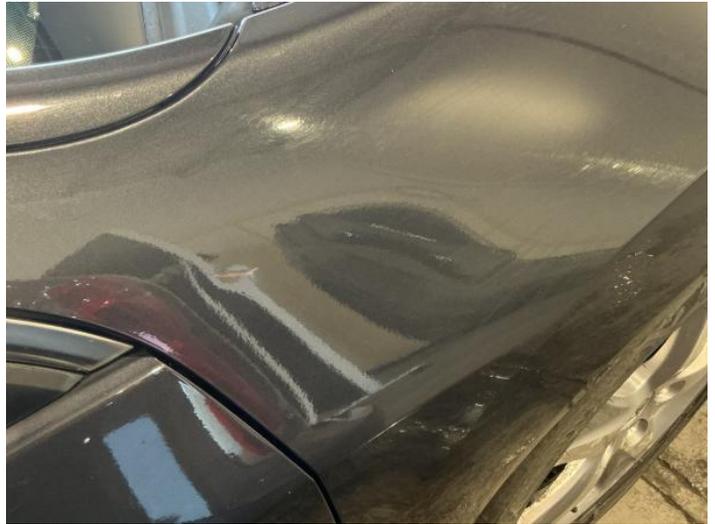
16: Wing osf
Dented
With Paint Damage

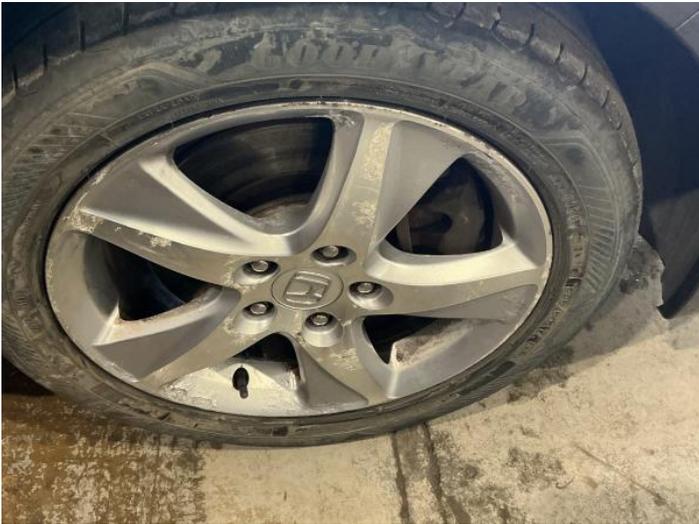
17: Wheel osf
Corroded
Light

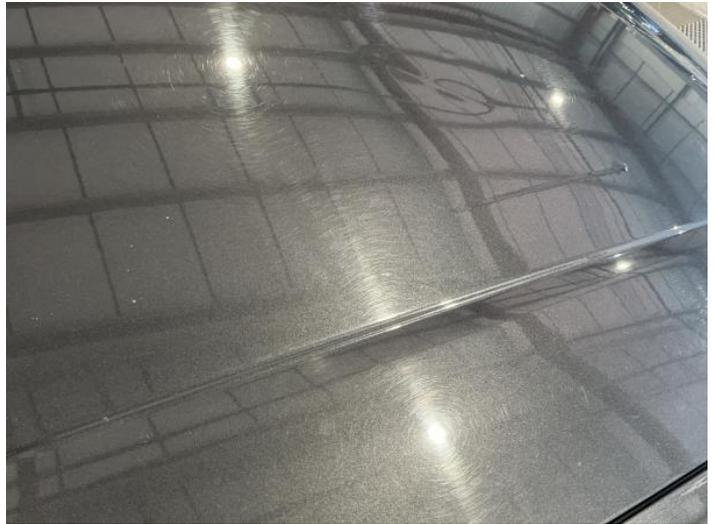
18: Bonnet
Dented
Over 30mm

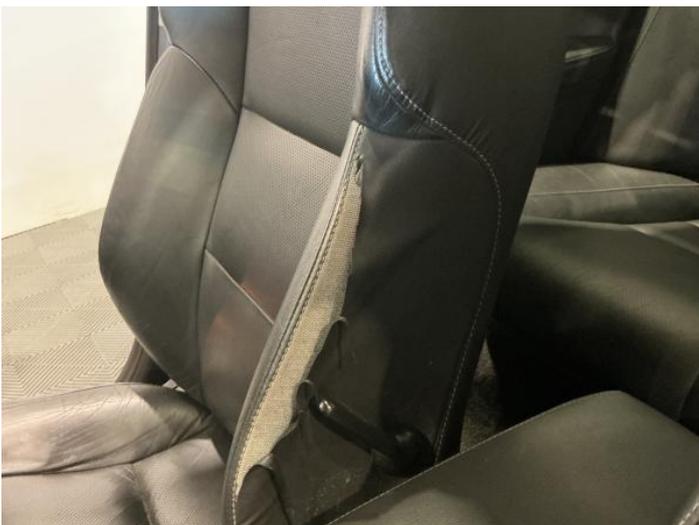
19: Seat Back Cover osf
Scuffed
Over 25mm

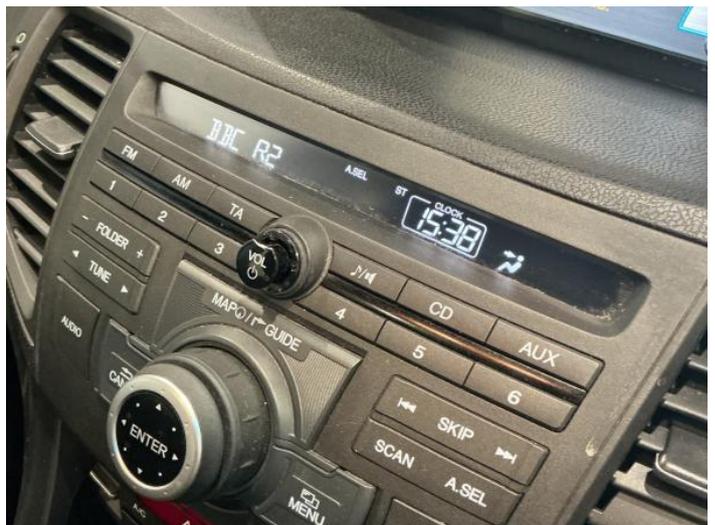
20: Switches And Controls
Broken
Replace
