VEHICLE INSPECTION REPORT

GN65XSF

Peugeot 208 1.2 PureTech 82 Active 3dr

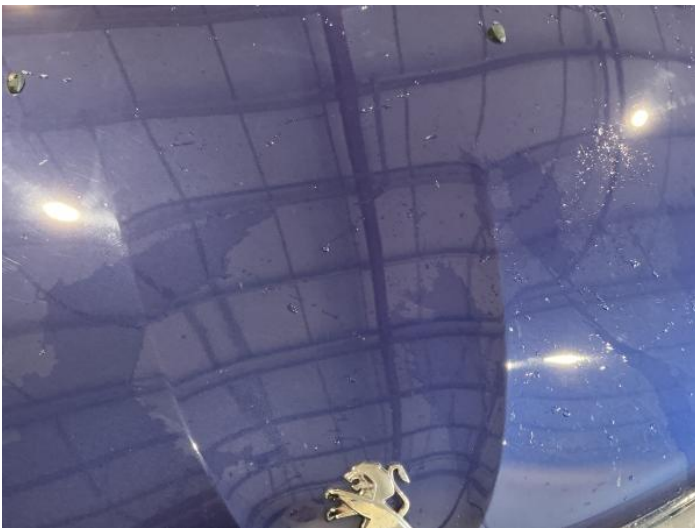
1: Bonnet
Chipped
1 To 5

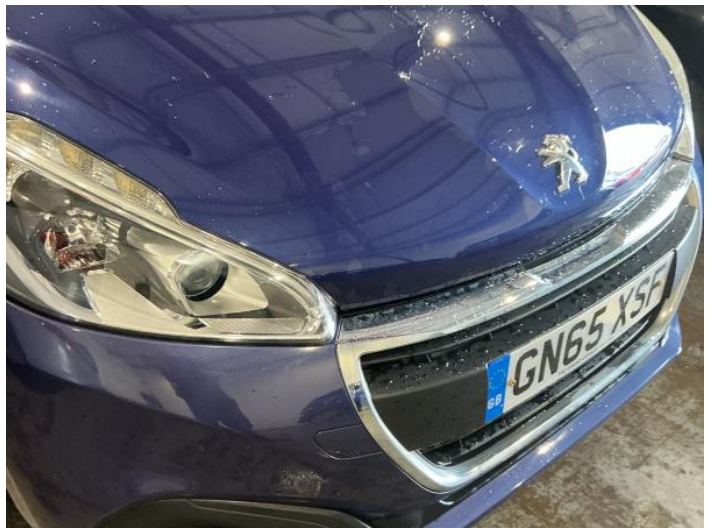
2: Bumper Front
Poor Previous Repair
Poor Paint

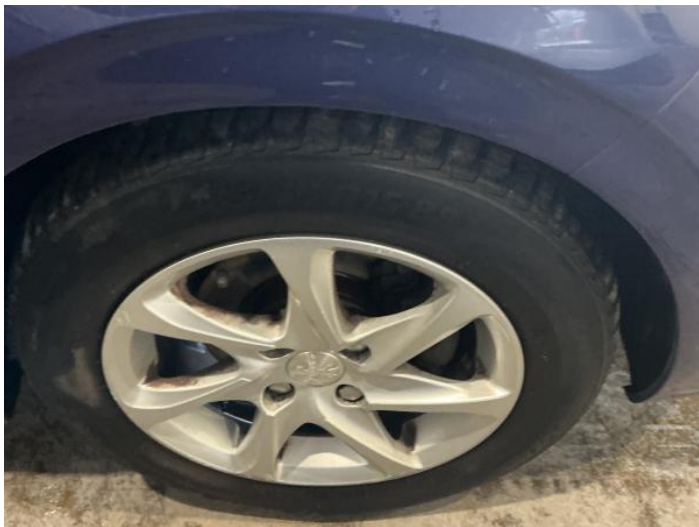
3: Wheel osf
Scratched
Up To 50mm

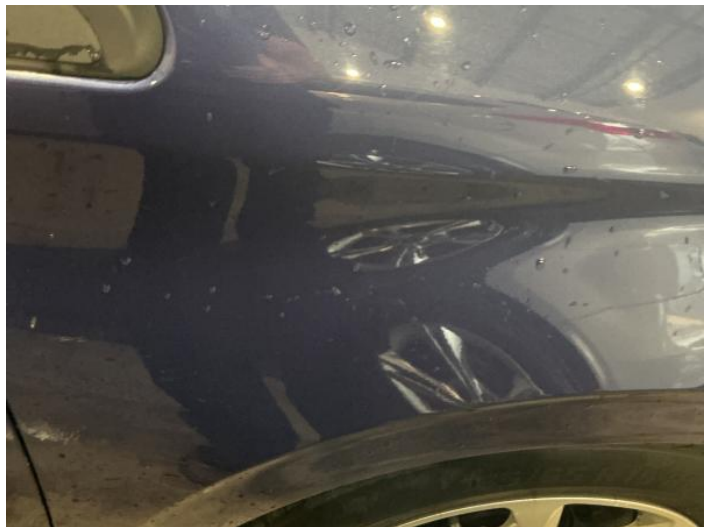
4: Wing osf
Chipped
1 To 5

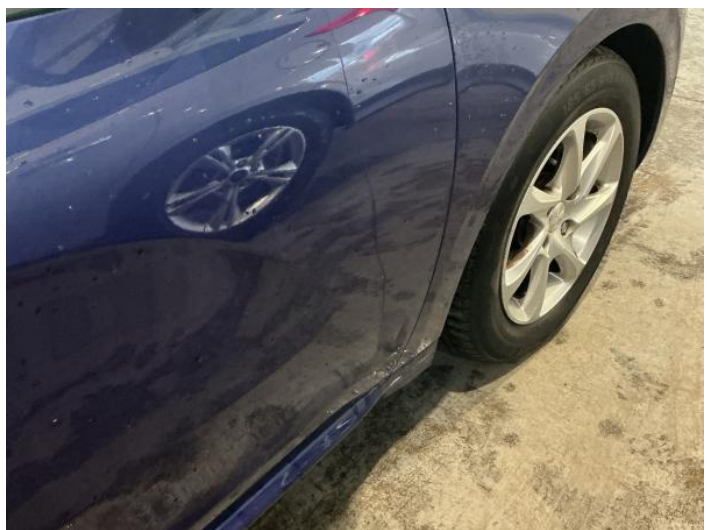
6: Door osf
Dented
Between 10mm + 30mm

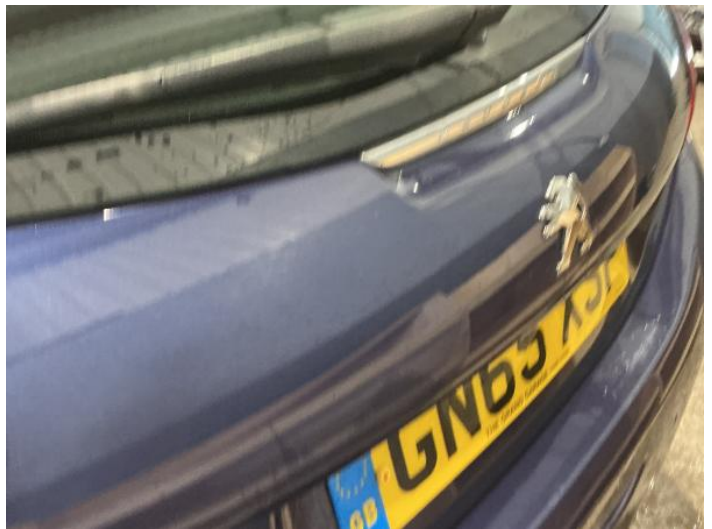
12: Boot Lid
Chipped
1 To 5

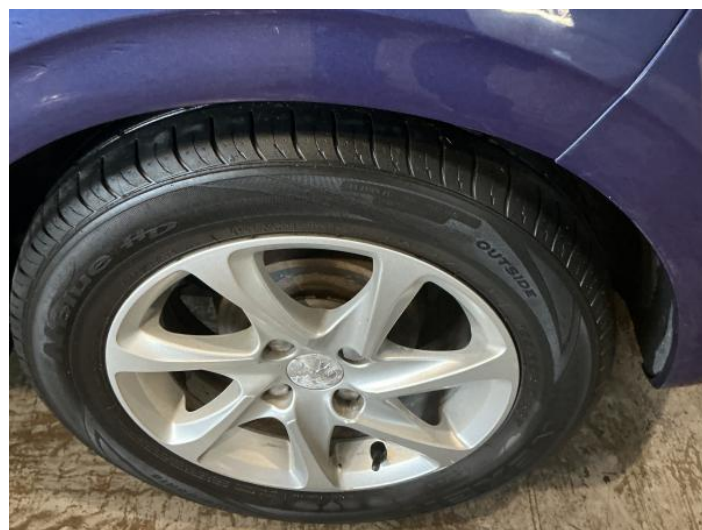
13: Wheel nsr
Scratched
Up To 50mm

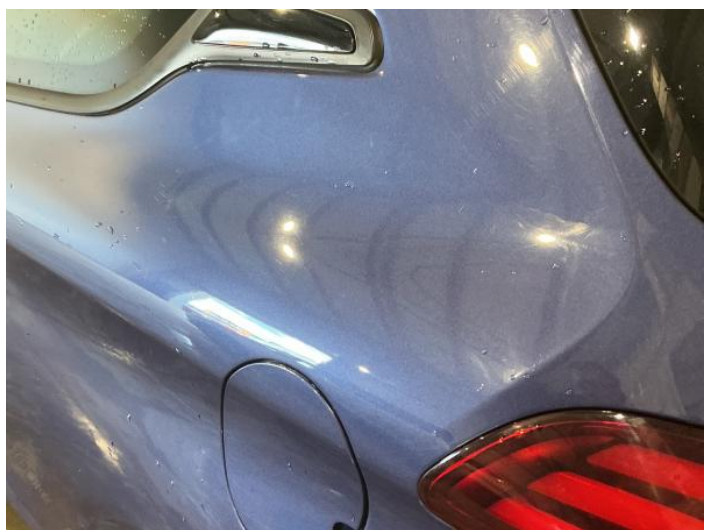
14: Qtr Panel nsr
Chipped
1 To 5

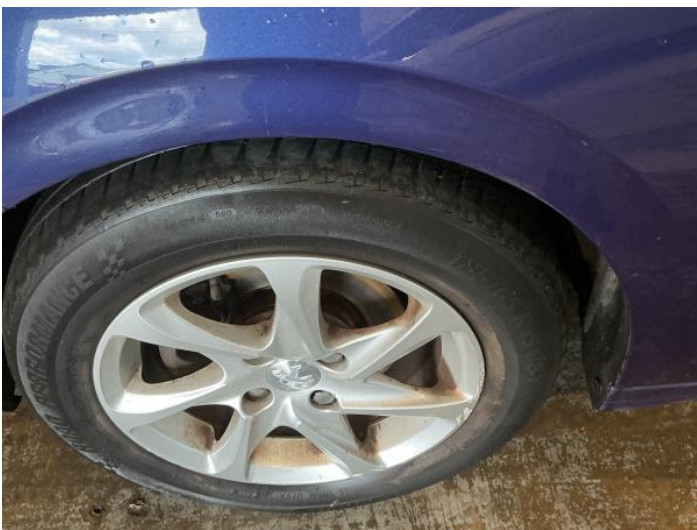
19: Wheel nsf
Scratched
Up To 50mm
