VEHICLE INSPECTION REPORT

MV14GZY

Ford Focus 1.0 EcoBoost Zetec Navigator 5dr

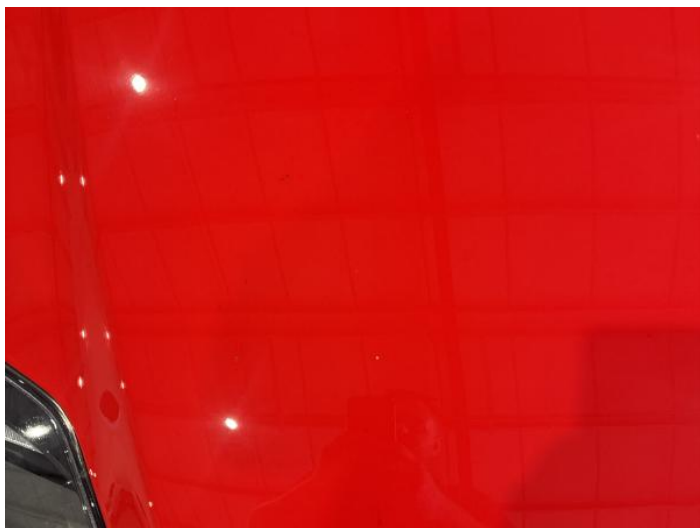
1: Bonnet
Chipped
1 To 5

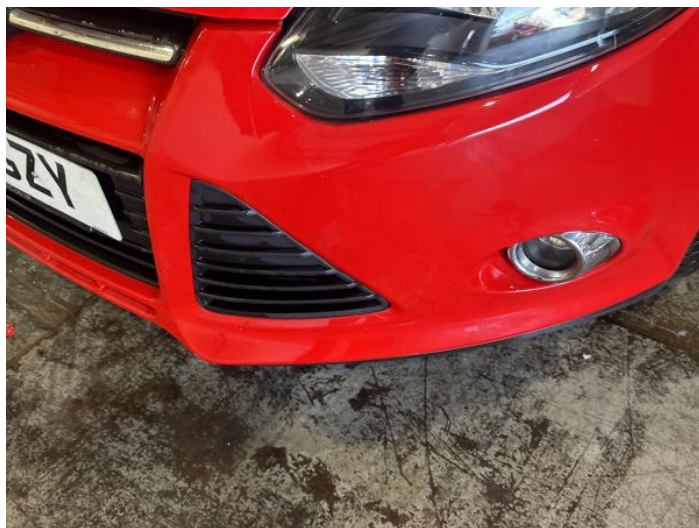
2: Bumper Front
Poor Previous Repair
Poor Colour

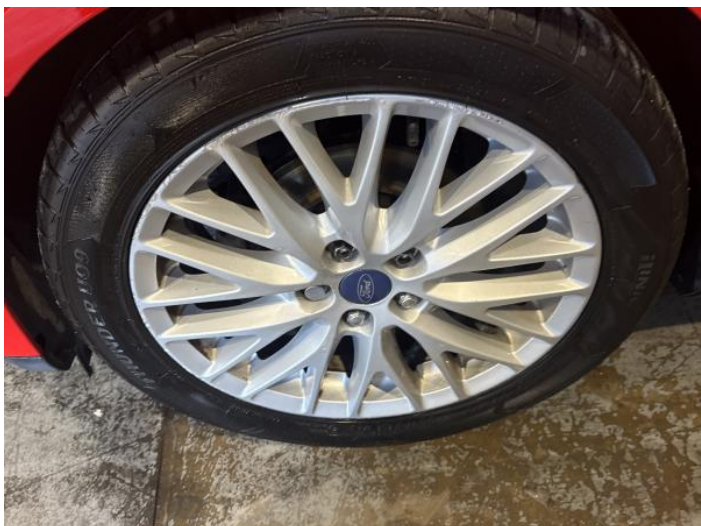
3: Wheel nsf
Scratched
Over 50mm

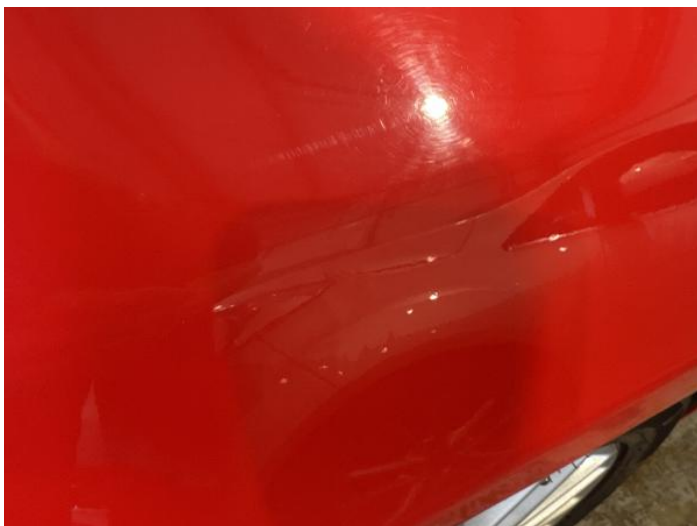
4: Wing nsf
Poor Previous Repair
Poor Paint

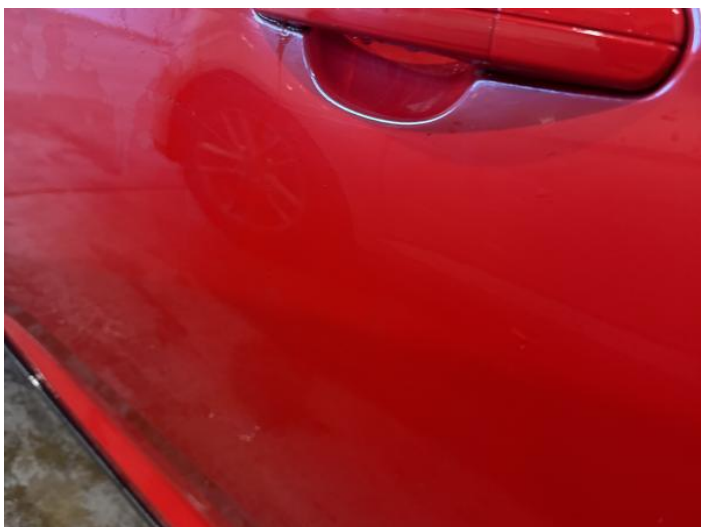
5: Door nsf
Dented
Between 10mm + 30mm

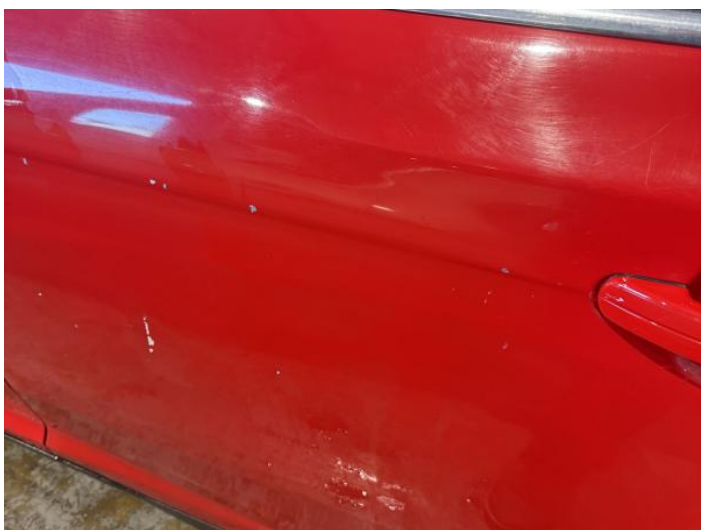
7: Door nsr
Chipped
Multiple Chips

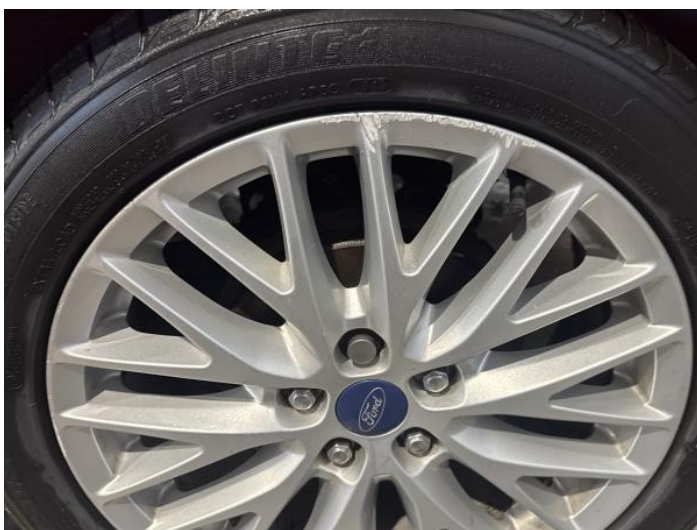
8: Wheel nsr
Scratched
Over 50mm

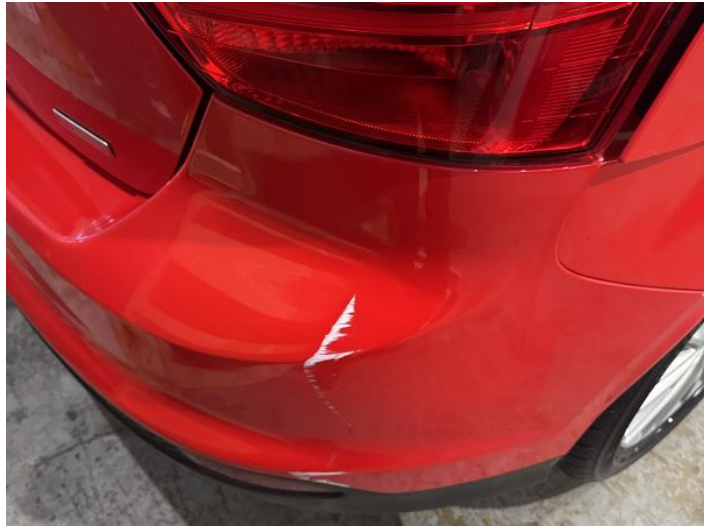
9: Qtr Panel nsr
Scratched
Over 25mm Not Thru Paint

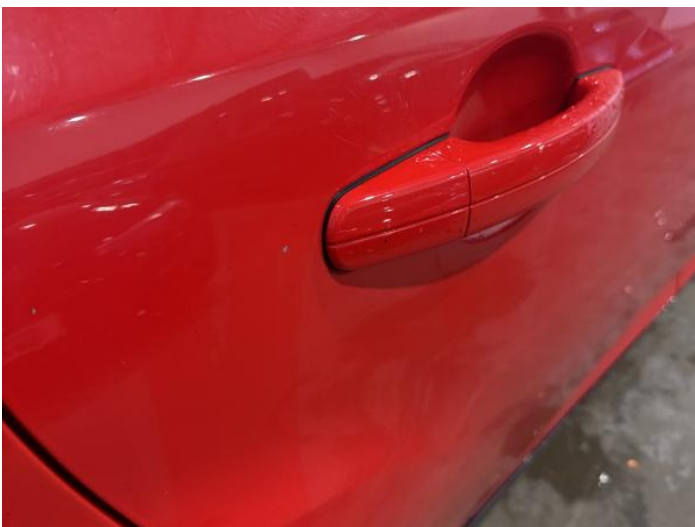
13: Door osr
Chipped
1 To 5

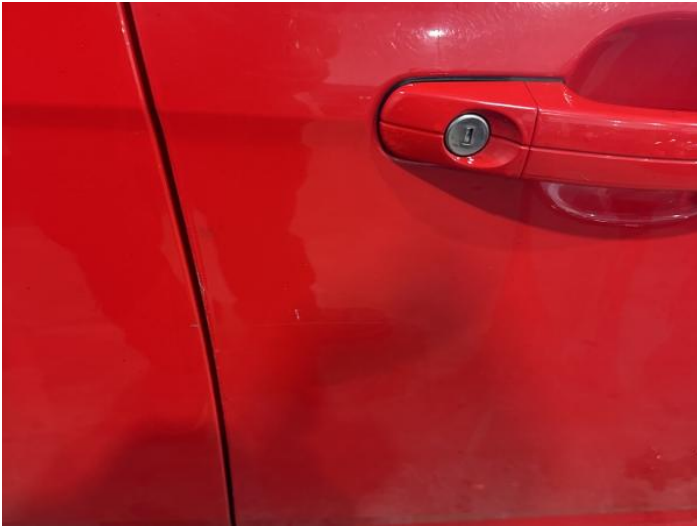
15: Door osf
Chipped
1 To 5

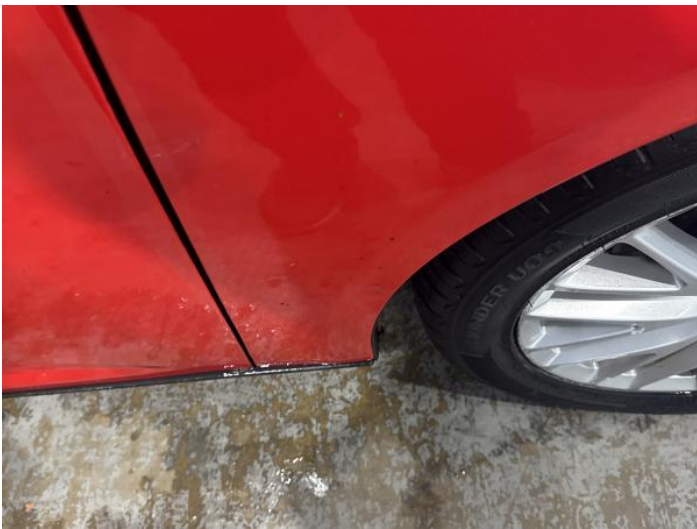
17: Wing osf
Dented
Between 10mm + 30mm

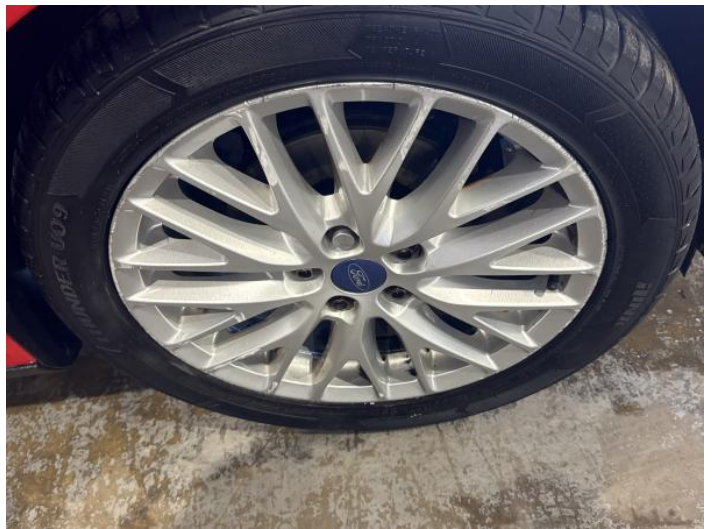
18: Wheel osf
Scratched
Over 50mm
