VEHICLE INSPECTION REPORT

GU67VPV

Ford B-Max 1.0 EcoBoost 125 Titanium Navigator 5dr

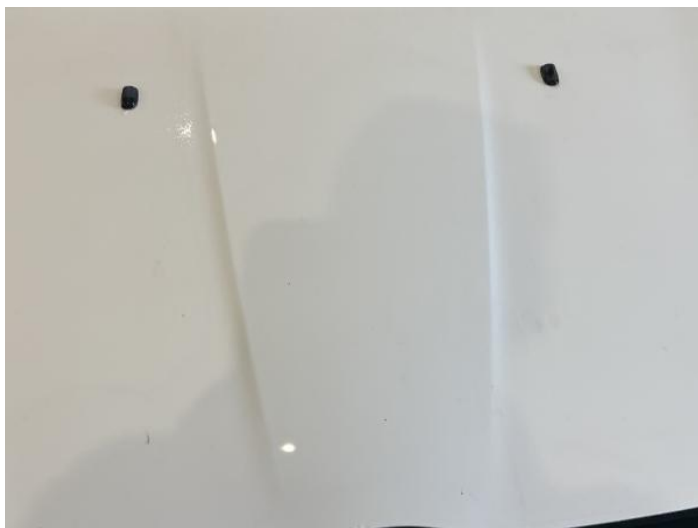
1: Bonnet
Chipped
1 To 5

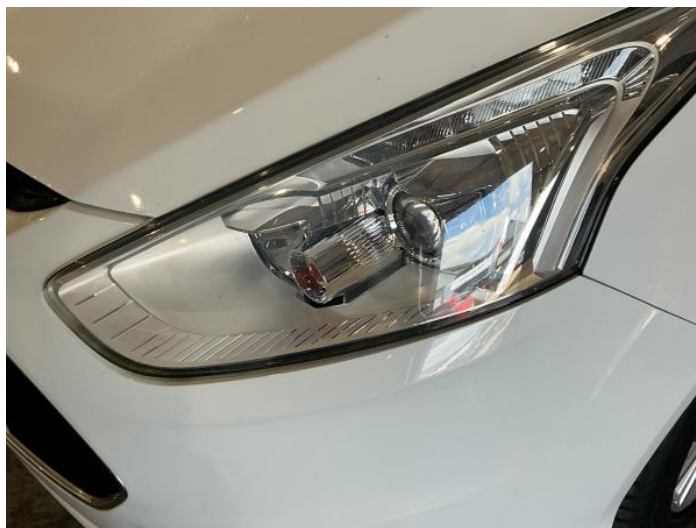
2: Bumper Front
Chipped
Multiple Chips

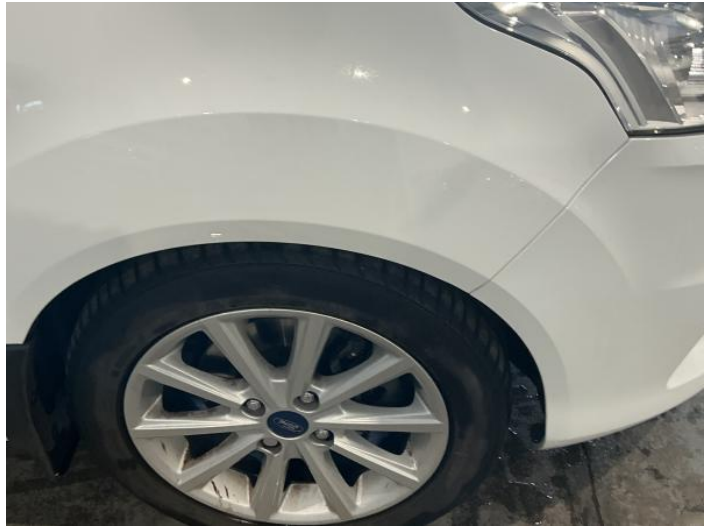
4: Wheel osf
Scratched
Up To 50mm

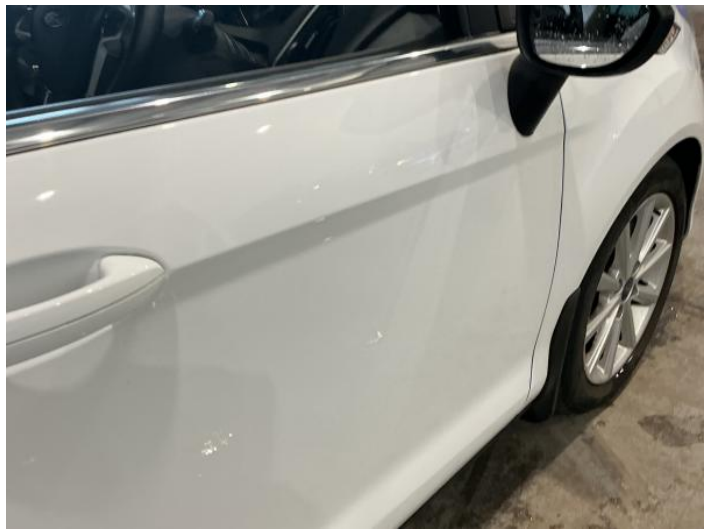
6: Door osf
Chipped
1 To 5

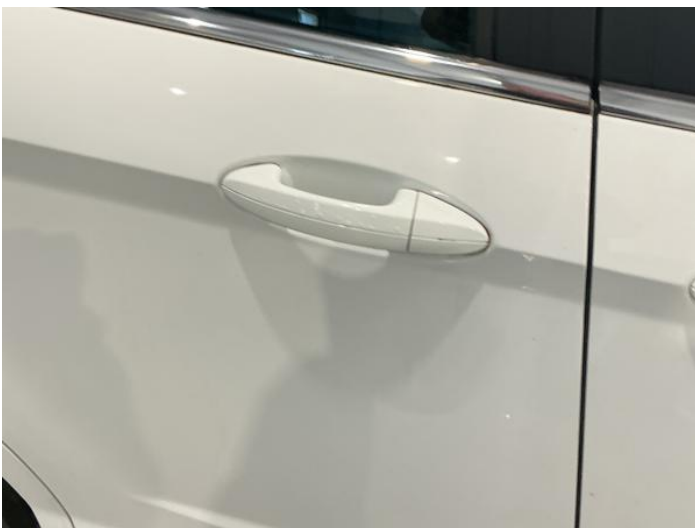
7: Door osr
Chipped
1 To 5

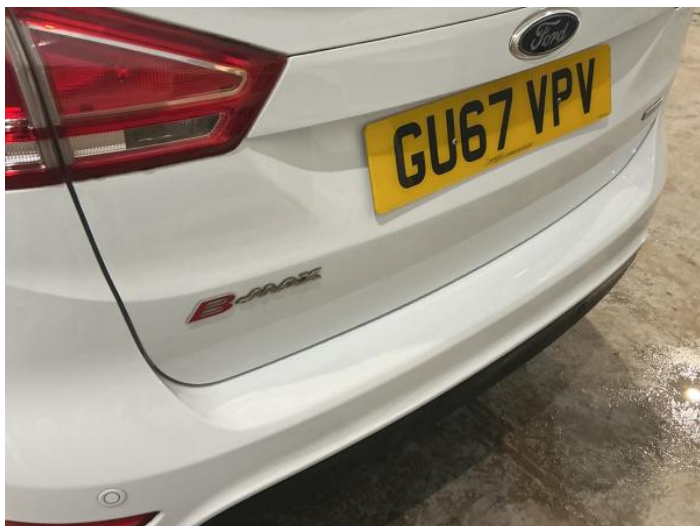
9: Bumper Rear
Chipped
Multiple Chips

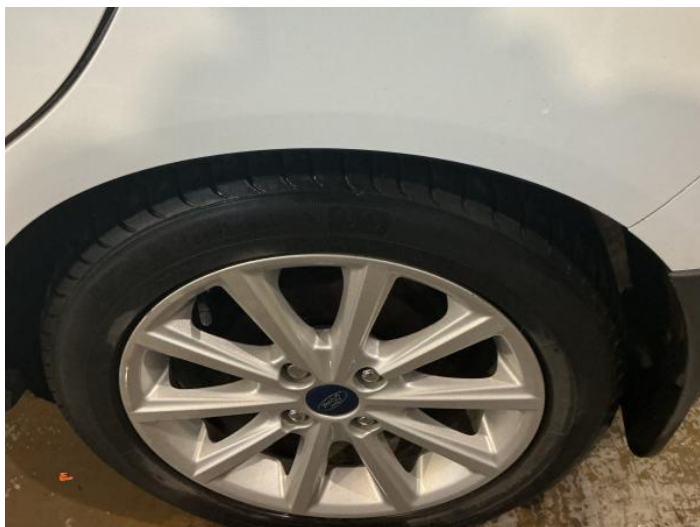
13: Wheel nsr
Scratched
Up To 50mm

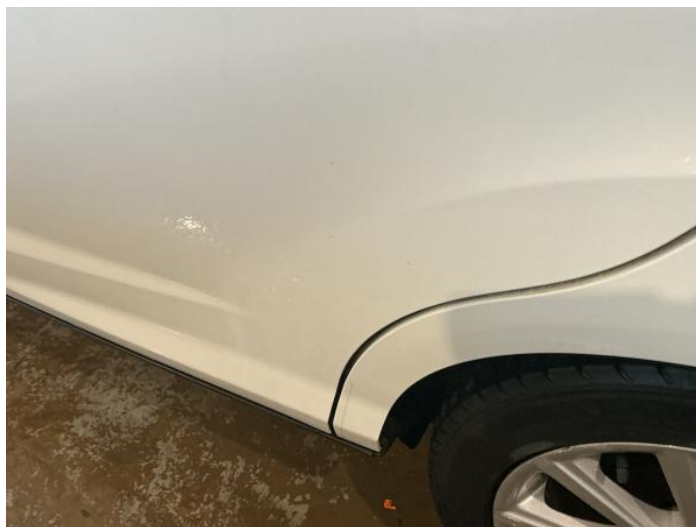
14: Door nsr
Dented
2 Or Less UpTo 10mm

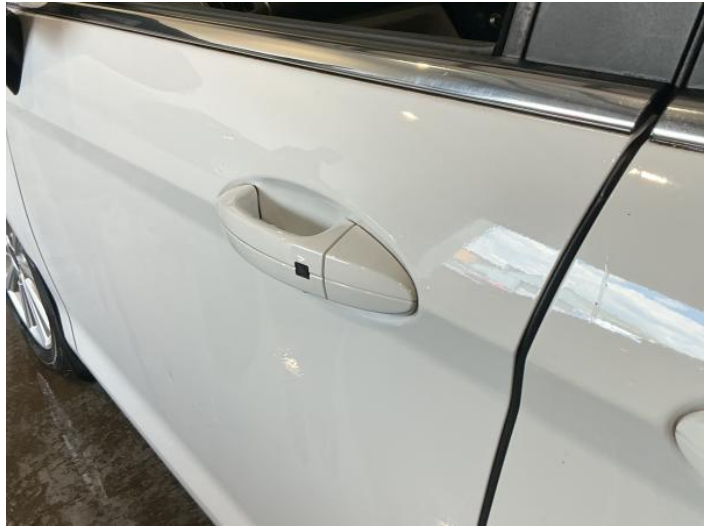
15: Door nsr
Scratched
Over 25mm Not Thru Paint

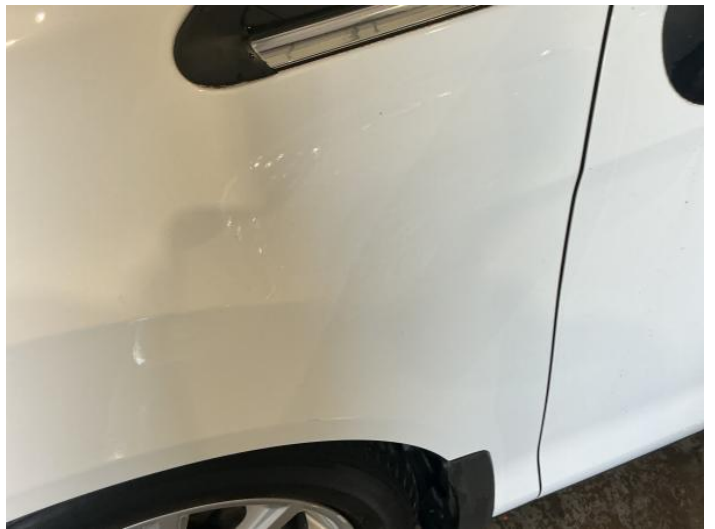
17: Door nsf
Scratched
Over 25mm Not Thru Paint

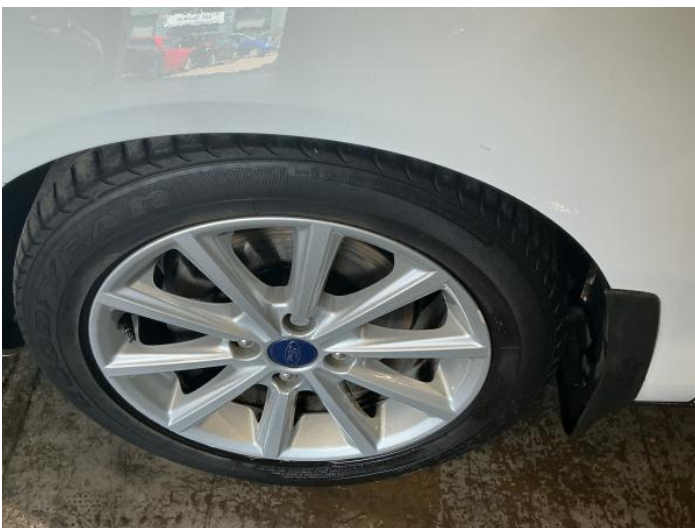
19: Wheel nsf
Scratched
Up To 50mm
