VEHICLE INSPECTION REPORT

GV11HCG

Toyota Auris 1.8 VVTi Hybrid T Spirit 5dr CVT Auto

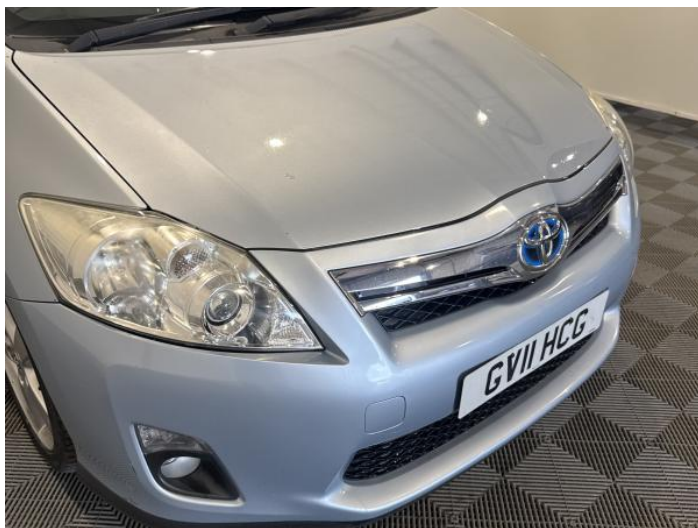
1: Bumper Front
Scratched
Over 100mm Thru Paint

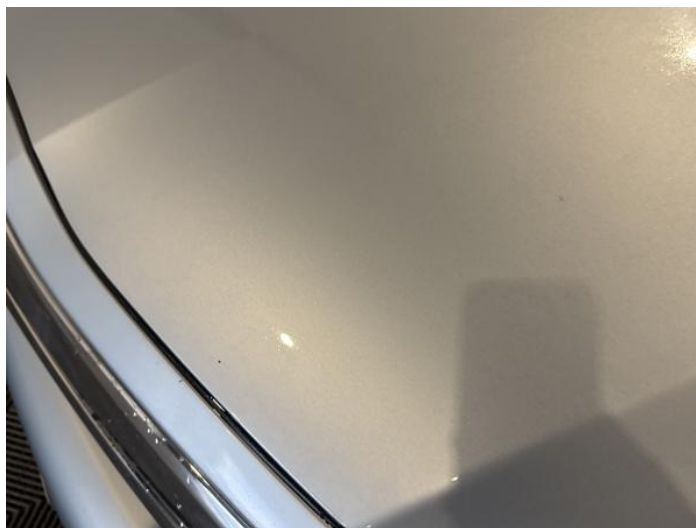
2: Bonnet
Chipped
Over 5mm

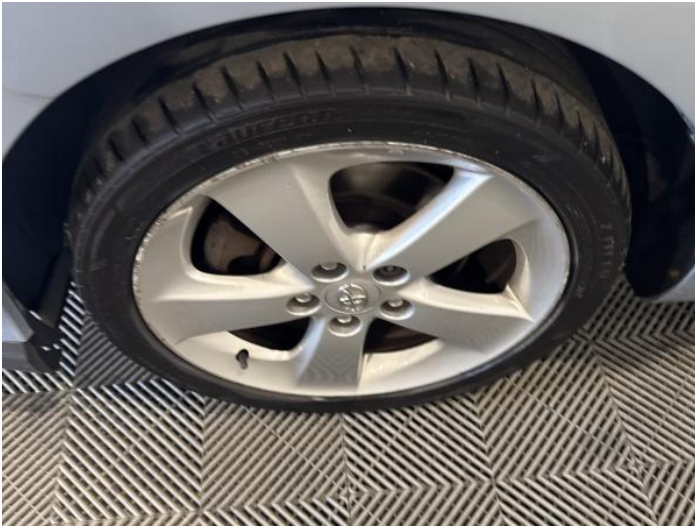
3: Wheel nsf
Scratched
Over 50mm

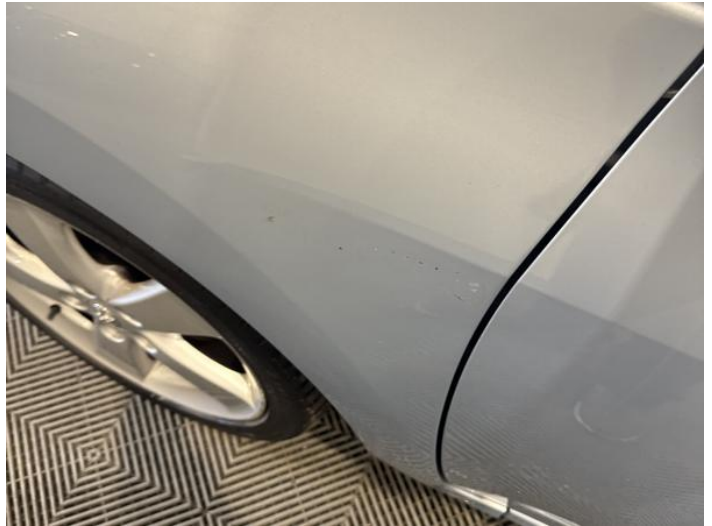
4: Wing nsf
Chipped
1 To 5

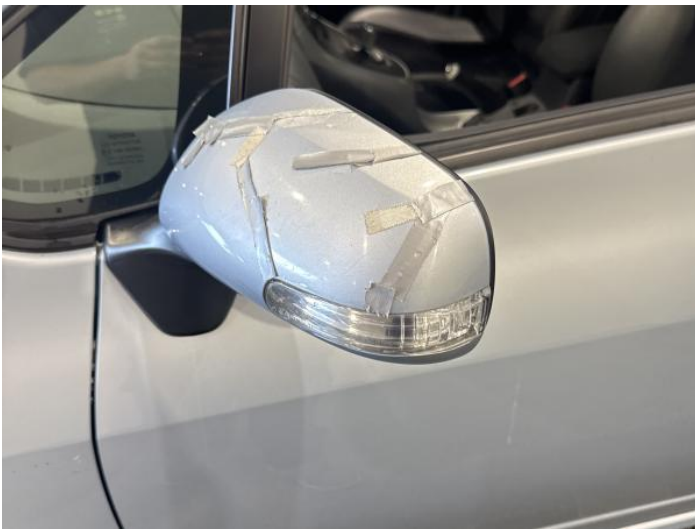
5: Door Mirror Assy nsf
Broken
Replace

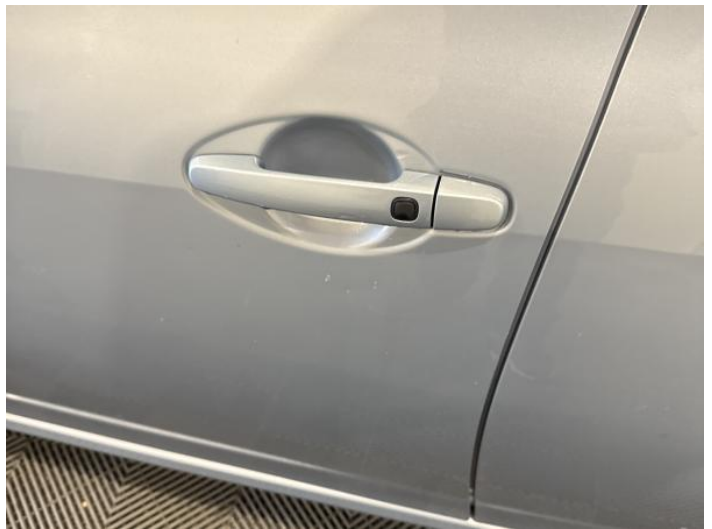
6: Door nsf
Chipped
1 To 5

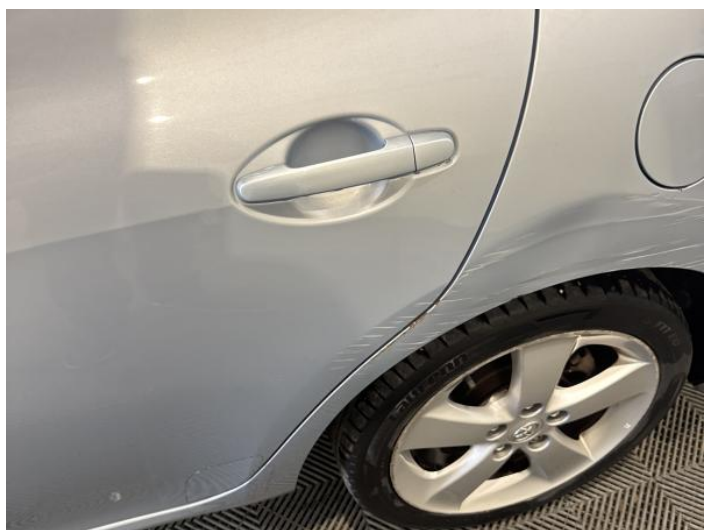
8: Door nsr
Scratched
Over 25mm Thru Paint

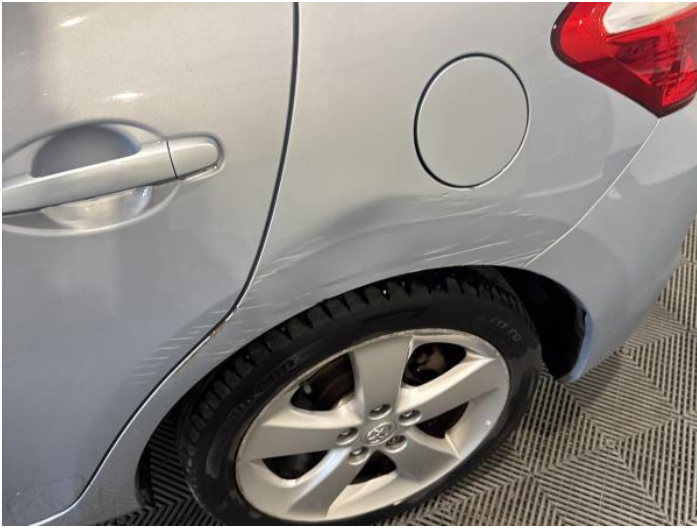
9: Qtr Panel nsr
Dented
With Paint Damage

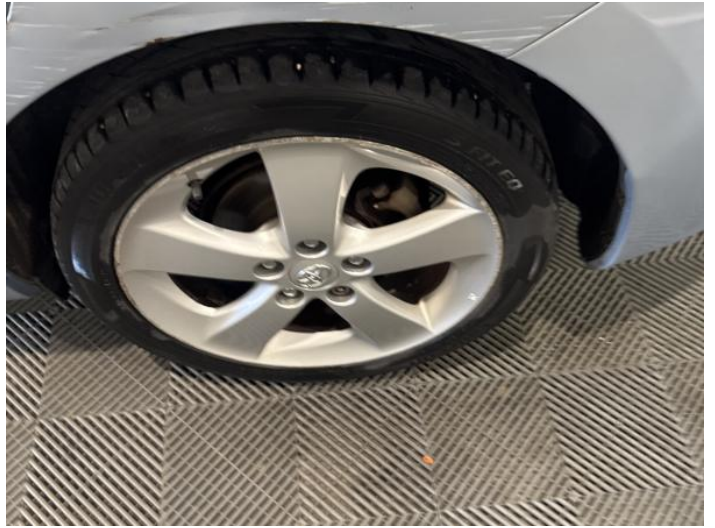
10: Wheel nsr
Scratched
Over 50mm

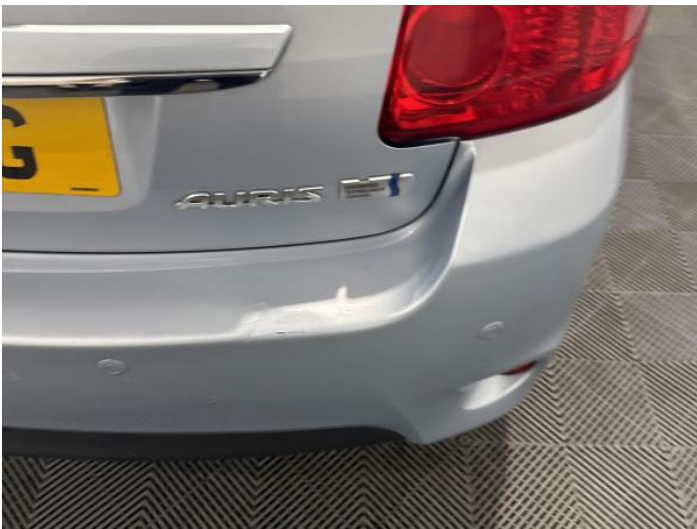
11: Bumper Rear
Poor Previous Repair
Rippled UpTo 30%

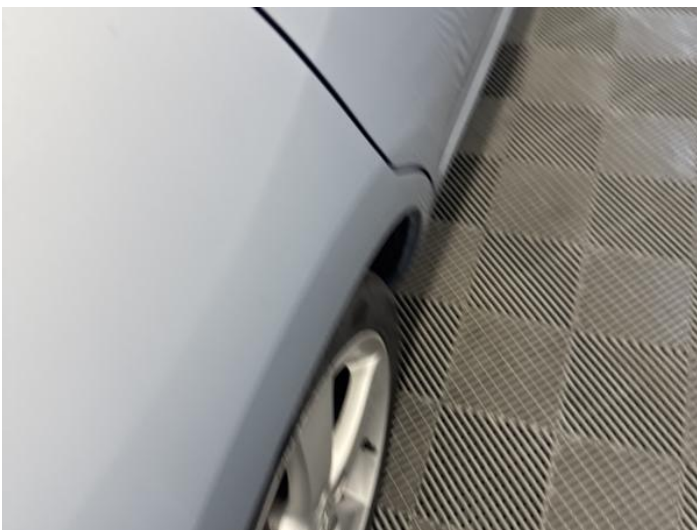
13: Qtr Panel osr
Dented
2 Or Less UpTo 10mm

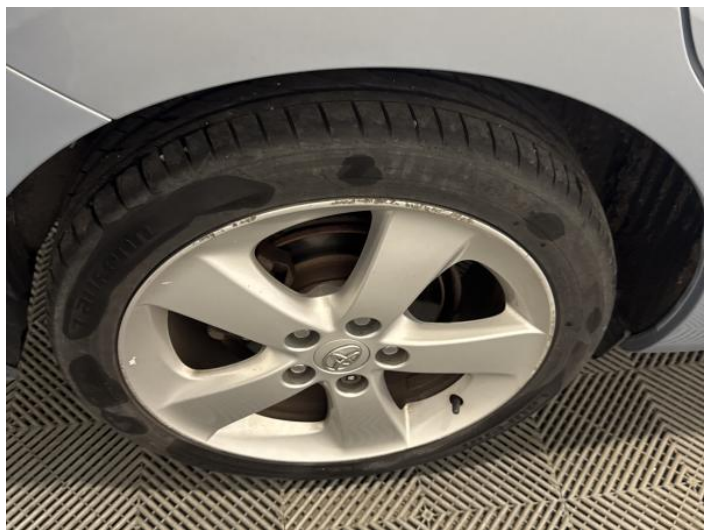
14: Wheel osr
Scratched
Over 50mm

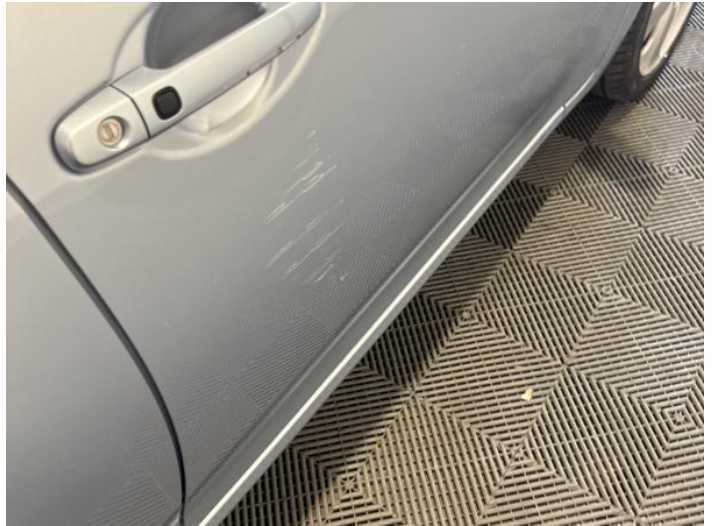
15: Door osf
Scratched
Over 25mm Not Thru Paint

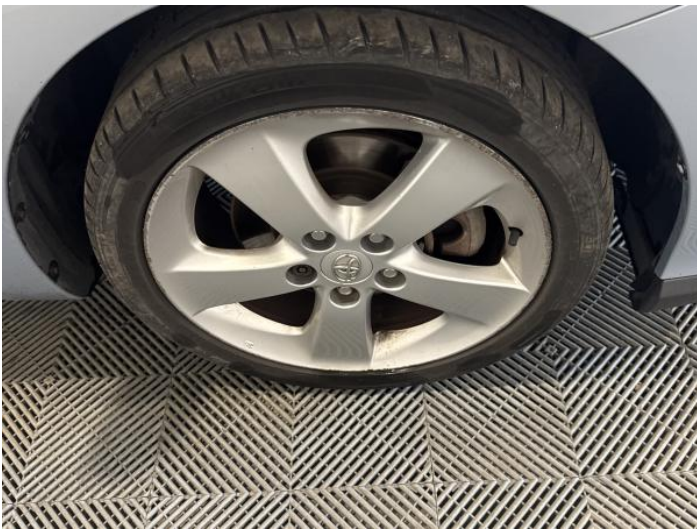
17: Wheel osf
Scratched
Over 50mm

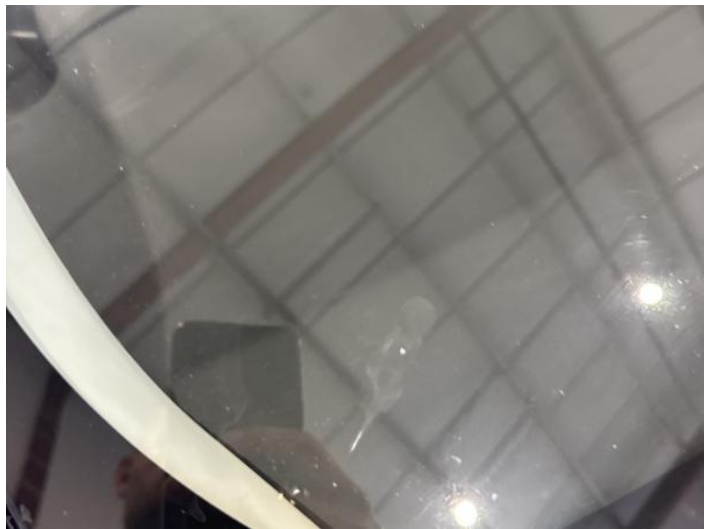
18: Screen Front
Chipped
UpTo 10mm
