# VEHICLE INSPECTION REPORT

**WR15NHG**

## Skoda Rapid Spaceback 1.6 TDI CR SE Tech 5dr

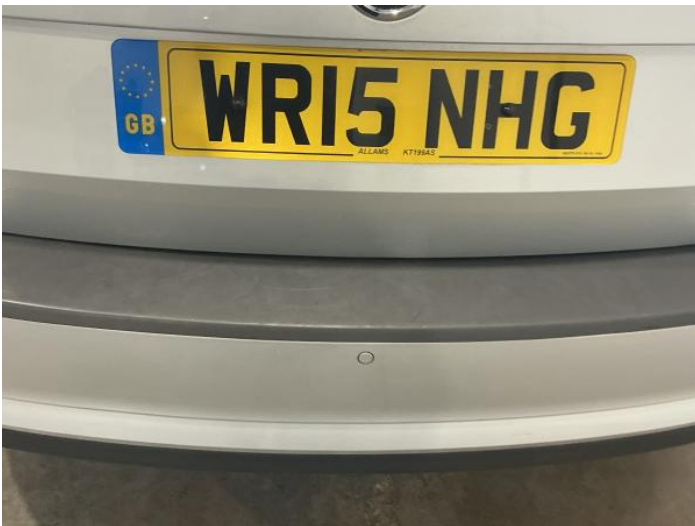
1: Bumper Rear  
Chipped  
Multiple Chips

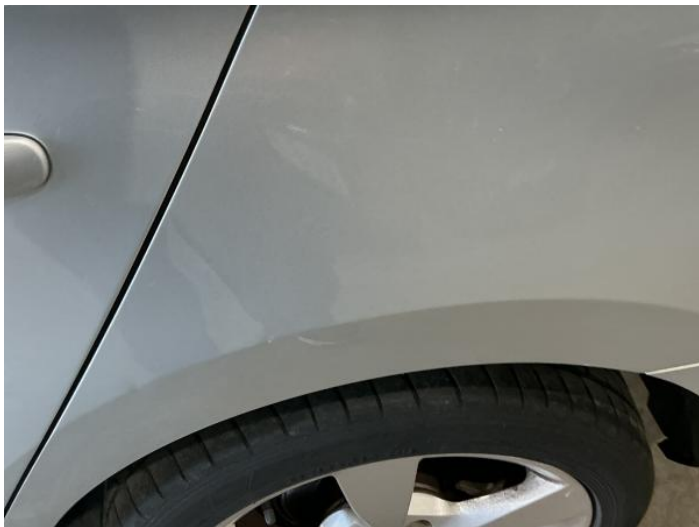
3: Qtr Panel nsr  
Dented  
Between 10mm + 30mm

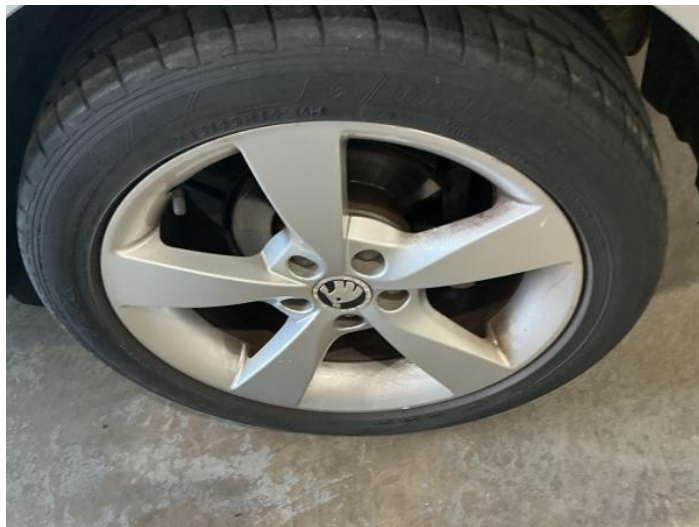
4: Wheel nsr  
Scratched  
Up To 50mm

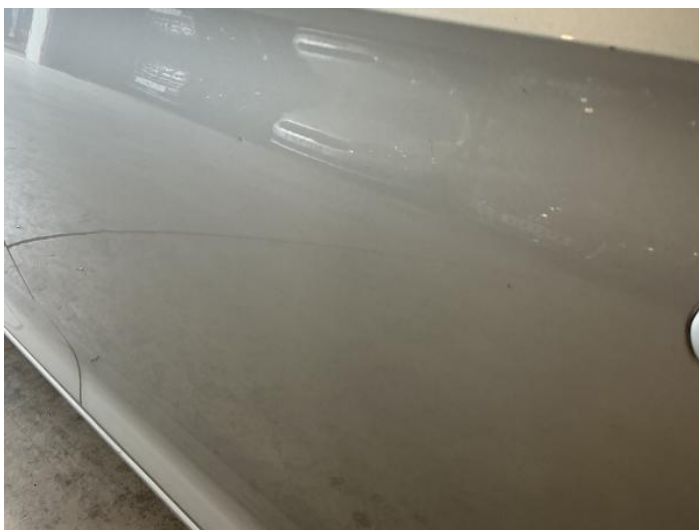
5: Door nsr  
Dented  
2 Or Less UpTo 10mm

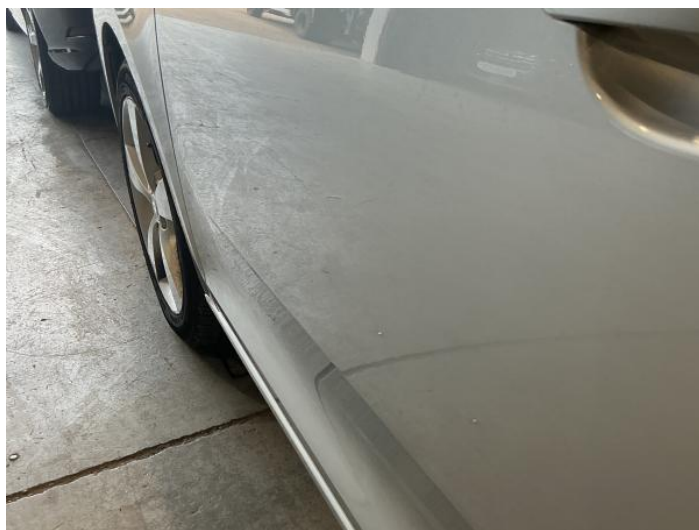
6: Door nsf  
Dented  
Over 30mm

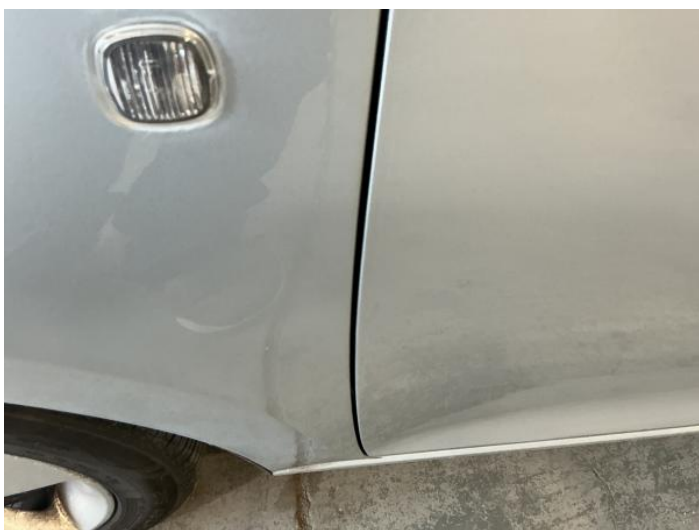
7: Wing nsf  
Dented  
Over 2 UpTo 10mm

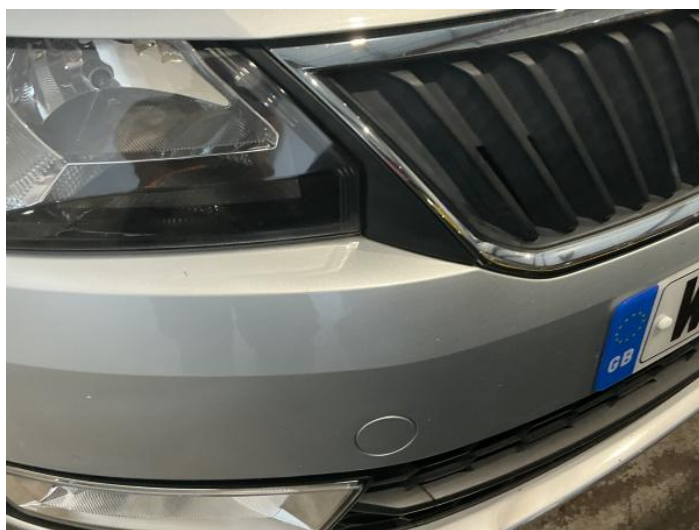
8: Bumper Front  
Poor Previous Repair  
Poor Paint

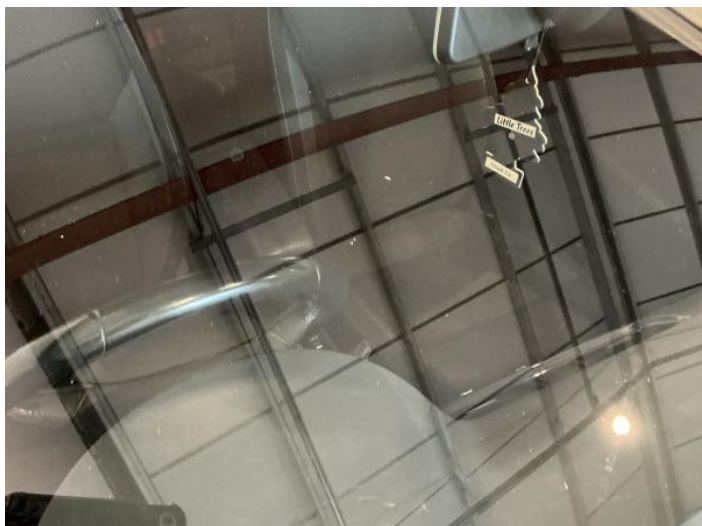
9: Screen Front  
Chipped  
UpTo 10mm

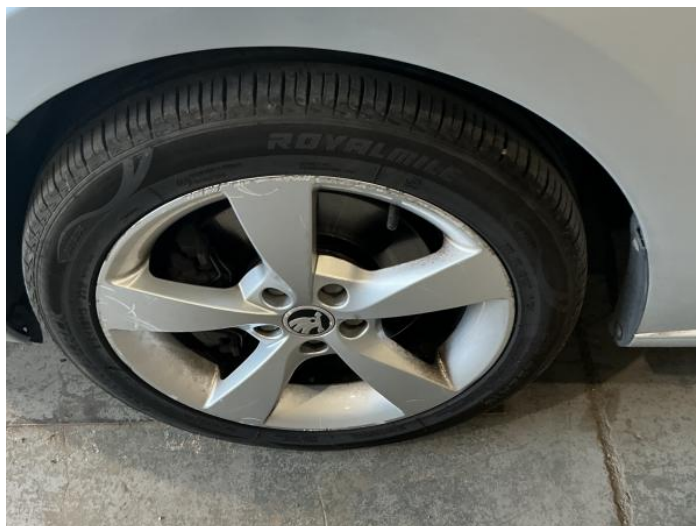
10: Wheel nsf  
Scratched  
Over 50mm

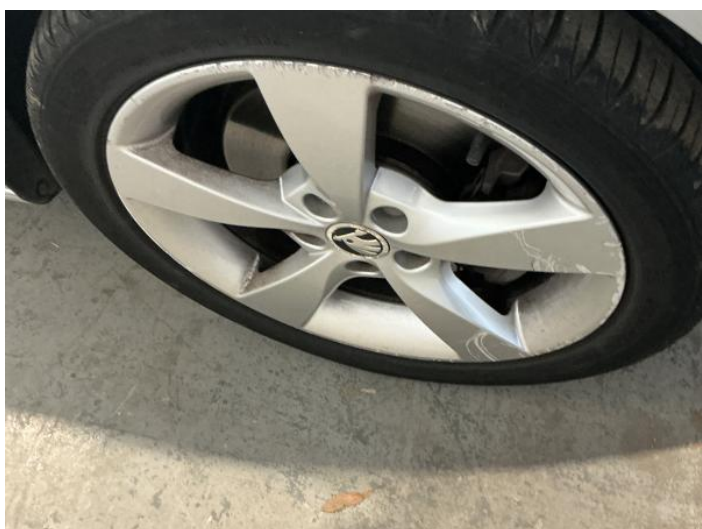
11: Wheel osf  
Scratched  
Over 50mm

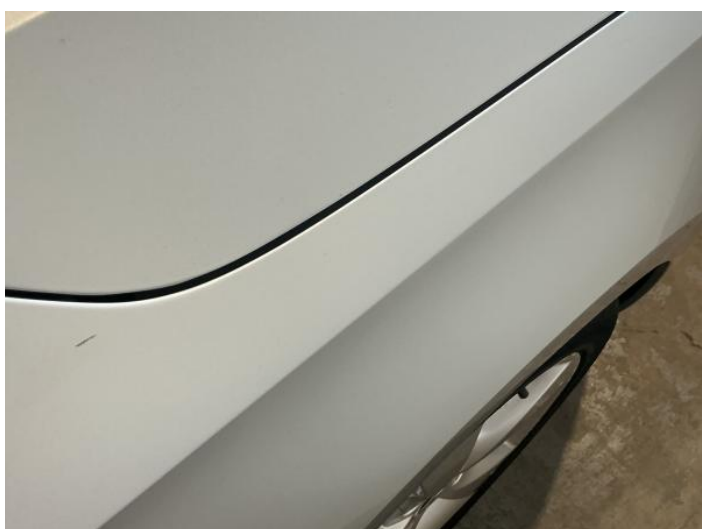
13: Wing osf  
Scratched  
UpTo 25mm Thru Paint
