VEHICLE INSPECTION REPORT

AU68FYP

Mazda CX-5 2.2d [184] Sport Nav+ 5dr Auto AWD

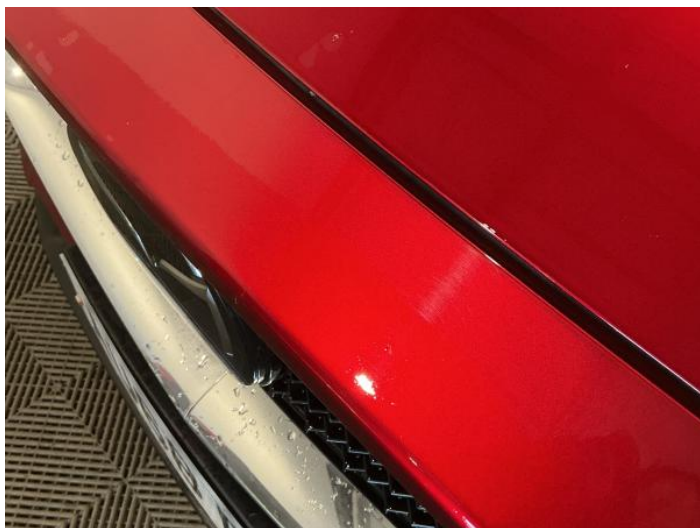
1: Bumper Front Moulding
Scratched (Painted)
UpTo 25mm Thru Paint

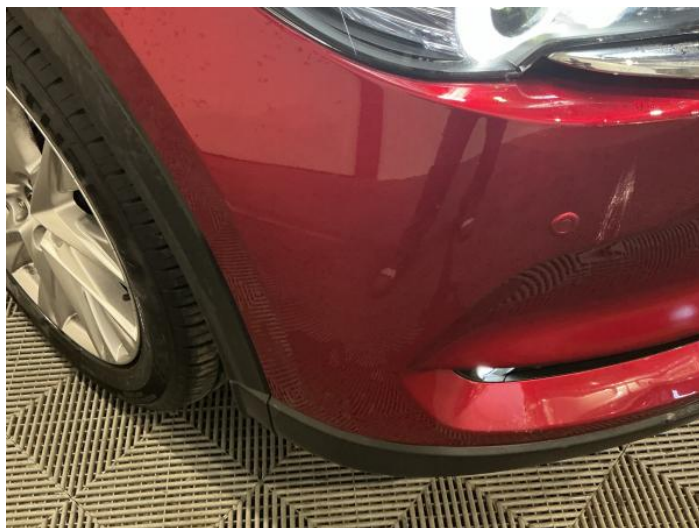
2: Bumper Front
Scratched
25 to 100mm Thru Paint

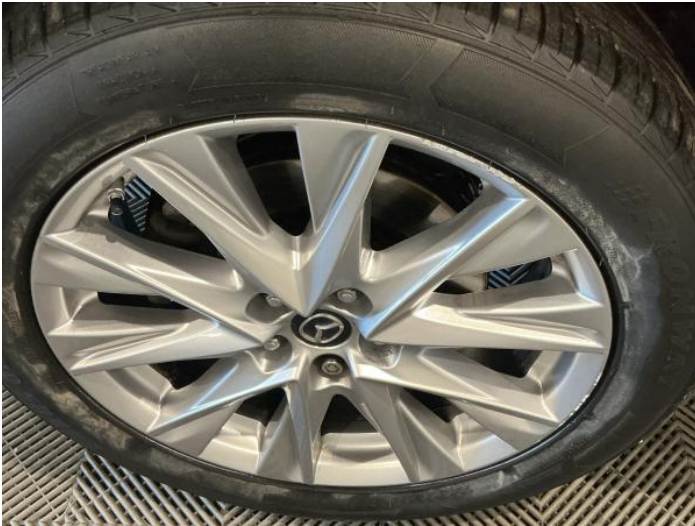
3: Wheel nsf
Scratched
Over 50mm

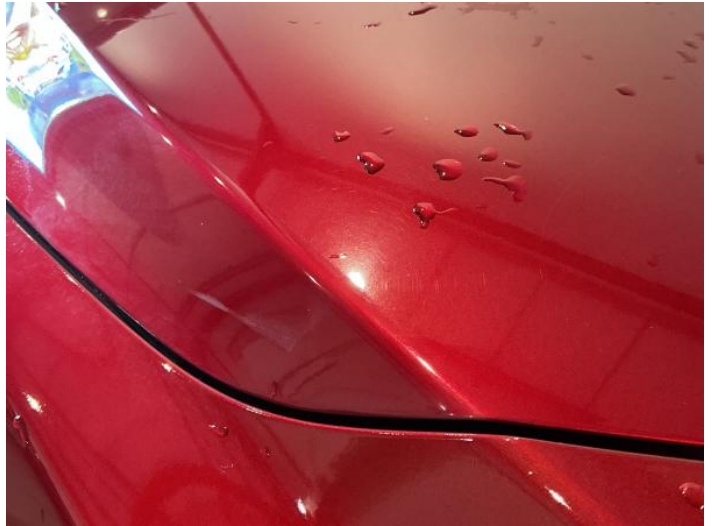
4: Bonnet
Scratched
Over 25mm Not Thru Paint

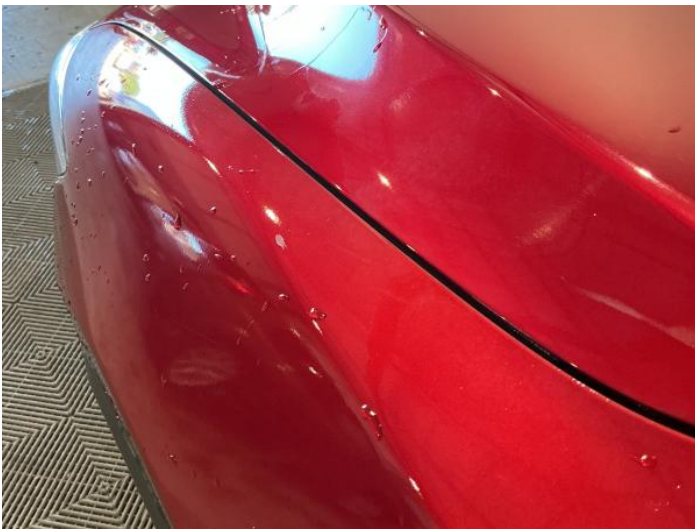
5: Wing nsf
Poor Previous Repair
Rippled UpTo 30%

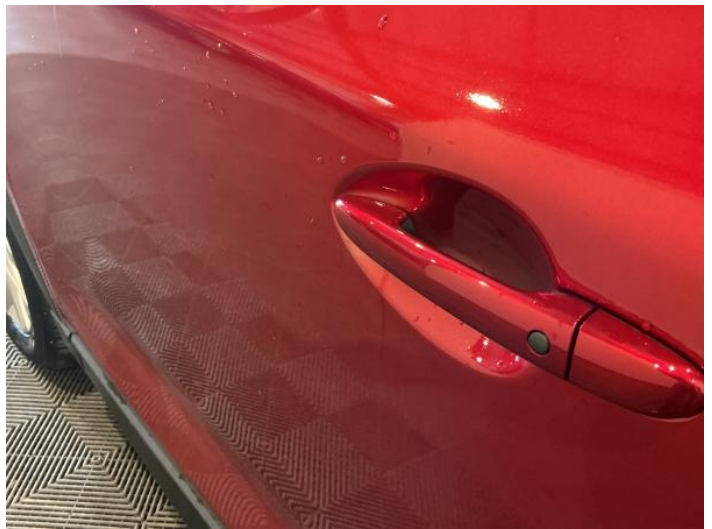
6: Door nsf
Poor Previous Repair
Poor Paint

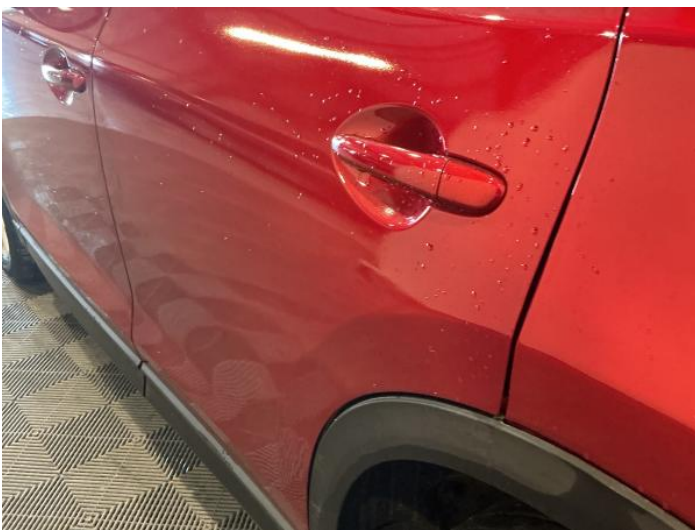
7: Door nsr
Poor Previous Repair
Rippled UpTo 30%

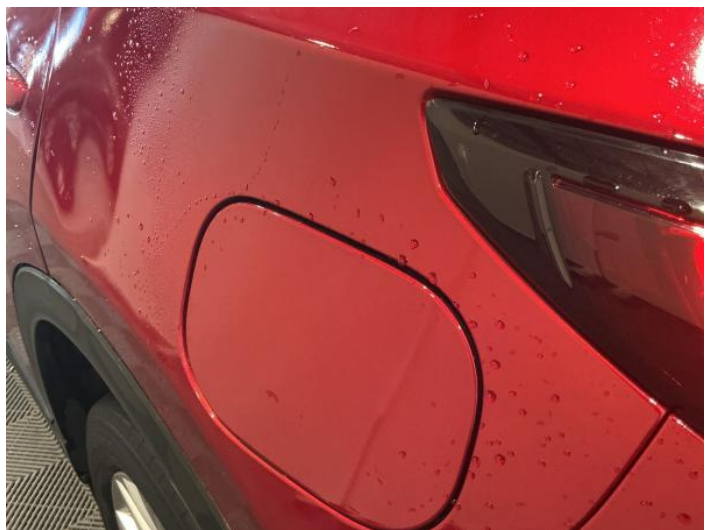
8: Qtr Panel nsr
Dented
Over 30mm

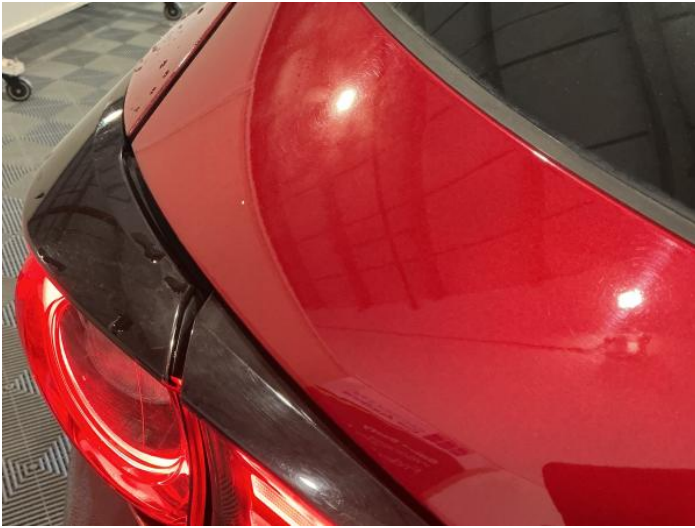
9: Tailgate
Scratched
Over 25mm Not Thru Paint

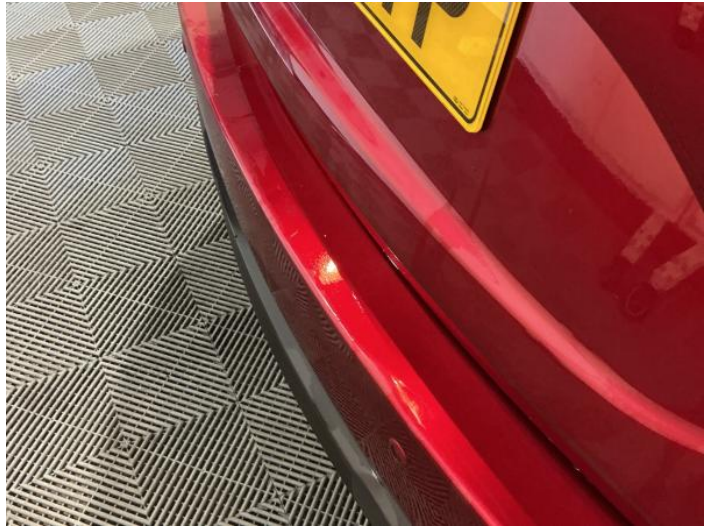
10: Bumper Rear
Scratched
25 to 100mm Thru Paint

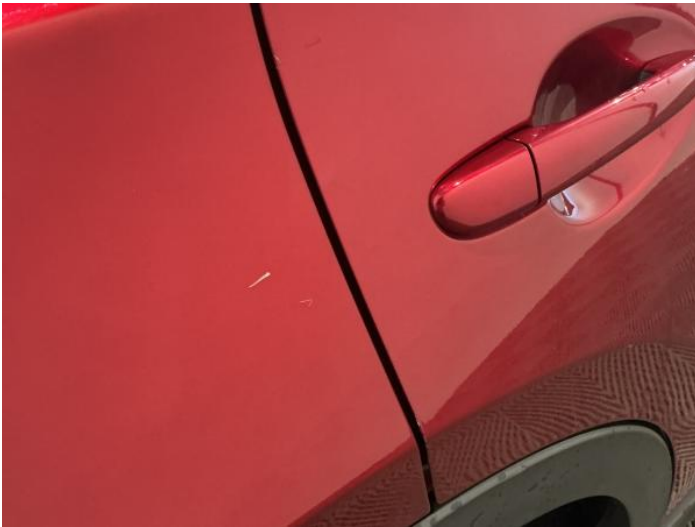
11: Qtr Panel nsr
Dented
Between 10mm + 30mm

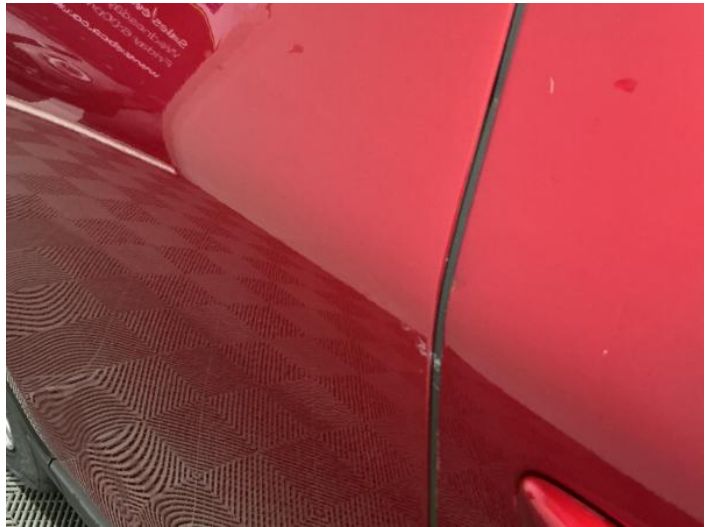
12: Door Moulding osr
Scratched (Painted)
UpTo 25mm Thru Paint

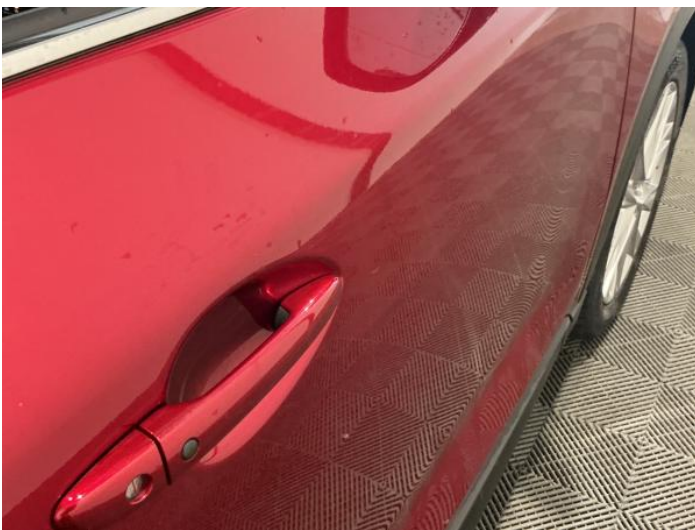
13: Door osf
Dented
Between 10mm + 30mm

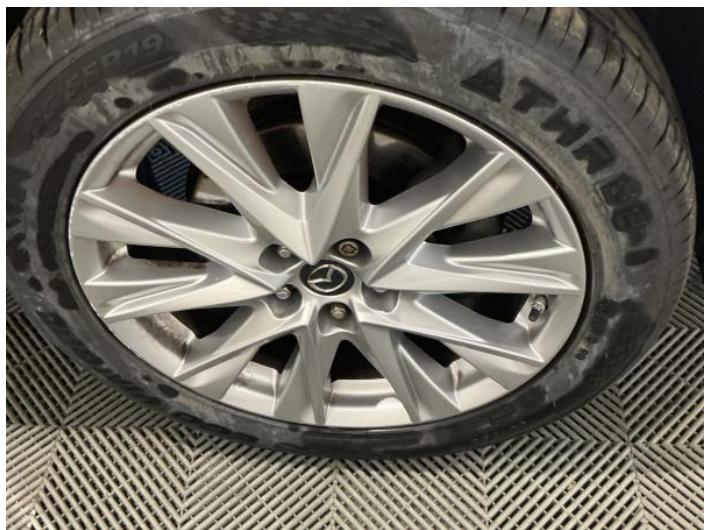
14: Wheel osf
Scratched
Over 50mm

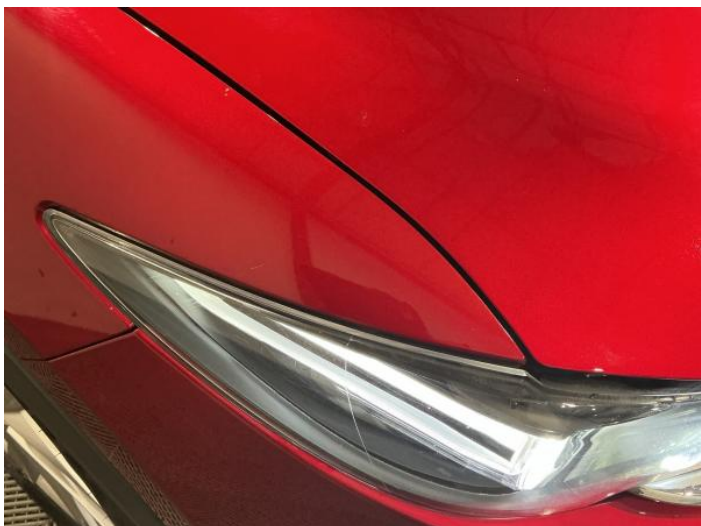
15: Wing osf
Scratched
UpTo 25mm Thru Paint
