VEHICLE INSPECTION REPORT

LG14JWW

Ford Fiesta 1.0 Zetec 5dr

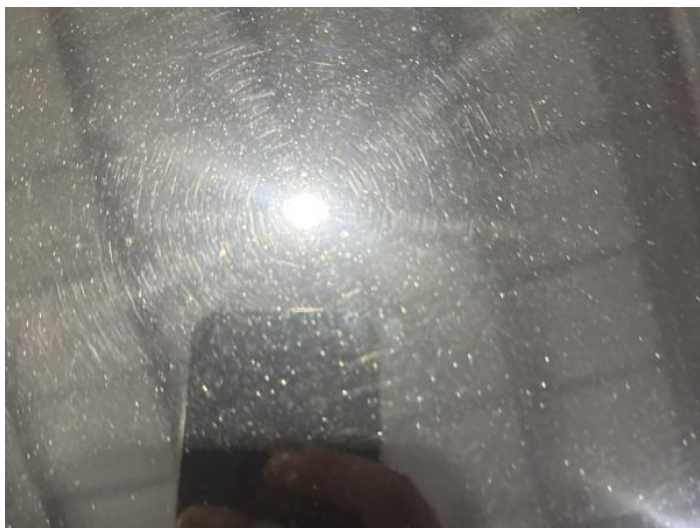
1: Bonnet
Chipped
1 To 5

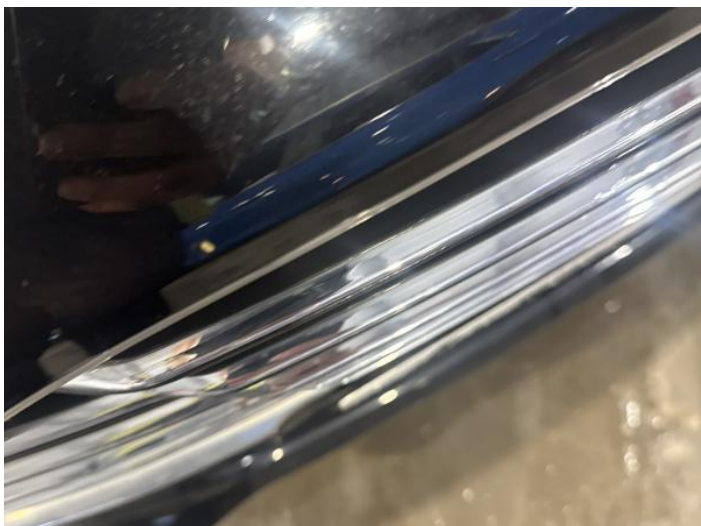
3: Bumper Front
Chipped
Multiple Chips

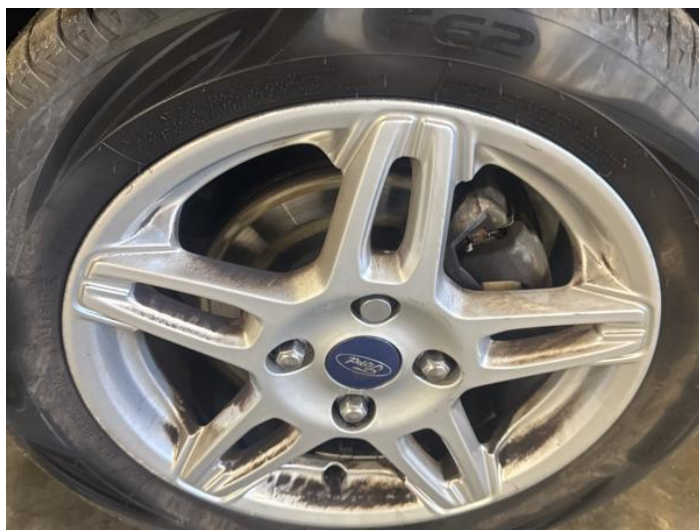
6: Wheel osf
Scratched
Over 50mm

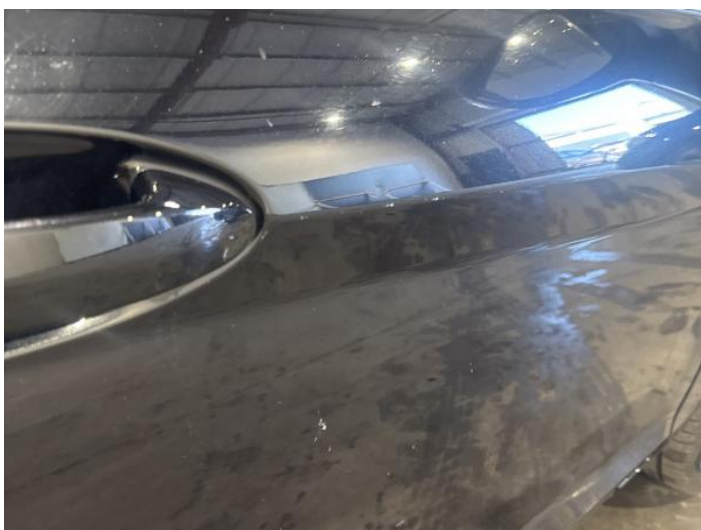
7: Door osf
Dented
With Paint Damage

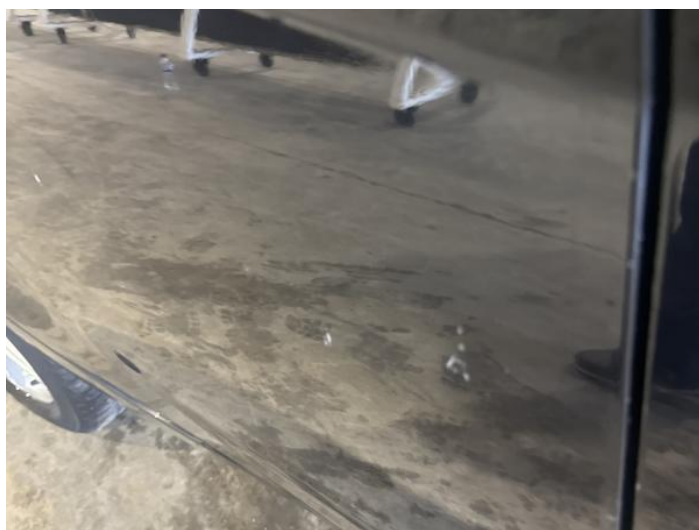
8: Door osf
Dented
With Paint Damage

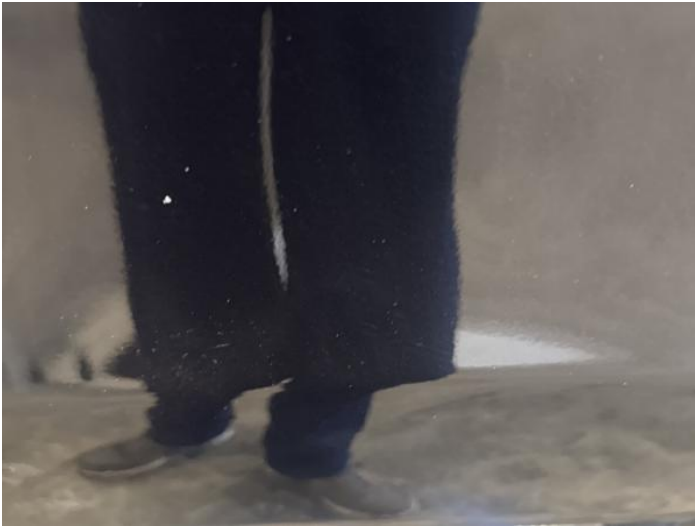
9: Qtr Panel osr
Chipped
1 To 5

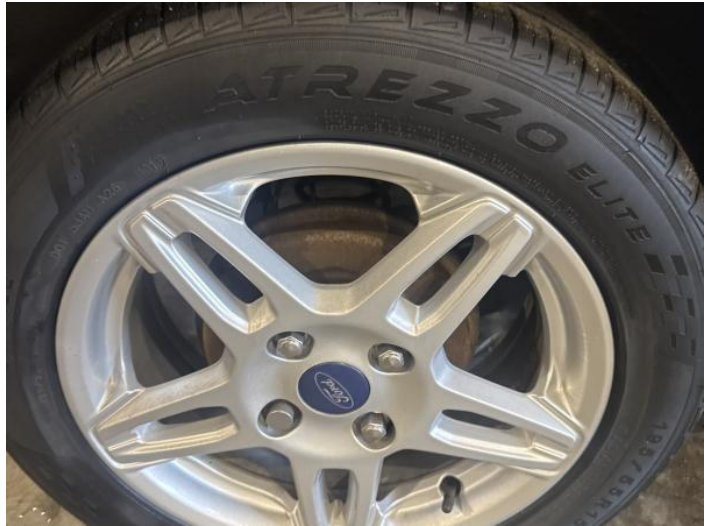
10: Wheel osr
Scratched
Up To 50mm

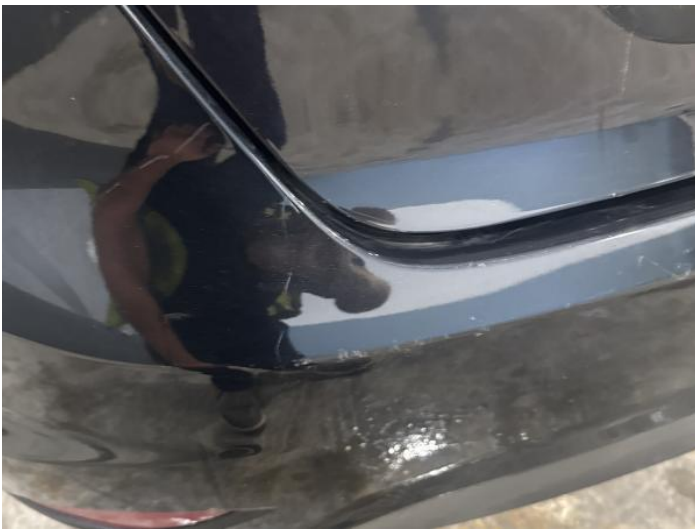
11: Bumper Rear
Scratched
Over 100mm Thru Paint

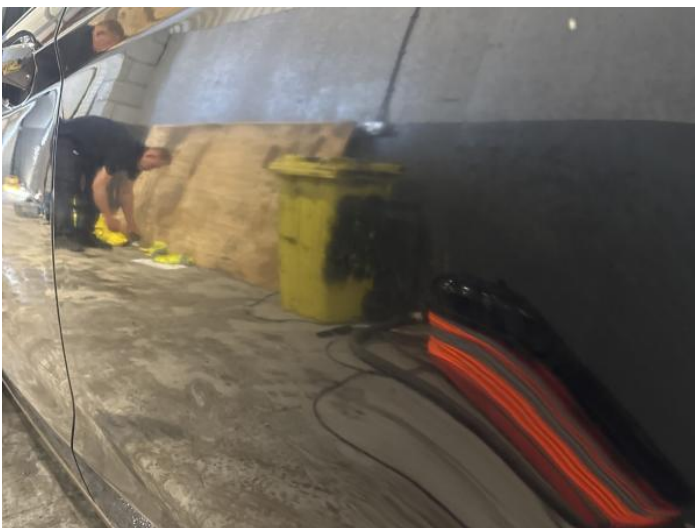
13: Door nsr
Dented
With Paint Damage

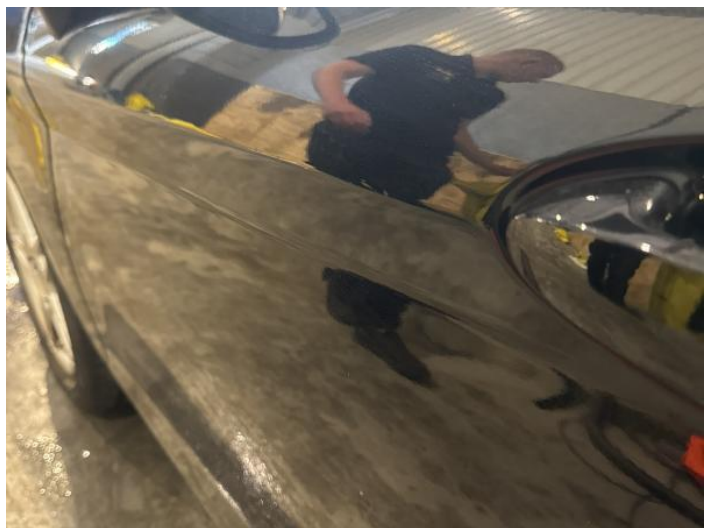
14: Door nsf
Dented
With Paint Damage

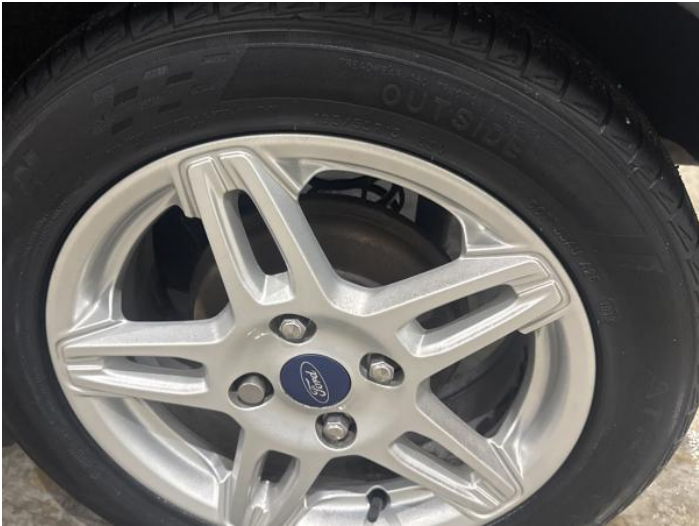
15: Wheel nsr
Scratched
Up To 50mm

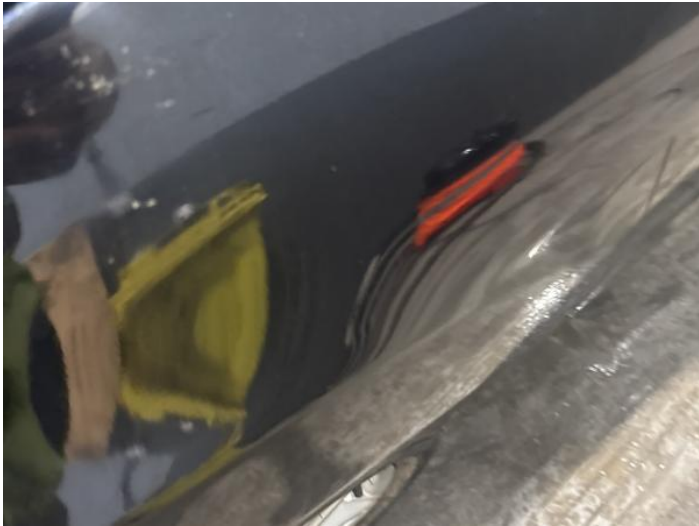
16: Wing nsf
Scratched
Over 25mm Not Thru Paint
