# VEHICLE INSPECTION REPORT

YF22NWO

## Vauxhall Crossland 1.5 Turbo D Design 5dr

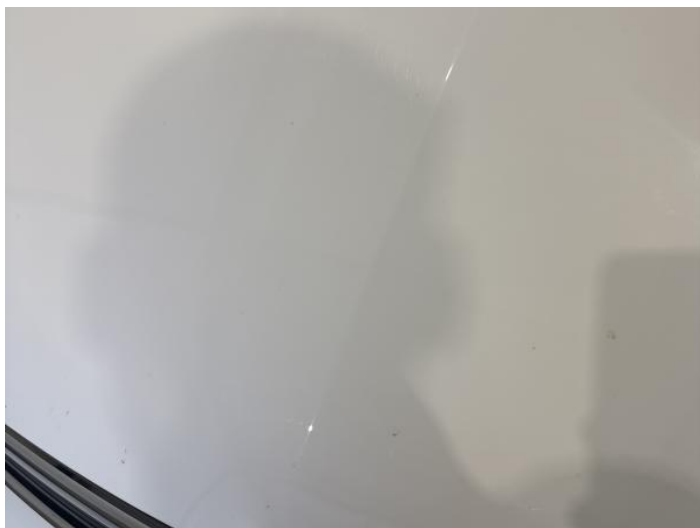
1: Bonnet  
Chipped  
1 To 5

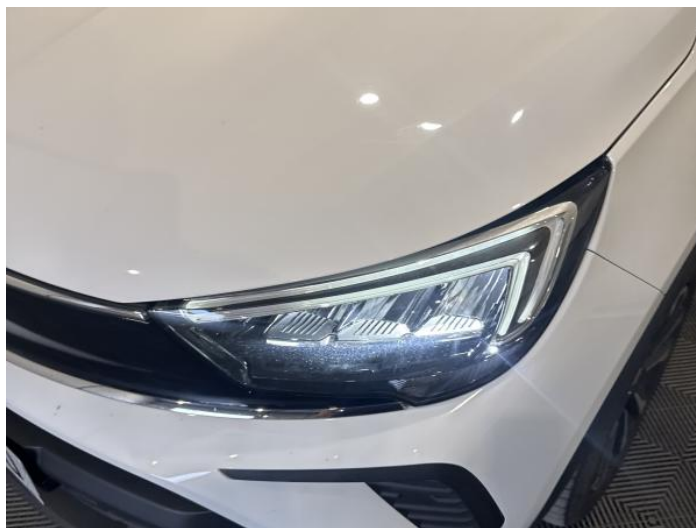
2: Bumper Front  
Chipped  
Multiple Chips

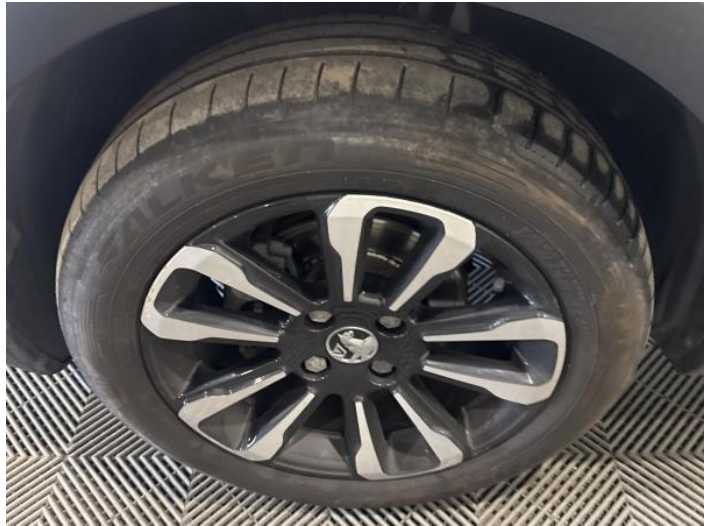
4: Wheel nsf  
Scratched  
Over 50mm

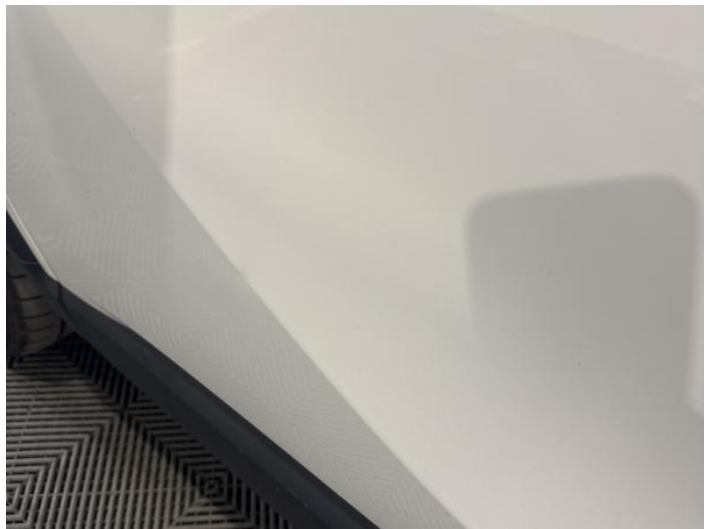
6: Door nsf  
Dented  
Between 10mm + 30mm

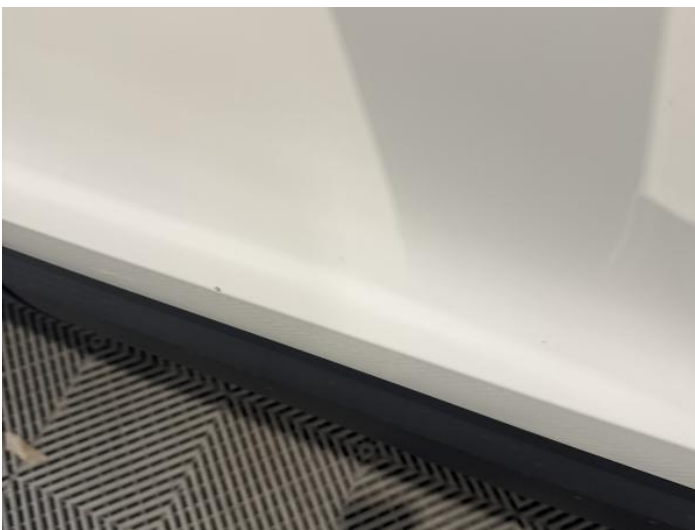
7: Door nsr  
Chipped  
1 To 5

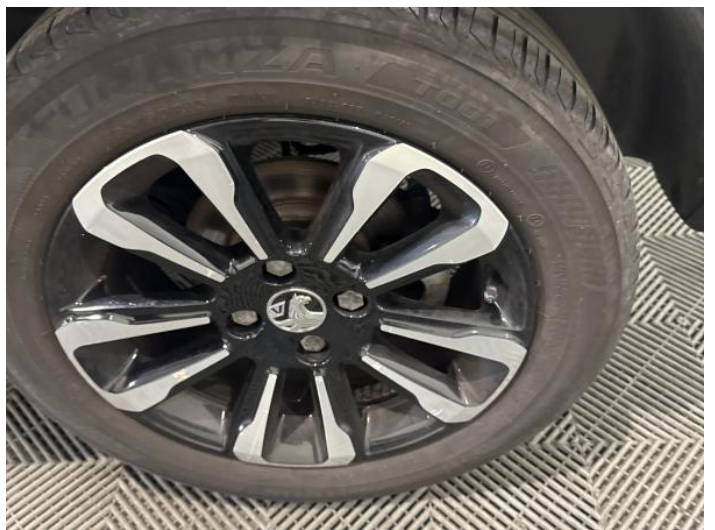
8: Wheel nsr  
Scratched  
Up To 50mm

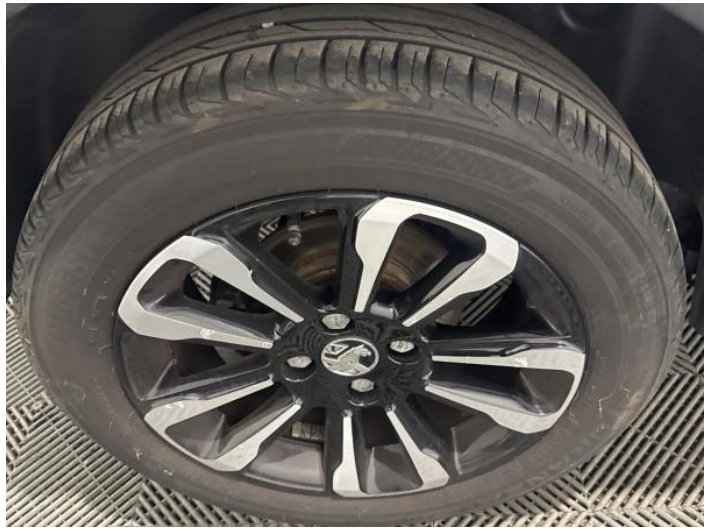
12: Wheel osr  
Scratched  
Over 50mm

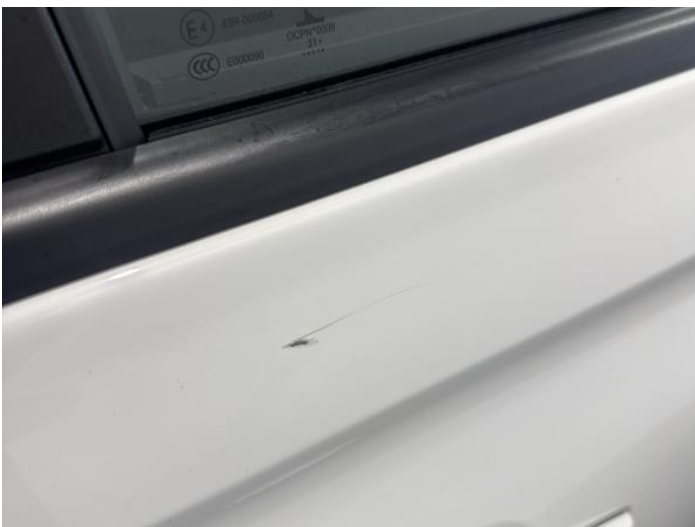
13: Door osr  
Scratched  
UpTo 25mm Thru Paint

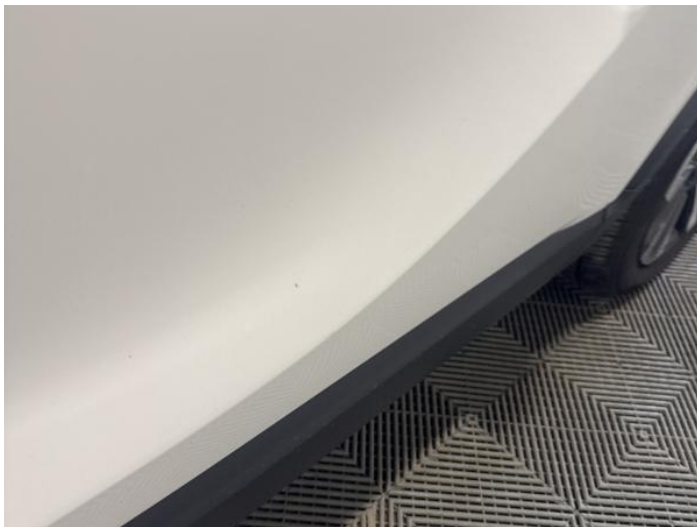
15: Door osf  
Chipped  
1 To 5

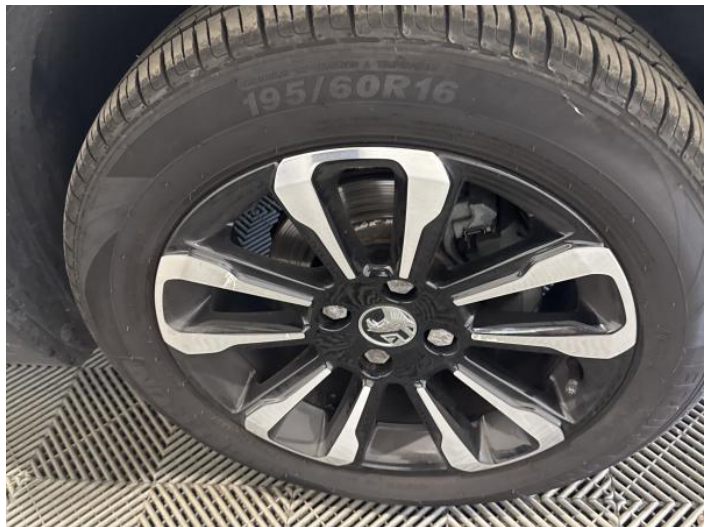
16: Wheel osf  
Scratched  
Up To 50mm
