VEHICLE INSPECTION REPORT

FL15MZZ

Lexus CT 200h 1.8 Advance 5dr CVT Auto

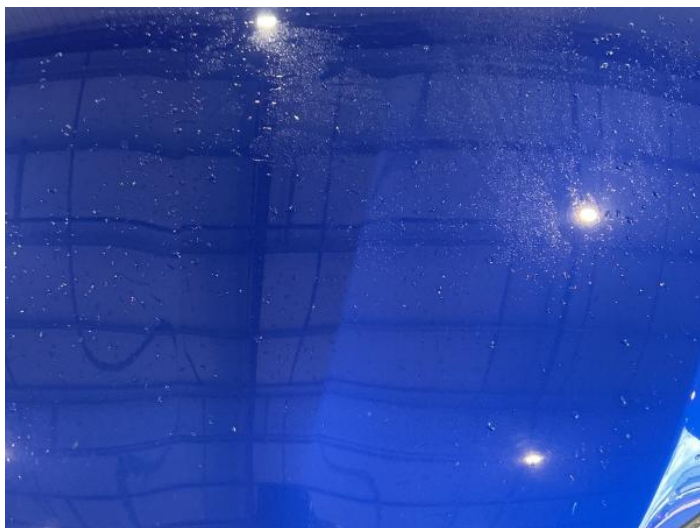
1: Bonnet
Chipped
1 To 5

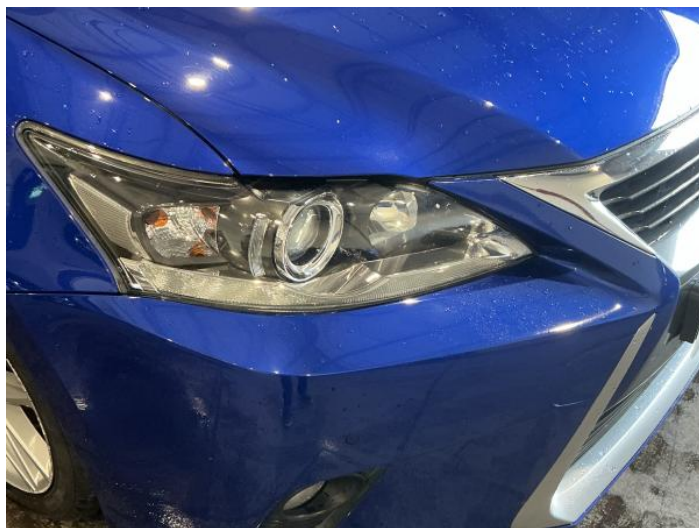
2: Bumper Front
Scratched
Over 100mm Thru Paint

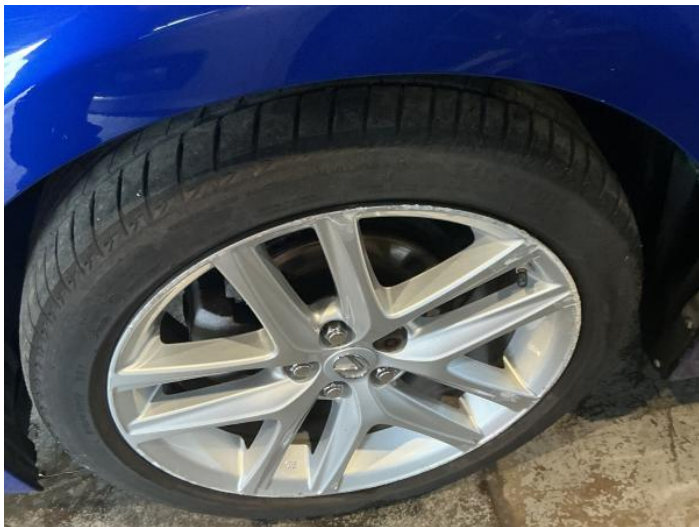
3: Wheel nsf
Scratched
Over 50mm

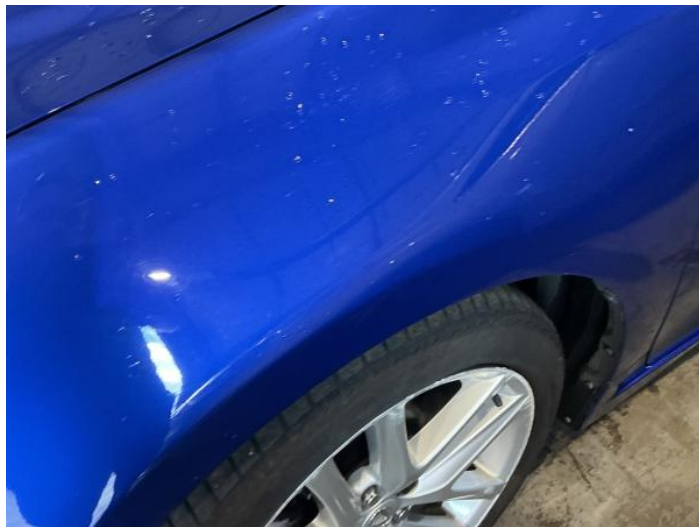
4: Wing nsf
Chipped
1 To 5

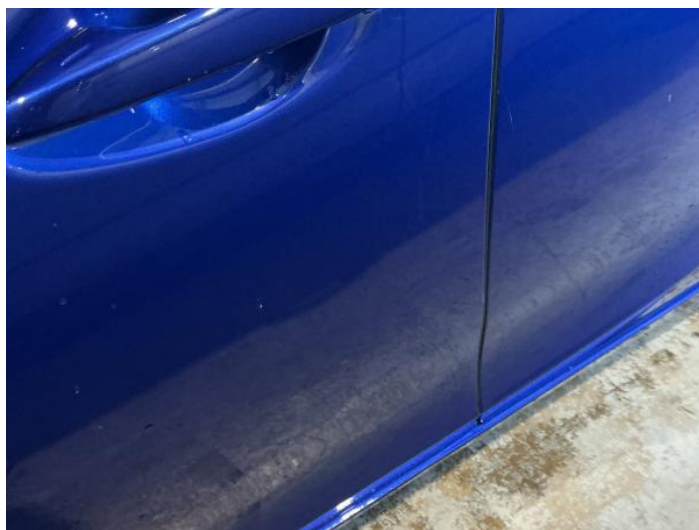
6: Door nsf
Dented
Between 10mm + 30mm

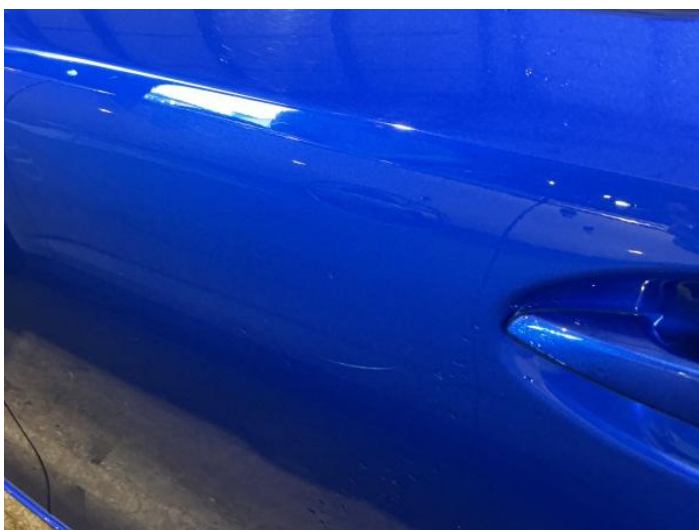
7: Door nsr
Chipped
1 To 5

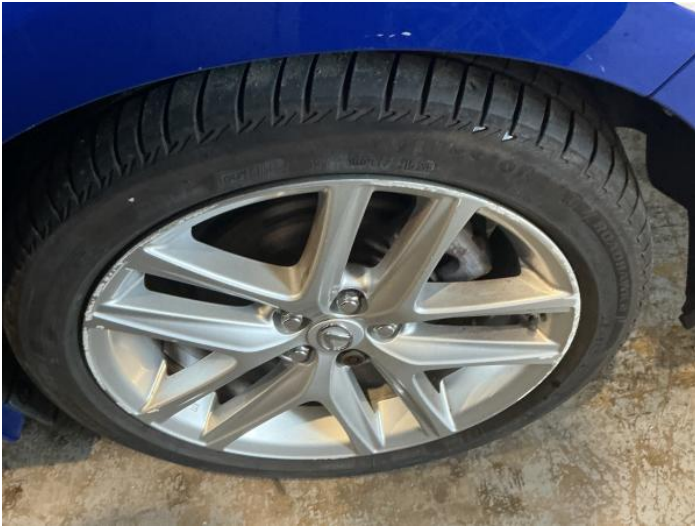
9: Wheel nsr
Scratched
Over 50mm

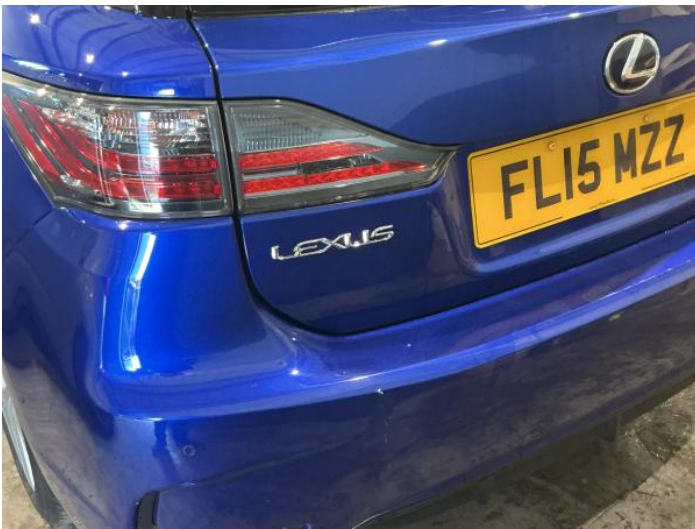
11: Bumper Rear
Poor Previous Repair
Paint Flake

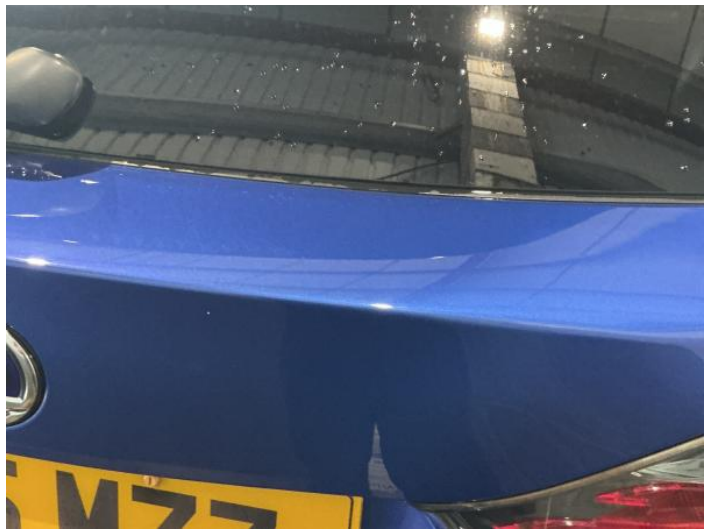
12: Boot Lid
Chipped
1 To 5

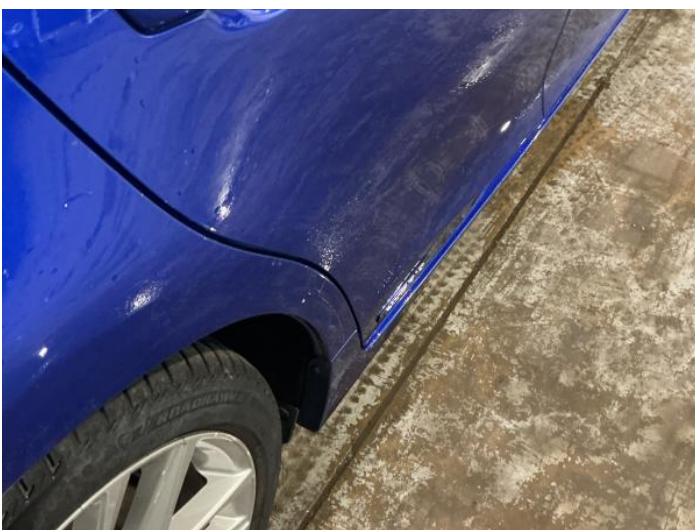
13: Qtr Panel osr
Chipped
1 To 5

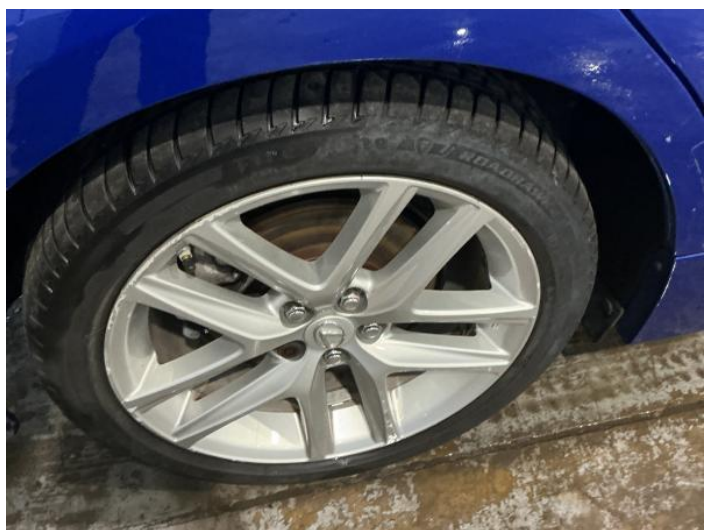
14: Wheel osr
Scratched
Over 50mm

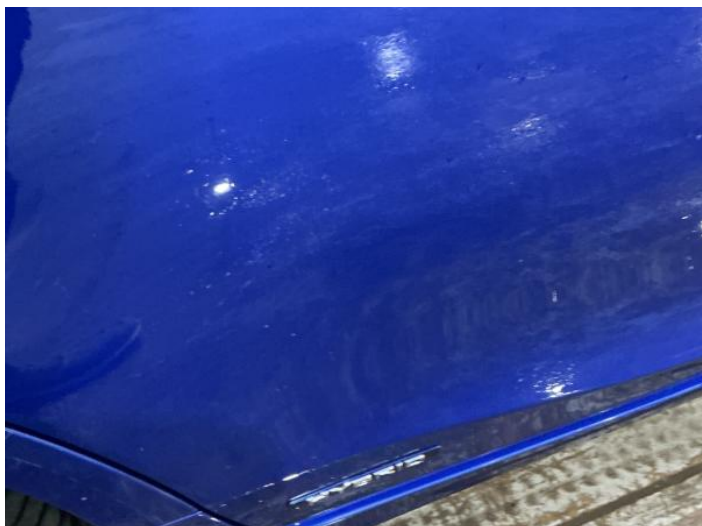
15: Door osr
Chipped
1 To 5

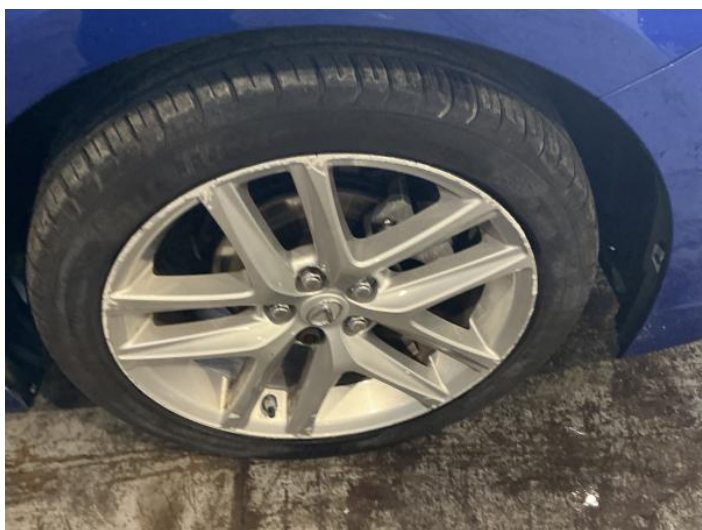
19: Wheel osf
Scratched
Over 50mm
