VEHICLE INSPECTION REPORT

OV60WYJ

Honda CR-V 2.0 i-VTEC ES 5dr

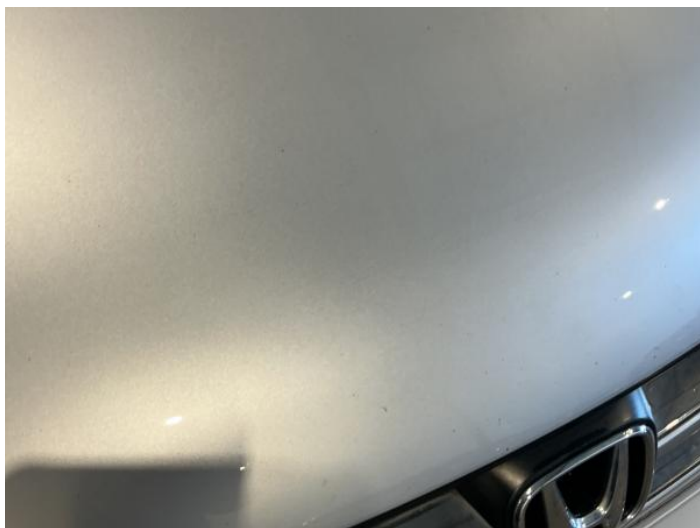
1: Bonnet
Chipped
1 To 5

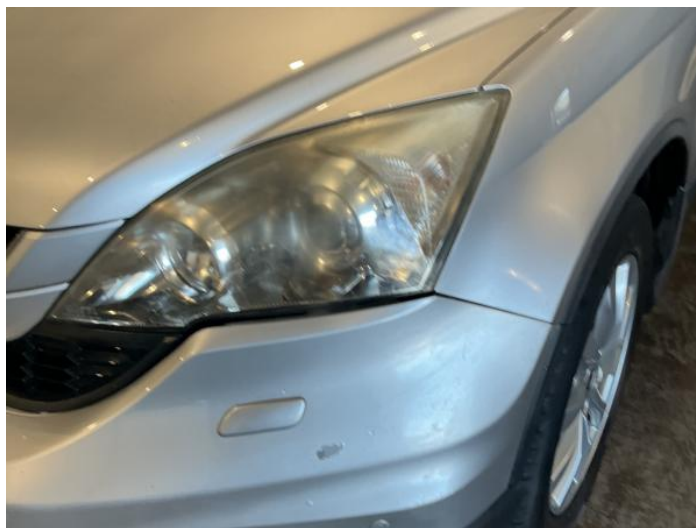
2: Bumper Front
Poor Previous Repair
Paint Flake

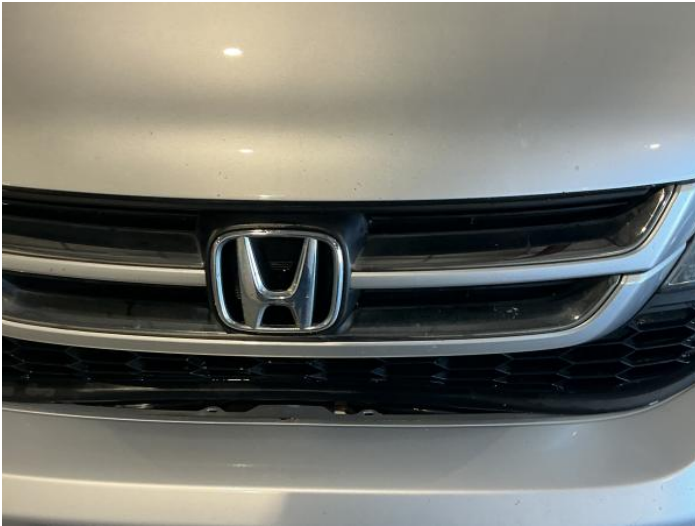
3: Bumper Front Grill
Broken
Replace

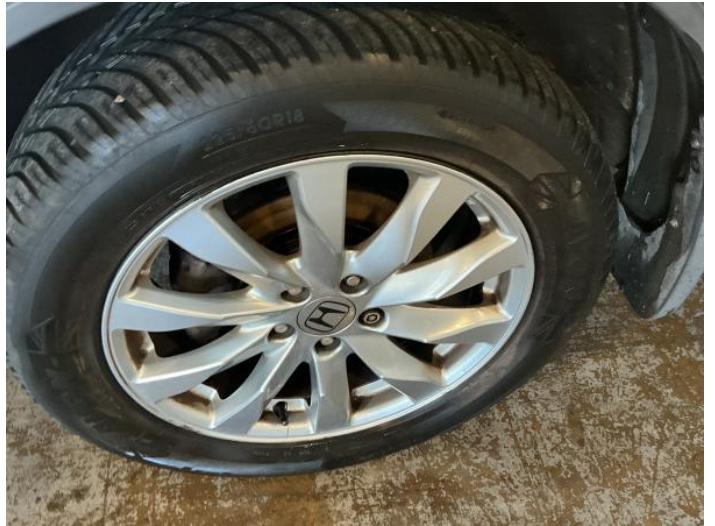
4: Wheel nsf
Scratched
Over 50mm

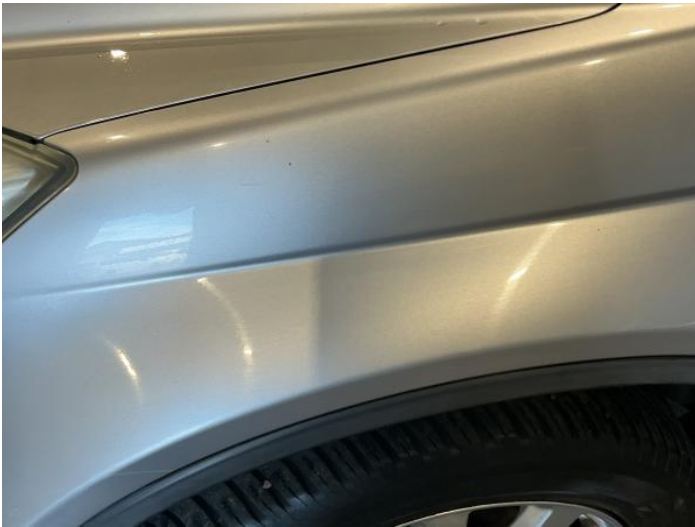
5: Wing nsf
Chipped
1 To 5

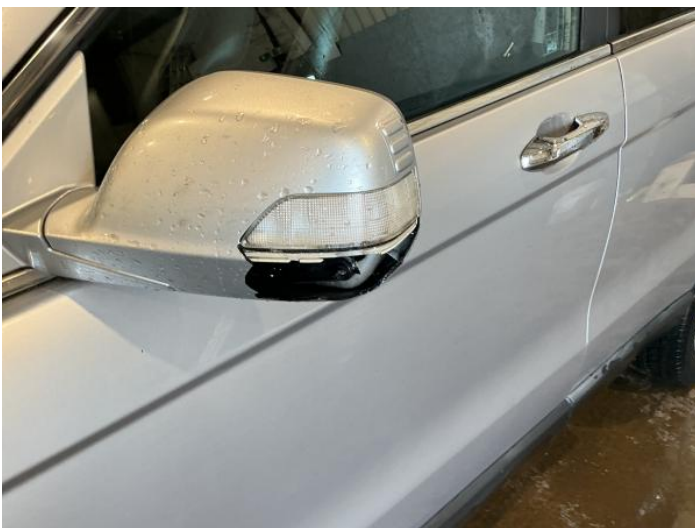
7: Door Mirror Assy nsf
Broken
Replace

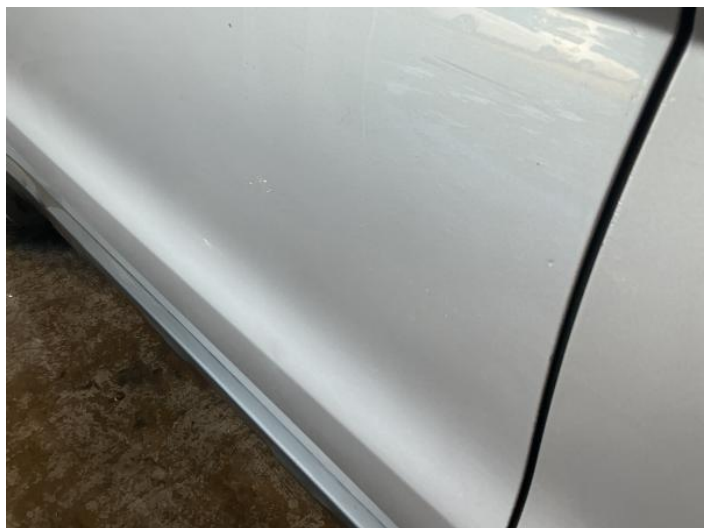
8: Door nsf
Dented
Between 10mm + 30mm

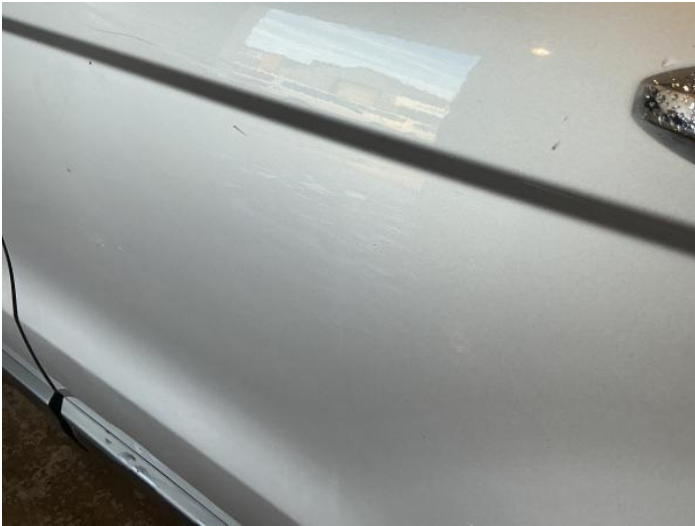
9: Door nsr
Dented
With Paint Damage

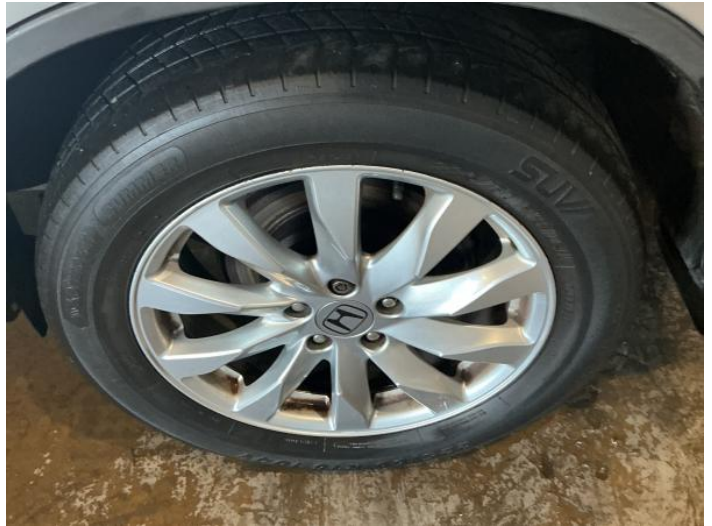
10: Wheel nsr
Scratched
Over 50mm

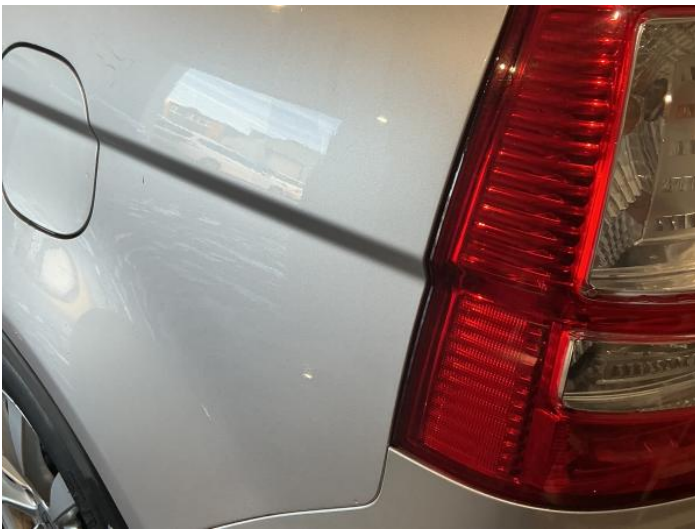
11: Qtr Panel nsr
Chipped
1 To 5

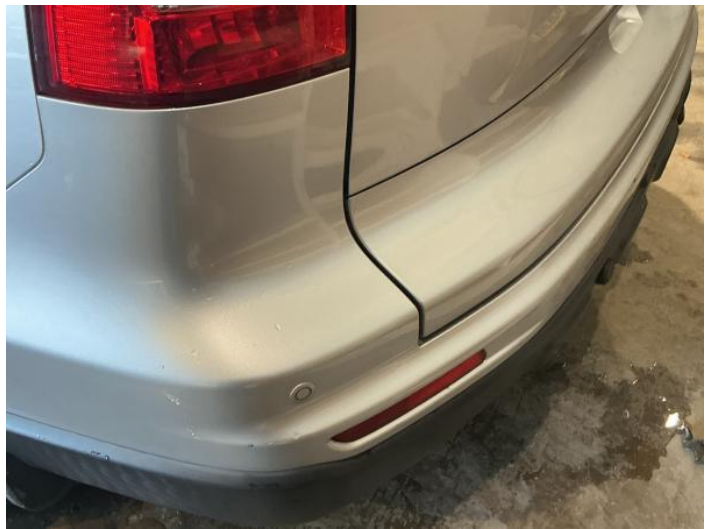
12: Bumper Rear
Scratched
Over 100mm Thru Paint

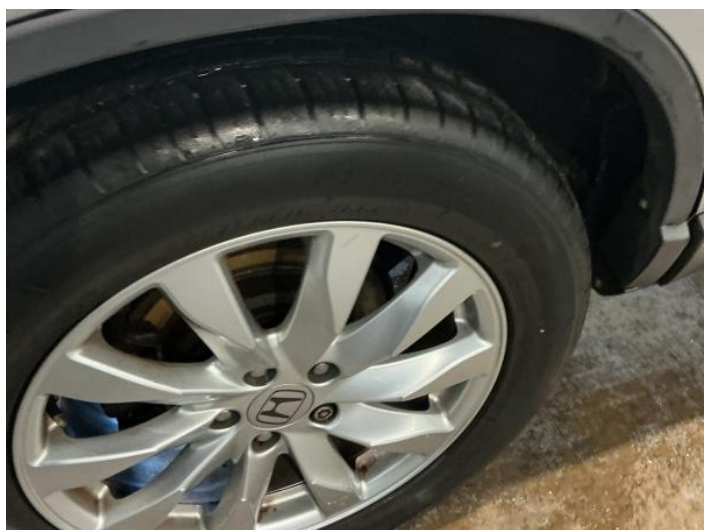
14: Wheel osr
Scratched
Over 50mm

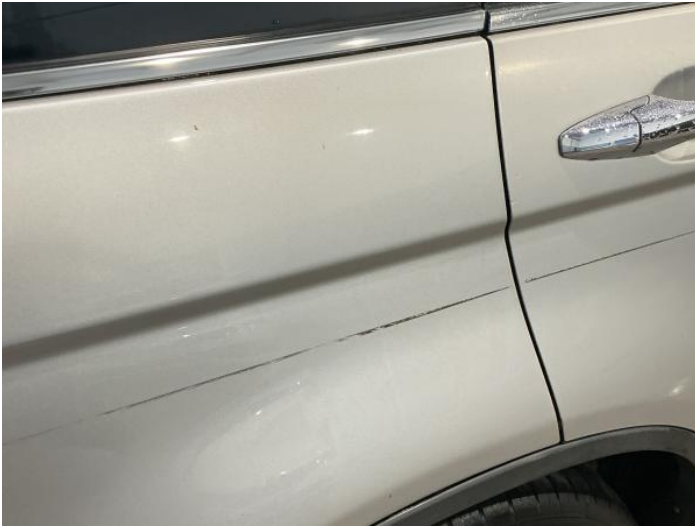
15: Qtr Panel osr
Scratched
Over 25mm Thru Paint

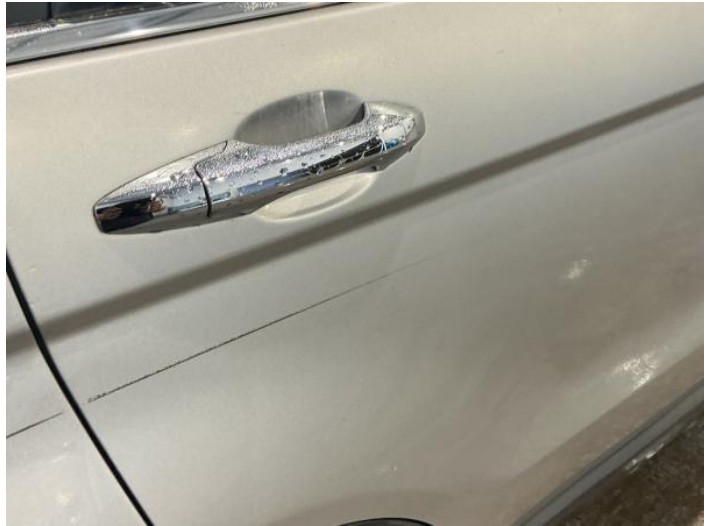
16: Door osr
Scratched
Over 25mm Thru Paint

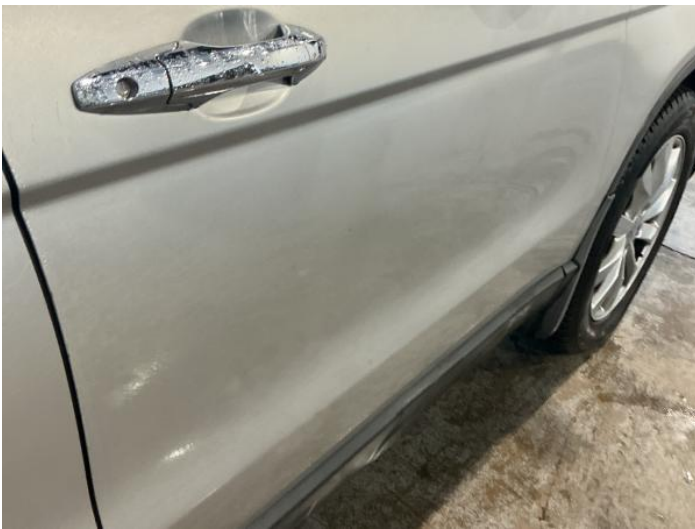
17: Door osf
Poor Previous Repair
Poor Paint

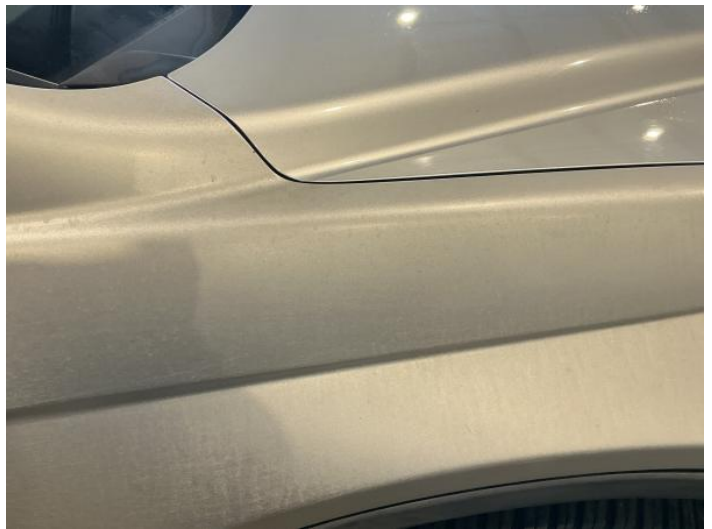
18: Wing osf
Poor Previous Repair
Poor Paint

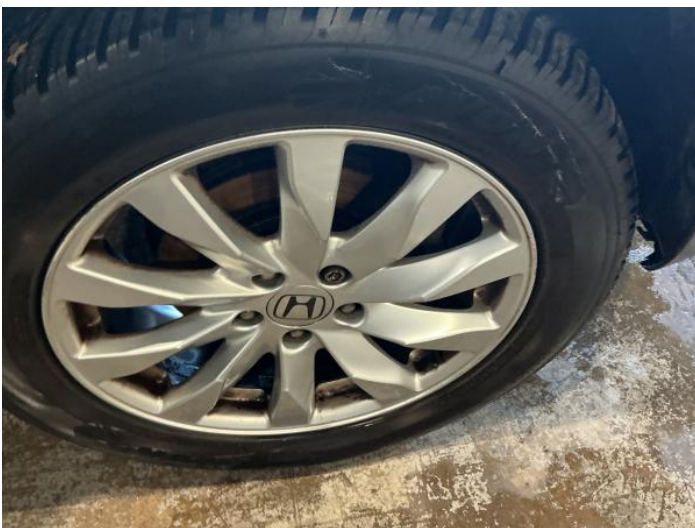
19: Wheel osf
Scratched
Over 50mm

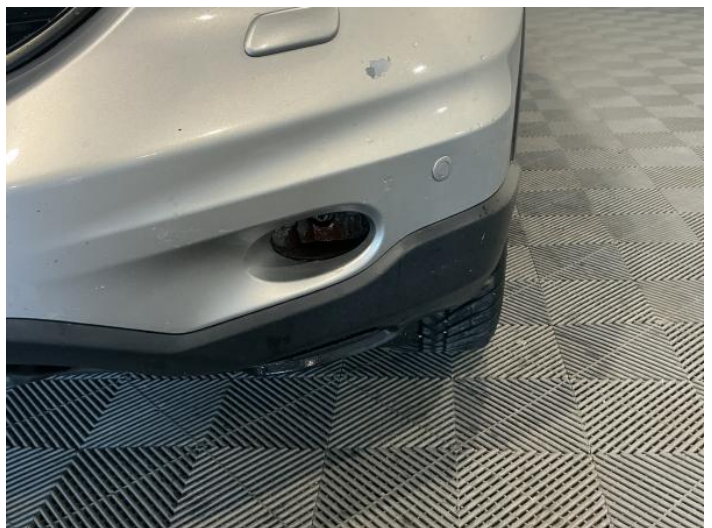
20: Fogdriving Lamp nsf
Broken
Replace
