VEHICLE INSPECTION REPORT

GM14HHW

Vauxhall Adam 1.2i Jam 3dr

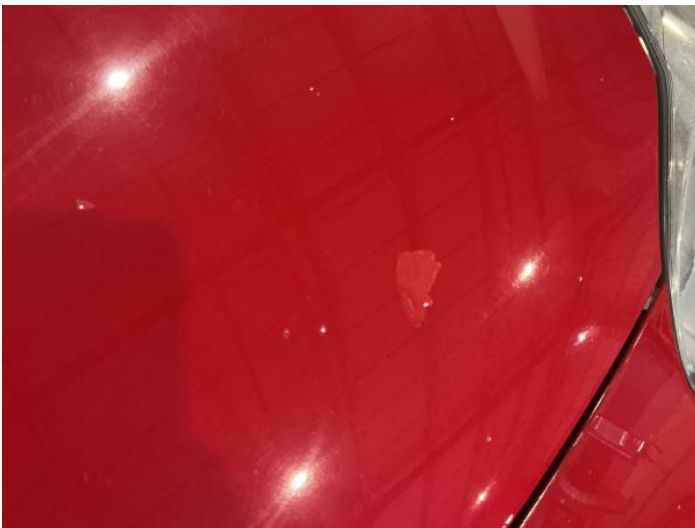
1: Bonnet
Poor Previous Repair
Paint Flake

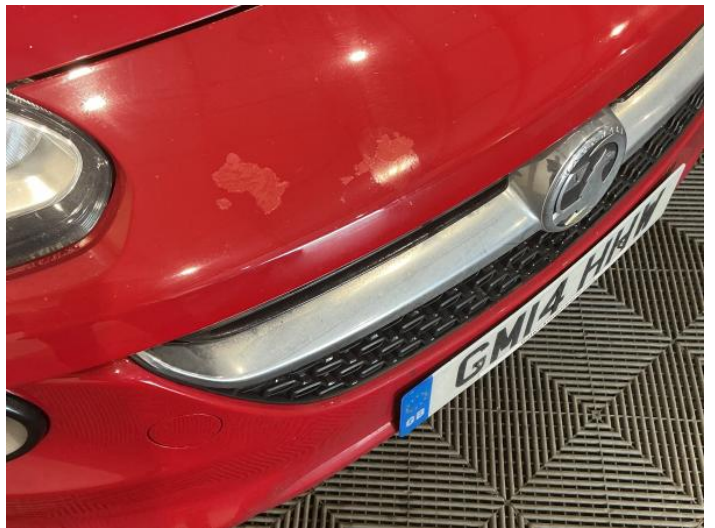
2: Bumper Front
Poor Previous Repair
Paint Flake

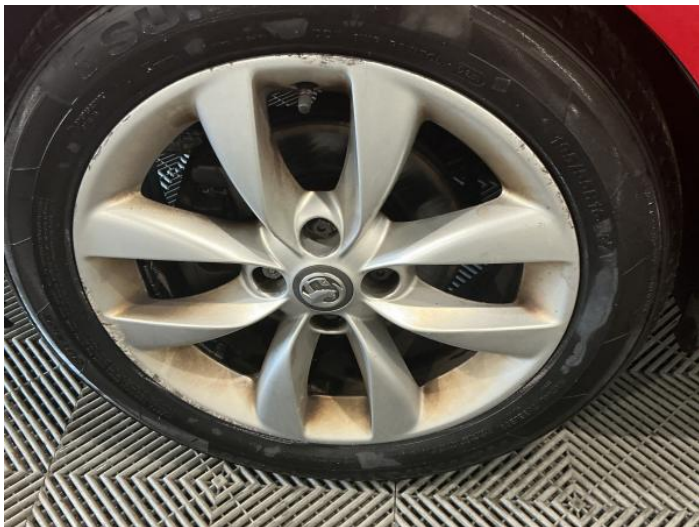
3: Wheel nsf
Scratched
Over 50mm

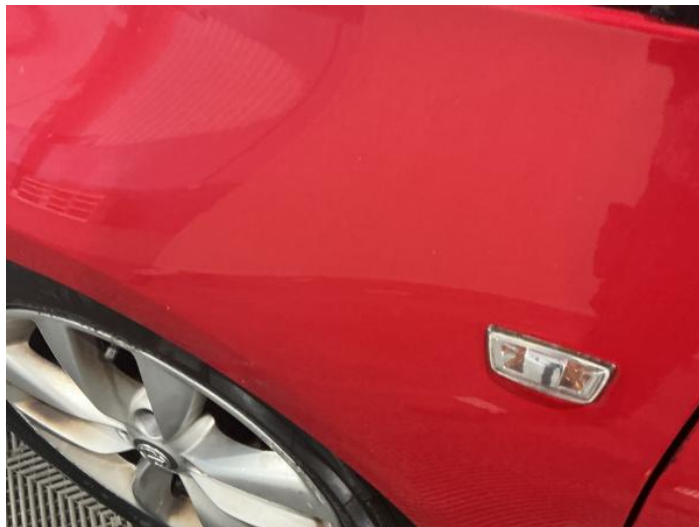
4: Wing nsf
Chipped
1 To 5

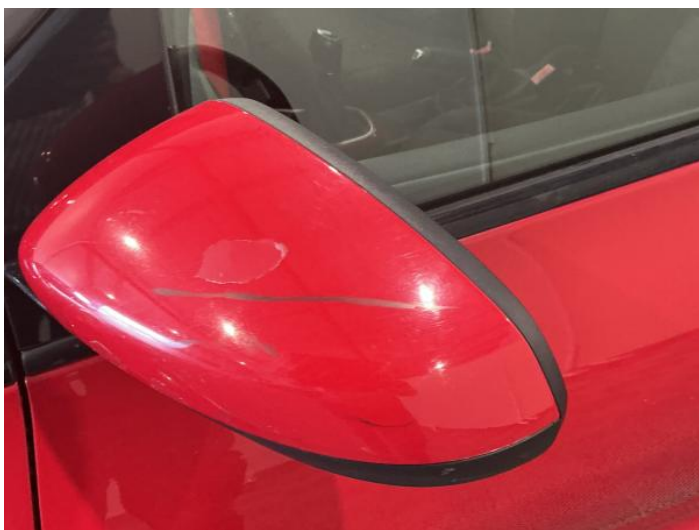
5: Door Mirror Assy nsf
Scratched (Painted)
Over 25mm Thru Paint

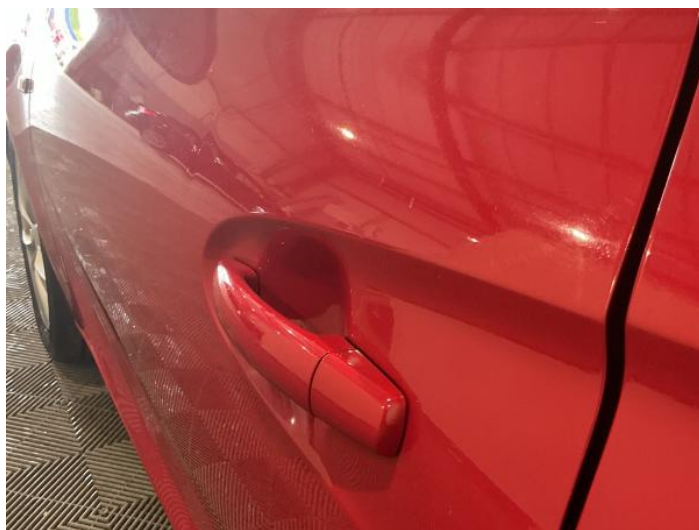
6: Door nsf
Dented
Over 30mm

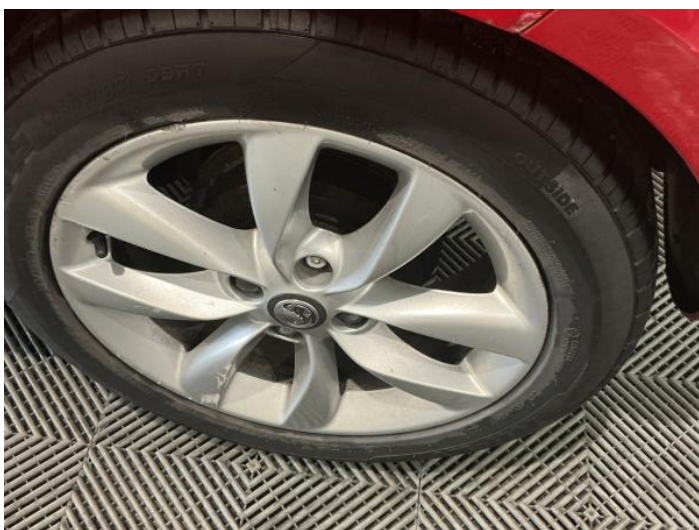
7: Wheel nsr
Scratched
Over 50mm

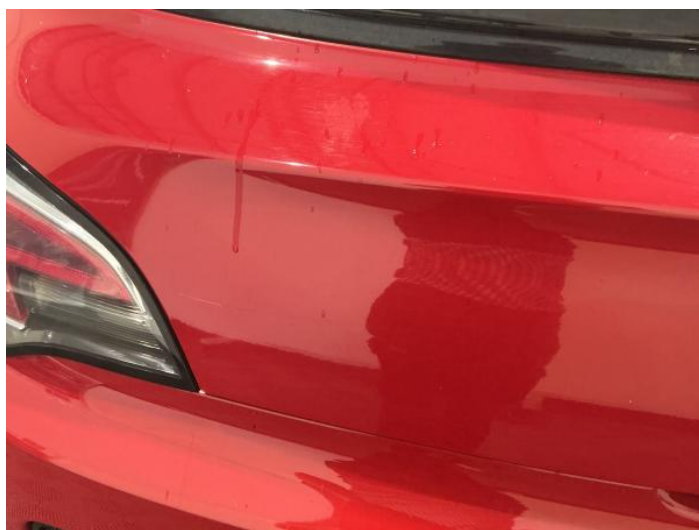
8: Tailgate
Scratched
Over 25mm Thru Paint

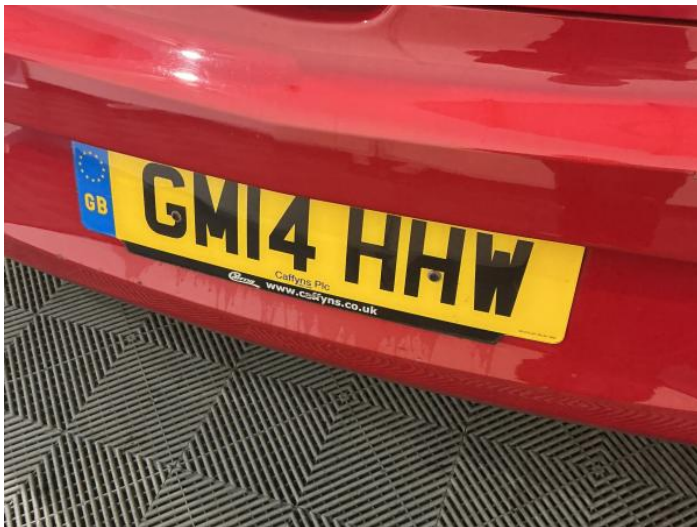
9: Bumper Rear
Chipped
Multiple Chips

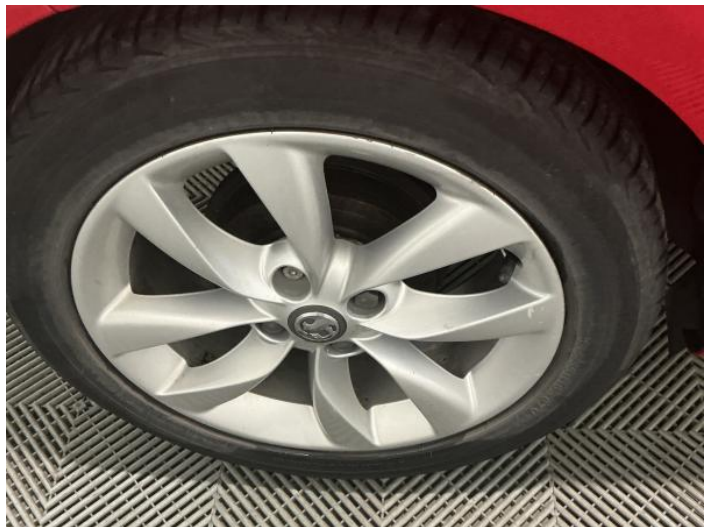
10: Wheel osr
Scratched
Over 50mm

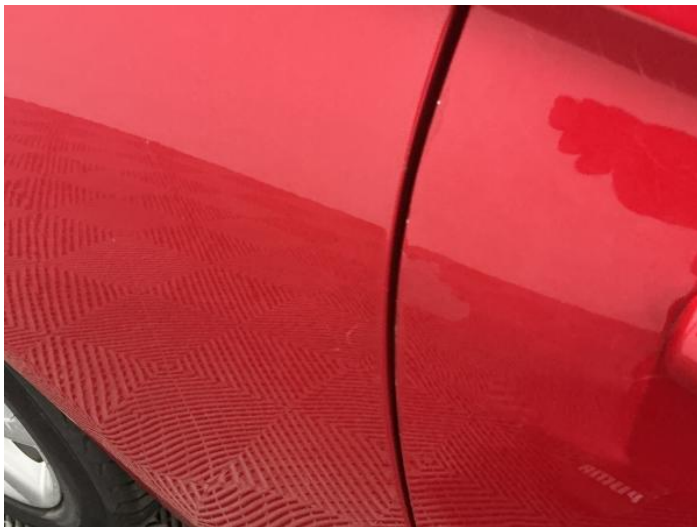
11: Qtr Panel osr
Scratched
UpTo 25mm Thru Paint

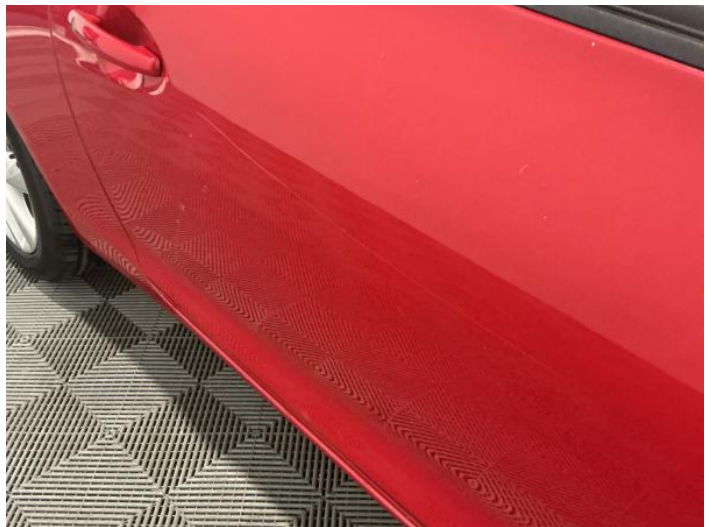
12: Door osf
Scratched
Over 25mm Thru Paint

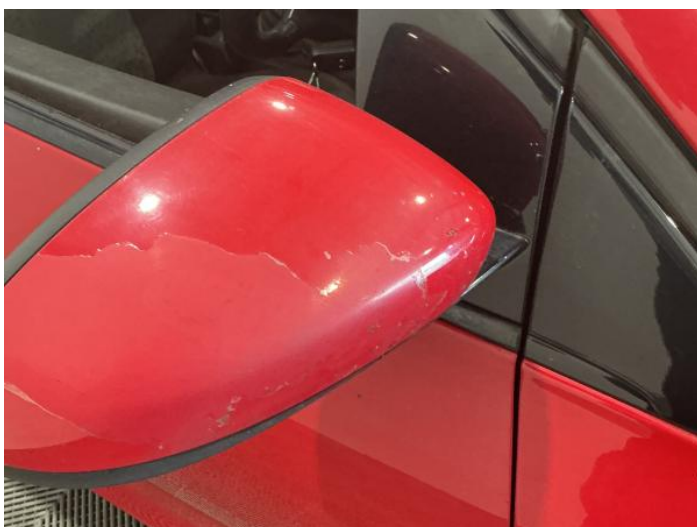
13: Door Mirror Assy osf
Scratched (Painted)
Over 25mm Not Thru Paint

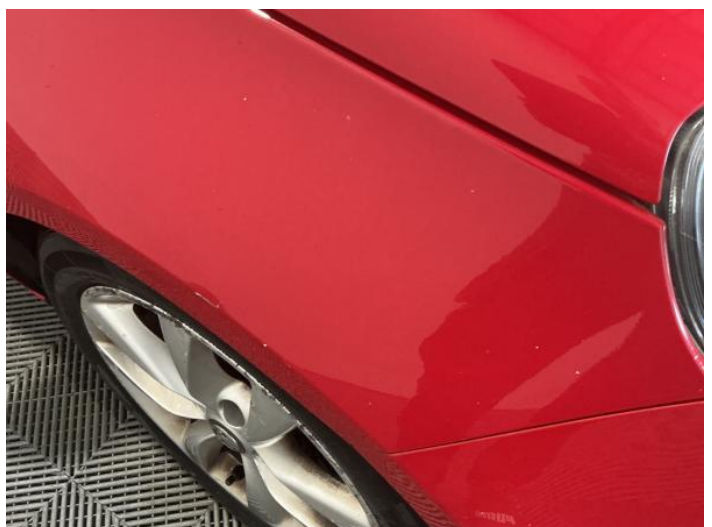
14: Wing osf
Dented
With Paint Damage

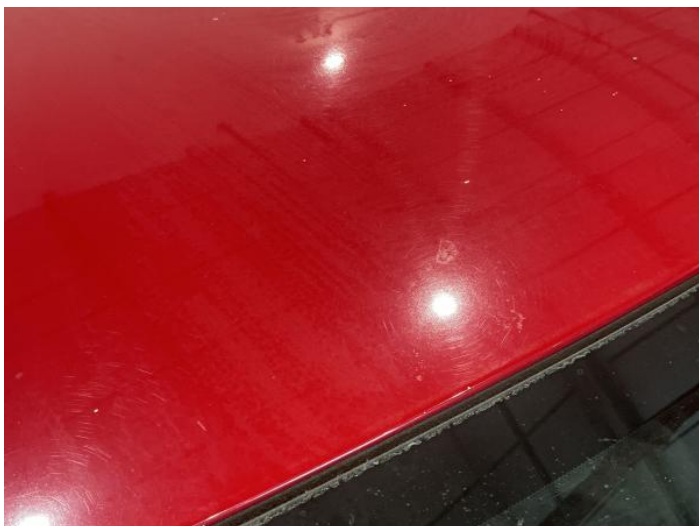
15: Roof
Chipped
1 To 5

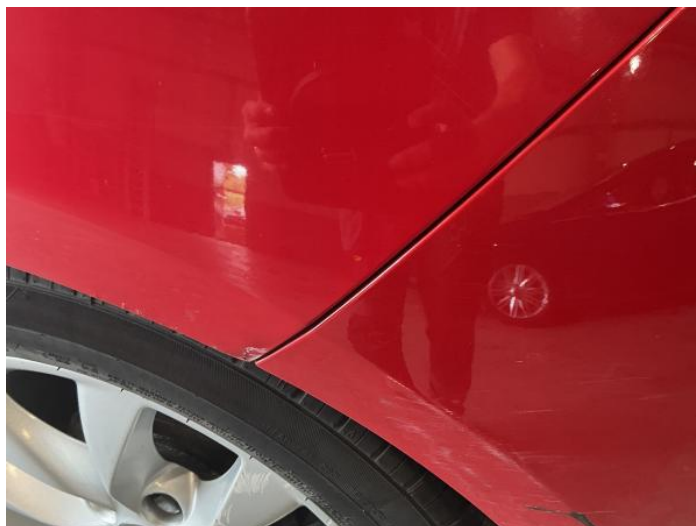
16: Qtr Panel nsr
Dented
With Paint Damage
