VEHICLE INSPECTION REPORT

CK66LZJ

Citroen C4 Cactus 1.2 PureTech [110] Flair Edition 5dr

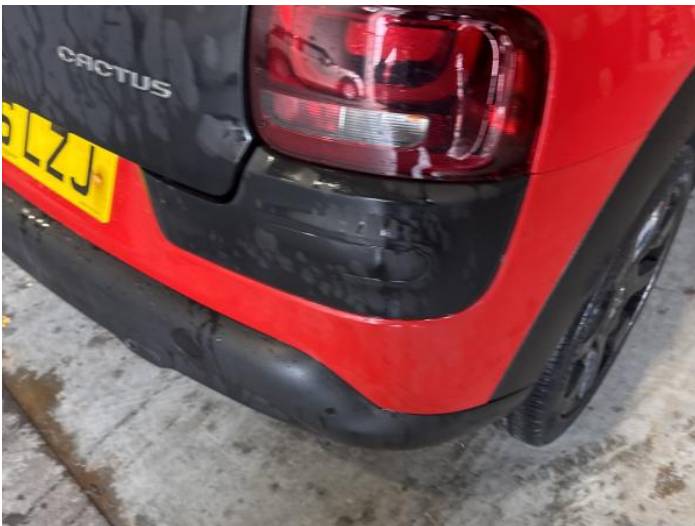
1: Bumper Rear
Chipped
Multiple Chips

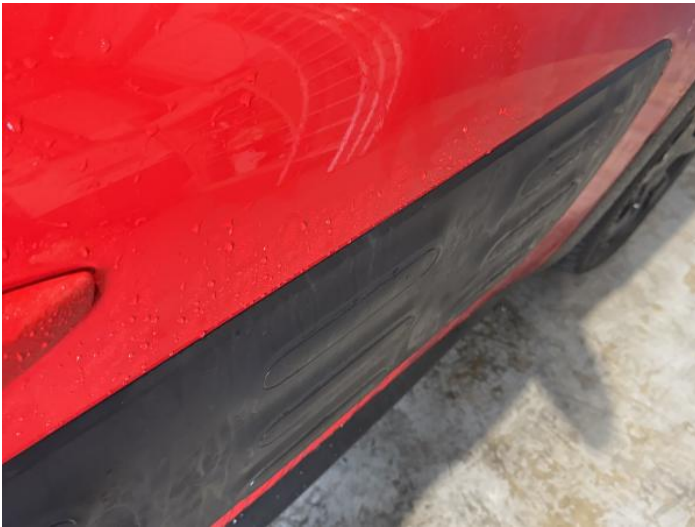
5: Door osf
Dented
Over 2 UpTo 10mm

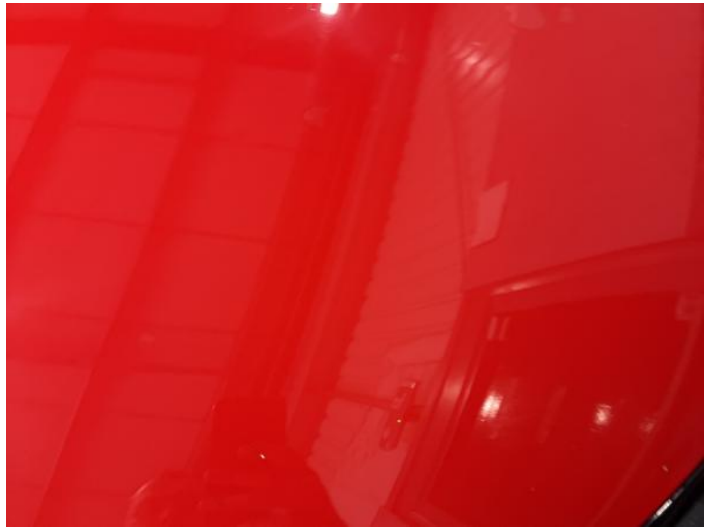
6: Bonnet
Chipped
1 To 5

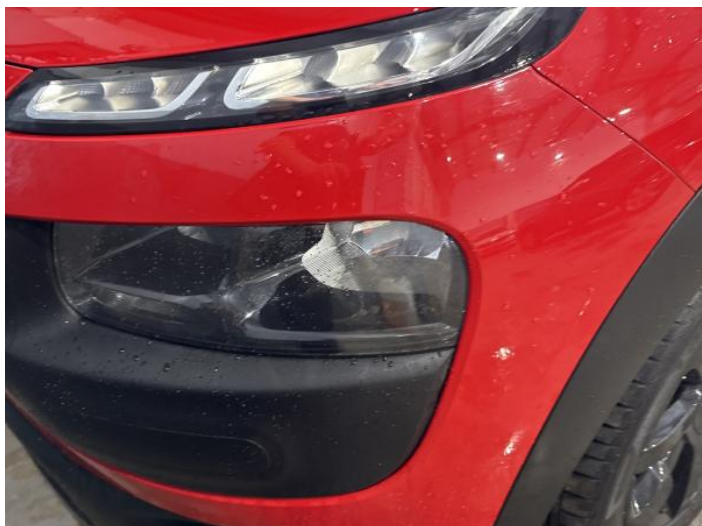
9: Bumper Front
Scratched
25 to 100mm Thru Paint

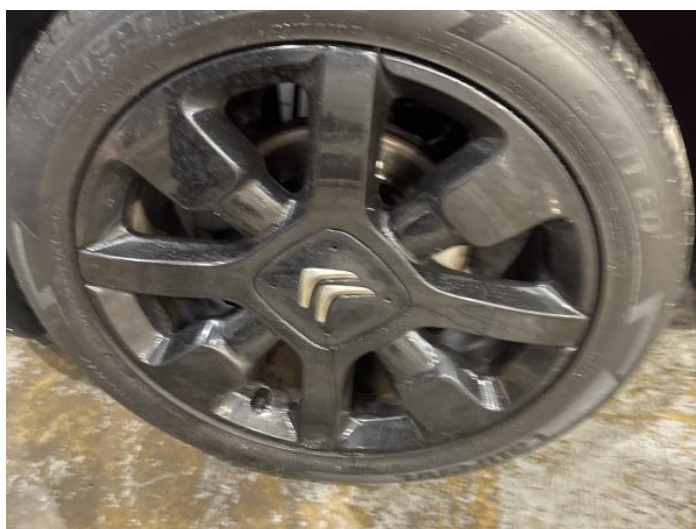
12: Wheel nsf
Scratched
Over 50mm

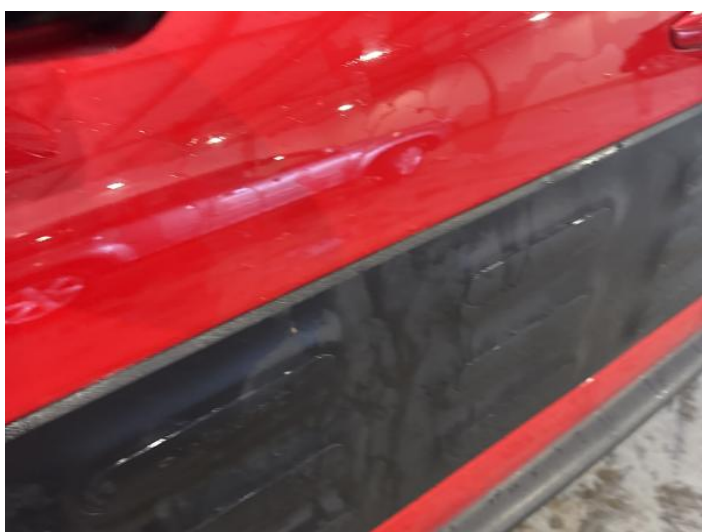
13: Door nsf
Chipped
1 To 5
