VEHICLE INSPECTION REPORT

LL15NHV

Nissan Qashqai 1.2 DiG-T N-Tec+ 5dr Xtronic

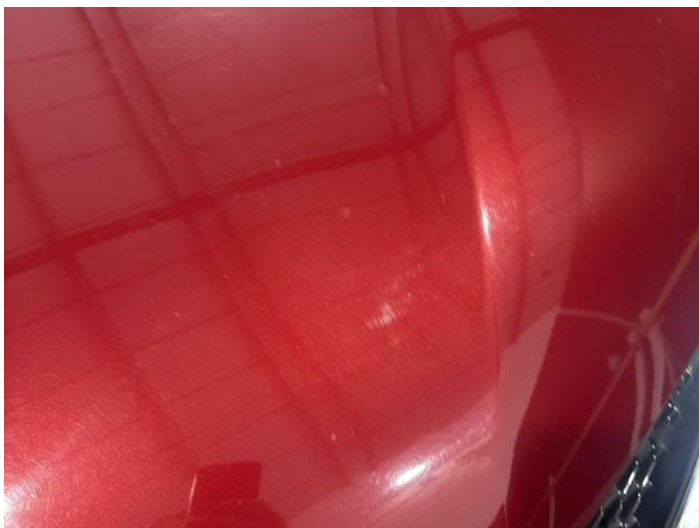
1: Bonnet
Chipped
1 To 5

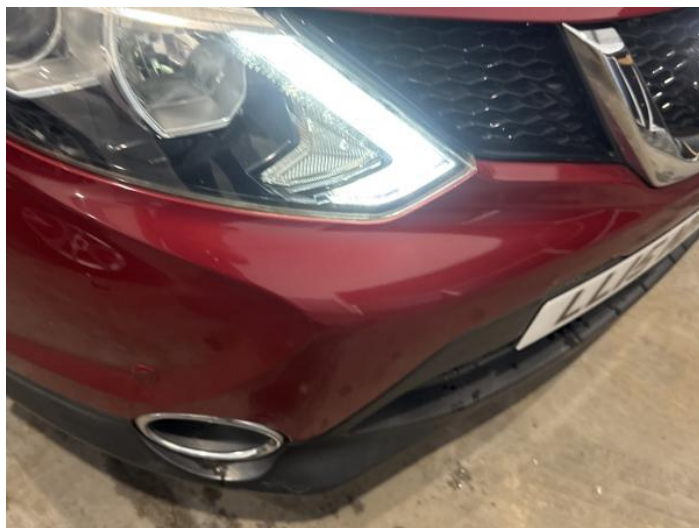
2: Bumper Front
Poor Previous Repair
Poor Paint

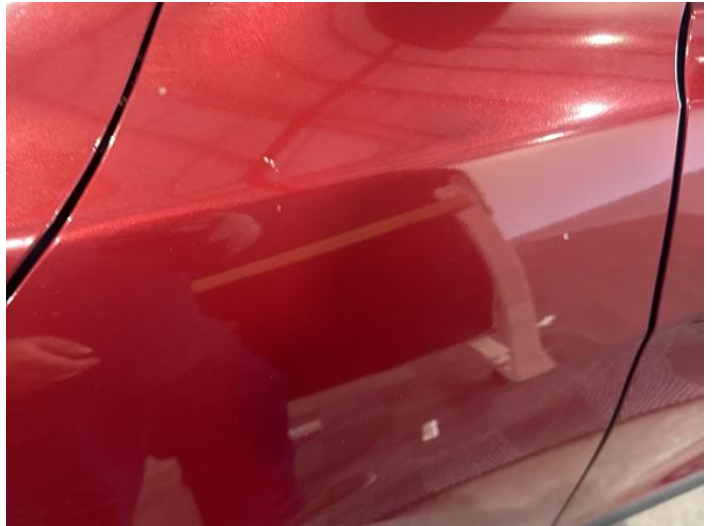
4: Wing nsf
Chipped
1 To 5

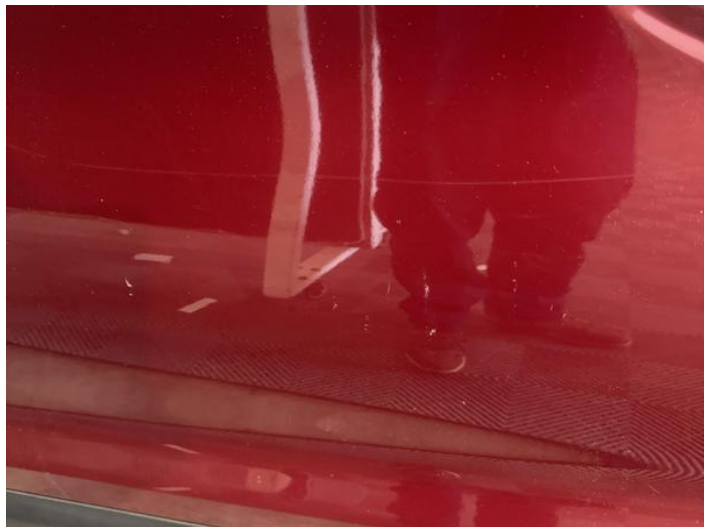
6: Door nsf
Chipped
Multiple Chips

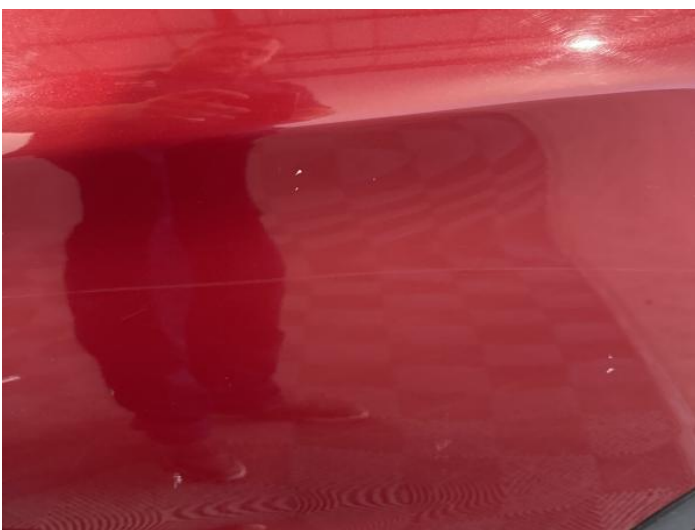
7: Door nsr
Dented
2 Or Less UpTo 10mm

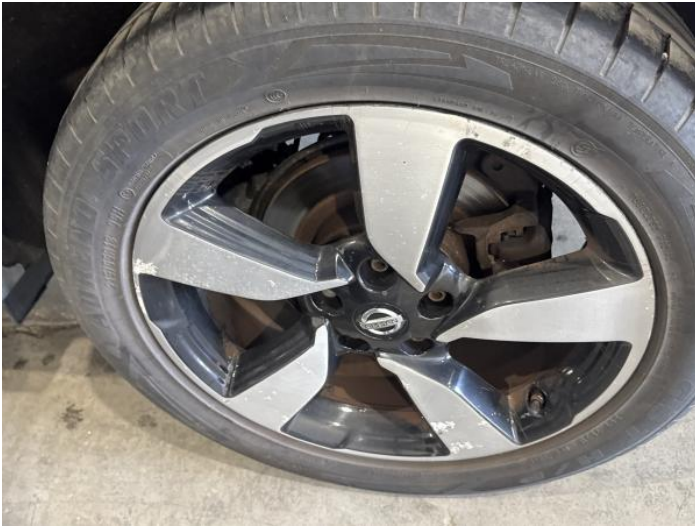
9: Wheel nsr
Scratched
Over 50mm

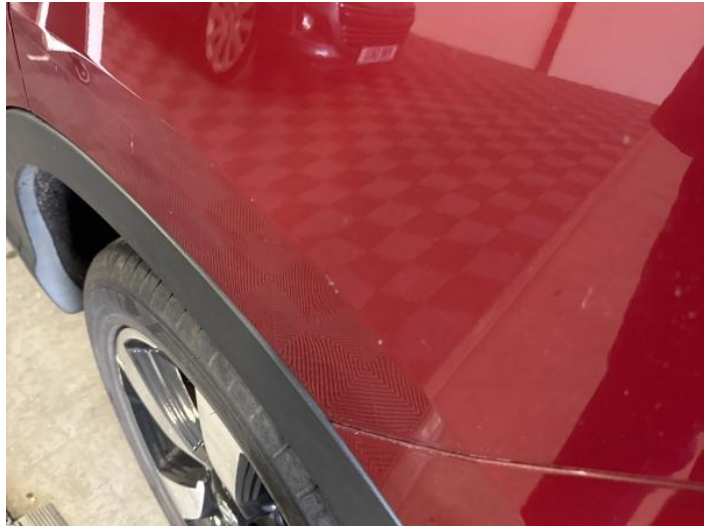
10: Qtr Panel nsr
Dented
Over 2 UpTo 10mm

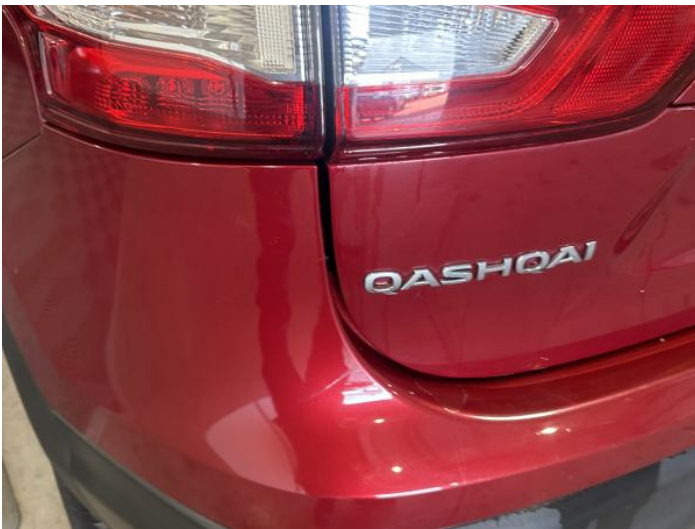
11: Bumper Rear
Poor Previous Repair
Paint Flake

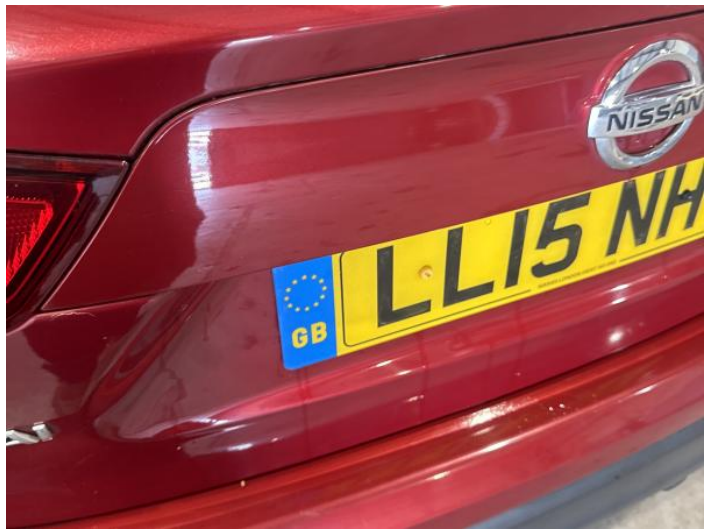
12: Boot Lid
Chipped
1 To 5

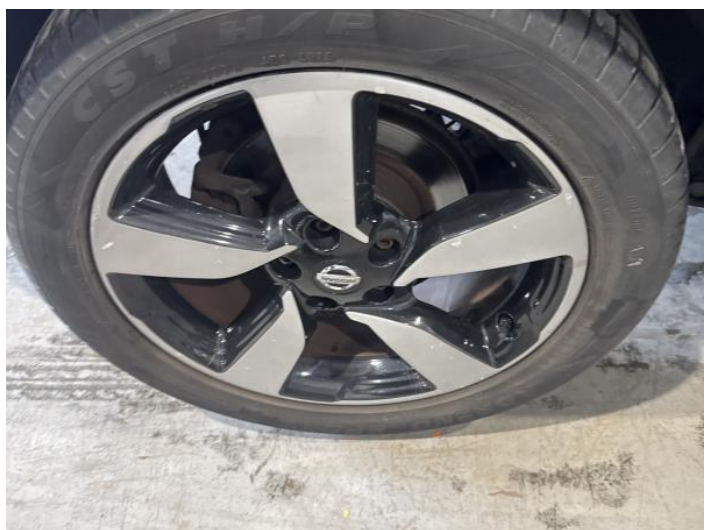
14: Wheel osr
Scratched
Over 50mm

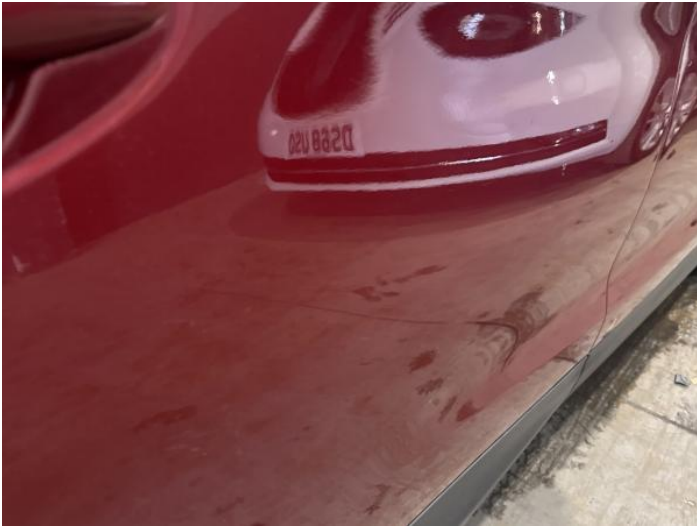
15: Door osr
Dented
Over 2 UpTo 10mm

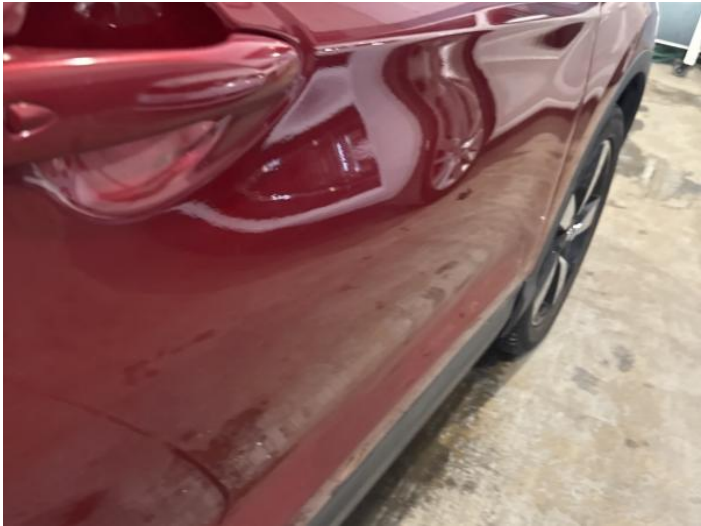
16: Door osf
Poor Previous Repair
Poor Paint

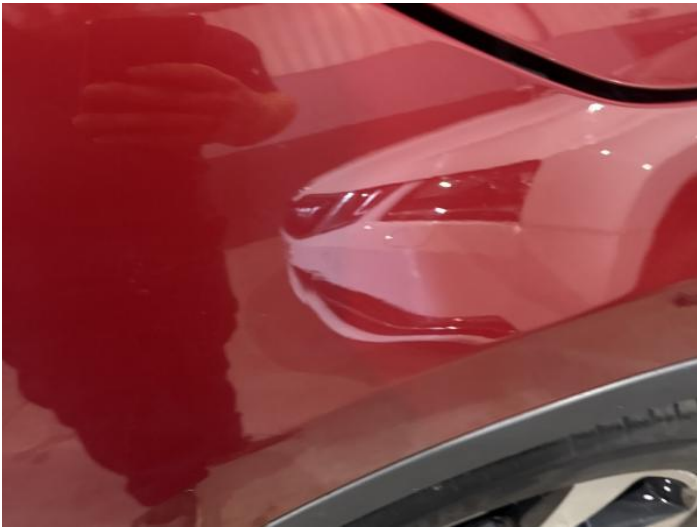
17: Wing osf
Dented
Over 2 UpTo 10mm

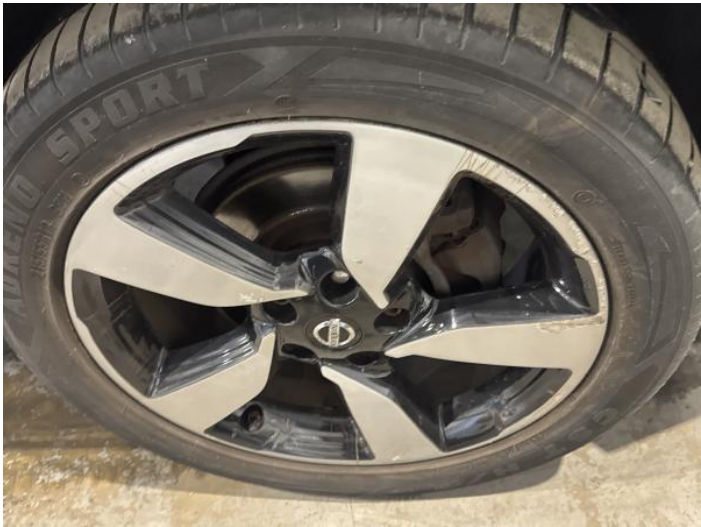
18: Wheel osf
Scratched
Over 50mm
