VEHICLE INSPECTION REPORT

MX63CZT

Vauxhall Astra 1.7 CDTi 16V ecoFLEX 130 Exclusiv 5dr [SS]

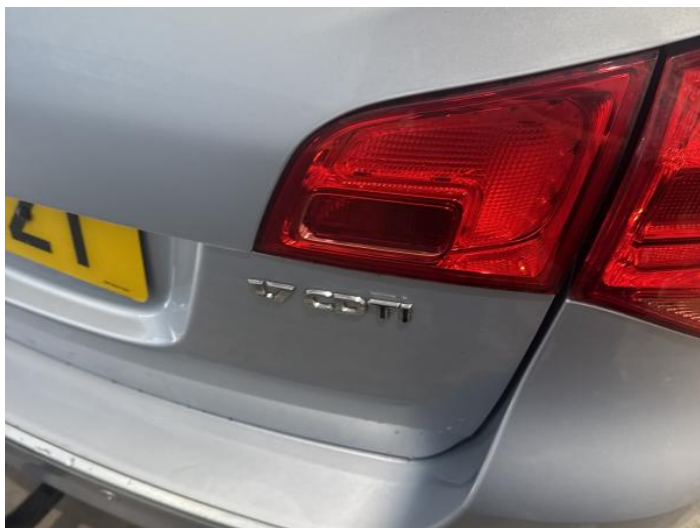
1: Bumper Rear
Scratched
25 to 100mm Thru Paint

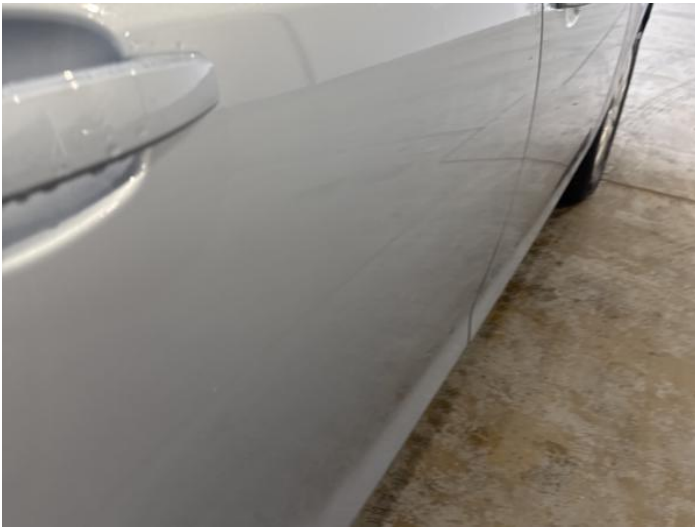
4: Qtr Panel osr
Chipped
1 To 5

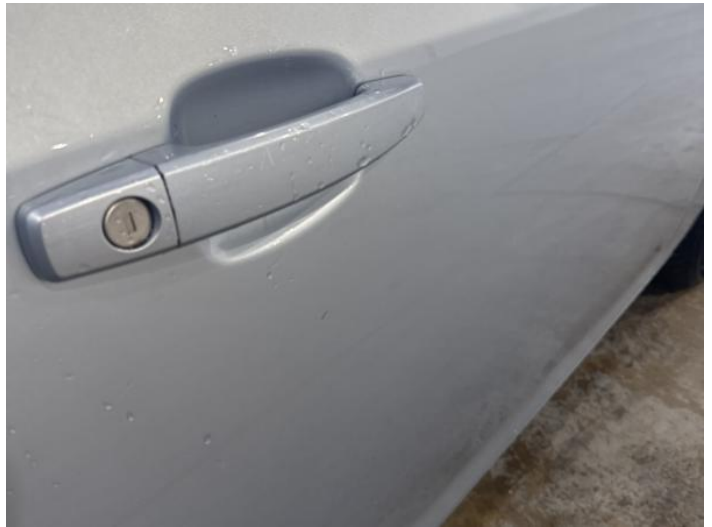
5: Door osr
Dented
Over 2 UpTo 10mm

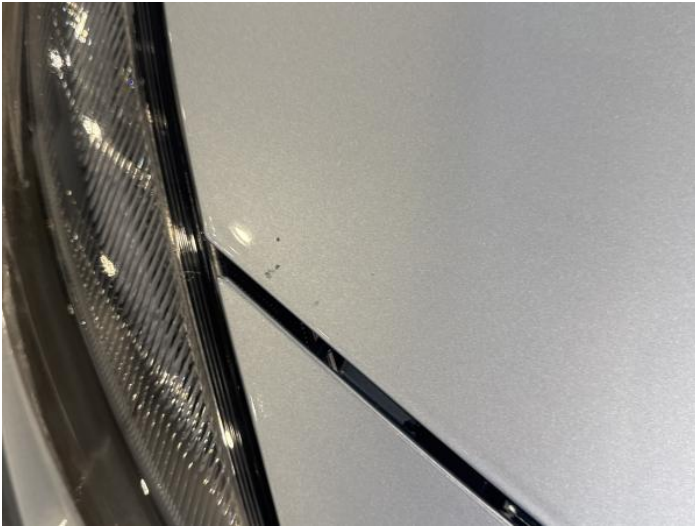
9: Bonnet
Chipped
1 To 5

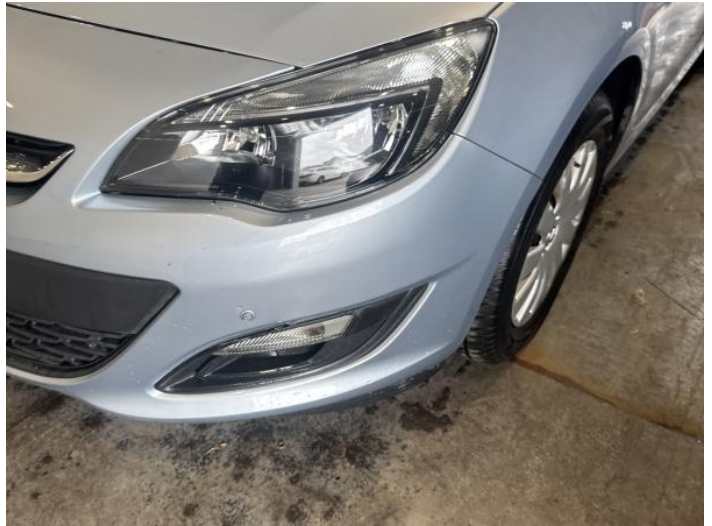
10: Bumper Front
Cracked
UpTo 25mm

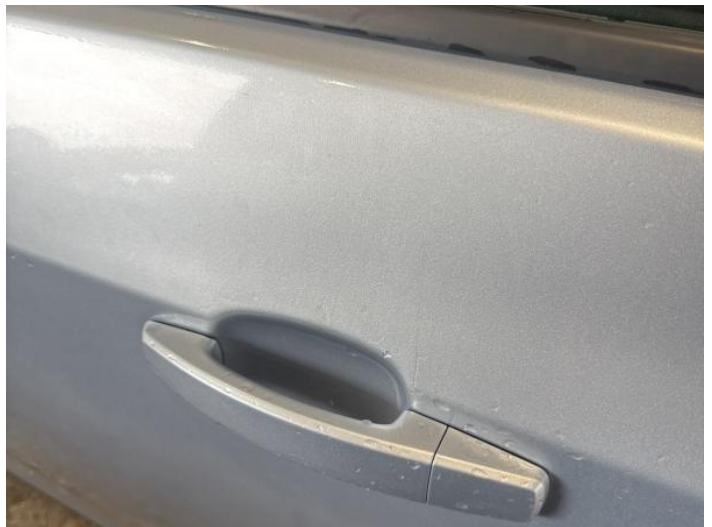
12: Door nsf
Poor Previous Repair
Poor Paint
