VEHICLE INSPECTION REPORT

DY13GKA

Vauxhall Antara 2.2 CDTi SE Nav 5dr [Start Stop]

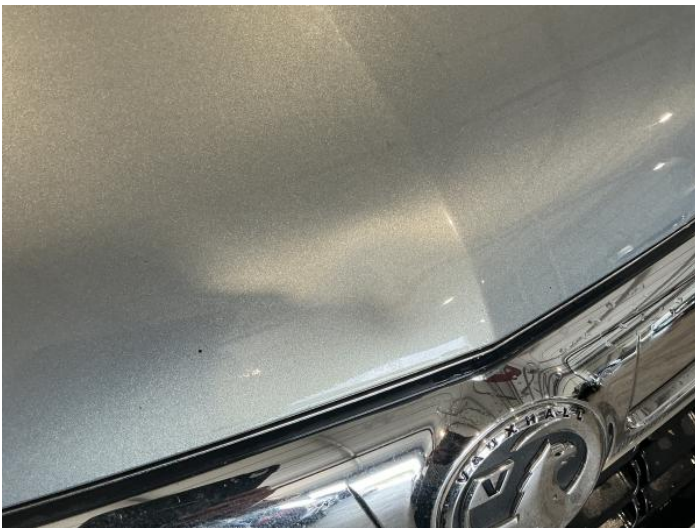
1: Bonnet
Chipped
1 To 5

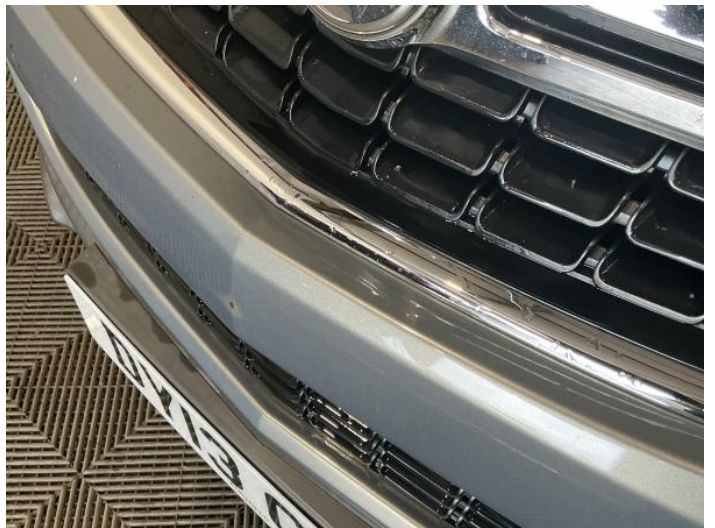
2: Bumper Front
Scratched
25 to 100mm Thru Paint

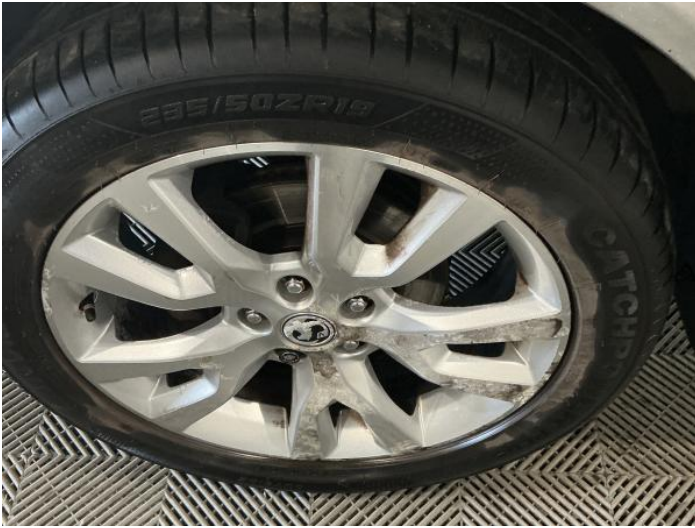
3: Wheel nsf
Scratched
Over 50mm

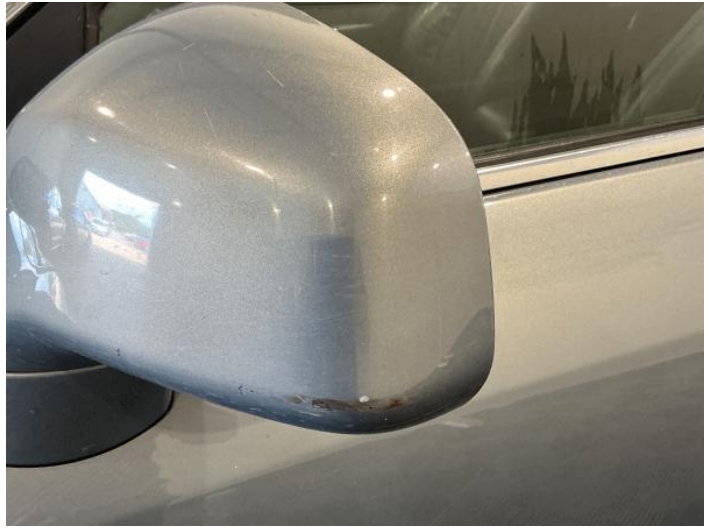
4: Door Mirror Assy nsf
Scratched (Painted)
Over 25mm Thru Paint

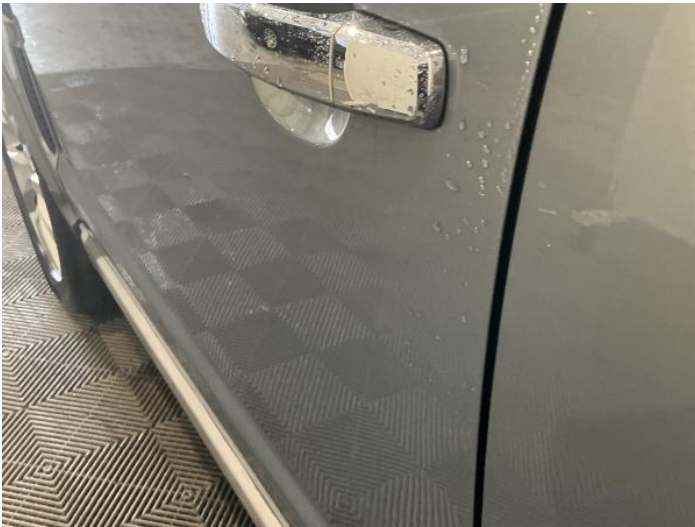
5: Door nsf
Dented
Between 10mm + 30mm

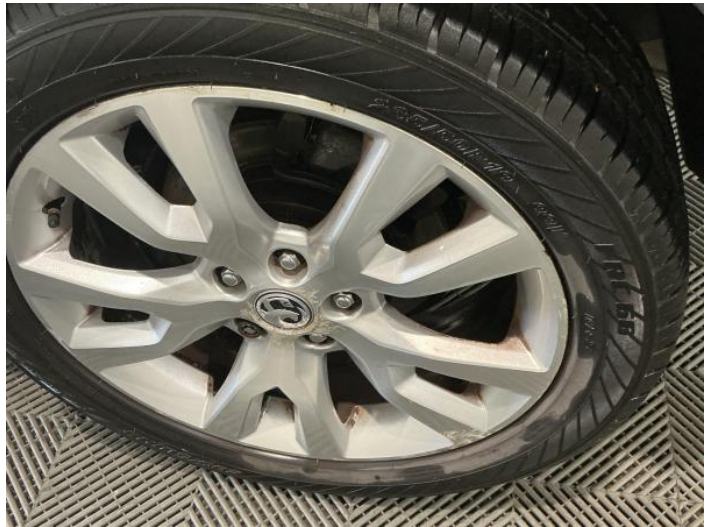
6: Wheel nsr
Scratched
Over 50mm

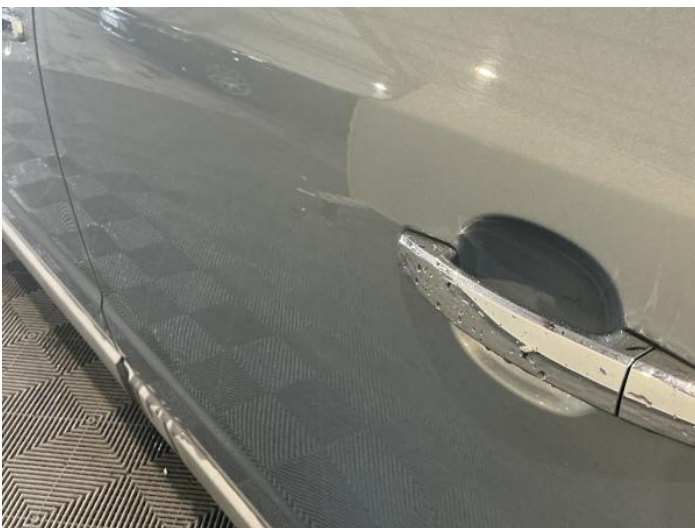
7: Door nsr
Dented
Between 10mm + 30mm

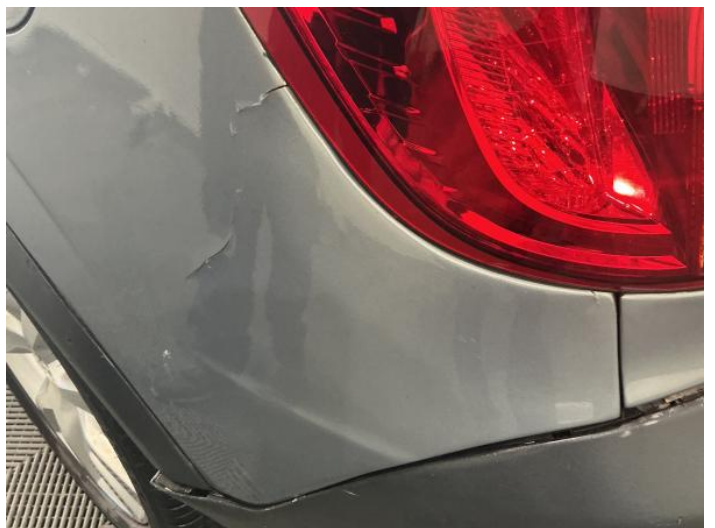
8: Qtr Panel nsr
Cracked
Replace

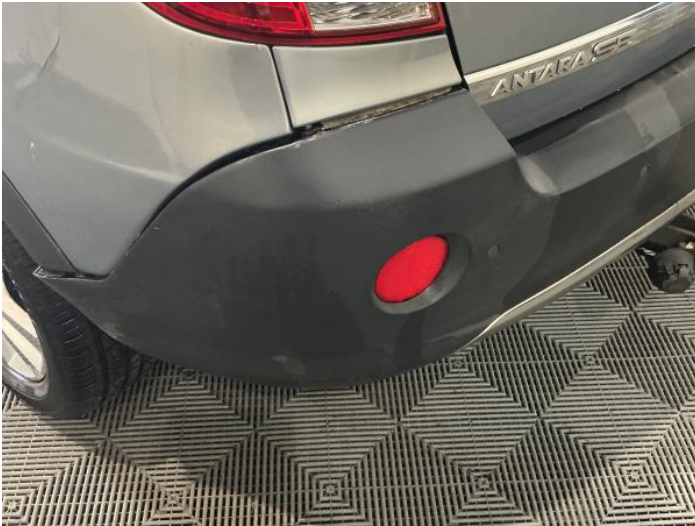
9: Bumper Rear
Insecure
Action Required

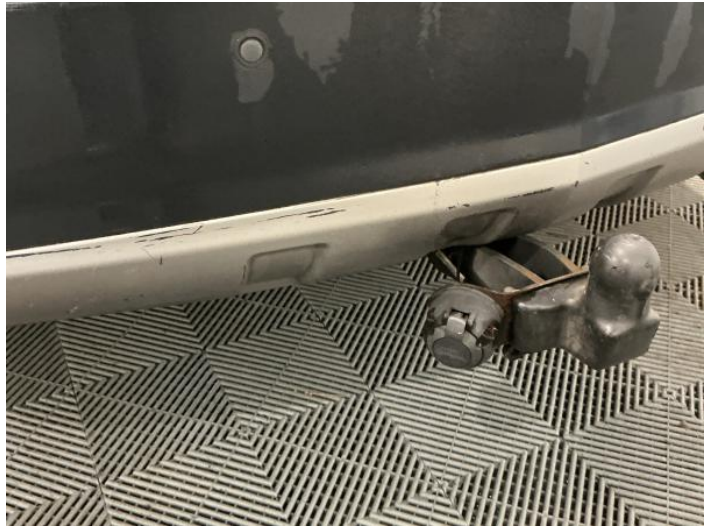
10: Bumper Rear Moulding
Scratched (Painted)
Over 25mm Thru Paint

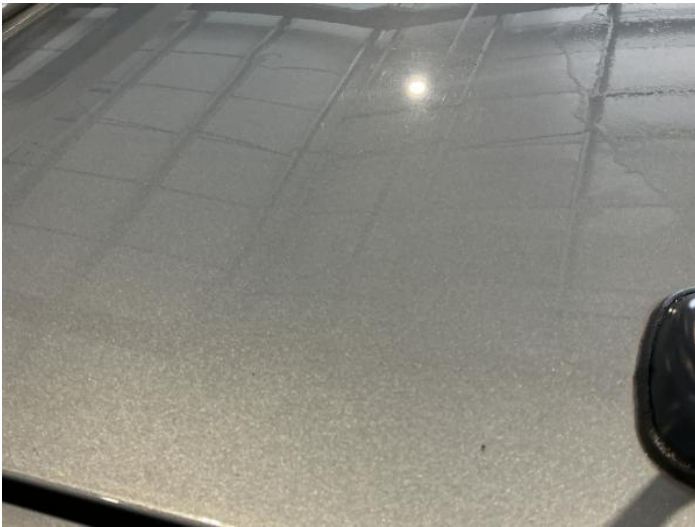
11: Roof
Dented
Between 10mm + 30mm

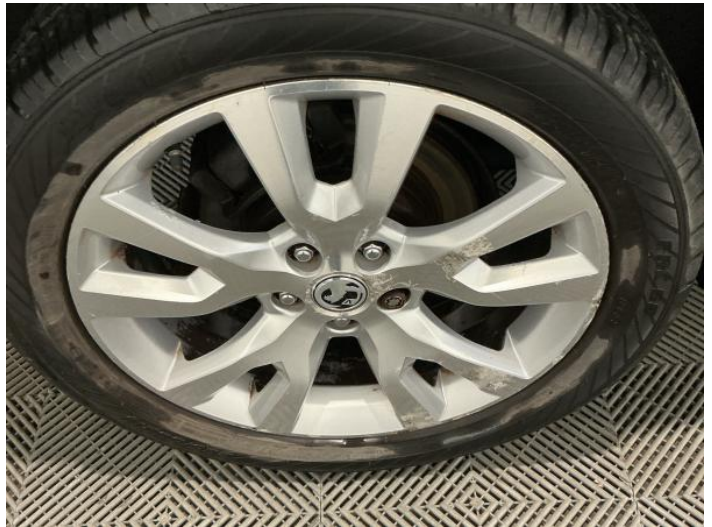
12: Wheel osr
Scratched
Over 50mm

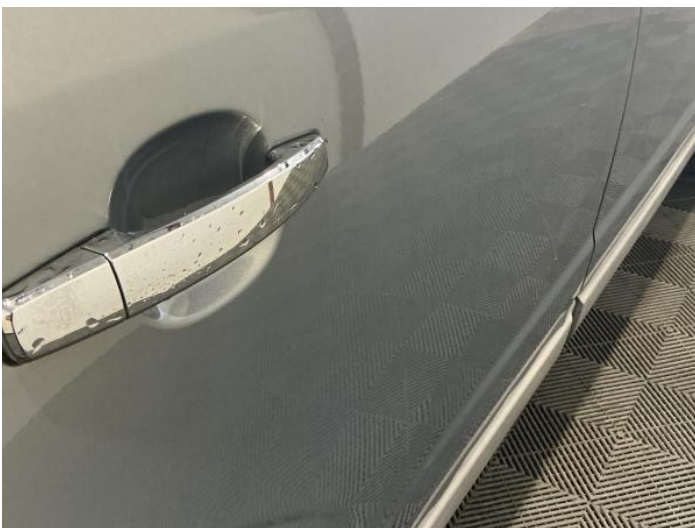
13: Door osr
Dented
Between 10mm + 30mm

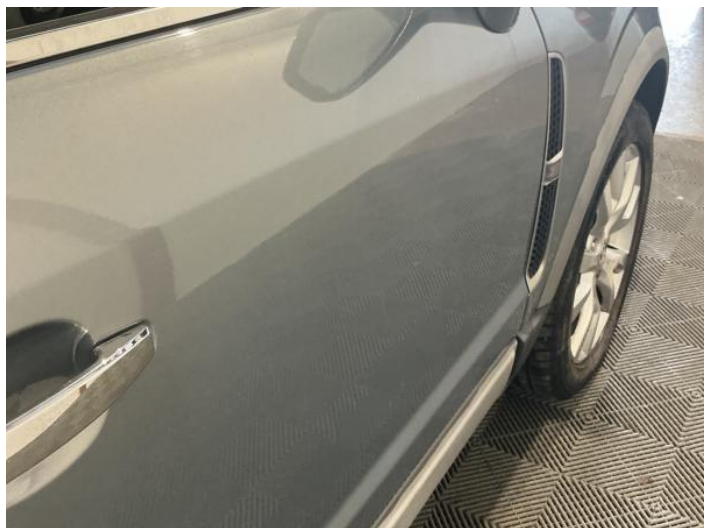
14: Door osf
Dented
Over 30mm

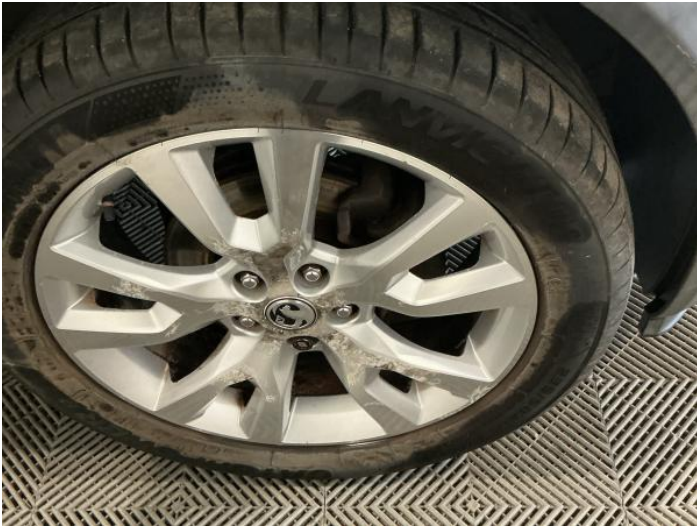
15: Wheel osf
Scratched
Over 50mm

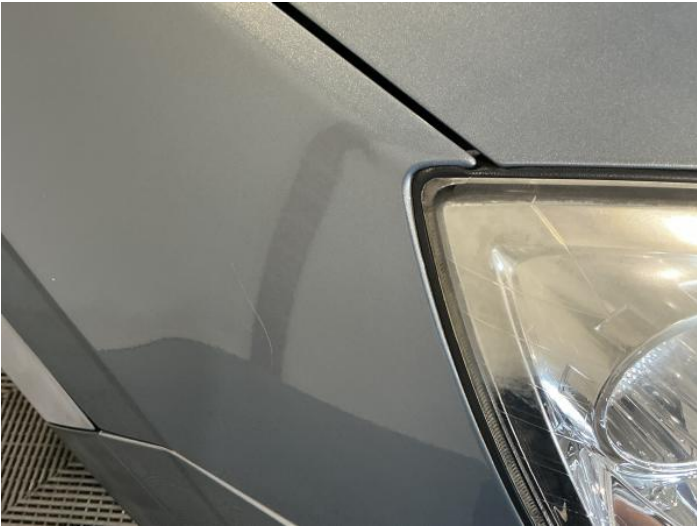
16: Wing osf
Scratched
Over 25mm Thru Paint
