VEHICLE INSPECTION REPORT

HN12XGZ

Nissan Micra 1.2 Kuro 5dr

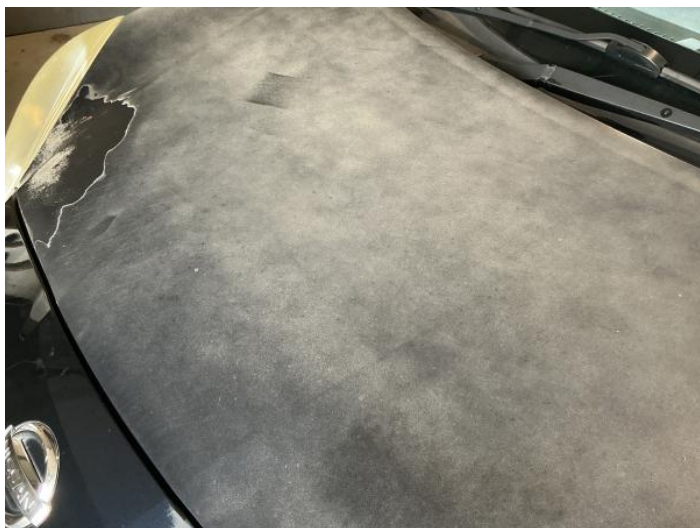
1: Bonnet
Scratched
Over 25mm Thru Paint

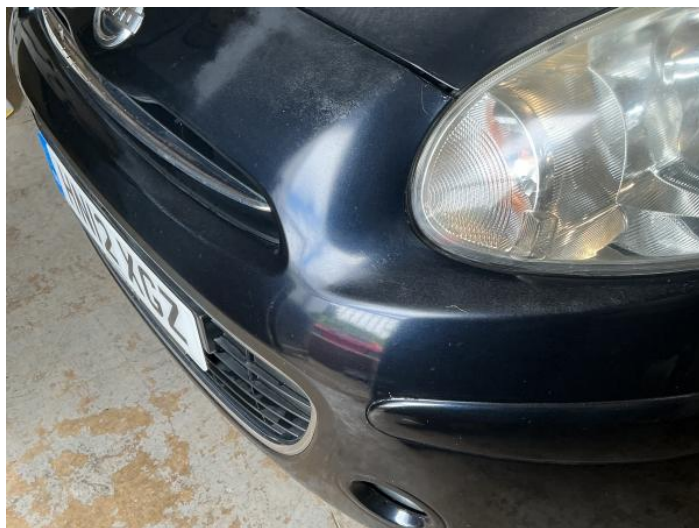
2: Bumper Front
Scratched
Over 100mm Thru Paint

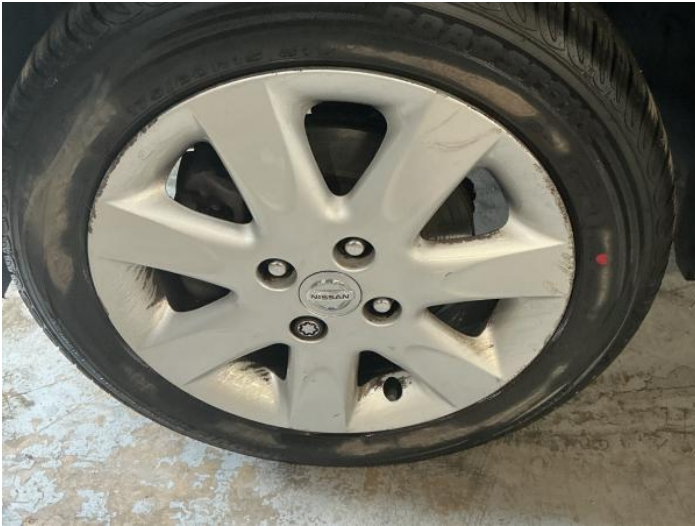
3: Wheel nsf
Scratched
Over 50mm

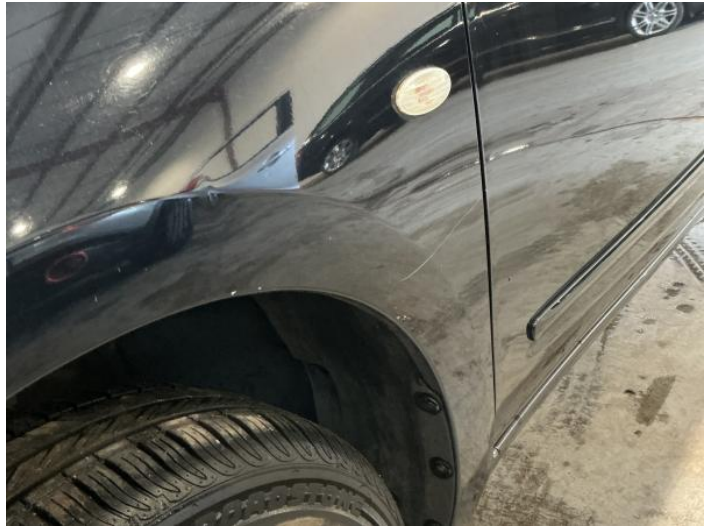
4: Wing nsf
Dented
With Paint Damage

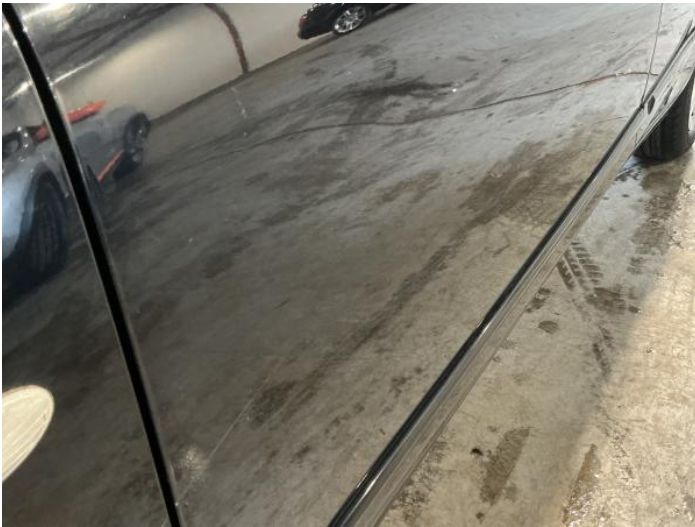
5: Door nsf
Dented
With Paint Damage

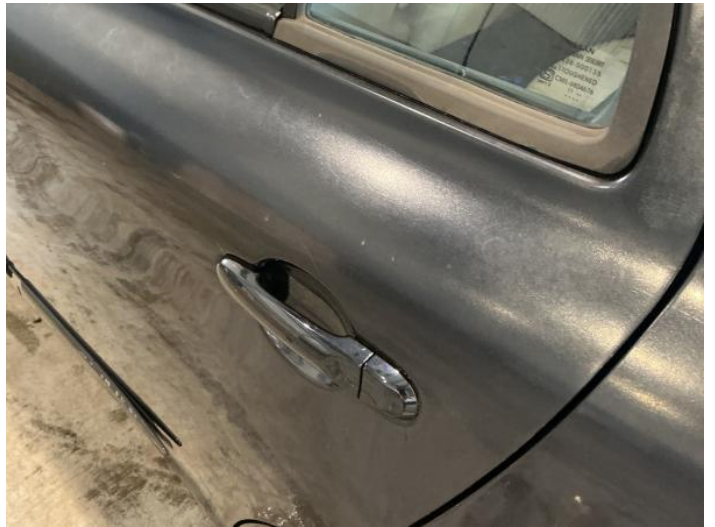
6: Door nsr
Dented
With Paint Damage

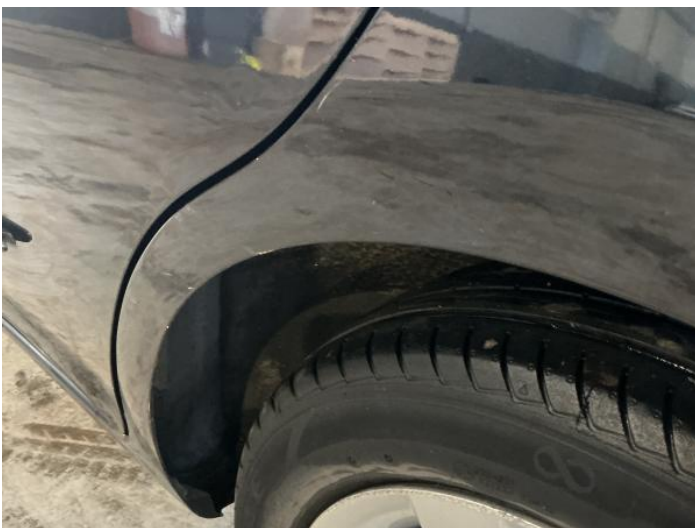
7: Qtr Panel nsr
Dented
With Paint Damage

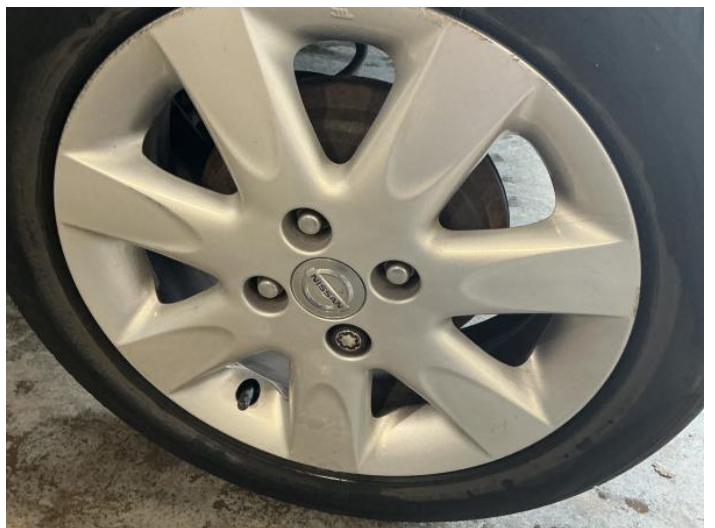
8: Wheel nsr
Scratched
Over 50mm

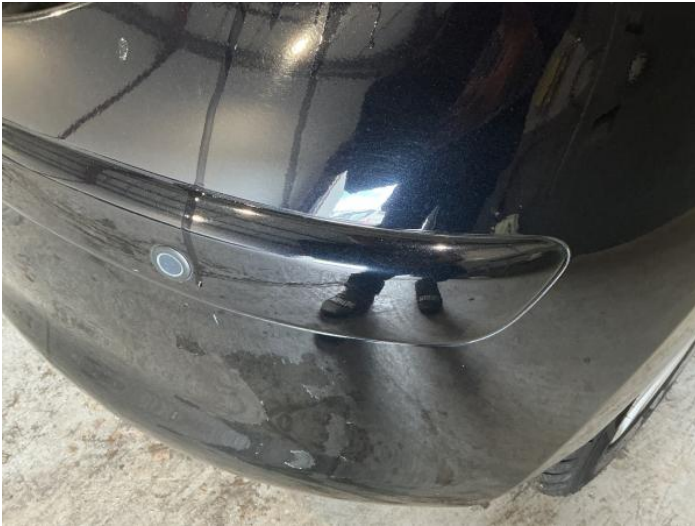
9: Bumper Rear
Scratched
25 to 100mm Thru Paint

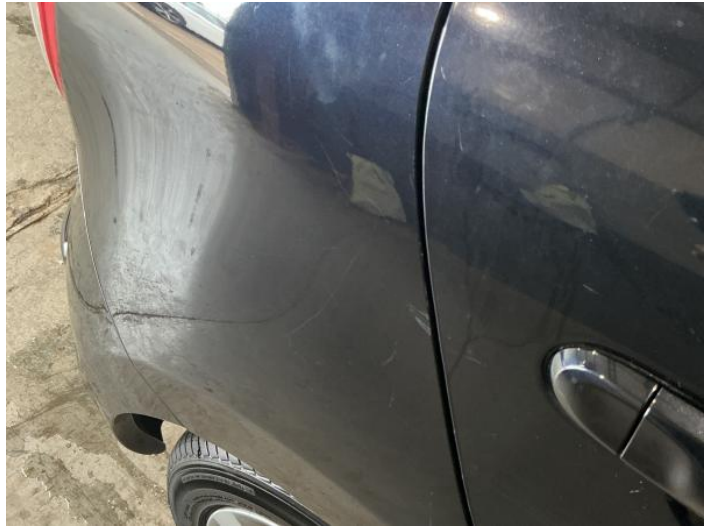
10: Qtr Panel osr
Scratched
Over 25mm Thru Paint

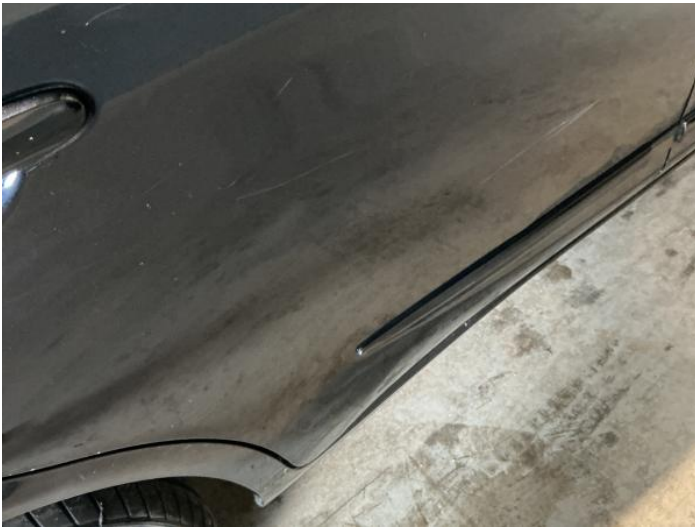
11: Door osr
Dented
With Paint Damage

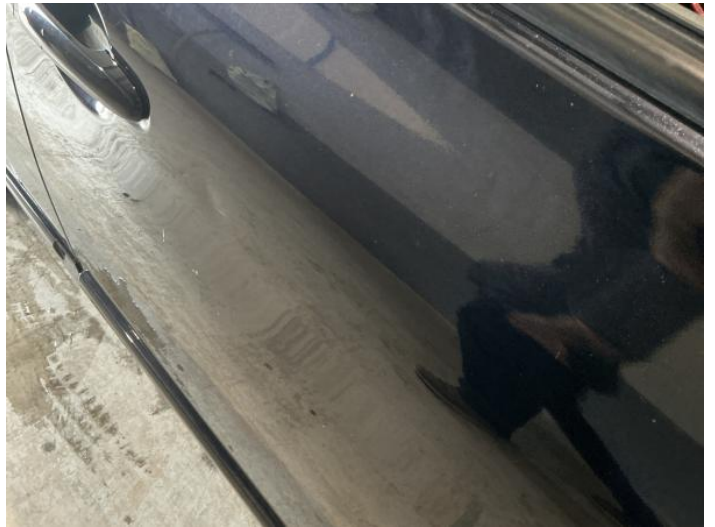
12: Door osf
Dented
Over 30mm

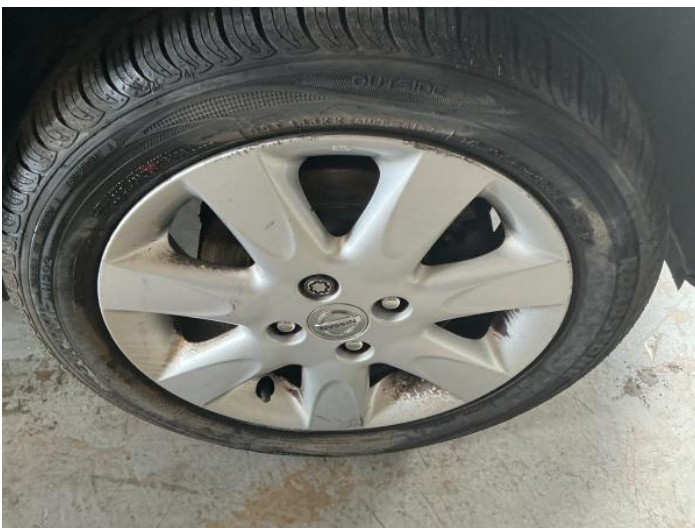
13: Wheel osf
Scratched
Over 50mm

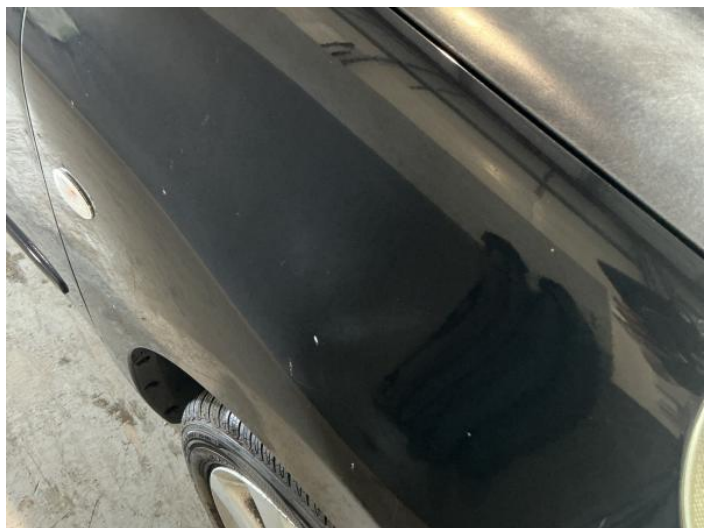
14: Wing osf
Scratched
Over 25mm Thru Paint

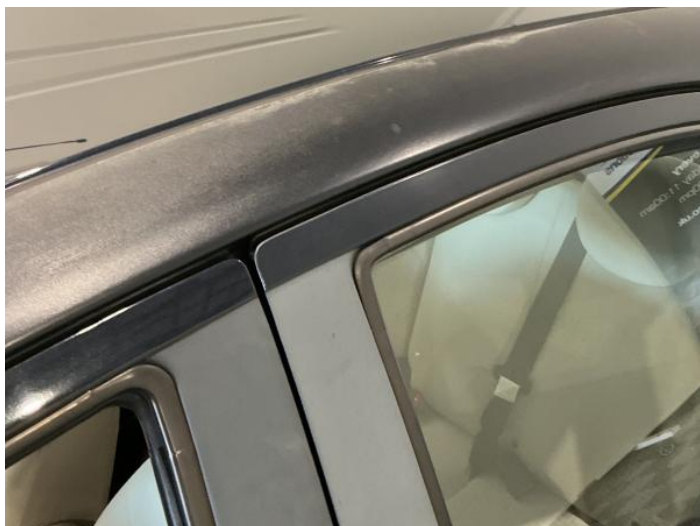
15: Roof
 Scratched
 Over 25mm Thru Paint
