VEHICLE INSPECTION REPORT

LG13SDO

Nissan Note 1.4 N-Tec+ 5dr

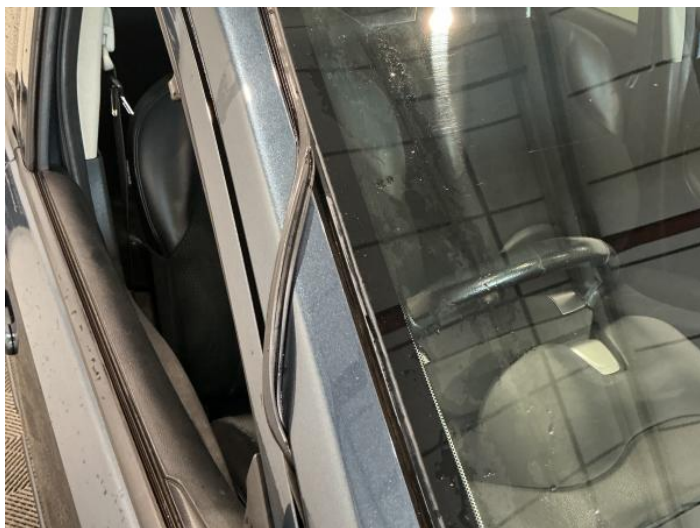
1: Aperture Seal of
Broken
Replace

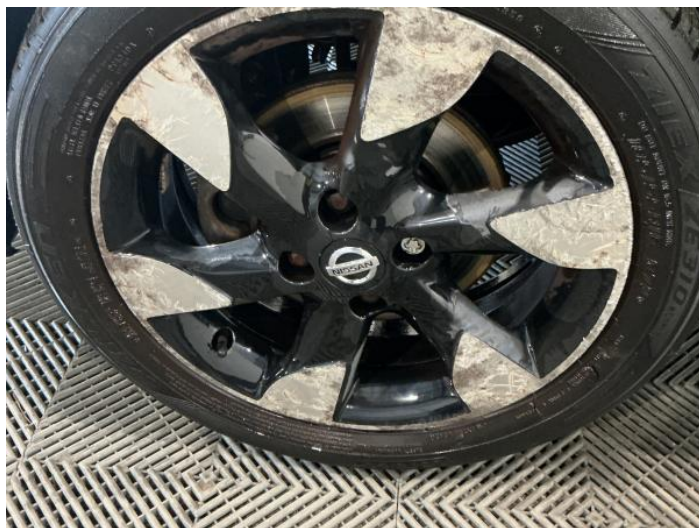
2: Wheel nsf
Scratched
Over 50mm

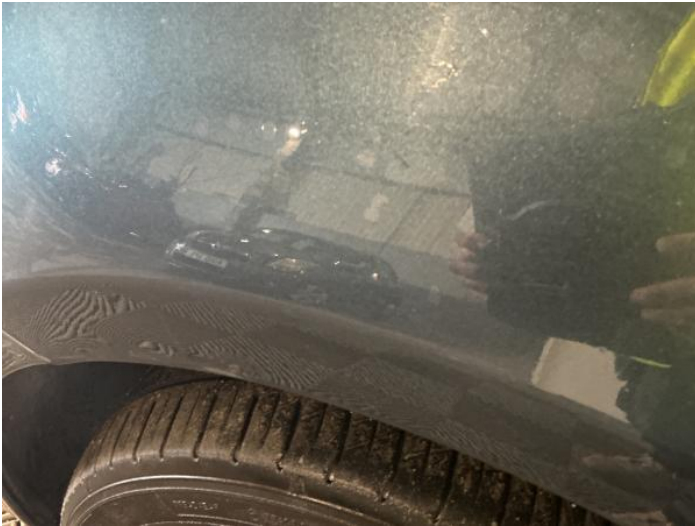
3: Wing nsf
Scratched
UpTo 25mm Thru Paint

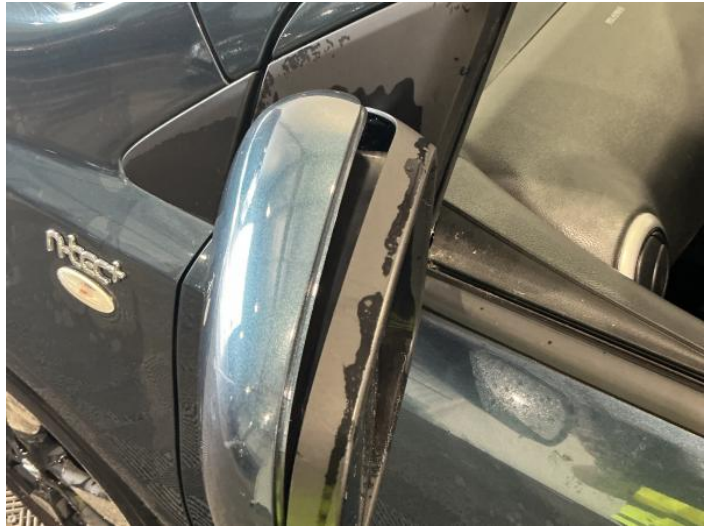
4: Door Mirror Assy nsf
Broken
Replace

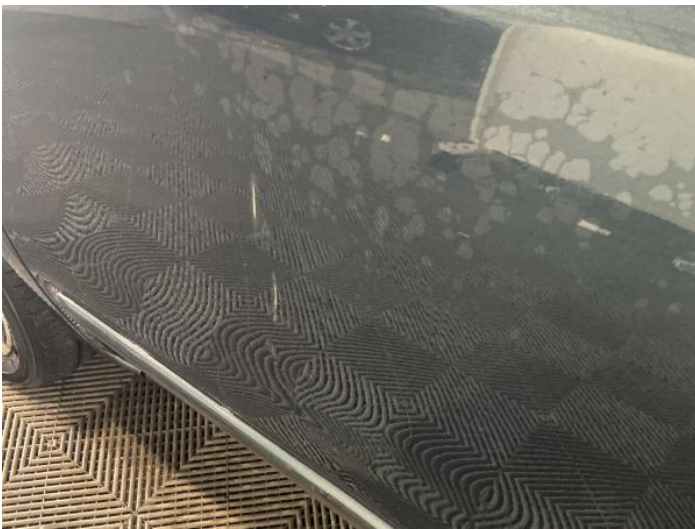
5: Door nsf
Dented
With Paint Damage

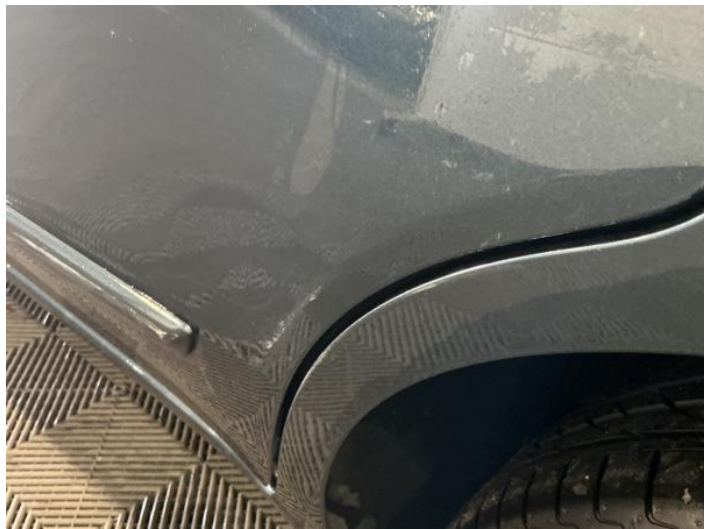
6: Door nsr
Scratched
Over 25mm Thru Paint

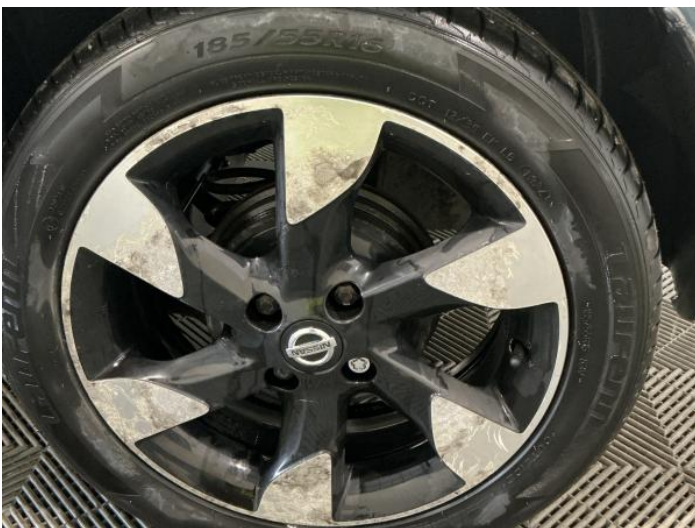
7: Wheel nsr
Scratched
Over 50mm

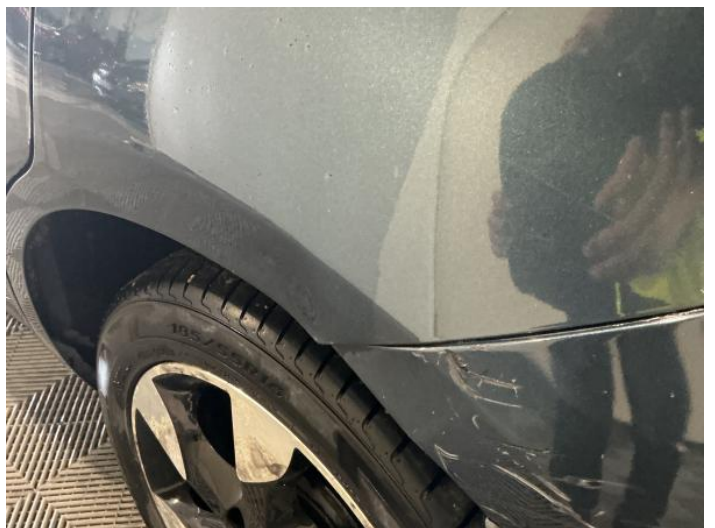
8: Qtr Panel nsr
Dented
Over 30mm

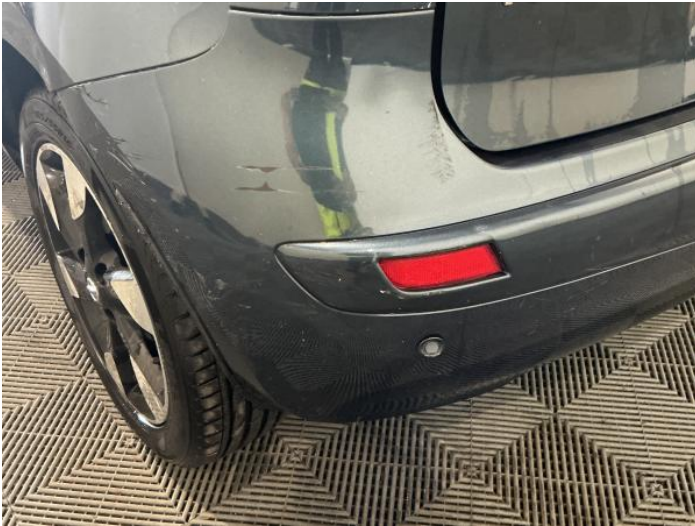
9: Bumper Rear
Dented
With Paint Damage

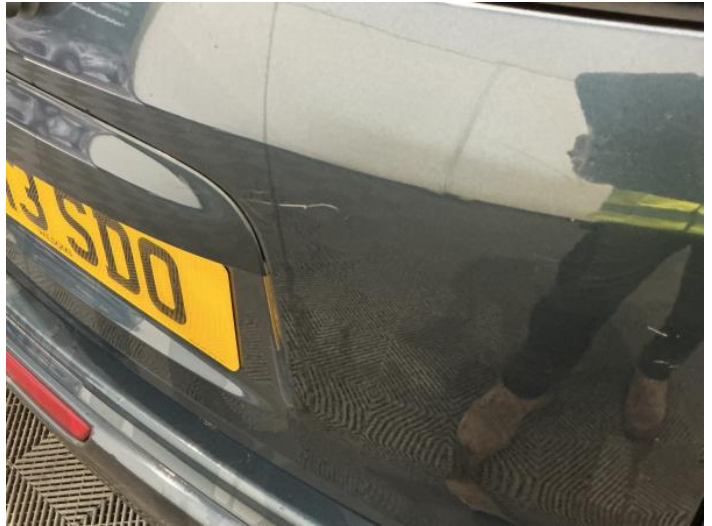
10: Tailgate
Scratched
Over 25mm Thru Paint

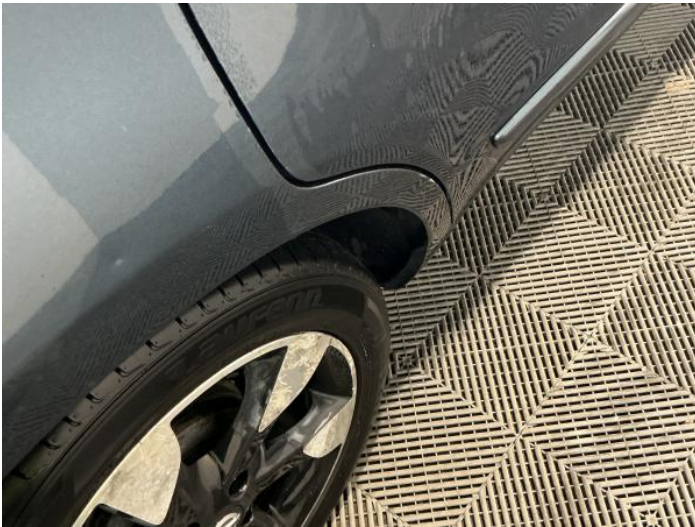
11: Qtr Panel osr
Dented
With Paint Damage

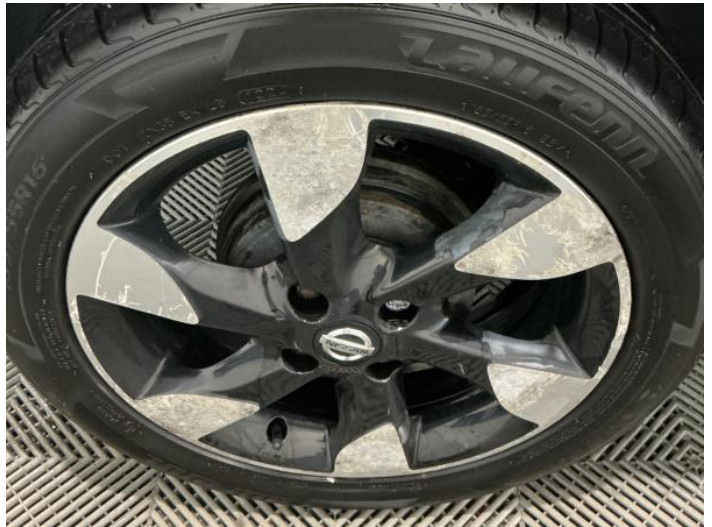
12: Wheel osr
Scratched
Over 50mm

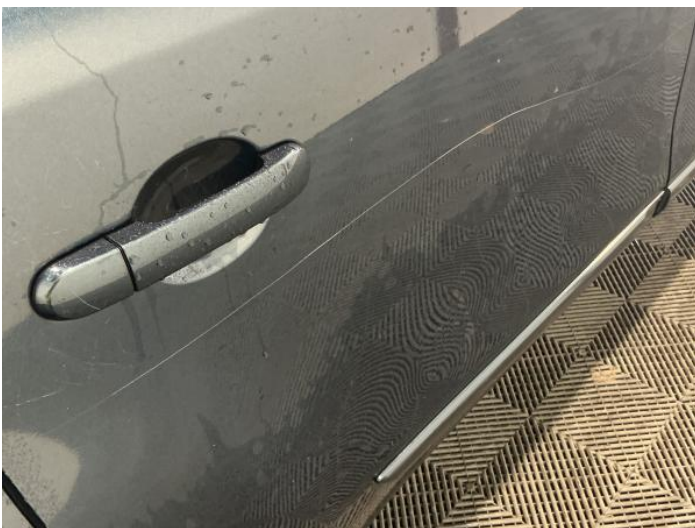
13: Door nsr
Scratched
Over 25mm Thru Paint

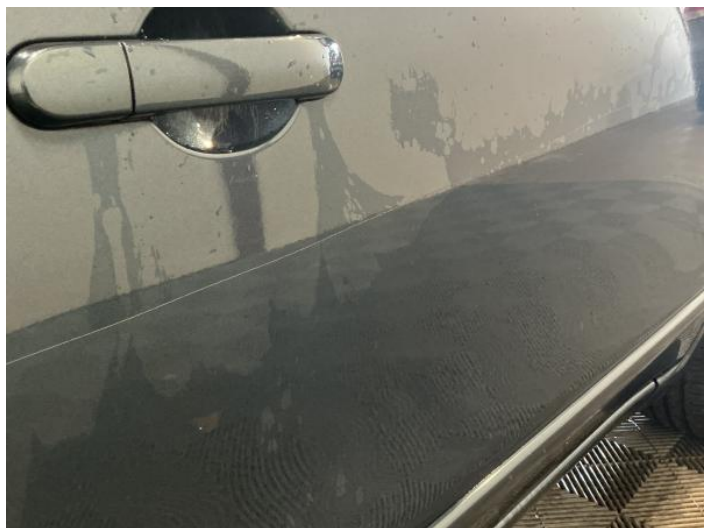
14: Door osf
Scratched
Over 25mm Thru Paint

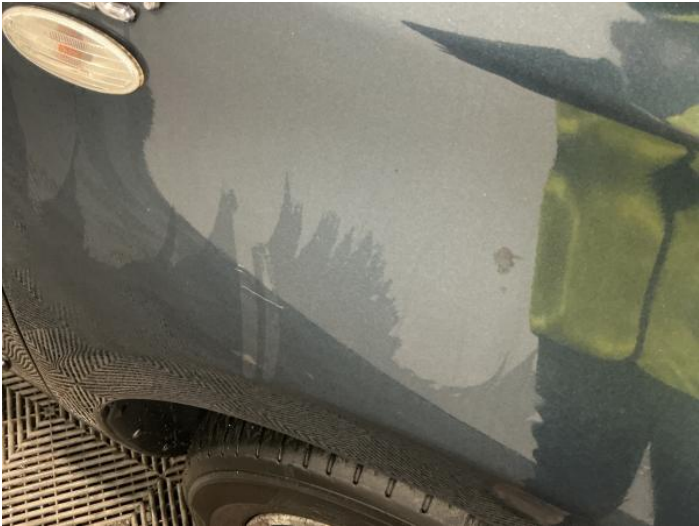
15: Wing osf
Scratched
UpTo 25mm Thru Paint

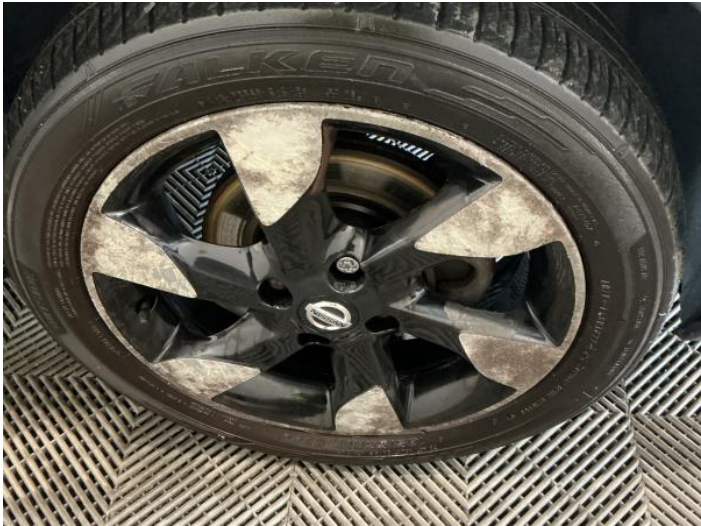
16: Wheel osf
Scratched
Over 50mm

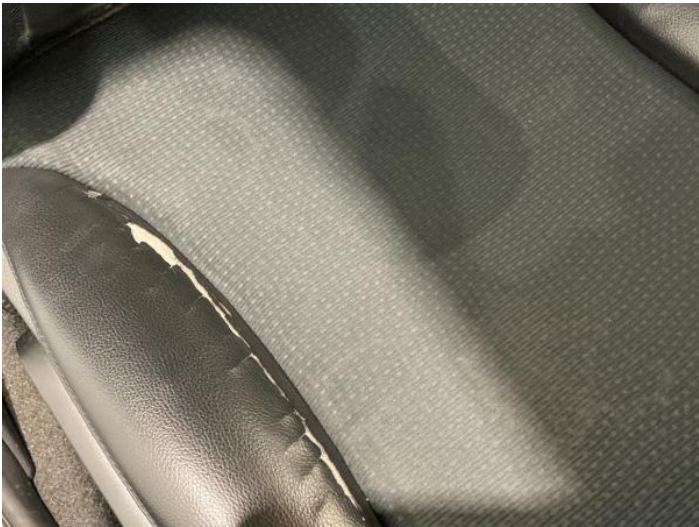
17: Seat Base Cover osf
Scuffed
Over 25mm
