VEHICLE INSPECTION REPORT

MV13BSU

Mercedes-Benz E Class E220 CDI BlueEFFICIENCY SE 4dr Tip Auto [7]

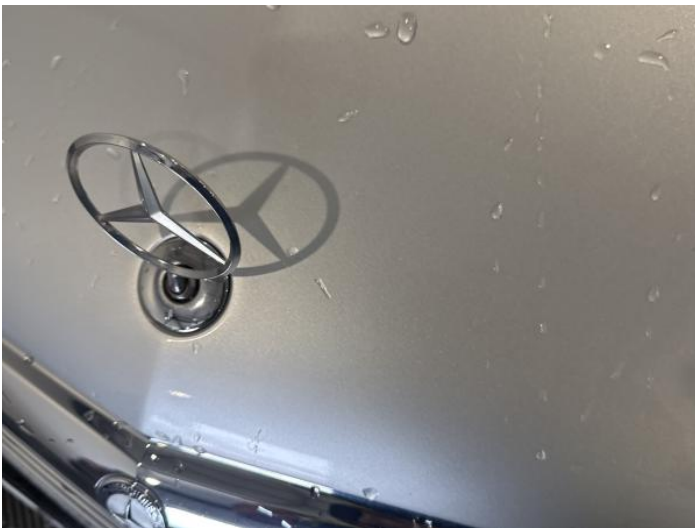
1: Bonnet
Chipped
1 To 5

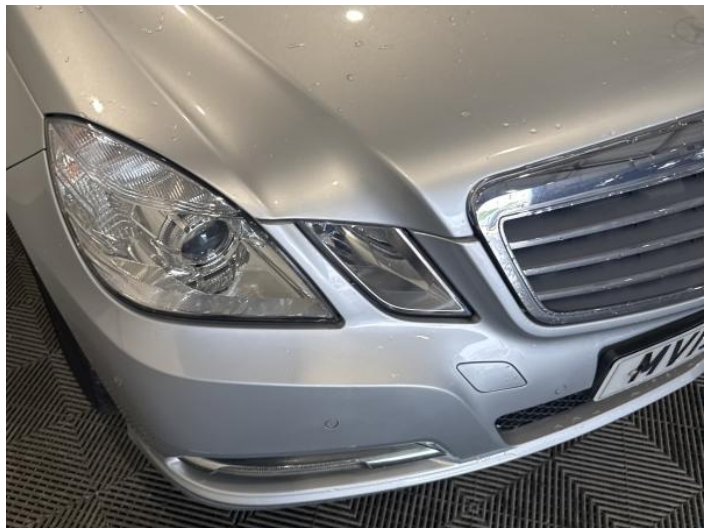
2: Bumper Front
Scratched
Over 100mm Thru Paint

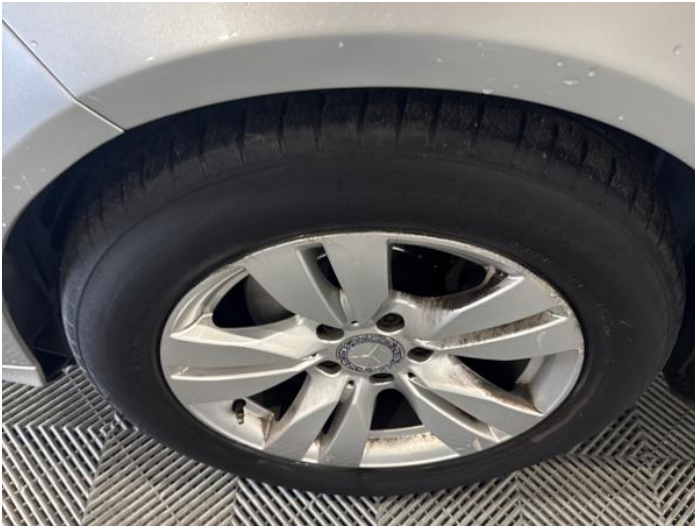
3: Wheel nsf
Scratched
Over 50mm

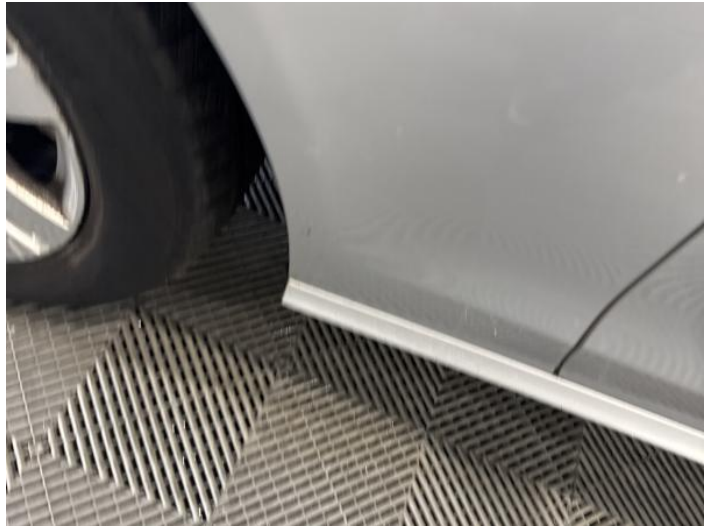
4: Wing nsf
Chipped
1 To 5

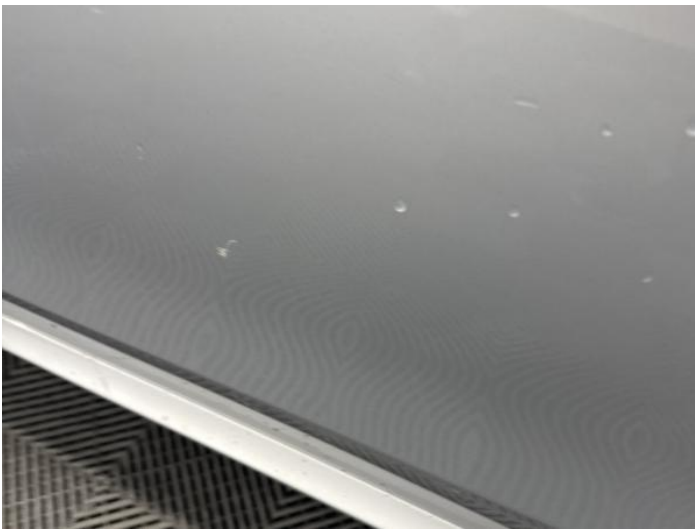
5: Door nsf
Chipped
Over 5mm

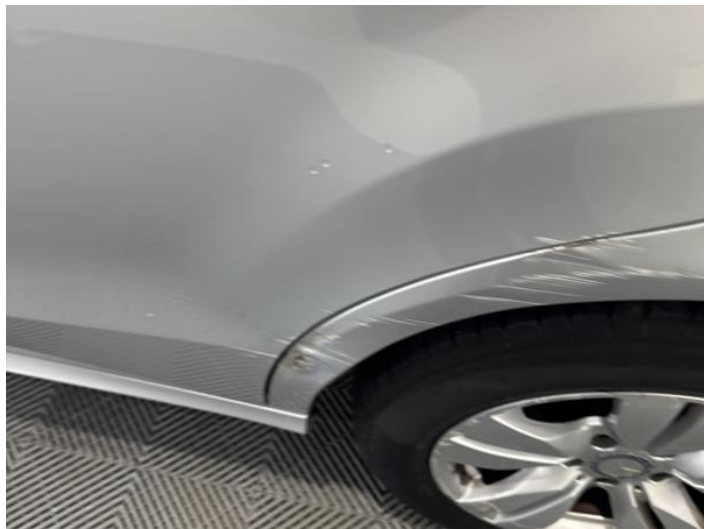
6: Door nsr
Dented
With Paint Damage

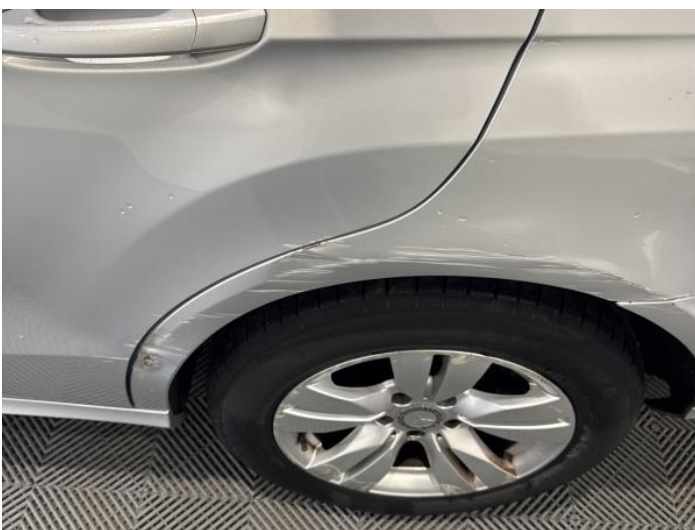
7: Qtr Panel nsr
Dented
With Paint Damage

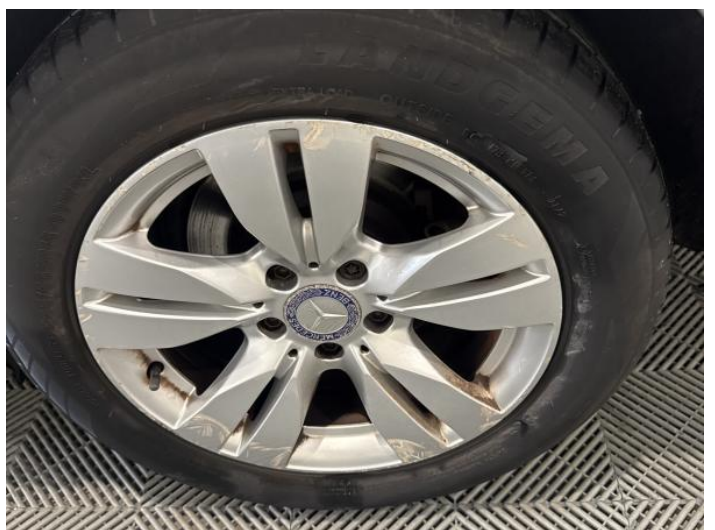
8: Wheel nsr
Scratched
Over 50mm

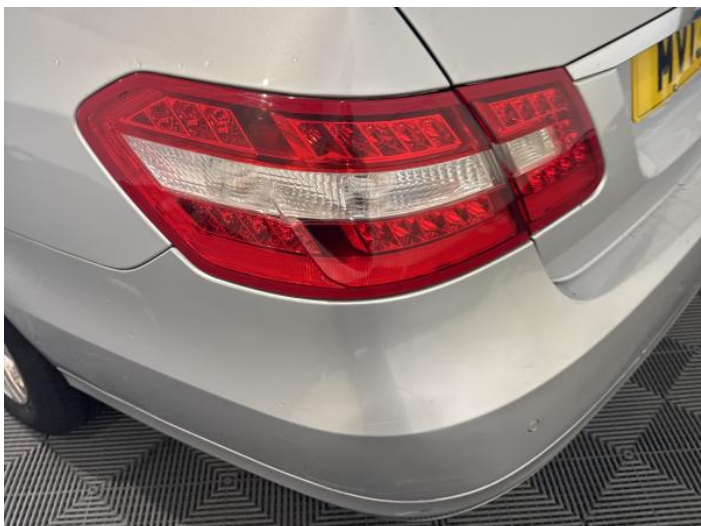
9: Bumper Rear
Scratched
Over 100mm Thru Paint

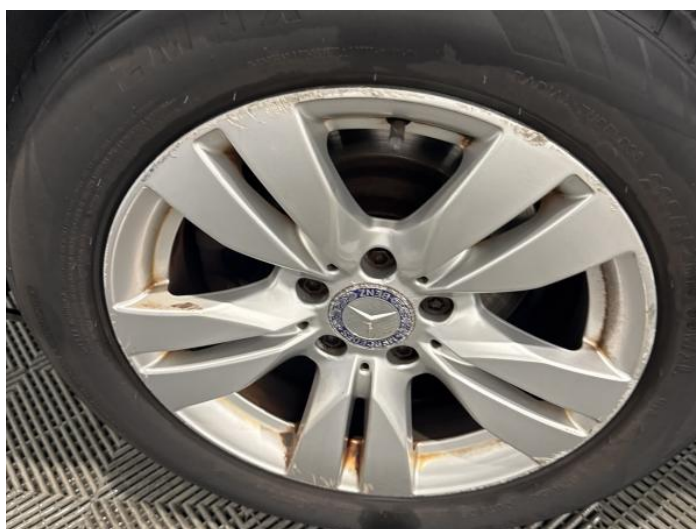
12: Wheel osr
Scratched
Over 50mm

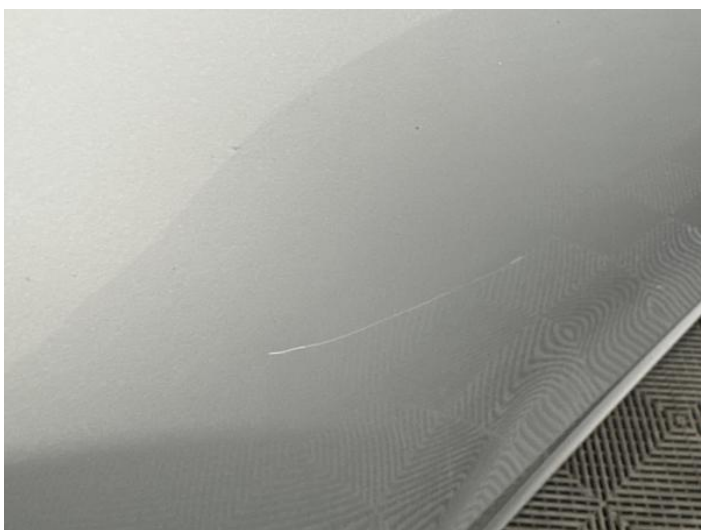
13: Door osr
Scratched
Over 25mm Thru Paint

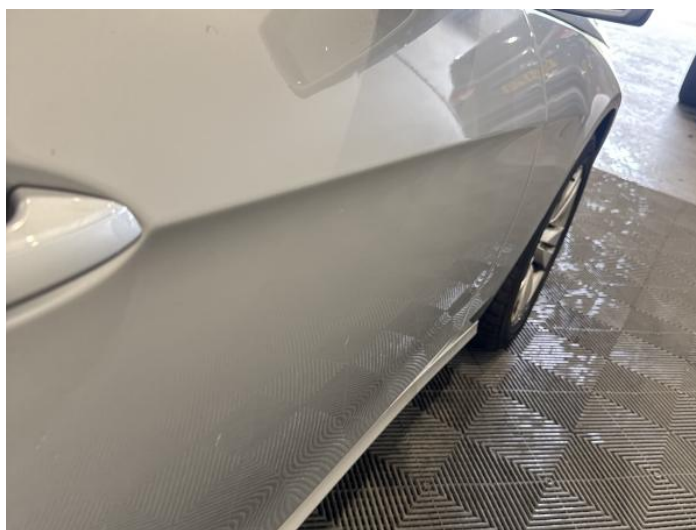
14: Door osf
Dented
Over 2 UpTo 10mm

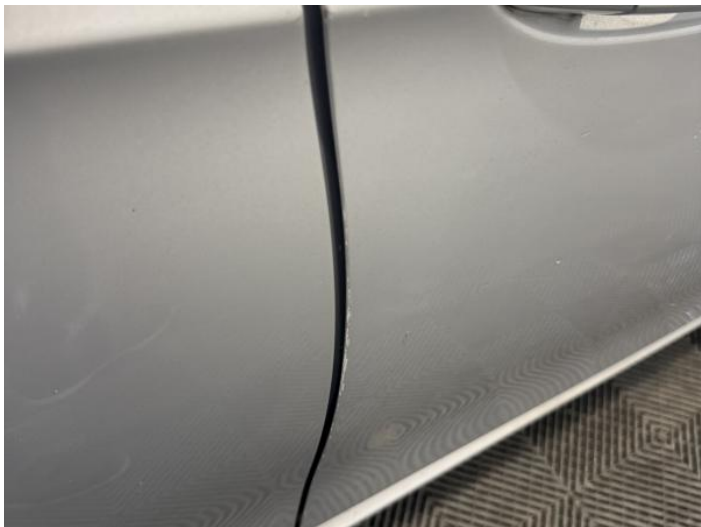
15: Door osf
Chipped
Edge Chip

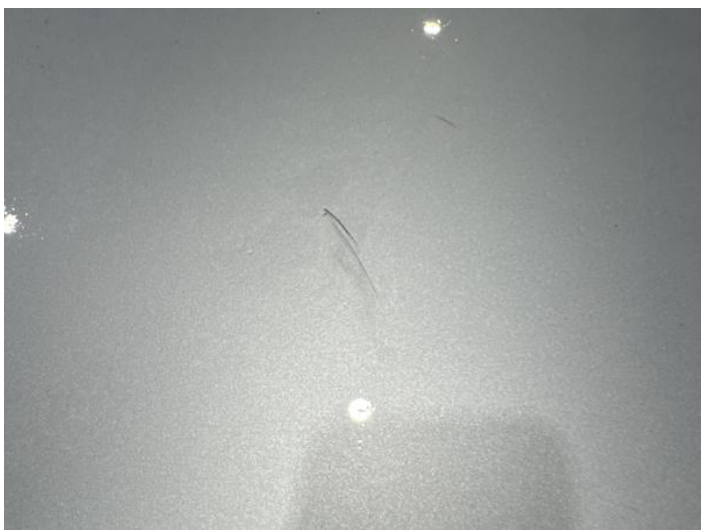
17: Roof
Scratched
UpTo 25mm Thru Paint

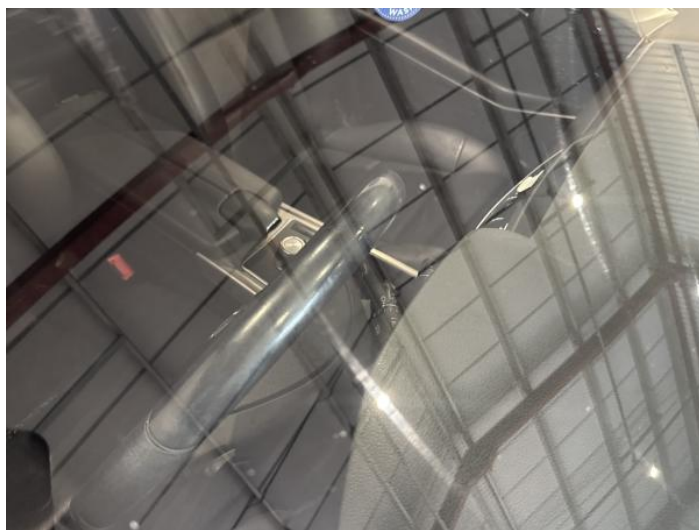
18: Screen Front
Chipped
UpTo 10mm

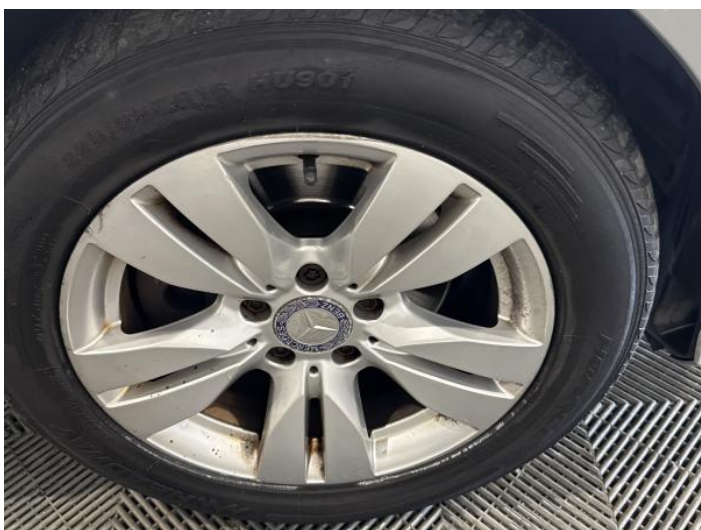
19: Wheel osf
Scratched
Over 50mm

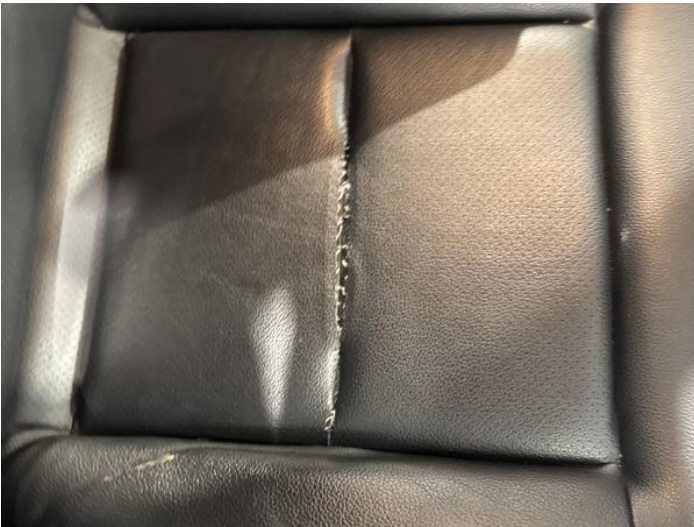
23: Seat Base Cover osf
Torn
Over 3mm
