VEHICLE INSPECTION REPORT

YG15UBO

Mazda 3 2.2d Sport Nav 5dr

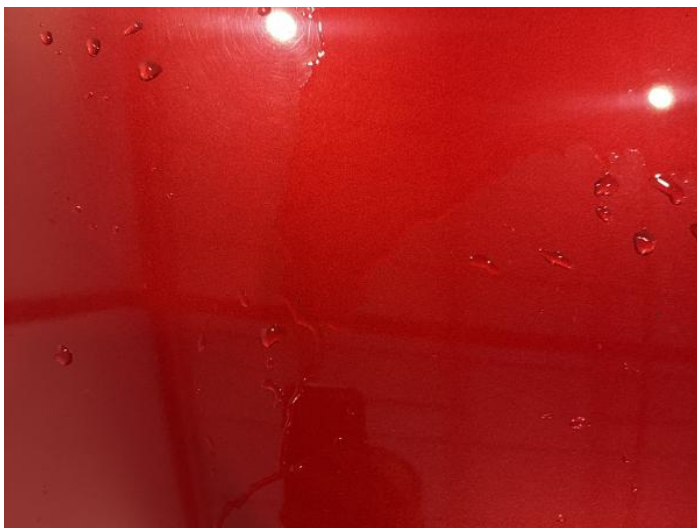
1: Bonnet
Chipped
1 To 5

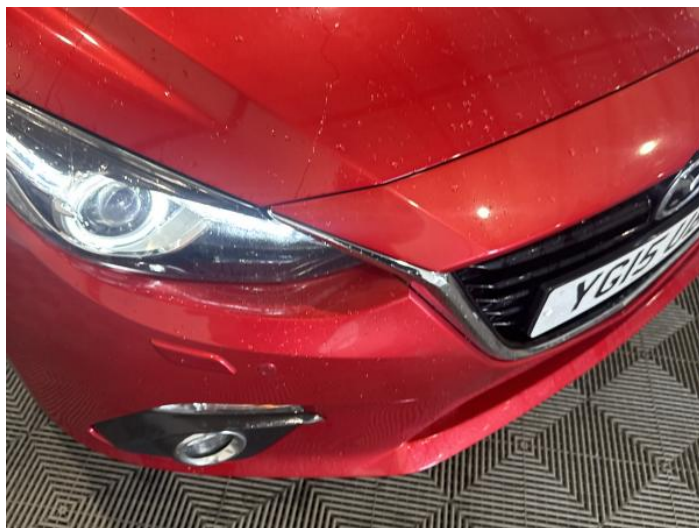
2: Bumper Front
Poor Previous Repair
Poor Paint

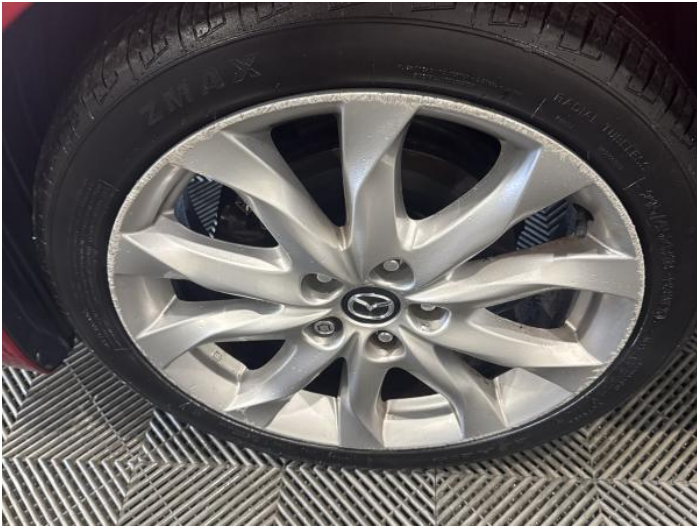
3: Wheel nsf
Scratched
Over 50mm

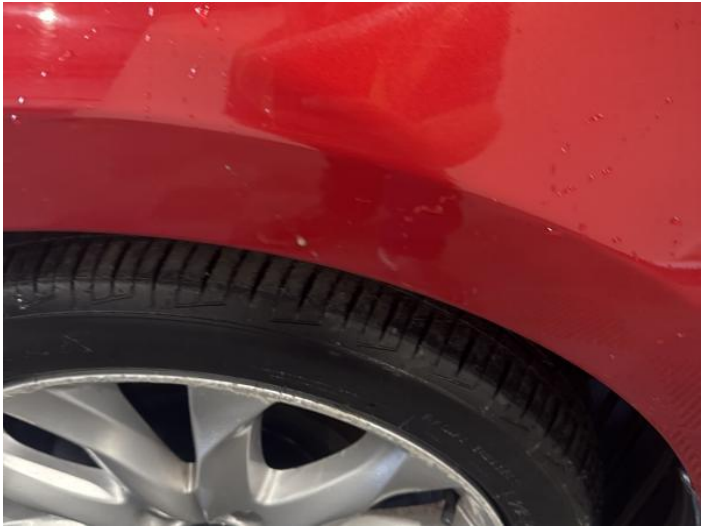
4: Wing nsf
Chipped
1 To 5

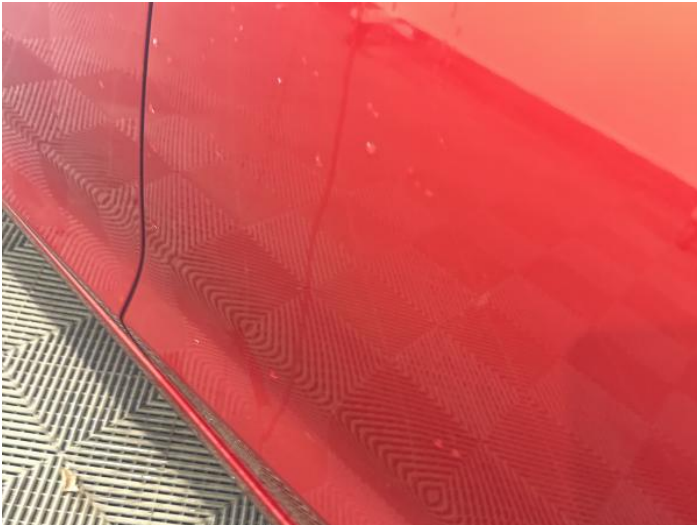
7: Door nsr
Chipped
1 To 5

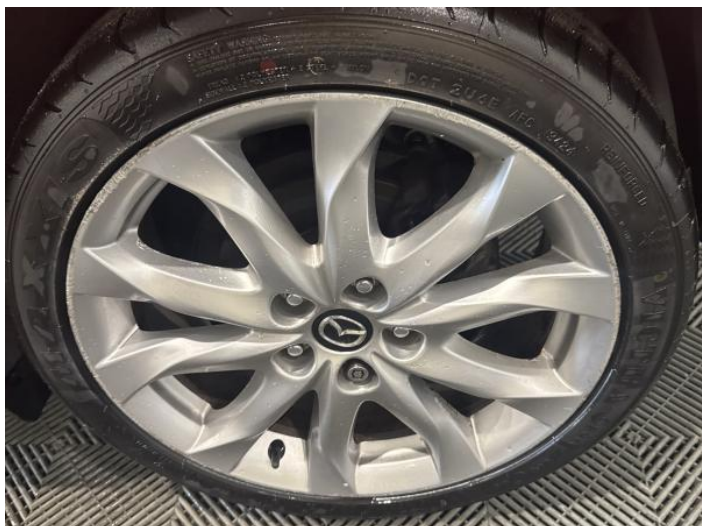
9: Wheel nsr
Scratched
Over 50mm

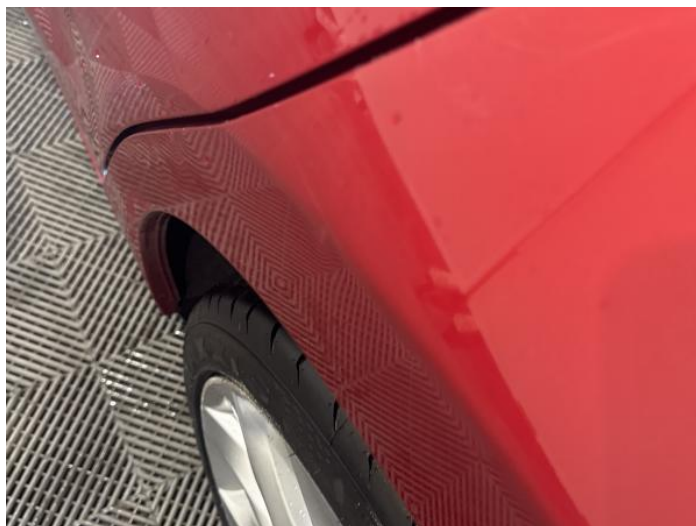
10: Qtr Panel nsr
Dented
Over 2 UpTo 10mm

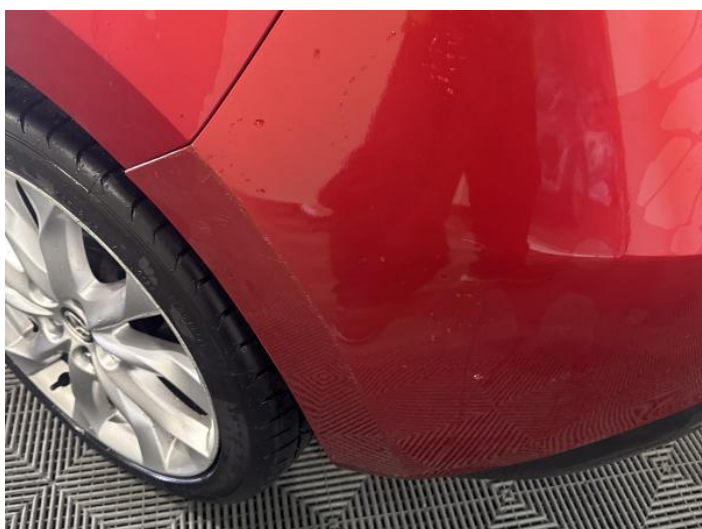
11: Bumper Rear
Scratched
Over 100mm Thru Paint

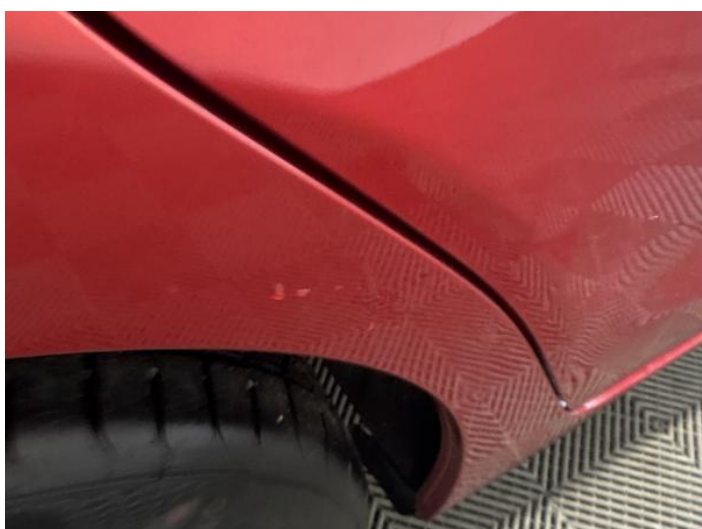
13: Qtr Panel osr
Dented
2 Or Less UpTo 10mm

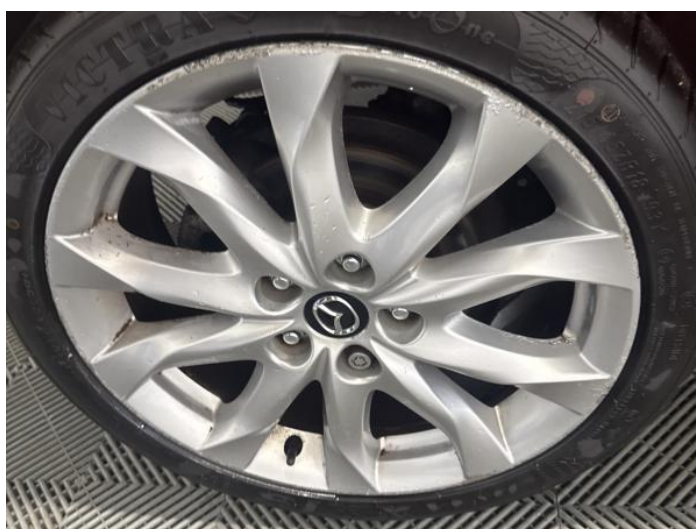
14: Wheel osr
Scratched
Over 50mm

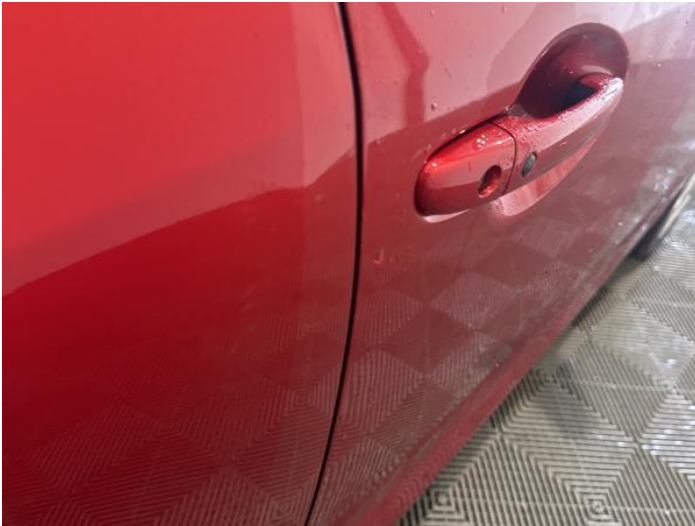
15: Door osr
Dented
Between 10mm + 30mm

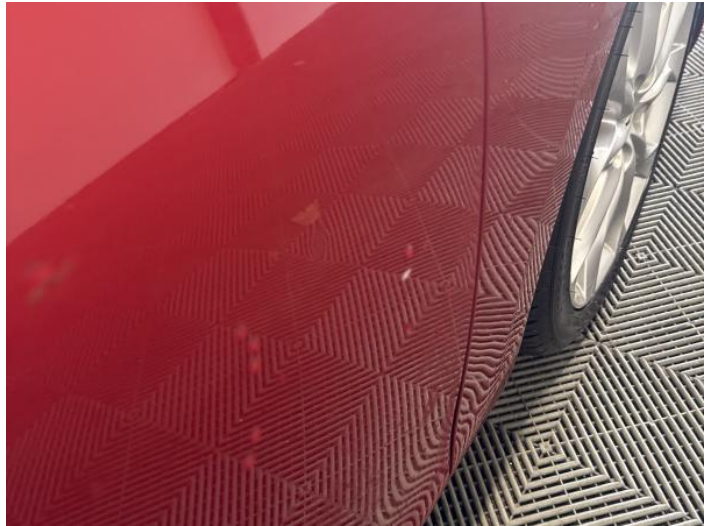
16: Door osf
Dented
2 Or Less UpTo 10mm

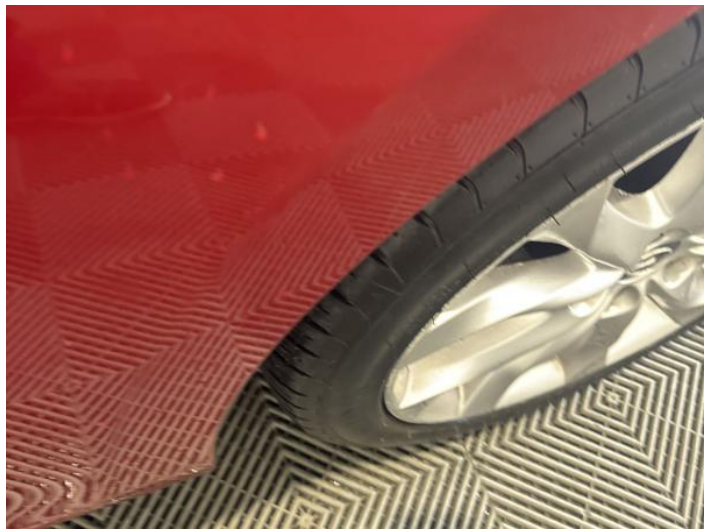
18: Wing osf
Chipped
1 To 5

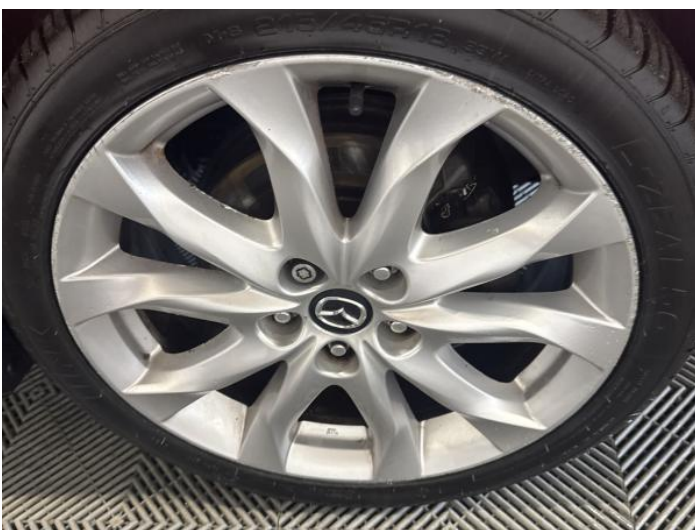
19: Wheel osf
Scratched
Over 50mm

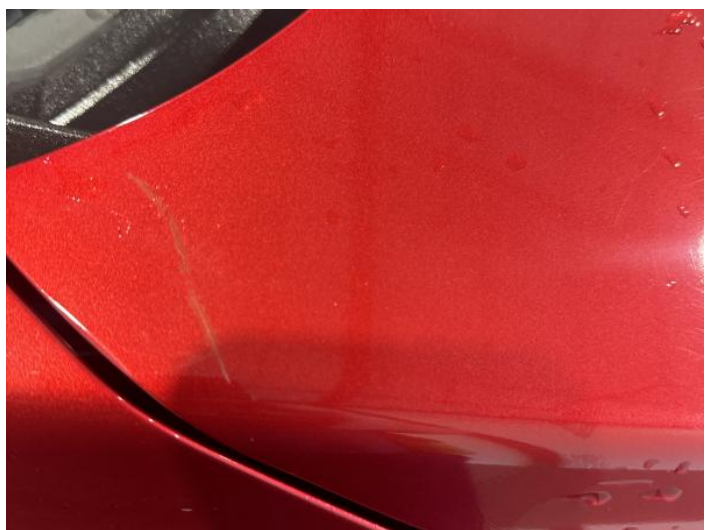
20: Bonnet
Scratched
Over 25mm Thru Paint
