# VEHICLE INSPECTION REPORT

**RF07BCE**

## Toyota Prius 1.5 VVTi T Spirit Hybrid 5dr CVT Auto

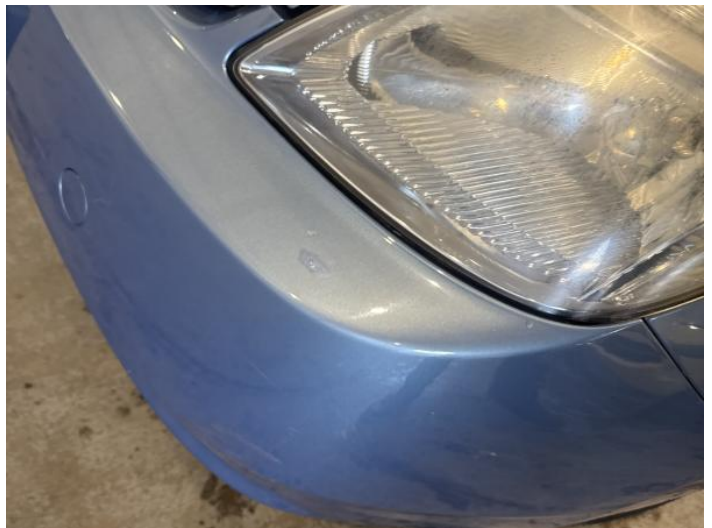
2: Bumper Front  
Poor Previous Repair  
Poor Paint

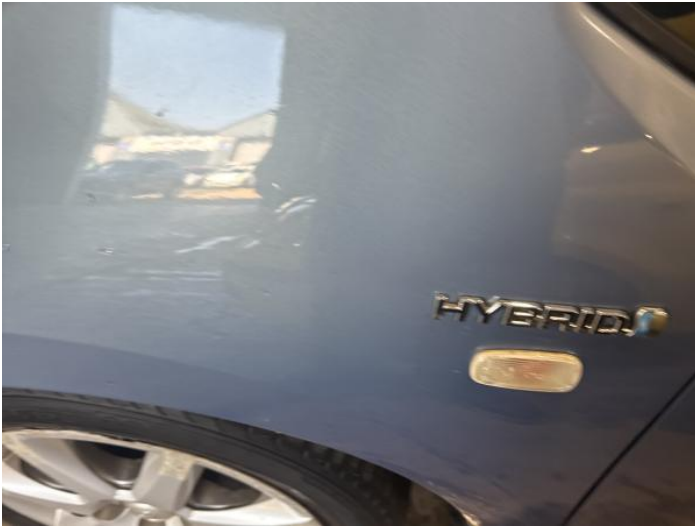
3: Wing nsf  
Chipped  
1 To 5

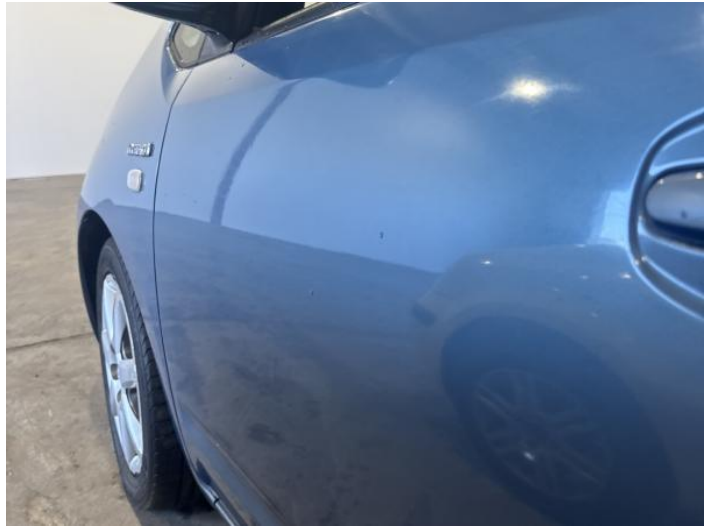
4: Door nsf  
Dented  
Over 2 UpTo 10mm

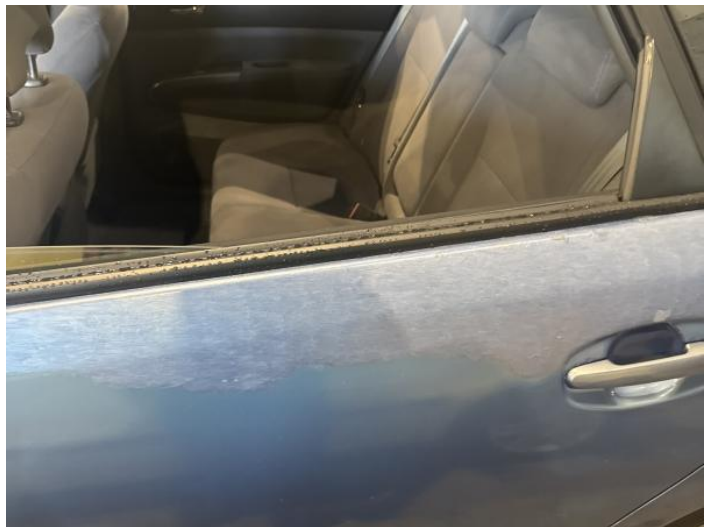
6: Door nsr  
Poor Previous Repair  
Poor Paint

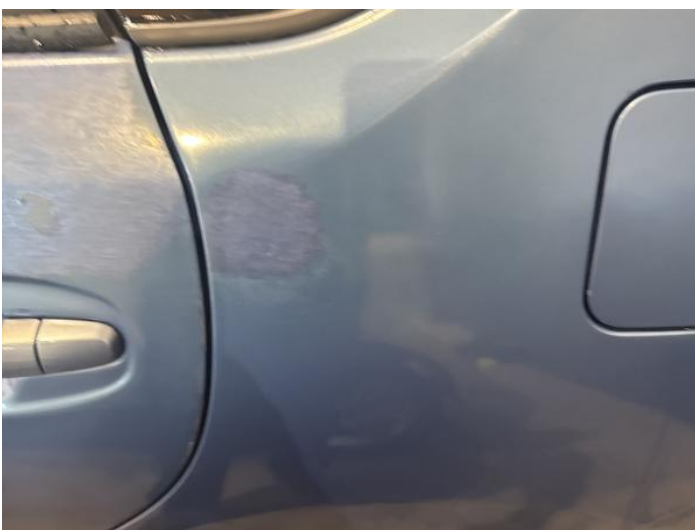
7: Qtr Panel nsr  
Poor Previous Repair  
Poor Paint

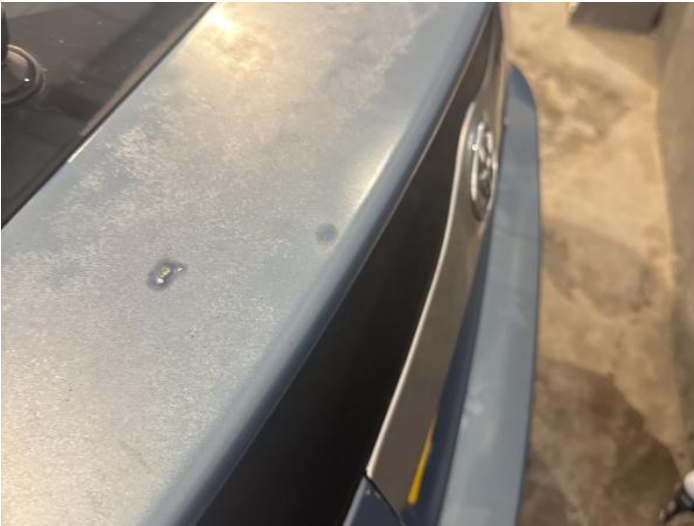
9: Boot Lid  
Poor Previous Repair  
Poor Paint

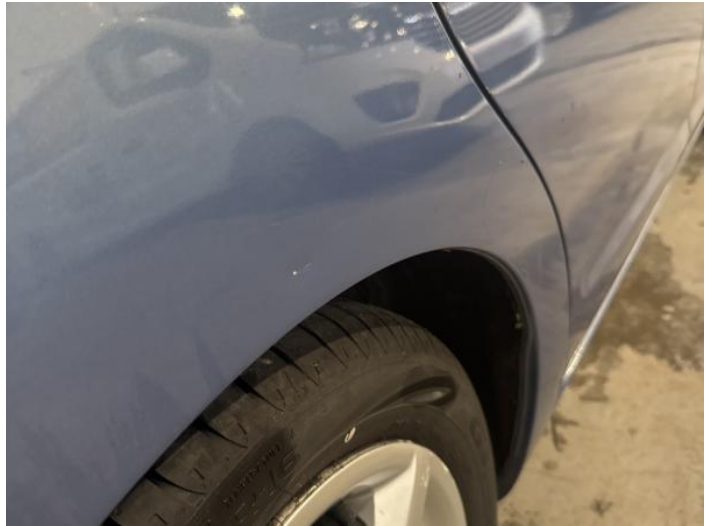
10: Qtr Panel osr  
Dented  
With Paint Damage

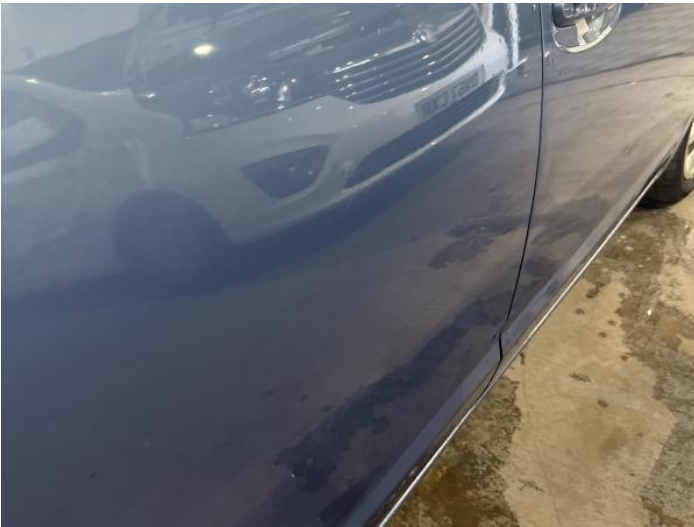
11: Door osr  
Poor Previous Repair  
Poor Paint

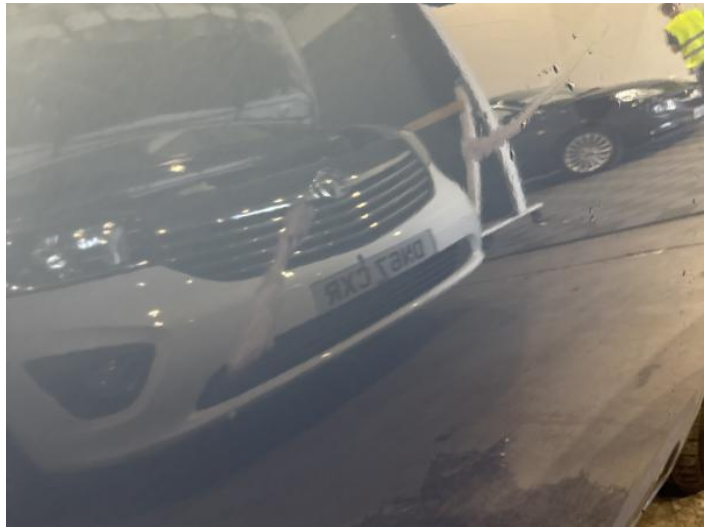
12: Door osf  
Poor Previous Repair  
Poor Paint

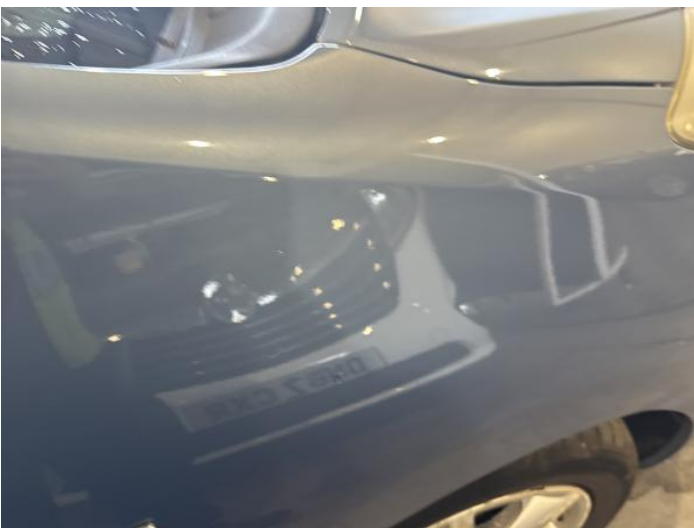
13: Wing osf  
Chipped  
1 To 5
