VEHICLE INSPECTION REPORT

LGZ9129

Volkswagen Touran 1.6 TDI 115 SE 5dr

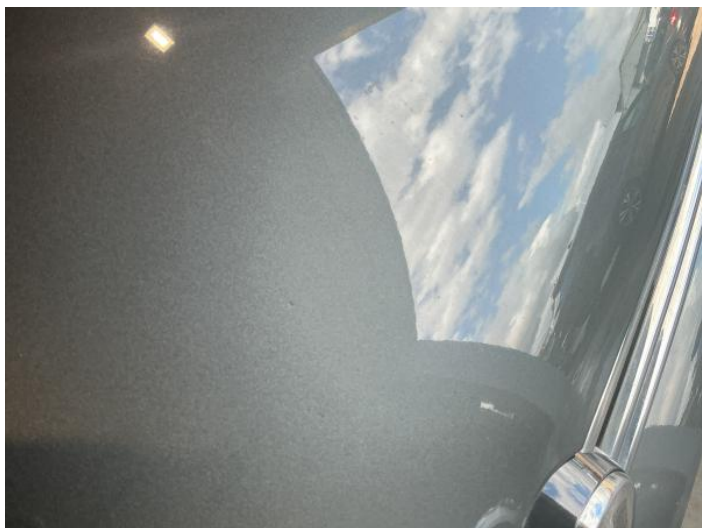
1: Bonnet
Chipped
Multiple Chips

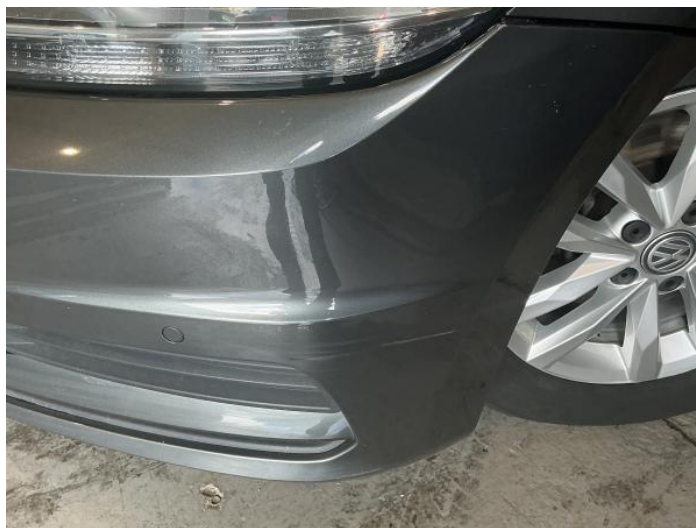
2: Bumper Front
Scratched
Over 100mm Thru Paint

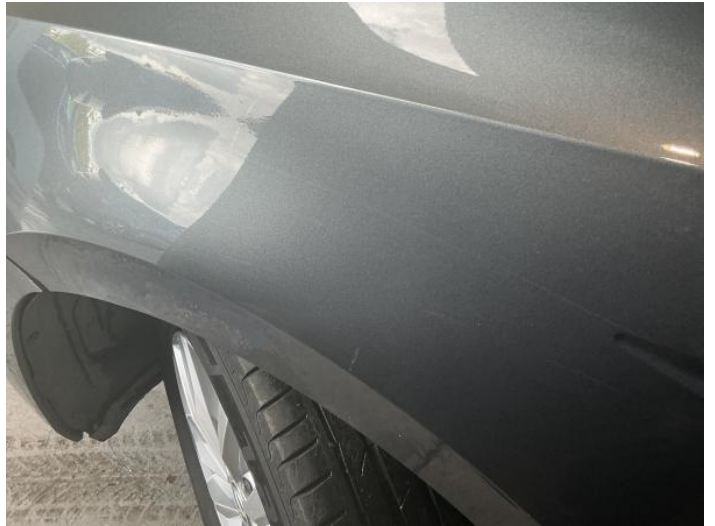
4: Wing nsf
Scratched
Over 25mm Thru Paint

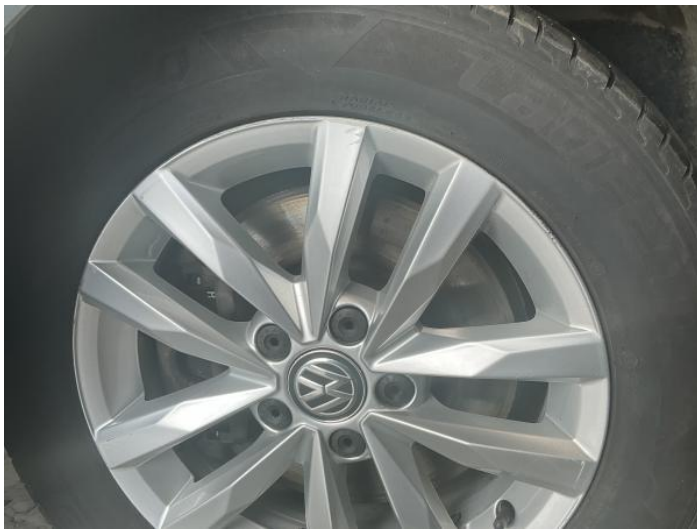
5: Wheel nsf
Scratched
Over 50mm

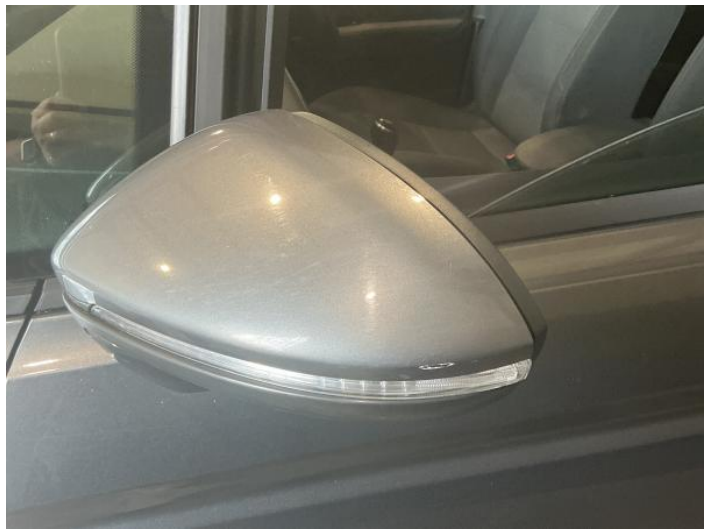
6: Door Mirror Assy nsf
Scratched (Painted)
UpTo 25mm Thru Paint

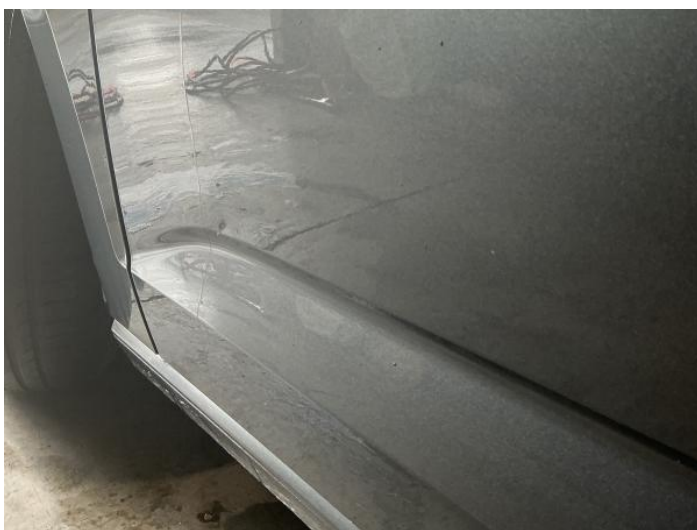
7: Door nsf
Dented
Between 10mm + 30mm

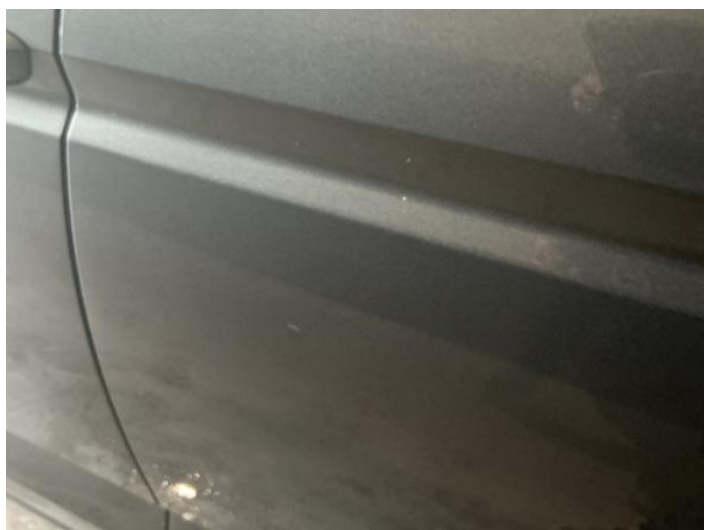
8: Door nsr
Scratched
UpTo 25mm Thru Paint

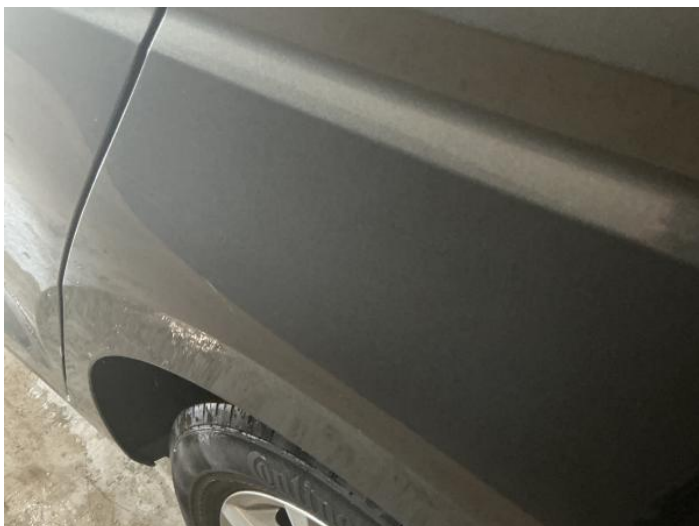
9: Qtr Panel nsr
Scratched
Over 25mm Thru Paint

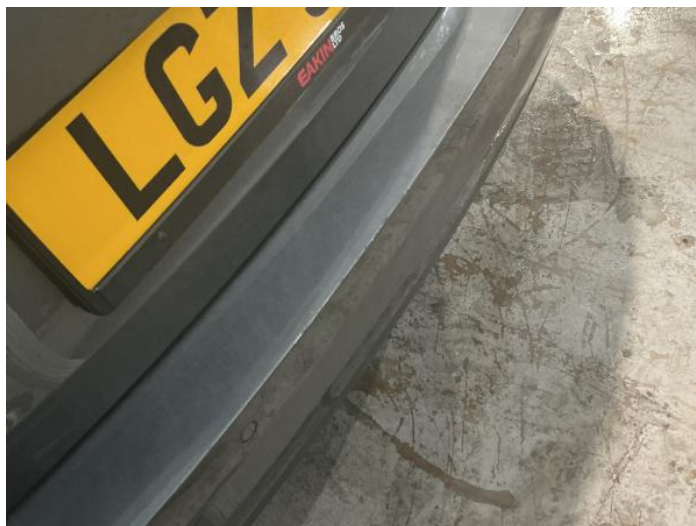
10: Bumper Rear
Scratched
Over 100mm Thru Paint

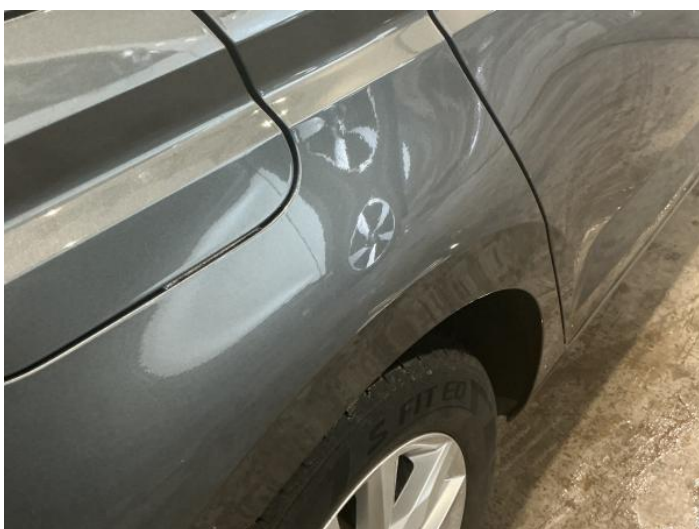
11: Qtr Panel osr
Dented
With Paint Damage

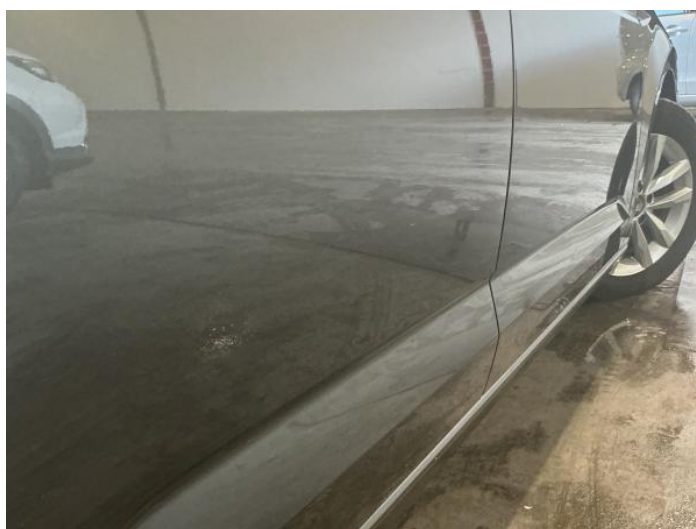
12: Door osr
Dented
Between 10mm + 30mm

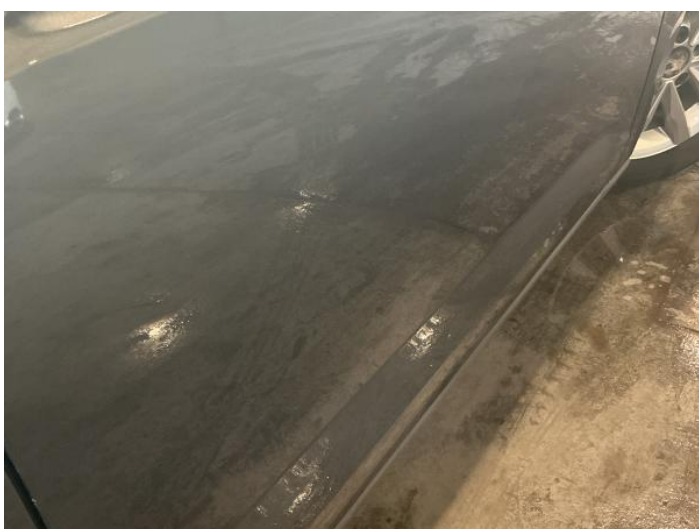
13: Door osf
Dented
Between 10mm + 30mm

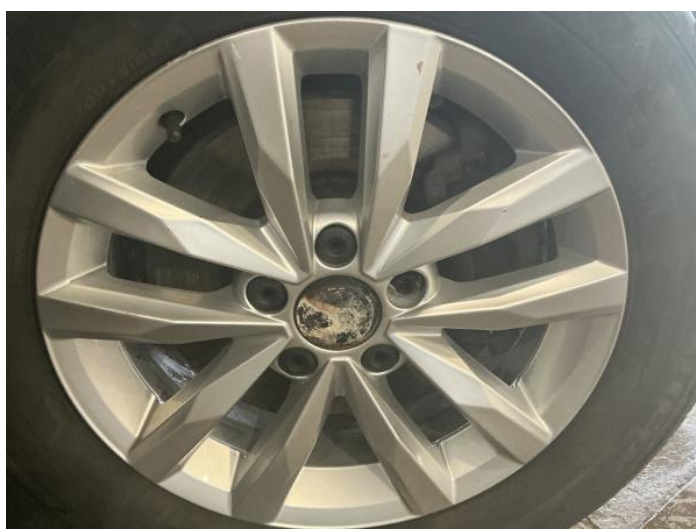
14: Wheel osf
Scratched
Up To 50mm
