VEHICLE INSPECTION REPORT

LP08OML

Mercedes-Benz A-Class A150 CLASSIC SE

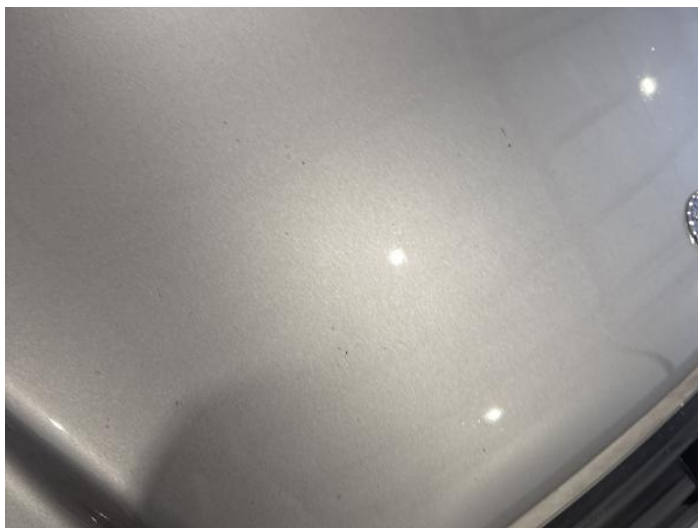
1: Bonnet
Chipped
Multiple Chips

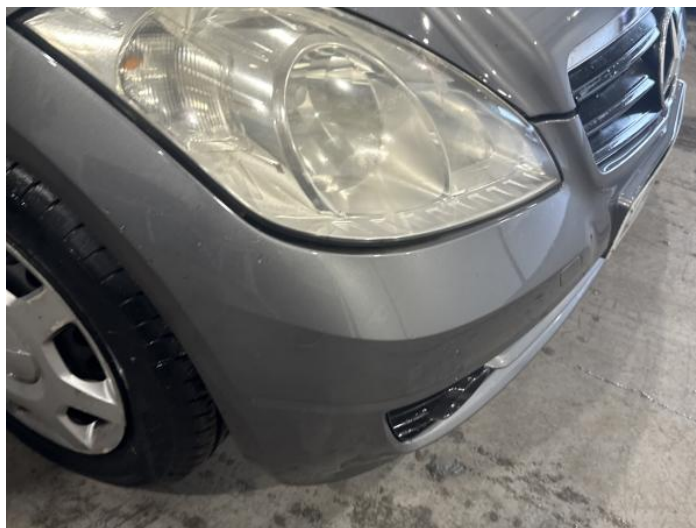
2: Bumper Front
Scratched
Over 100mm Thru Paint

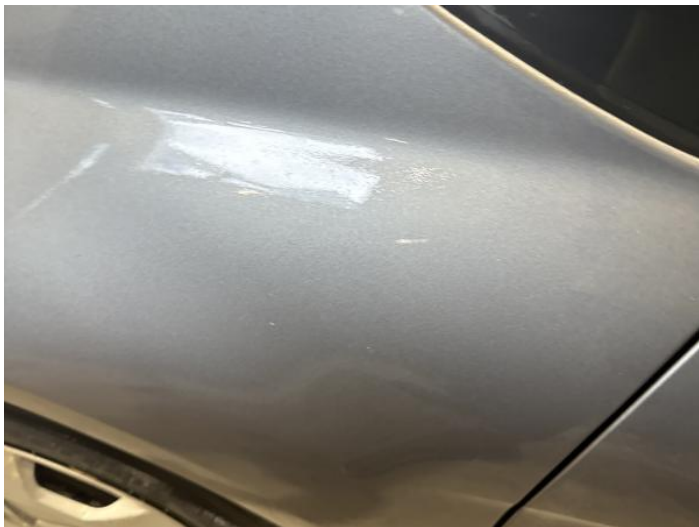
3: Wing nsf
Chipped
1 To 5

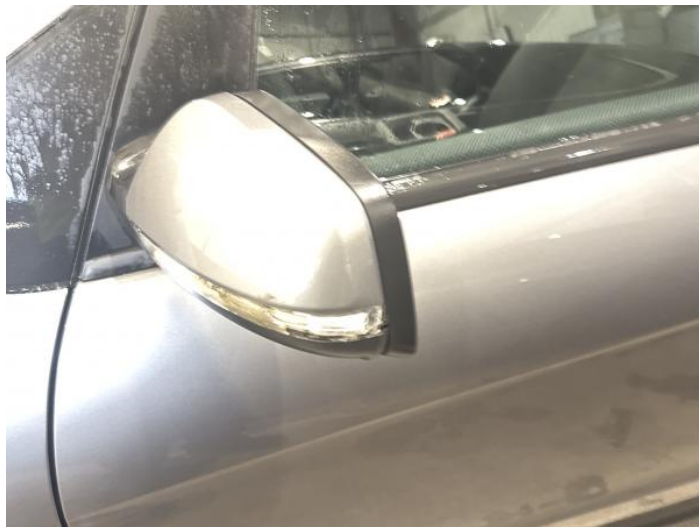
4: Door Mirror Assy nsf
Broken
Replace

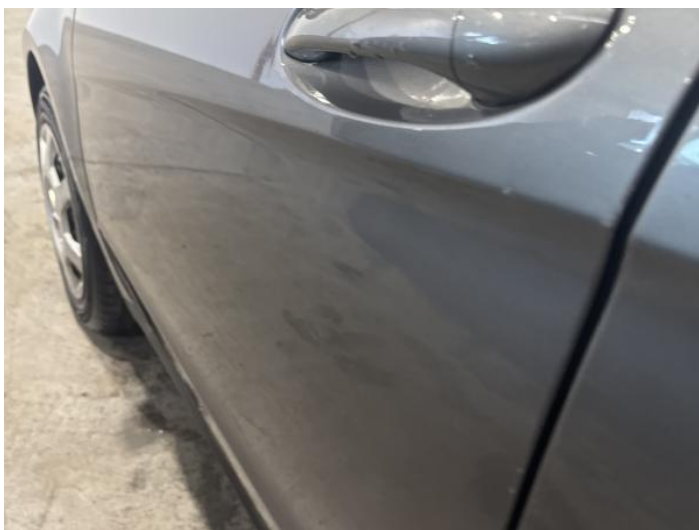
5: Door nsf
Chipped
1 To 5

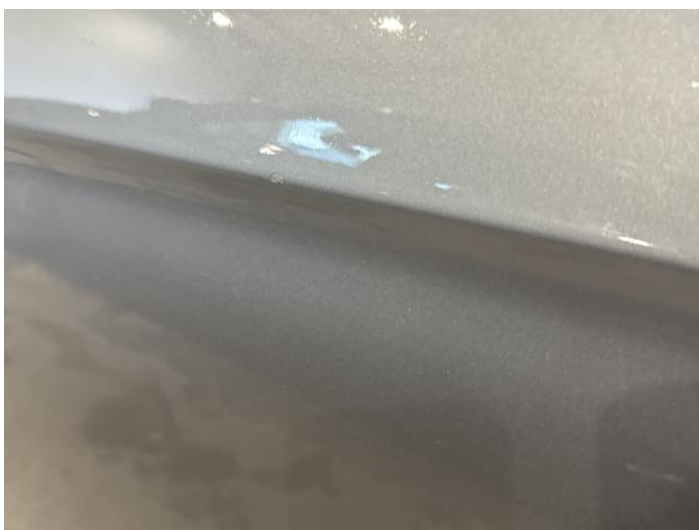
7: Door nsr
Chipped
1 To 5

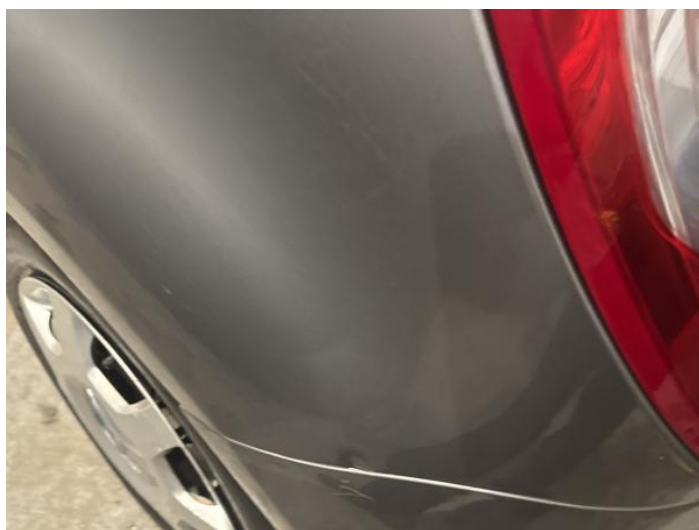
8: Qtr Panel nsr
Dented
Between 10mm + 30mm

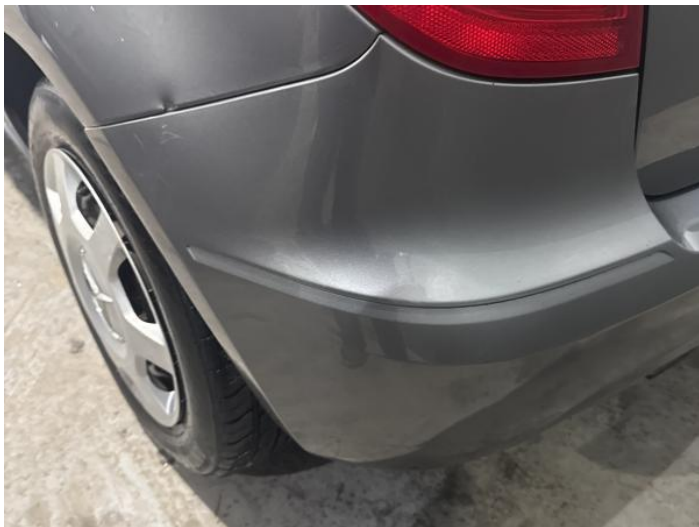
9: Bumper Rear
 Scratched
 Over 100mm Thru Paint

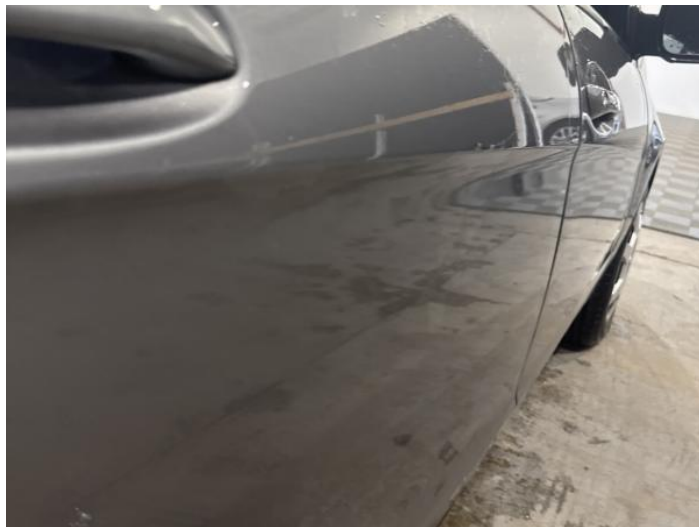
12: Door osr
 Dented
 Over 2 UpTo 10mm

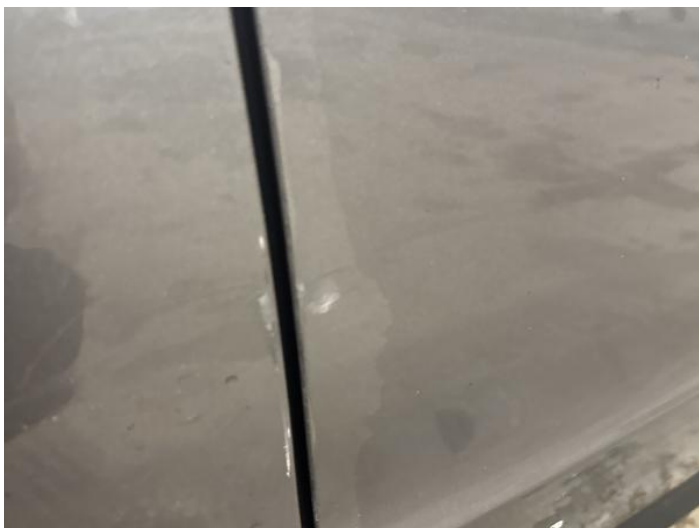
13: Door osr
 Scratched
 UpTo 25mm Thru Paint

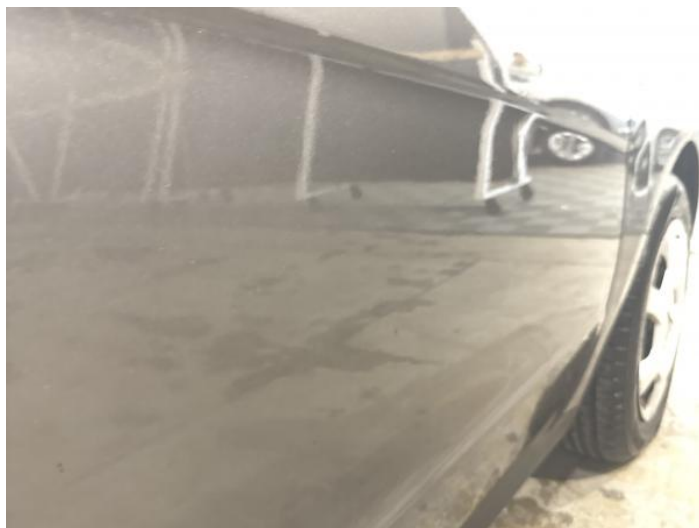
14: Door osf
 Chipped
 1 To 5

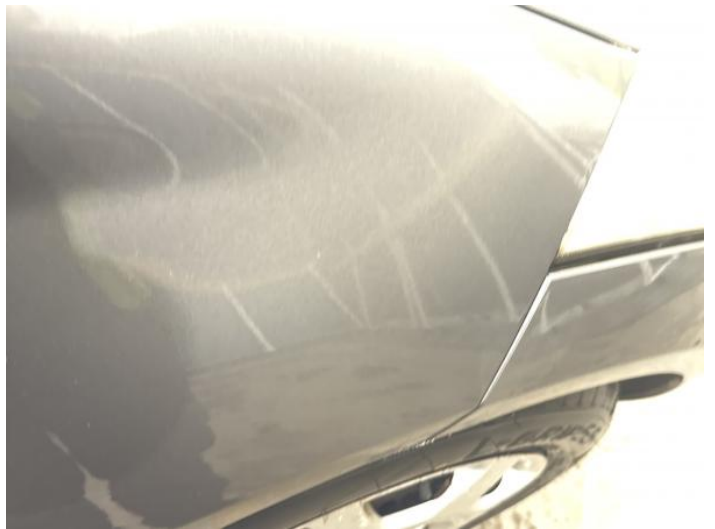
15: Door osf
Scratched
Over 25mm Not Thru Paint

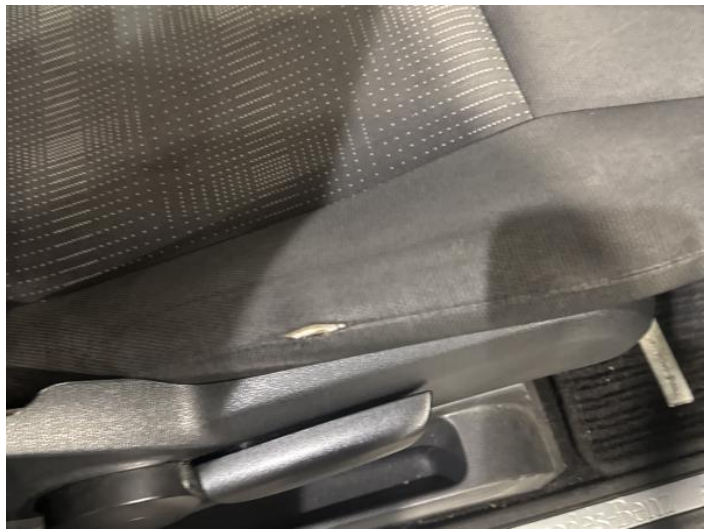
18: Seat Base Cover osf
Torn
Over 3mm
