# VEHICLE INSPECTION REPORT

**CP14OSZ**

## Peugeot 2008 1.6 VTi Allure 5dr

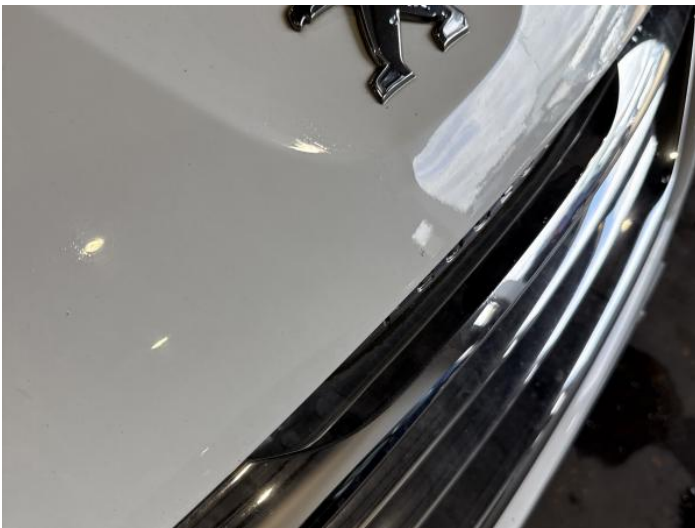
1: Bonnet  
Dented  
Between 10mm + 30mm

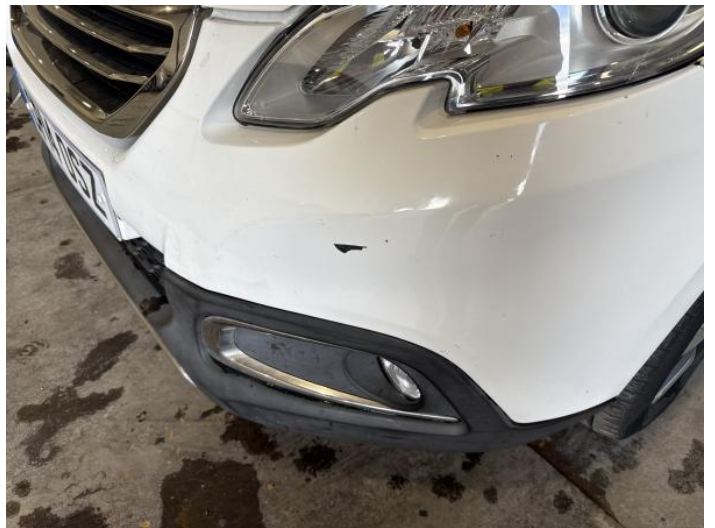
2: Bumper Front  
Scratched  
Over 100mm Thru Paint

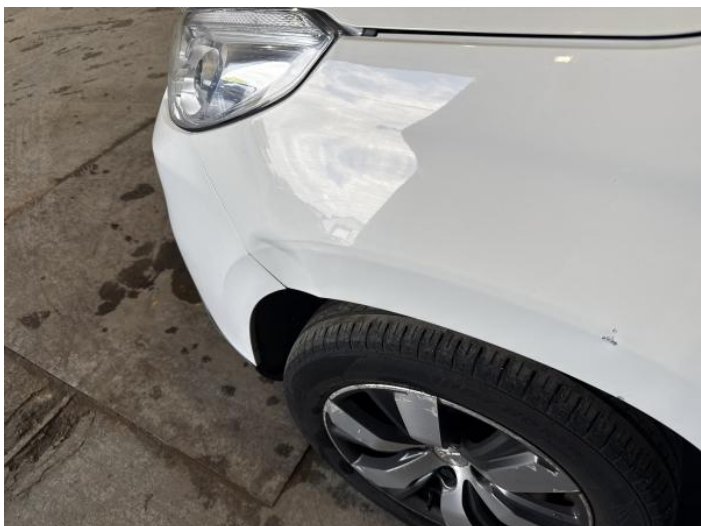
3: Wing nsf  
Dented  
Over 30mm

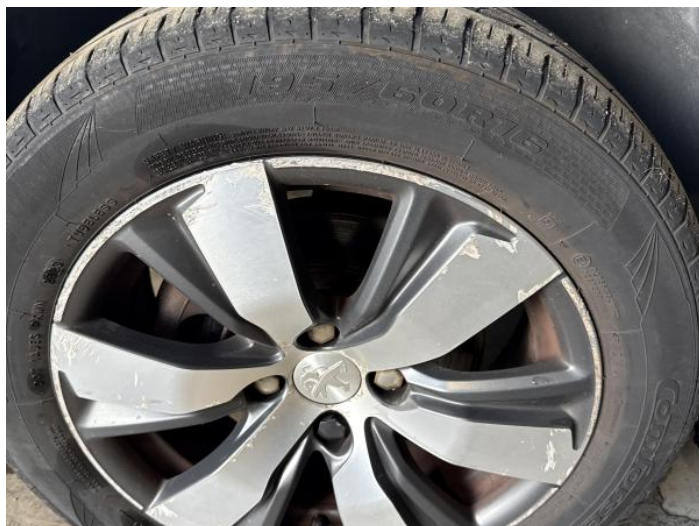
4: Wheel nsf  
Scratched  
Over 50mm

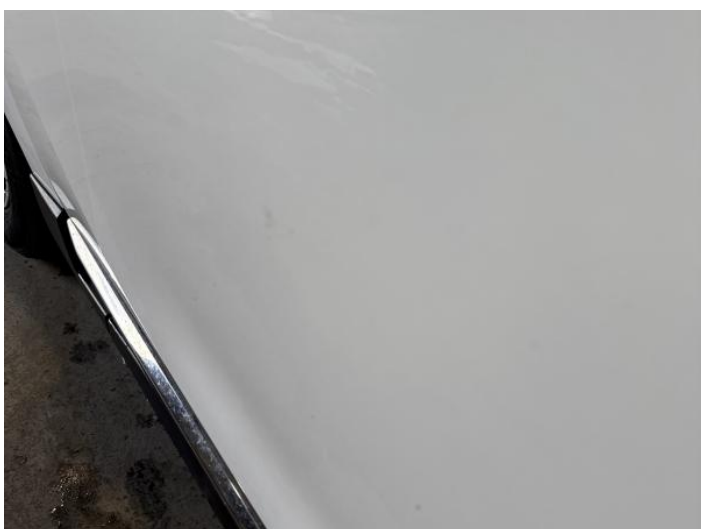
5: Door nsf  
Scratched  
UpTo 25mm Thru Paint

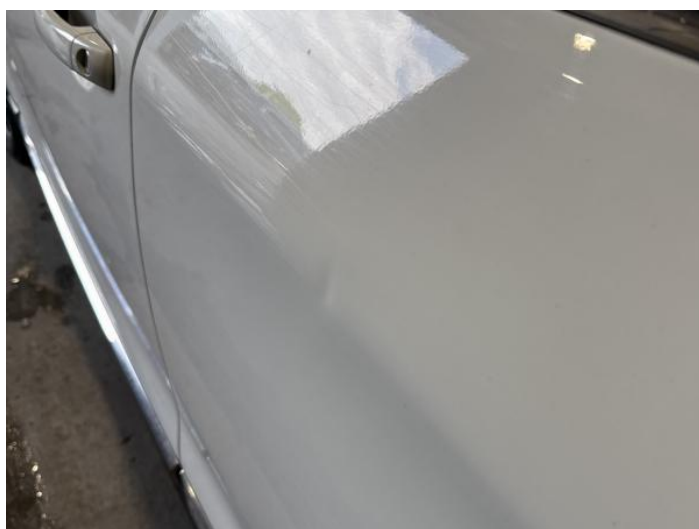
6: Door nsr  
Dented  
Between 10mm + 30mm

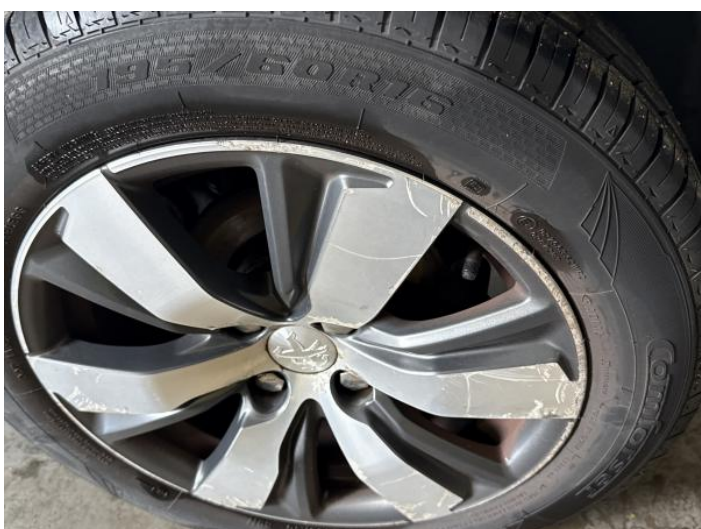
7: Wheel nsr  
Scratched  
Over 50mm

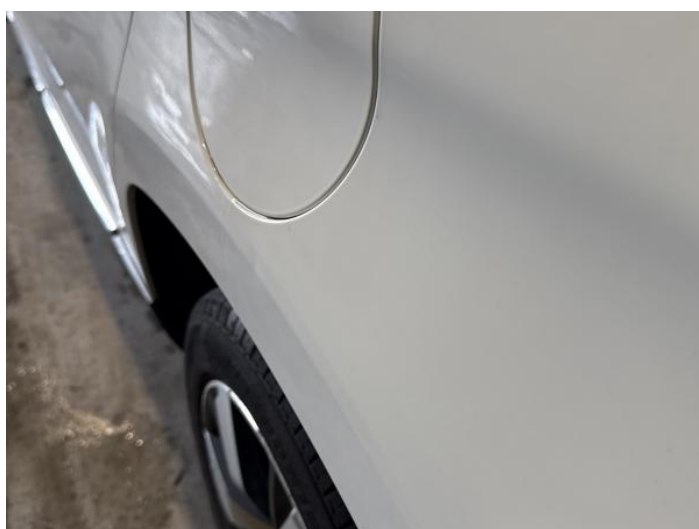
8: Qtr Panel nsr  
Dented  
Between 10mm + 30mm

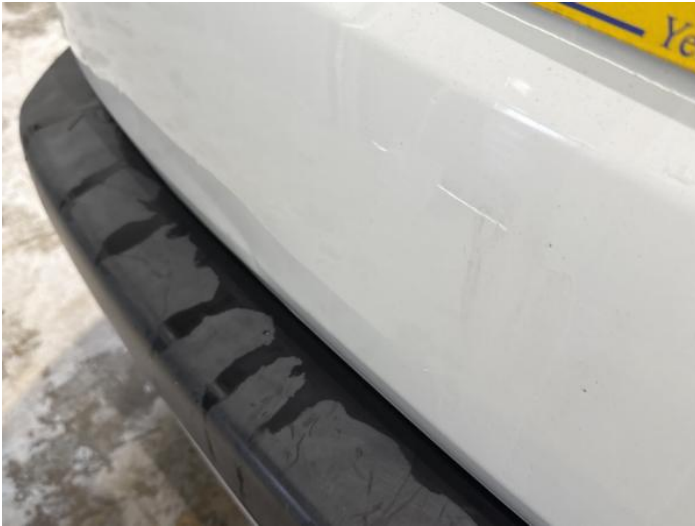
9: Tailgate  
Dented  
Over 30mm

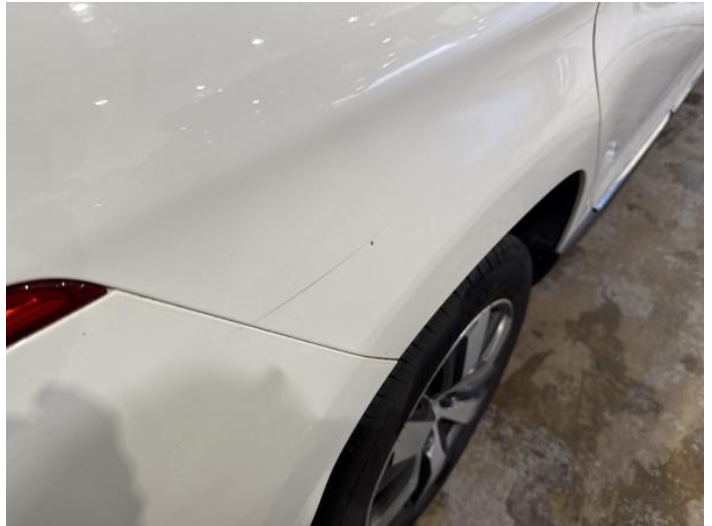
10: Qtr Panel osr  
Scratched  
Over 25mm Thru Paint

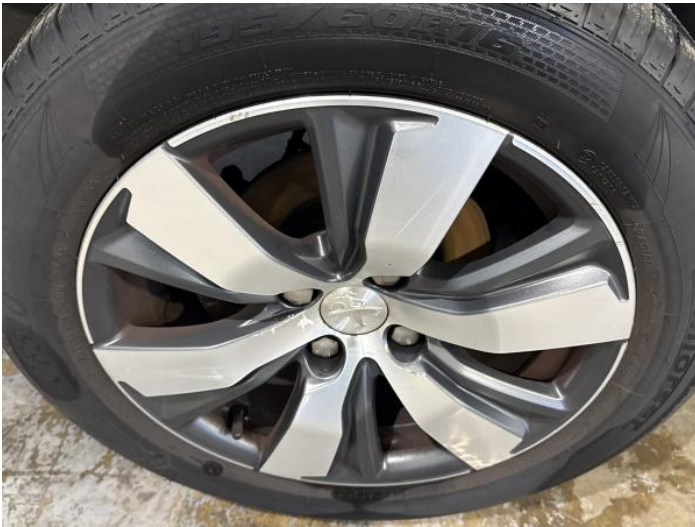
11: Wheel osr  
Scratched  
Up To 50mm

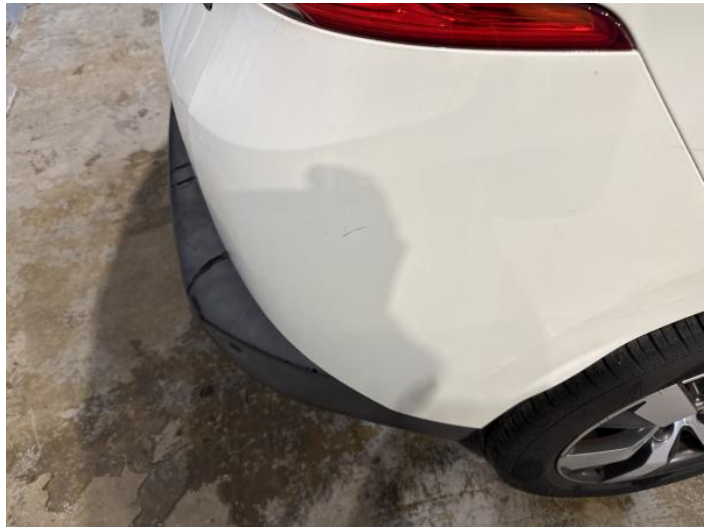
12: Bumper Rear  
Scratched  
25 to 100mm Thru Paint

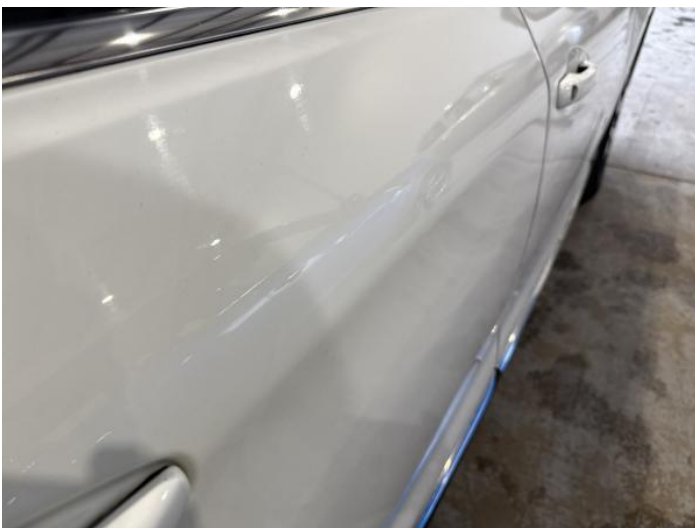
13: Door osr  
Dented  
Between 10mm + 30mm

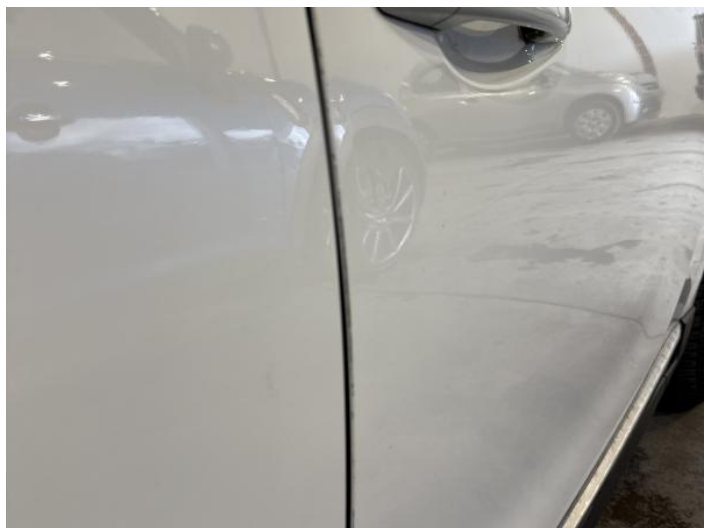
14: Door osf  
Chipped  
Edge Chip

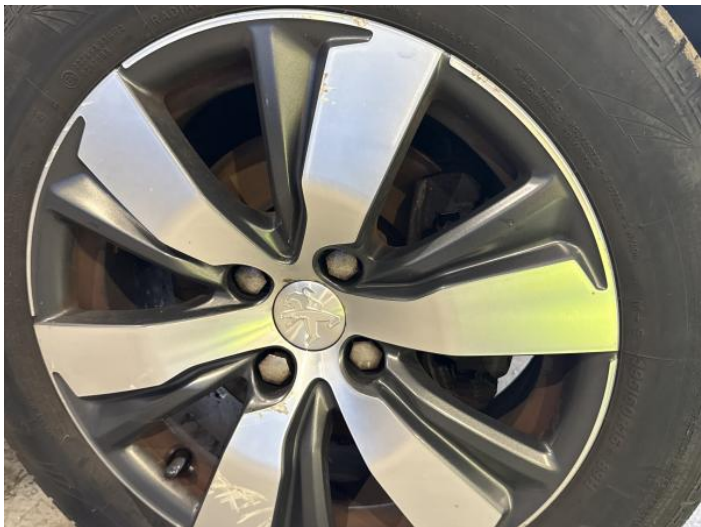
15: Wheel of  
Scratched  
Over 50mm
