VEHICLE INSPECTION REPORT

WV14VCX

Citroen C5 2.2 HDI 16V Exclusive [200] 4dr Auto

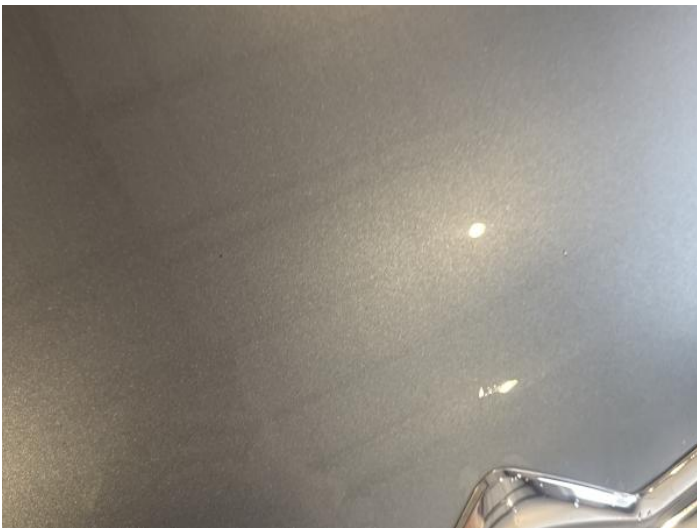
1: Bonnet
Poor Previous Repair
Poor Paint

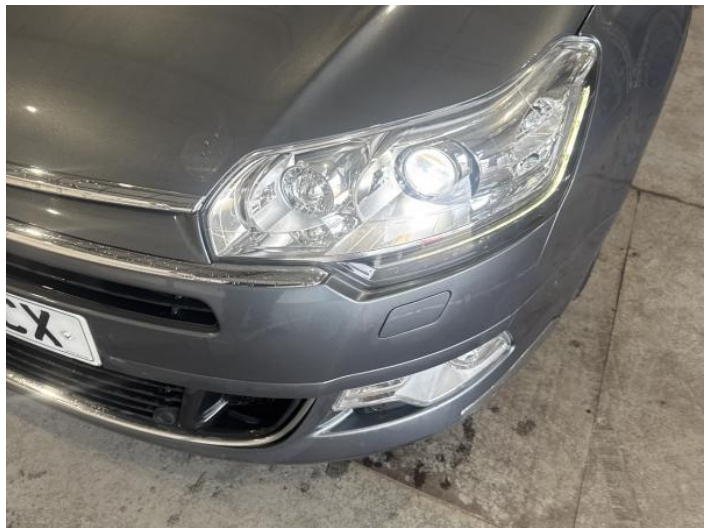
2: Bumper Front
Scratched
25 to 100mm Thru Paint

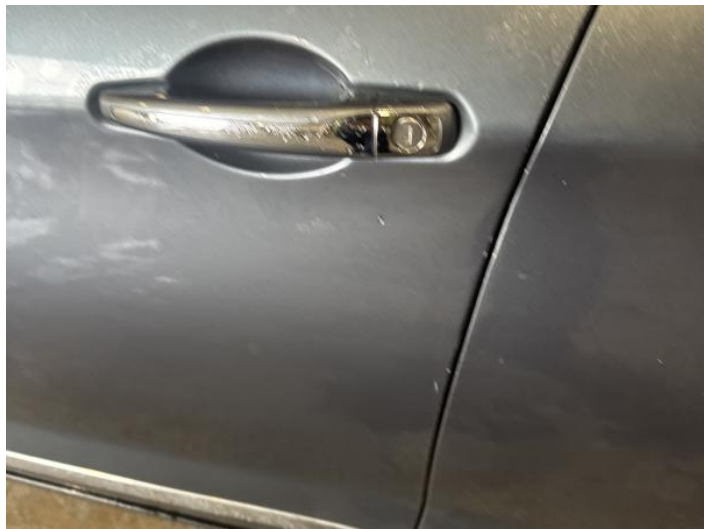
5: Wing nsf
Scratched
Over 25mm Not Thru Paint

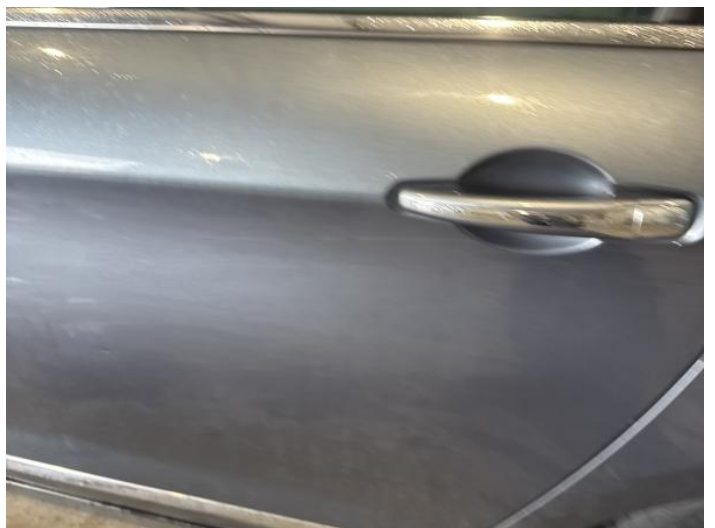
7: Door nsf
Scratched
Over 25mm Not Thru Paint

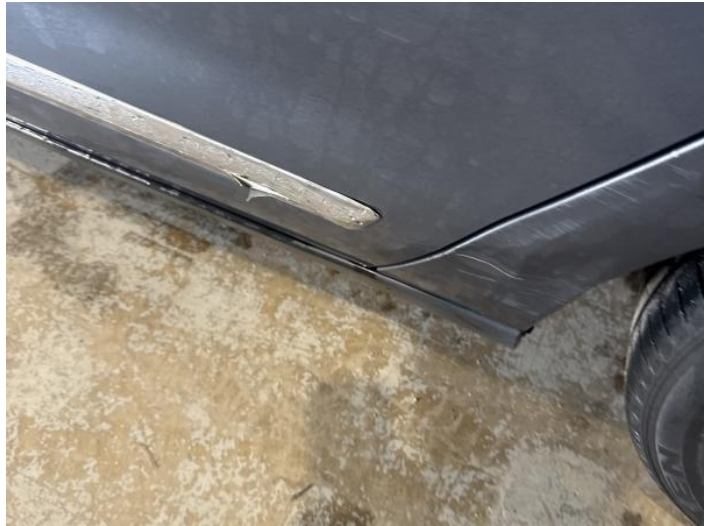
9: Door nsr
Scratched
Over 25mm Not Thru Paint

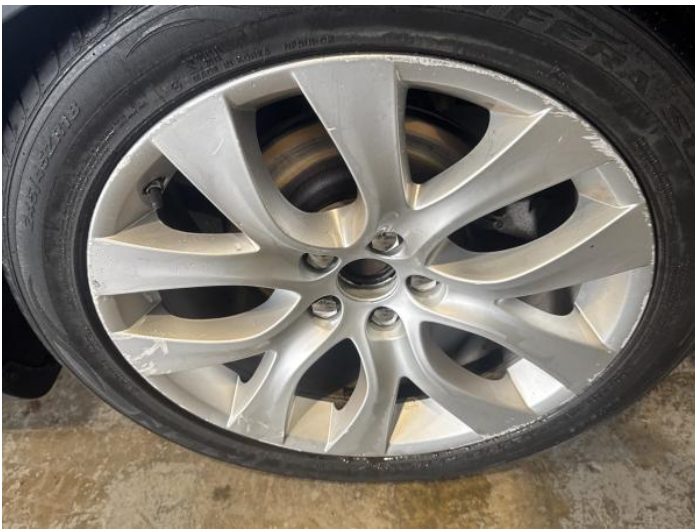
11: Wheel nsr
Scratched
Over 50mm

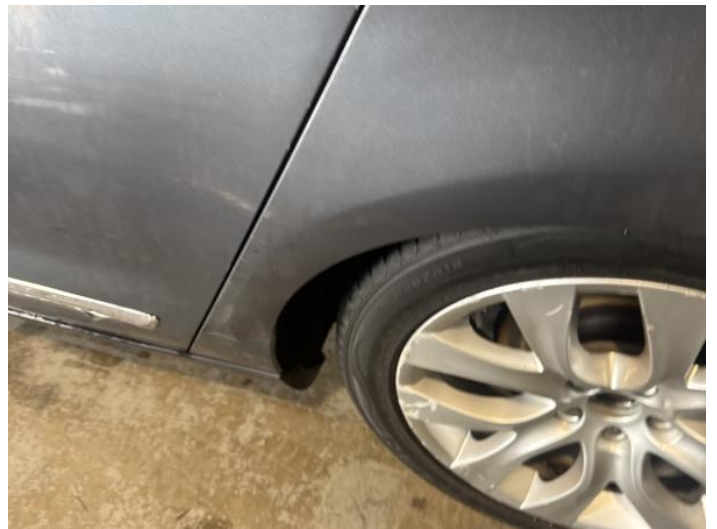
12: Qtr Panel nsr
Dented
With Paint Damage

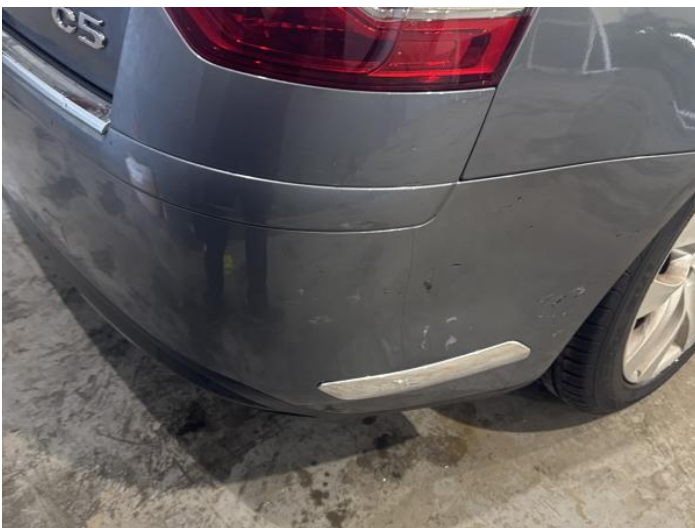
13: Bumper Rear
Scratched
Over 100mm Thru Paint

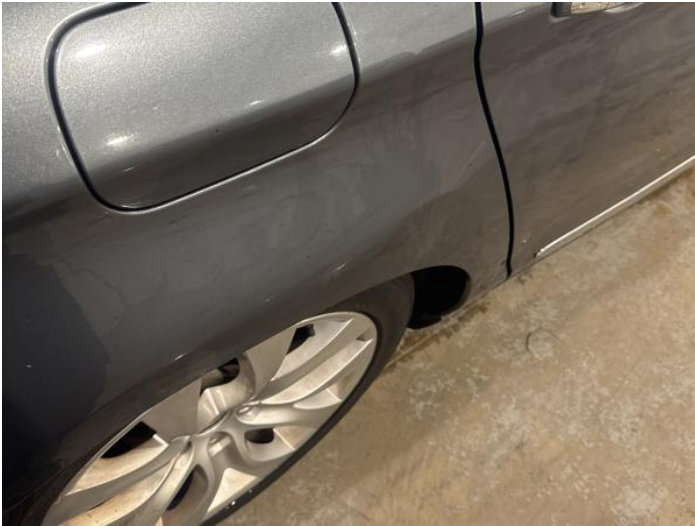
15: Qtr Panel osr
Dented
Over 30mm

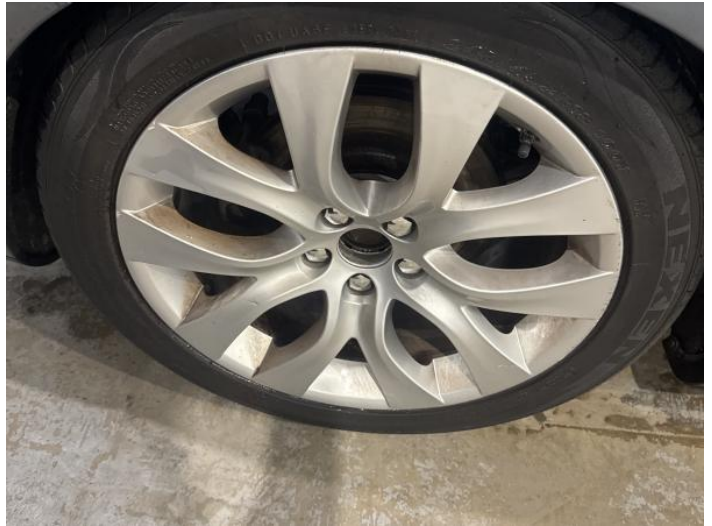
16: Wheel osr
Scratched
Over 50mm

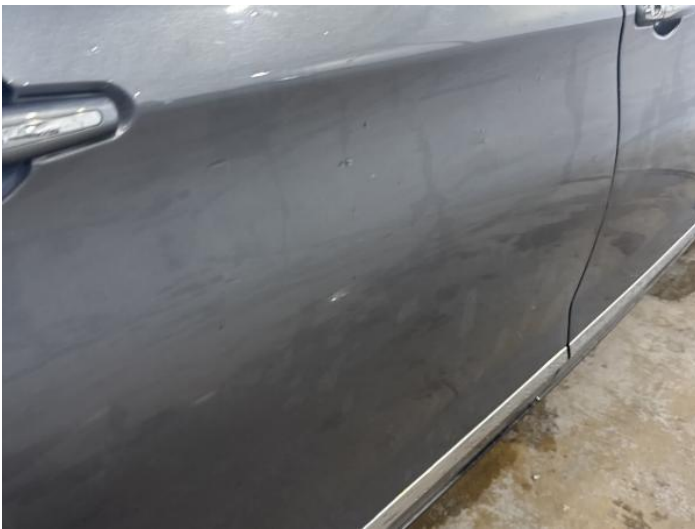
17: Door osr
Dented
With Paint Damage

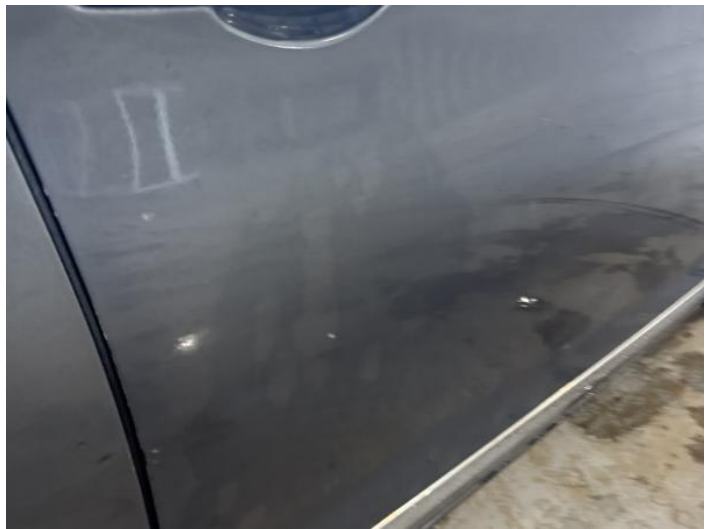
18: Door osf
Dented
With Paint Damage

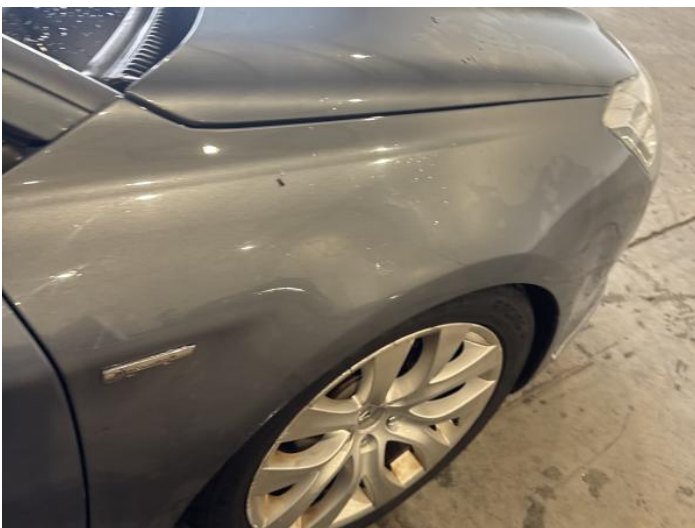
19: Wing osf
Poor Previous Repair
Poor Paint

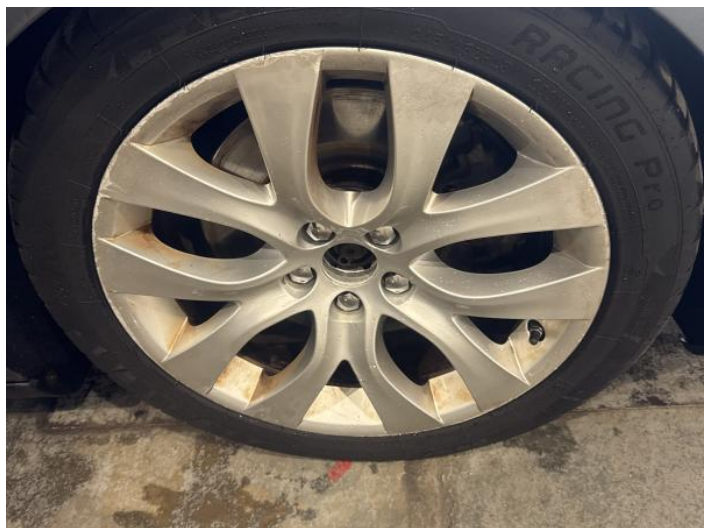
20: Wheel osf
Scratched
Over 50mm

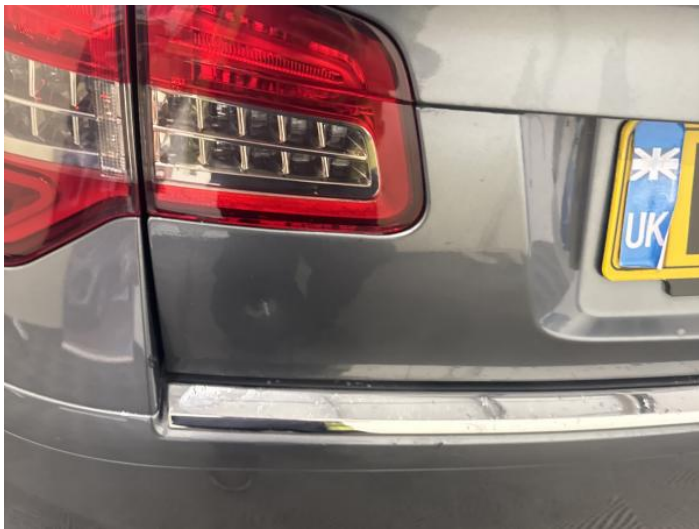
21: Boot Lid
Dented
Between 10mm + 30mm
