VEHICLE INSPECTION REPORT

GJ68LNP

Skoda Karoq 1.0 TSI SE Nav Plus 5dr

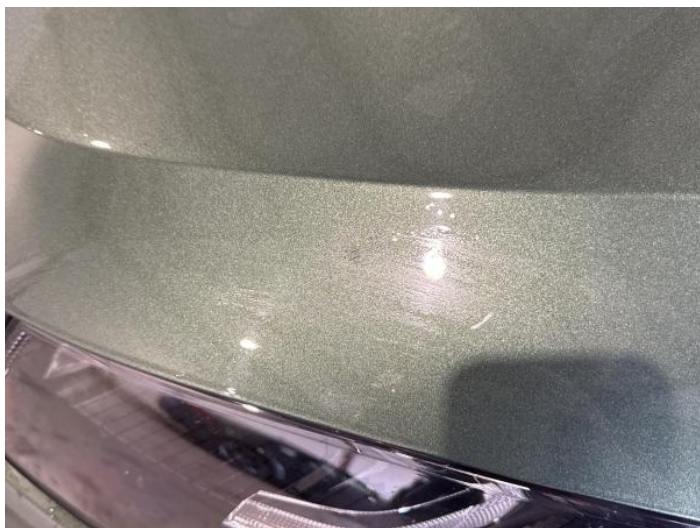
1: Bonnet
Scratched
UpTo 25mm Thru Paint

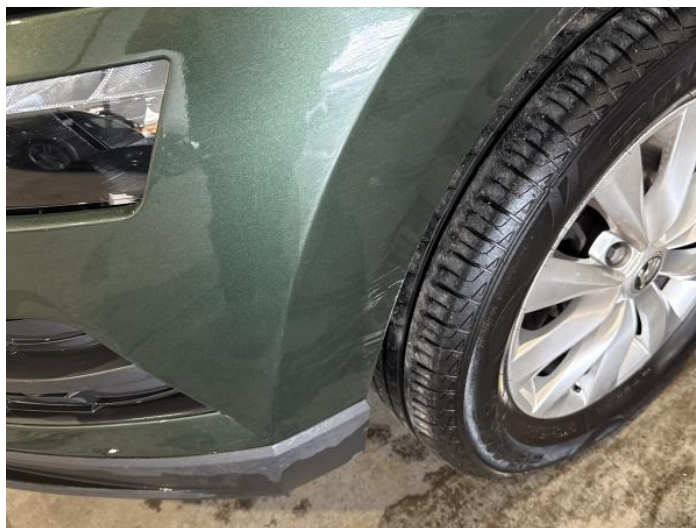
2: Bumper Front
Scratched
Over 100mm Thru Paint

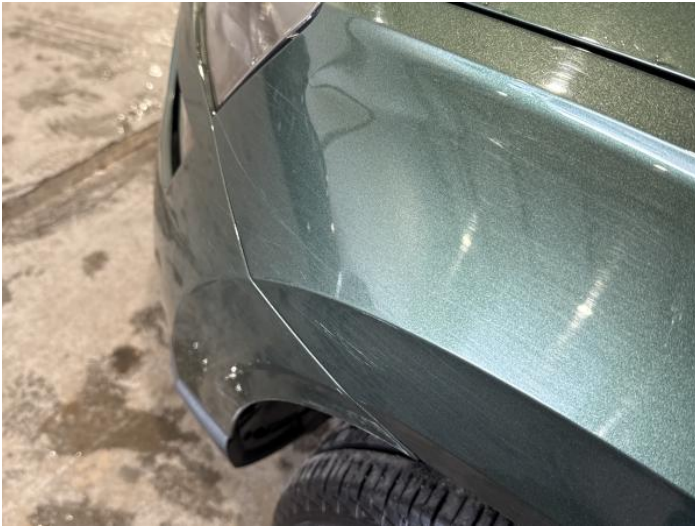
3: Wing nsf
Dented
With Paint Damage

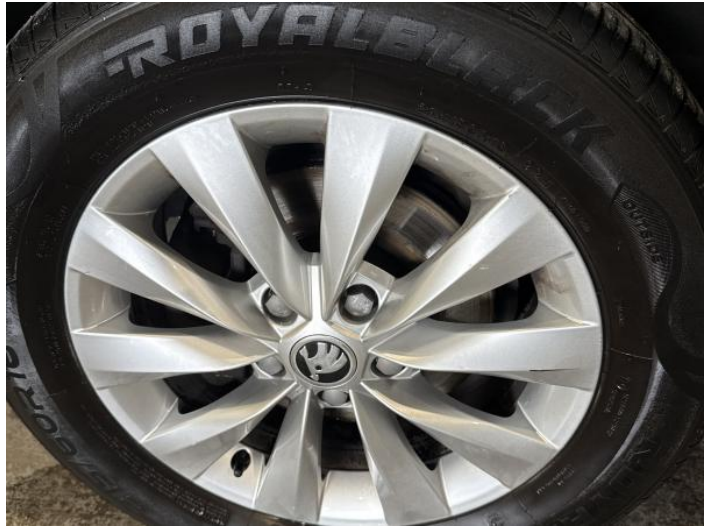
4: Wheel nsf
Scratched
Up To 50mm

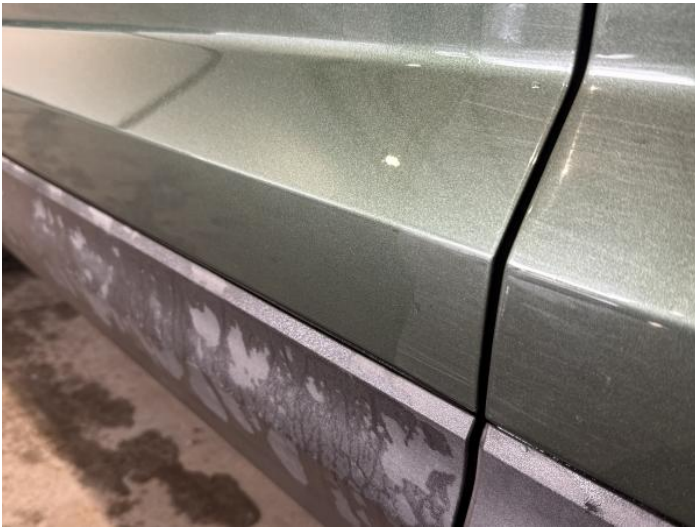
5: Door nsf
Scratched
Up To 25mm Thru Paint

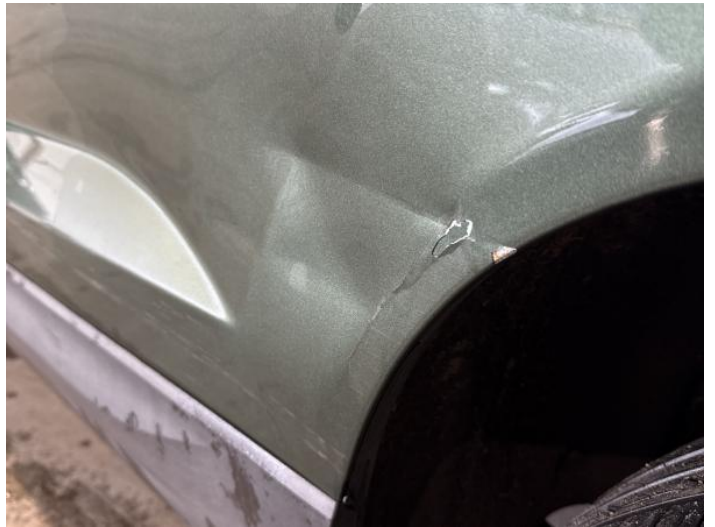
6: Door nsr
Dented
With Paint Damage

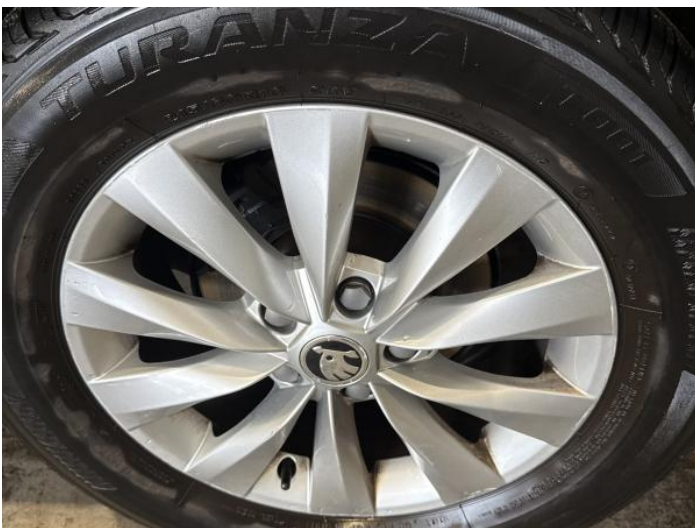
7: Wheel nsr
Scratched
Over 50mm

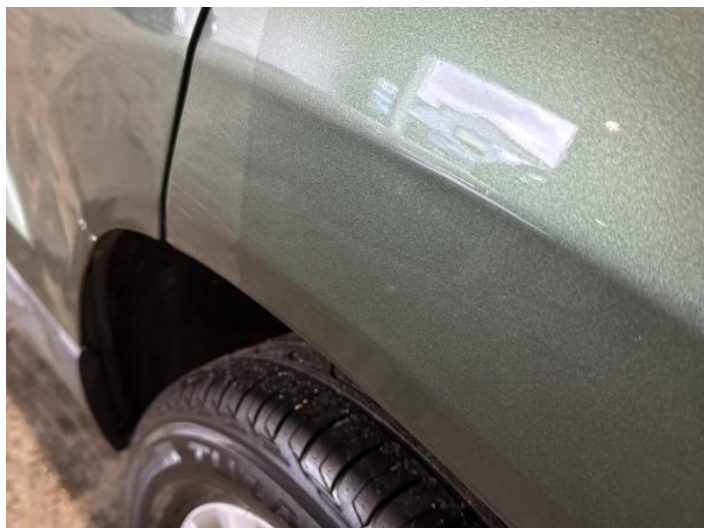
8: Qtr Panel nsr
Dented
Over 30mm

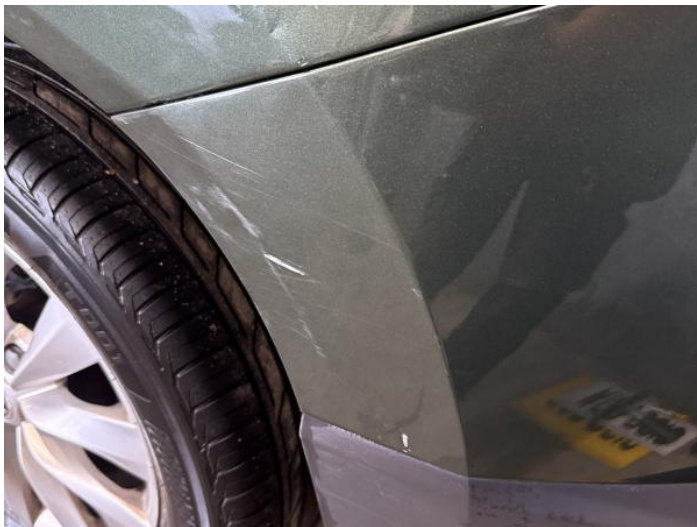
9: Bumper Rear
Scratched
Over 100mm Thru Paint

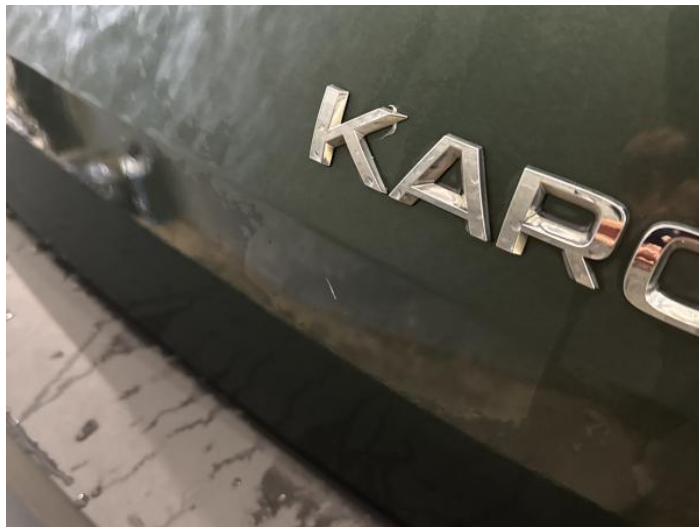
10: Tailgate
Scratched
UpTo 25mm Thru Paint

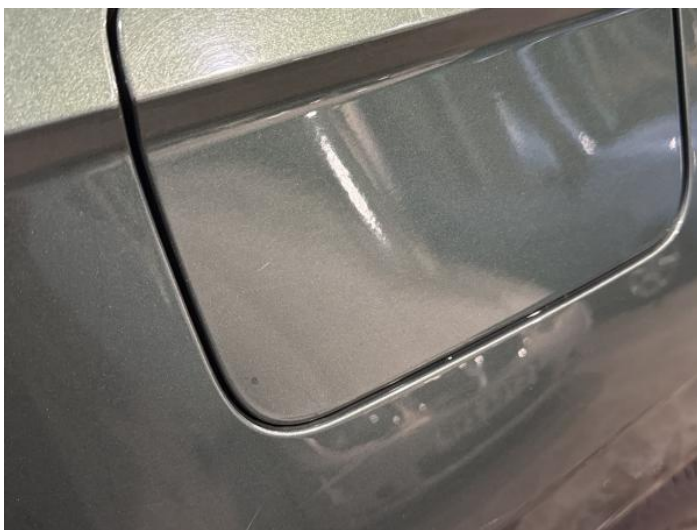
11: Qtr Panel osr
Scratched
UpTo 25mm Thru Paint

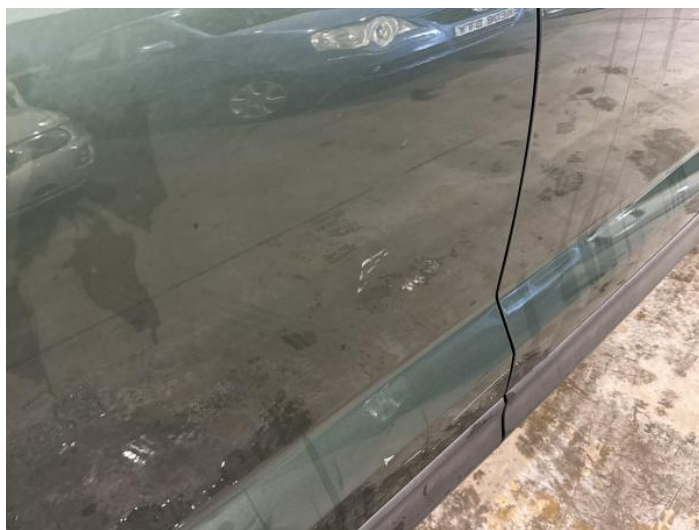
12: Door osr
Dented
With Paint Damage

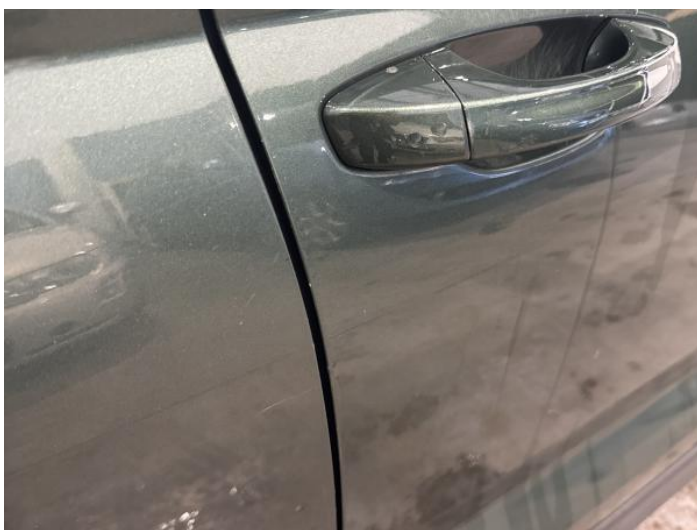
13: Door osf
Chipped
Edge Chip

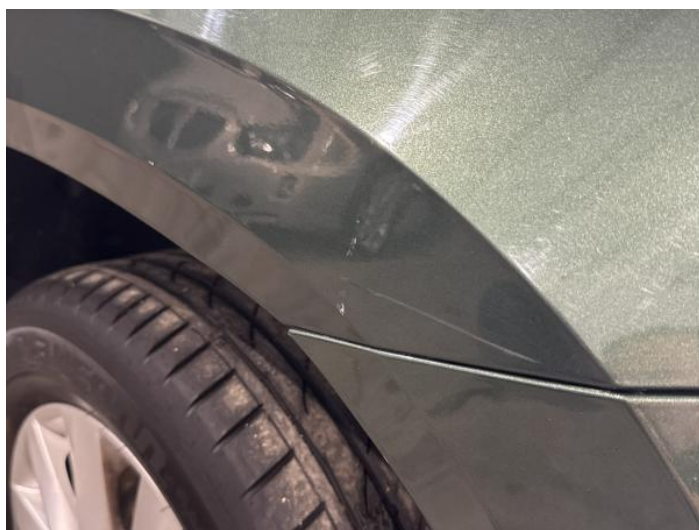
14: Wing osf
Dented
With Paint Damage

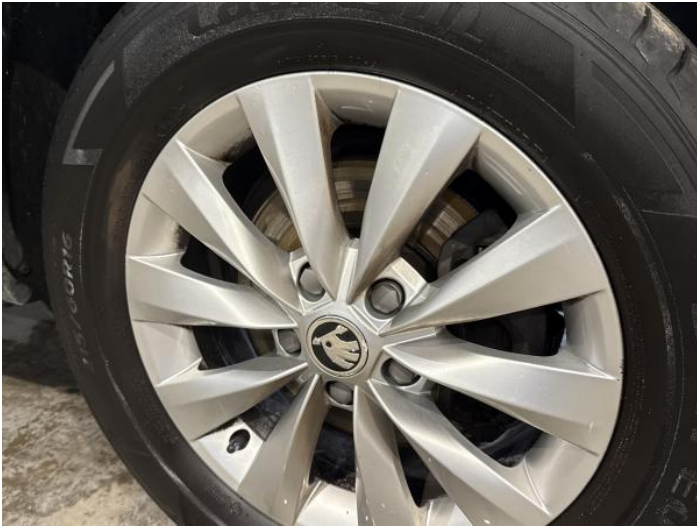
15: Wheel osf
Scratched
Up To 50mm

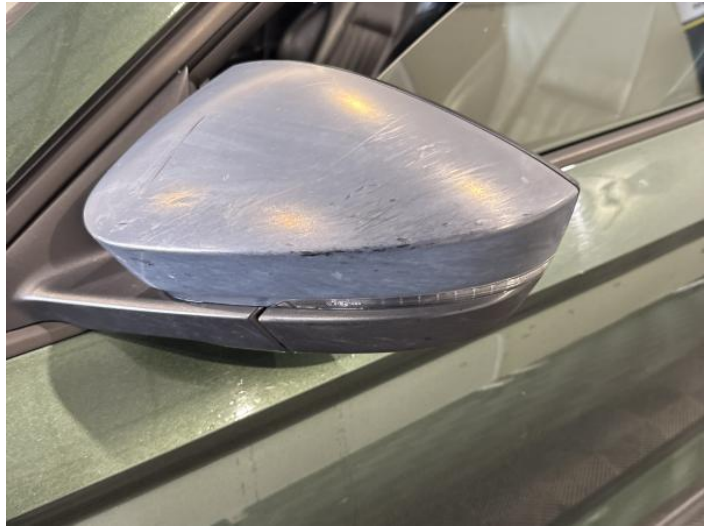
16: Door Mirror Assy nsf
Scratched (Painted)
Over 25mm Thru Paint

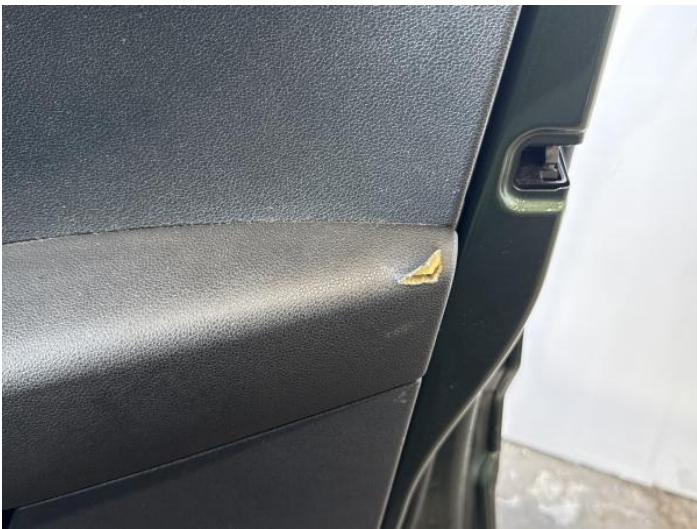
17: Door Pad osf
Scuffed
UpTo 25mm
