# VEHICLE INSPECTION REPORT

**DG57SWU**

## Ford C-Max 1.8 Titanium 5dr

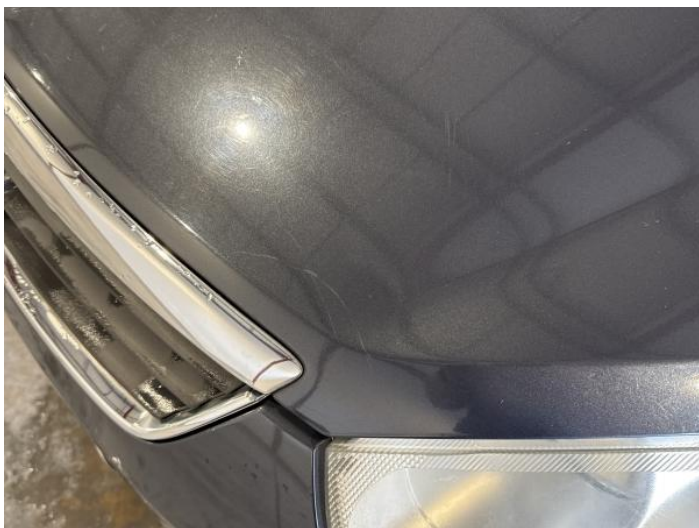
1: Bonnet  
Scratched  
Over 25mm Thru Paint

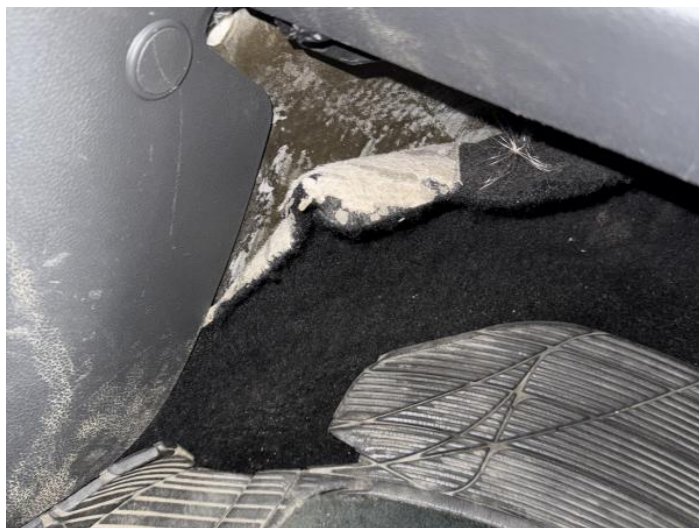
2: Carpets Front  
Scuffed  
Over 25mm

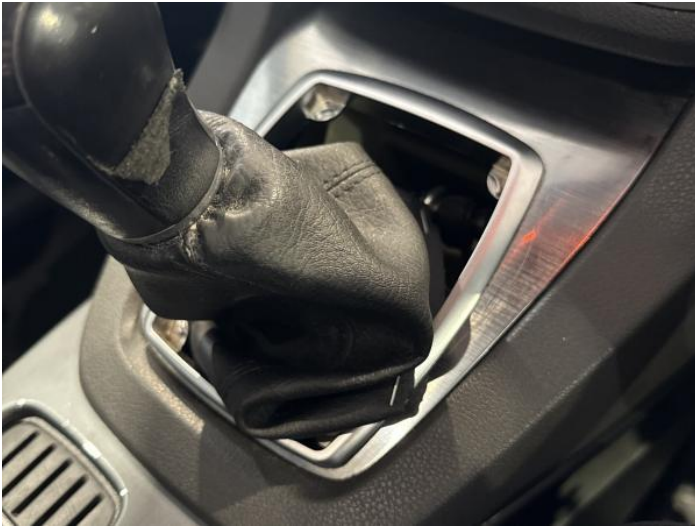
3: Switches And Controls  
Broken  
Replace

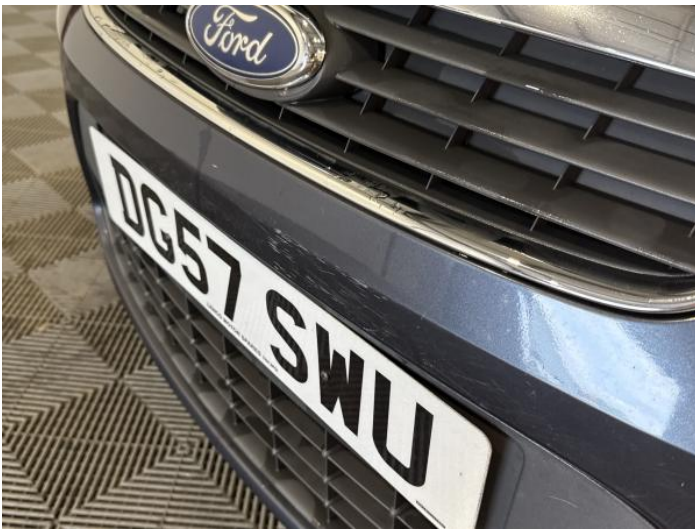
5: Bumper Front  
Scratched  
Over 100mm Thru Paint

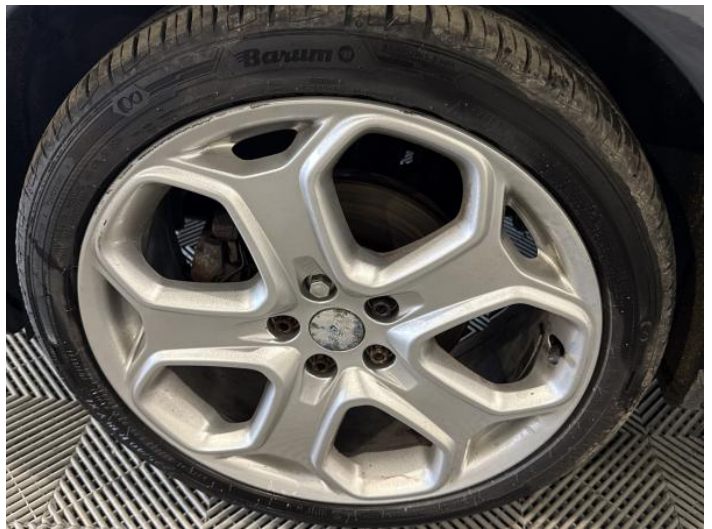
6: Wheel nsf  
Scratched  
Over 50mm

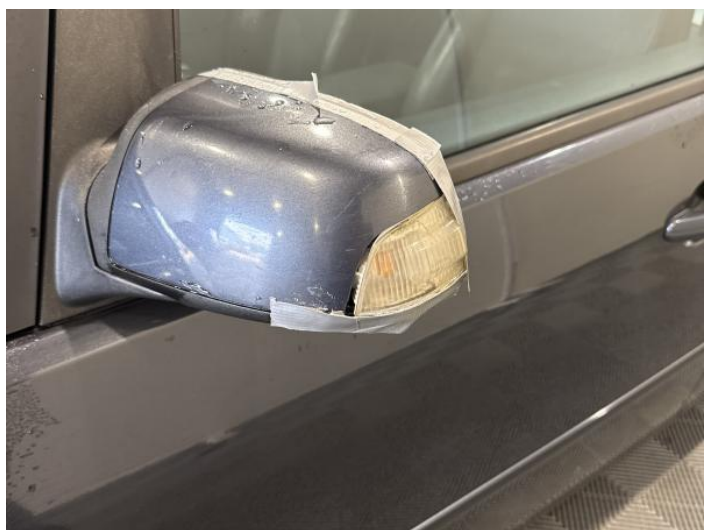
8: Door Mirror Assy nsf  
Broken  
Replace

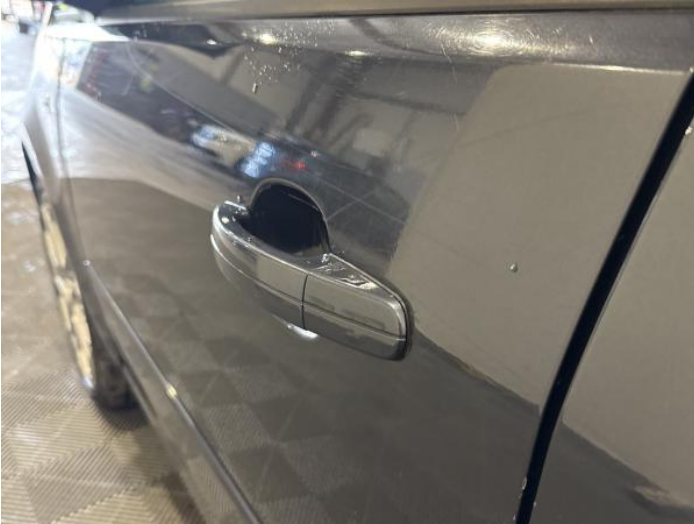
9: Door nsf  
Dented  
Over 30mm

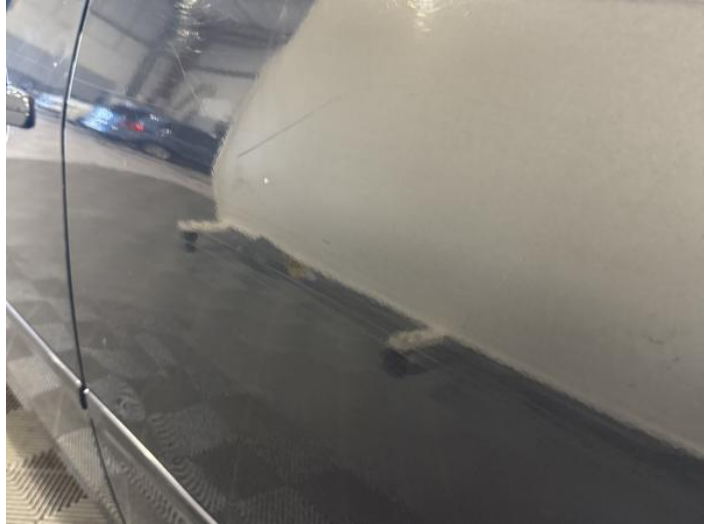
10: Door nsr  
Dented  
With Paint Damage

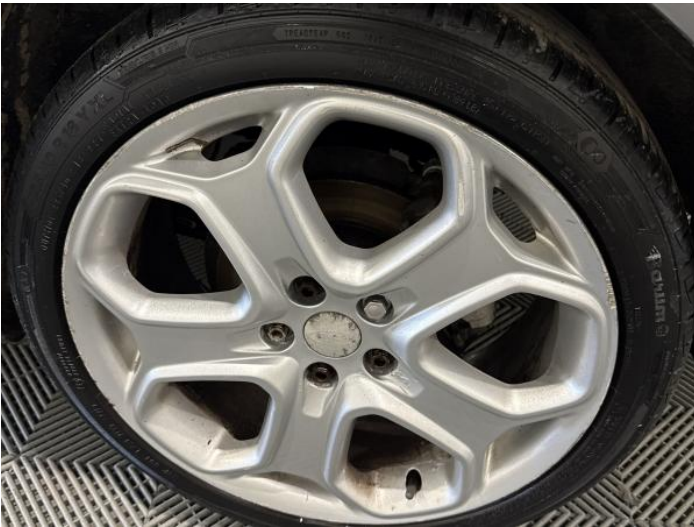
11: Wheel nsr  
Scratched  
Over 50mm

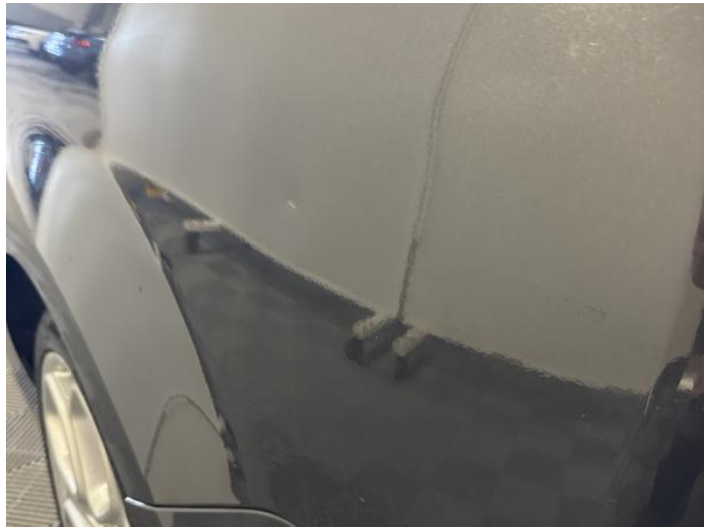
12: Qtr Panel nsr  
Dented  
With Paint Damage

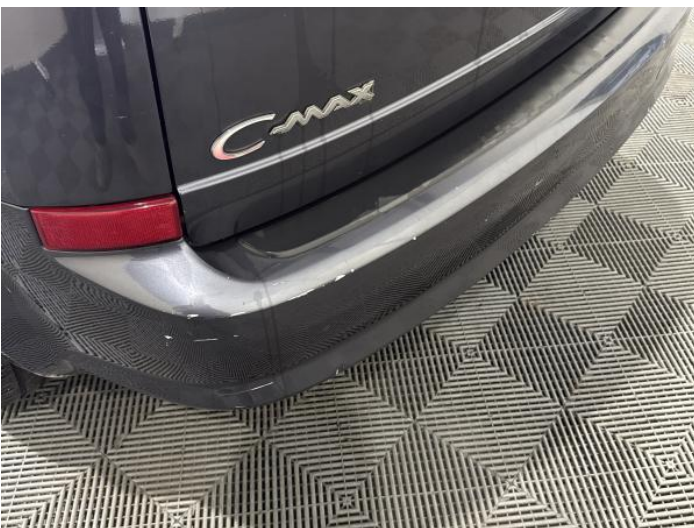
13: Bumper Rear  
Scratched  
Over 100mm Thru Paint

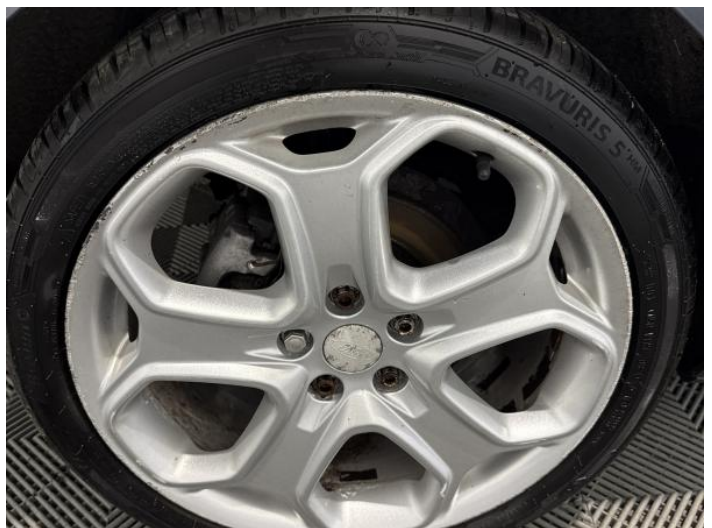
14: Wheel osr  
Scratched  
Over 50mm

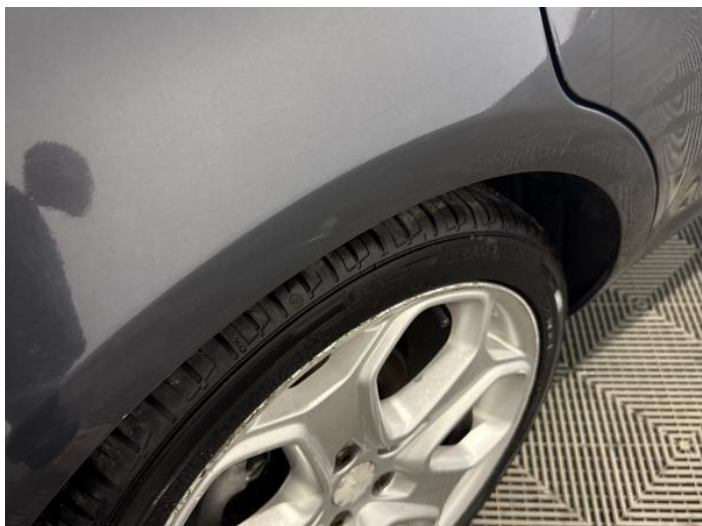
15: Qtr Panel osr  
Scratched  
UpTo 25mm Thru Paint

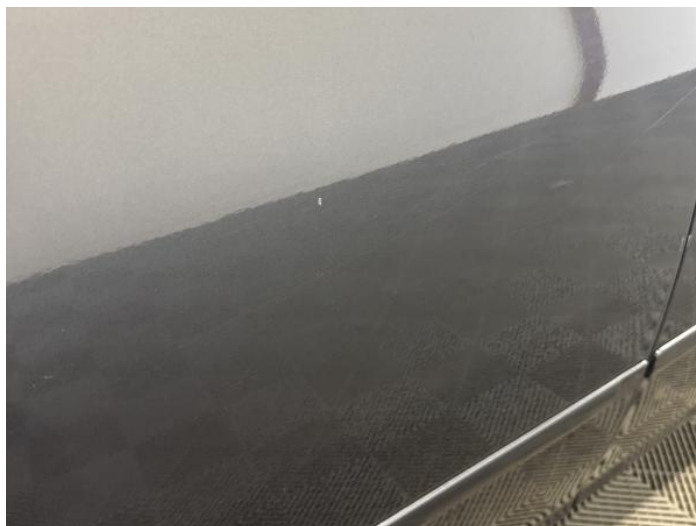
16: Door osr  
Scratched  
Over 25mm Thru Paint

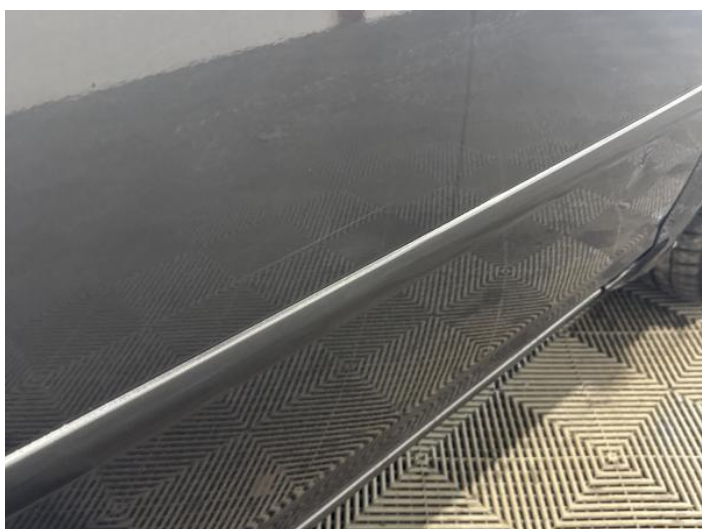
17: Door osf  
Scratched  
Over 25mm Thru Paint

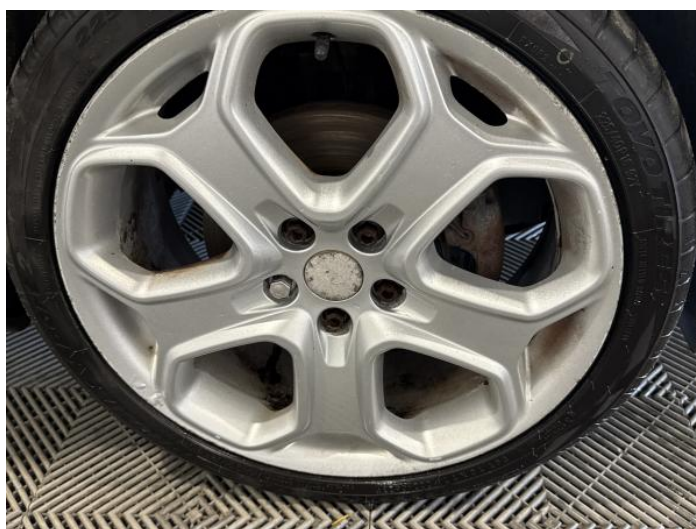
18: Wheel osf  
Scratched  
Over 50mm

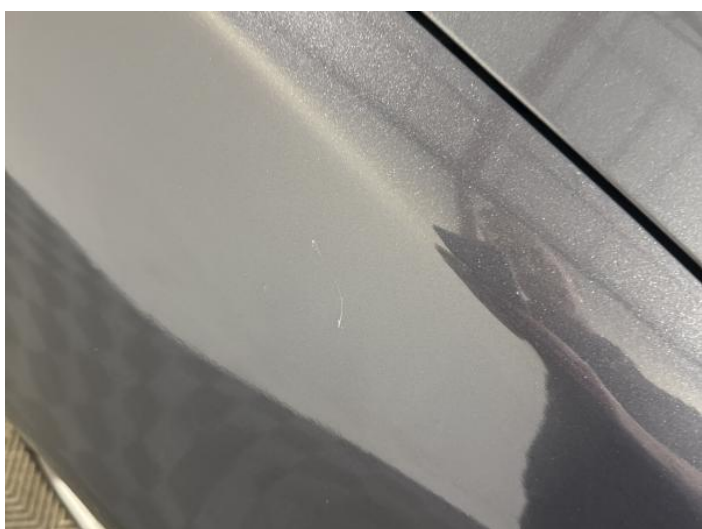
19: Wing osf  
Scratched  
UpTo 25mm Thru Paint
