VEHICLE INSPECTION REPORT

WO21JWA

DS Ds 3 1.2 PureTech 130 Elegance 5dr EAT8

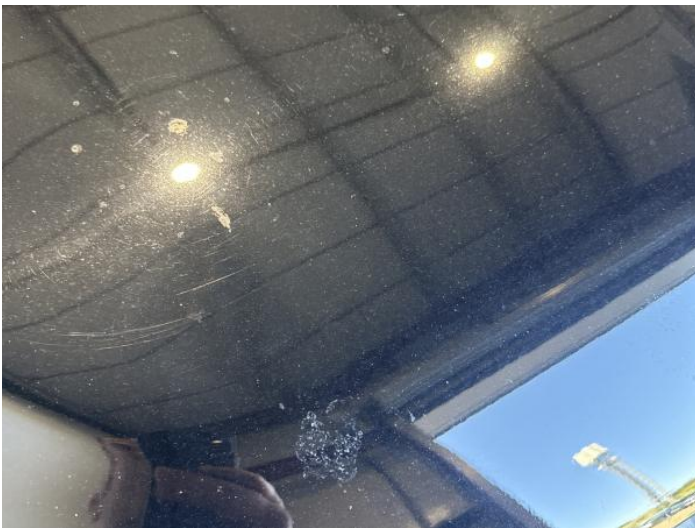
1: Bonnet
Scratched
Over 25mm Thru Paint

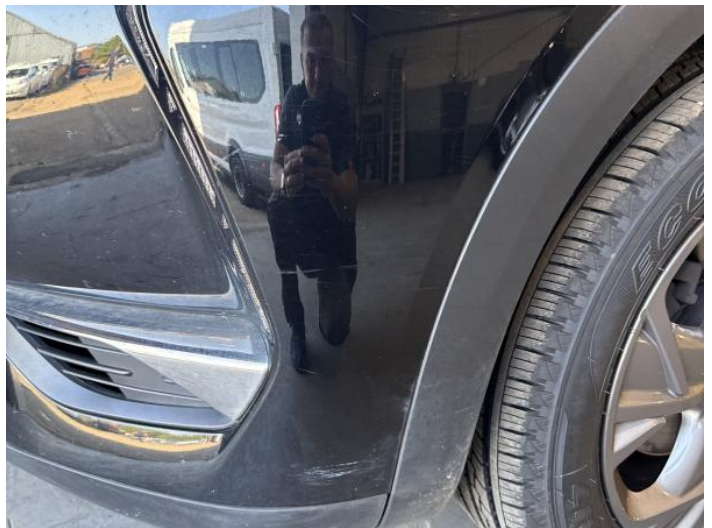
2: Bumper Front
Scratched
Over 100mm Thru Paint

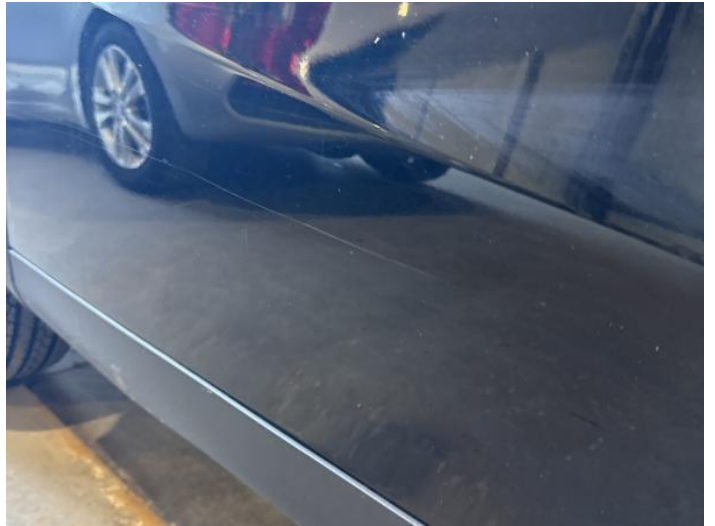
3: Wing nsf
Scratched
Over 25mm Not Thru Paint

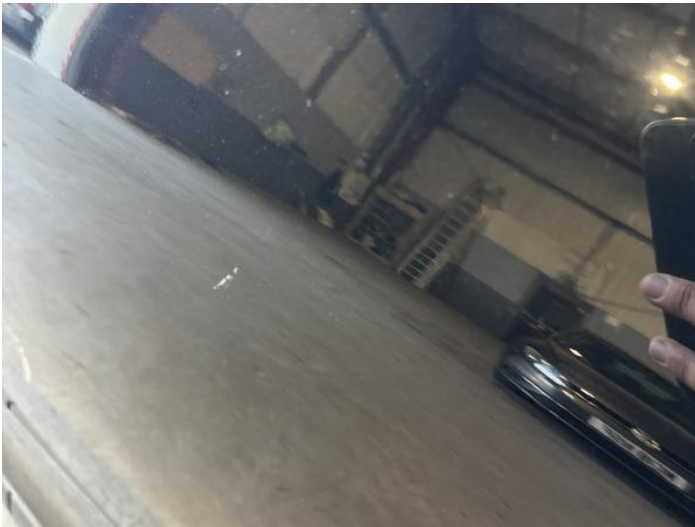
5: Door nsr
Scratched
Over 25mm Thru Paint

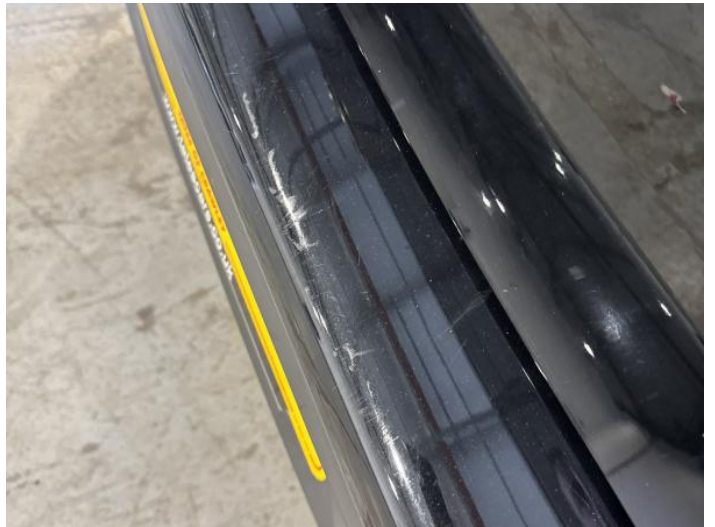
6: Bumper Rear
Scratched
Over 100mm Thru Paint

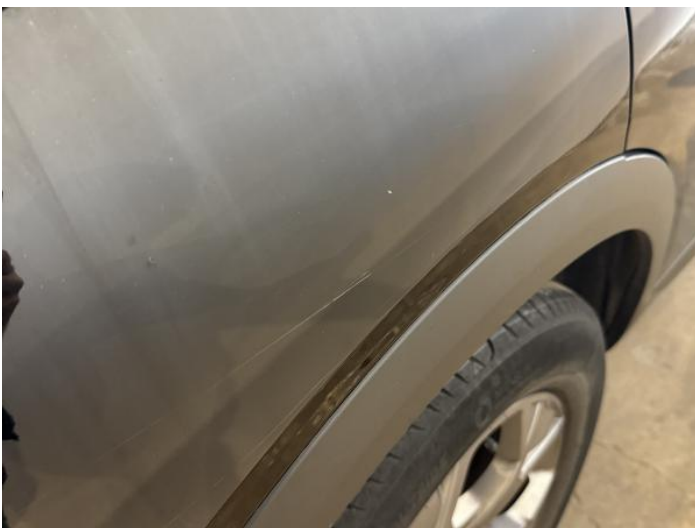
7: Qtr Panel osr
Scratched
Over 25mm Thru Paint

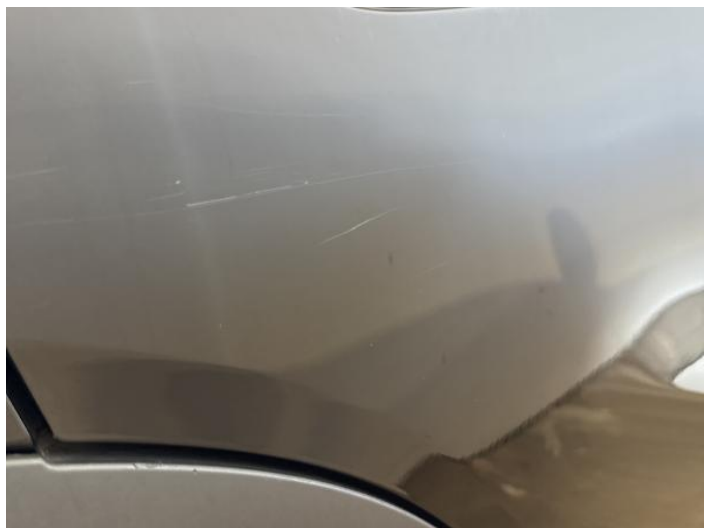
8: Door osr
Scratched
Over 25mm Thru Paint

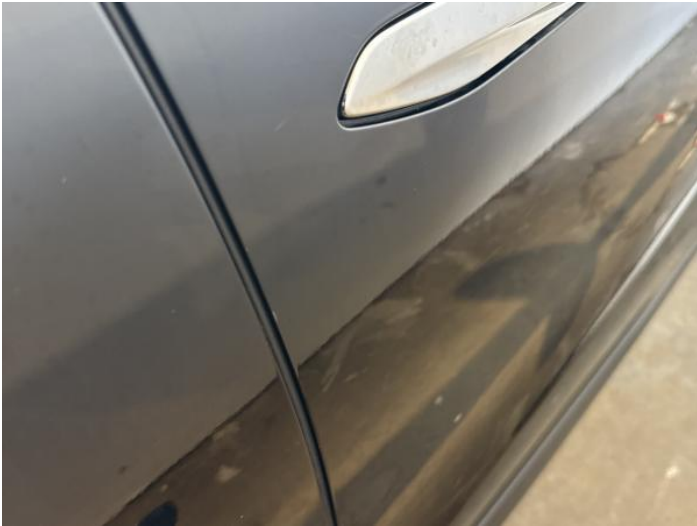
9: Door osf
Chipped
Edge Chip

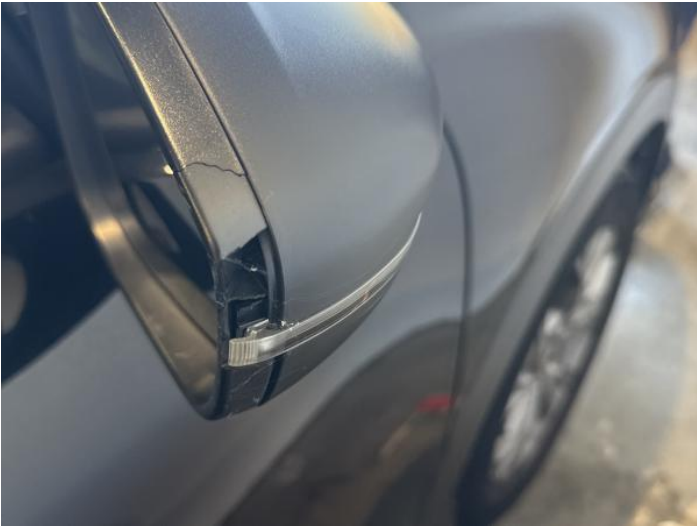
10: Door osf
Cracked
Replace

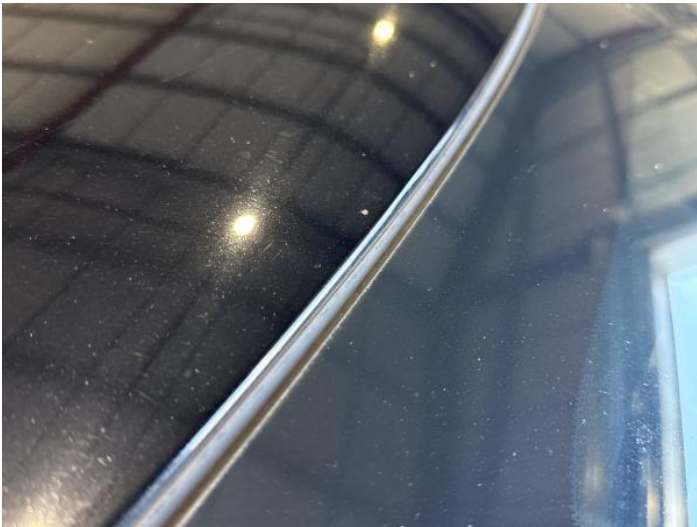
11: Roof
Scratched
Over 25mm Thru Paint

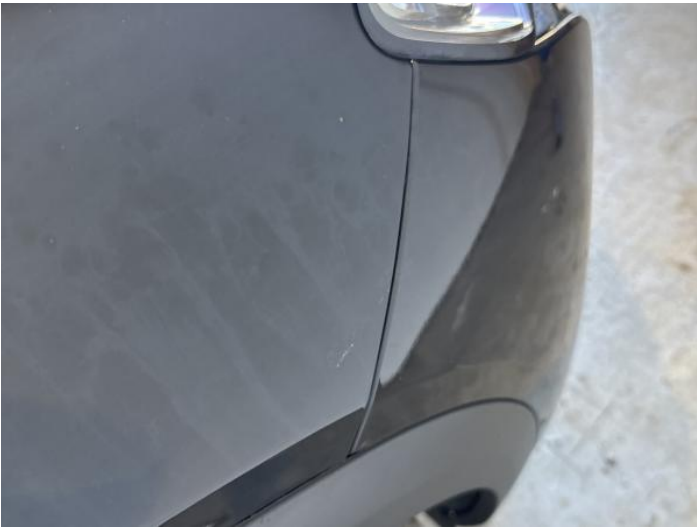
12: Wing osf
Scratched
UpTo 25mm Thru Paint
