# VEHICLE INSPECTION REPORT

**GY65ULF**

## Peugeot 208 1.2 PureTech 82 Active 3dr

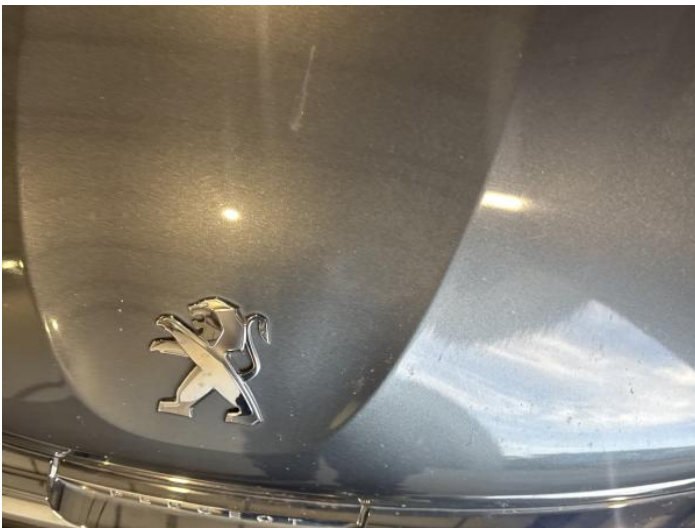
1: Bonnet  
Chipped  
Multiple Chips

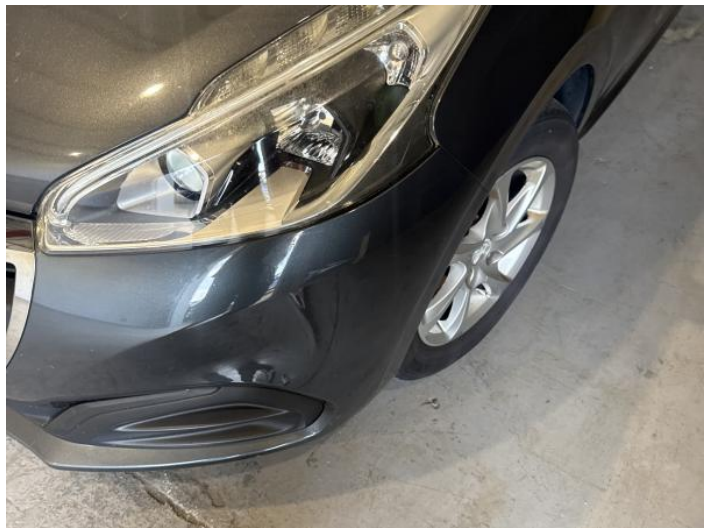
2: Bumper Front  
Scratched  
25 to 100mm Thru Paint

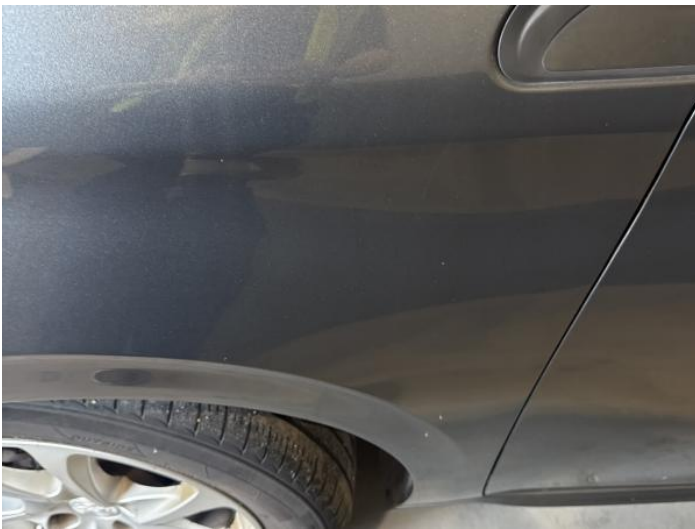
5: Wing nsf  
Chipped  
1 To 5

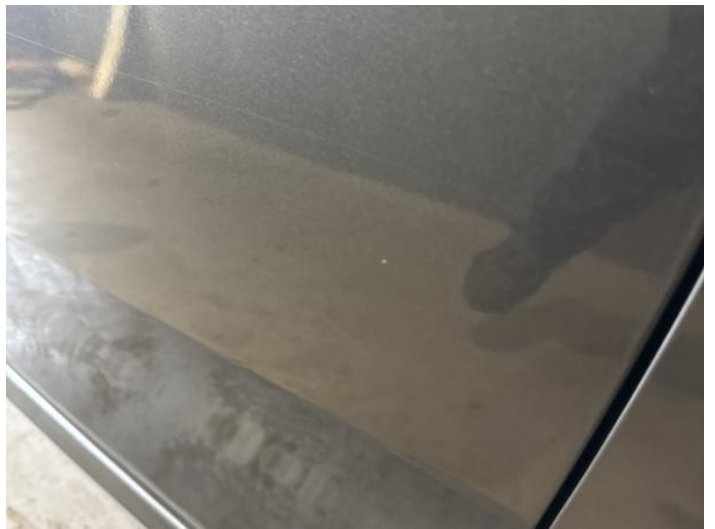
6: Door nsf  
Dented  
Over 30mm

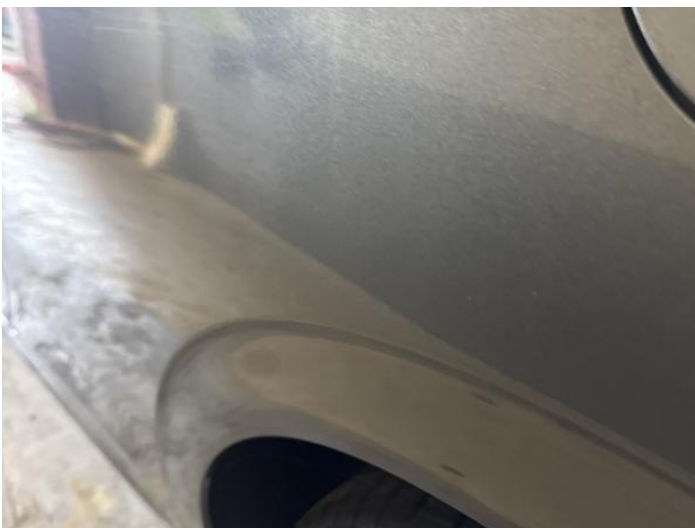
7: Qtr Panel nsr  
Dented  
Over 2 UpTo 10mm

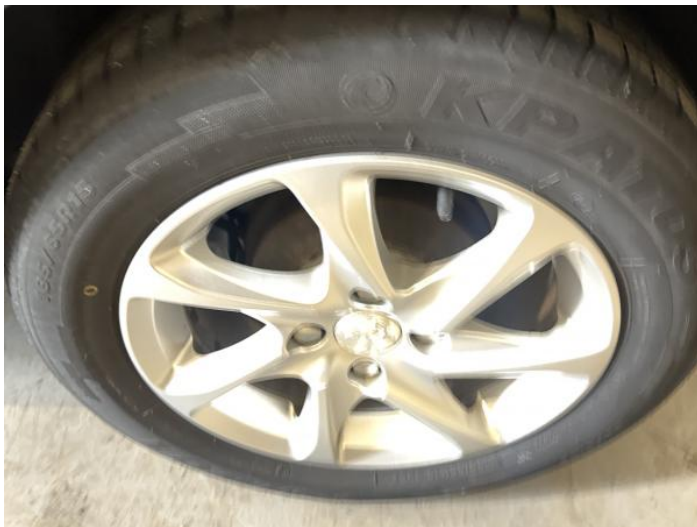
9: Wheel nsr  
Scratched  
Up To 50mm

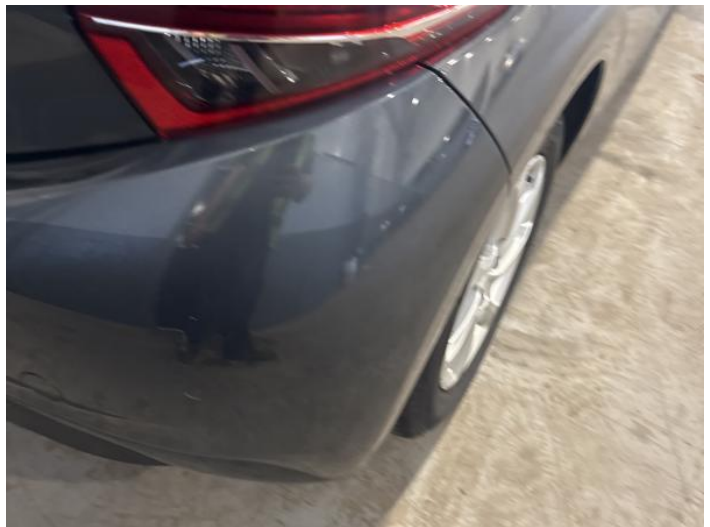
10: Bumper Rear  
Scratched  
25 to 100mm Thru Paint

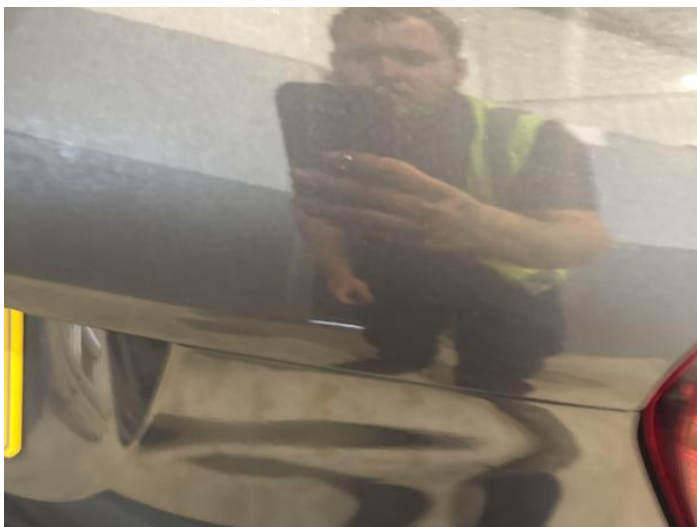
13: Boot Lid  
Chipped  
1 To 5

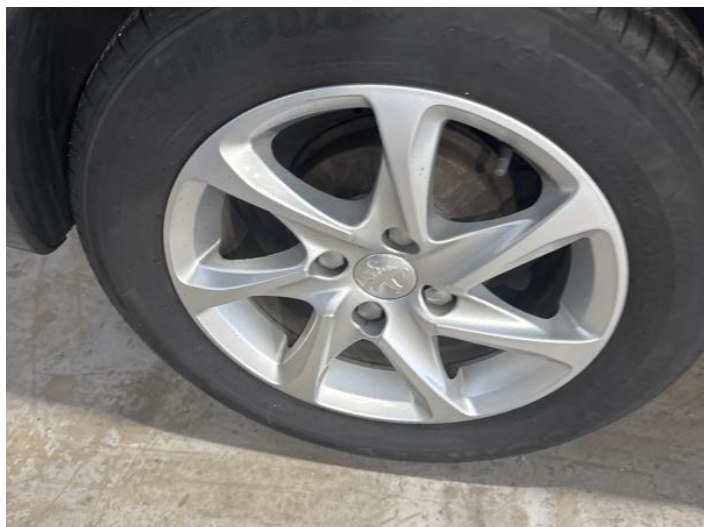
14: Wheel osr  
Scratched  
Up To 50mm

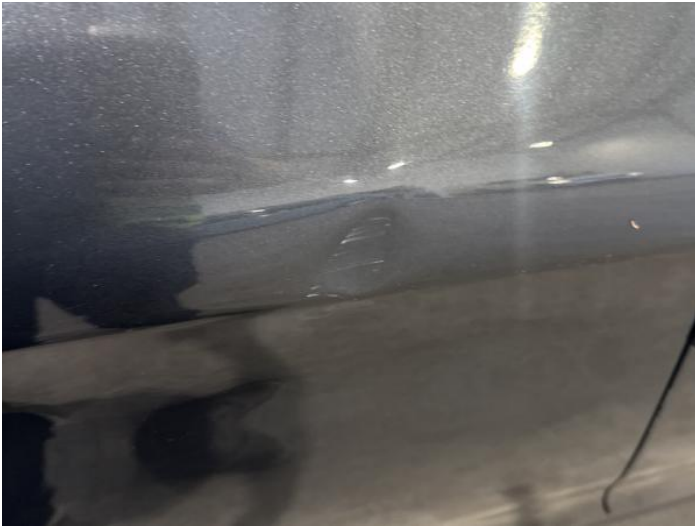
15: Qtr Panel osf  
Dented  
With Paint Damage

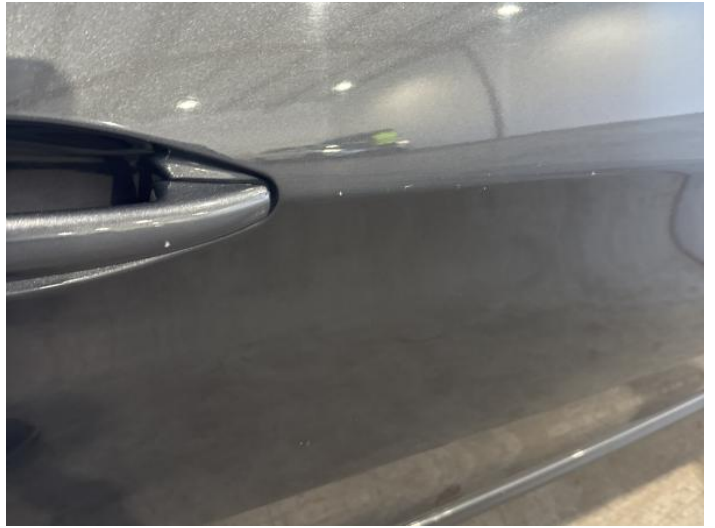
16: Door osf  
Chipped  
Multiple Chips

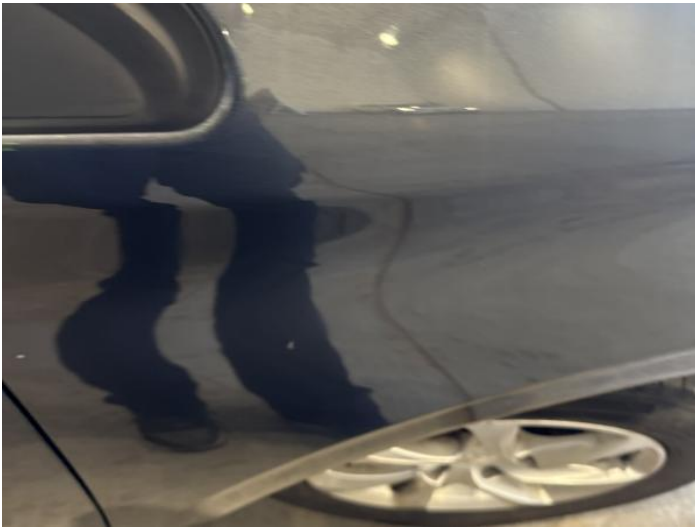
17: Wing osf  
Chipped  
1 To 5

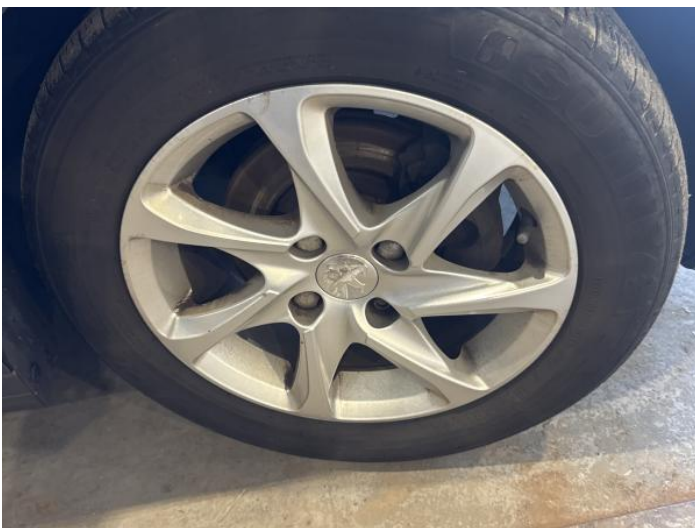
19: Wheel osf  
Scratched  
Up To 50mm
