VEHICLE INSPECTION REPORT

GL63NZY

Fiat 500 1.2 Lounge 3dr [Start Stop]

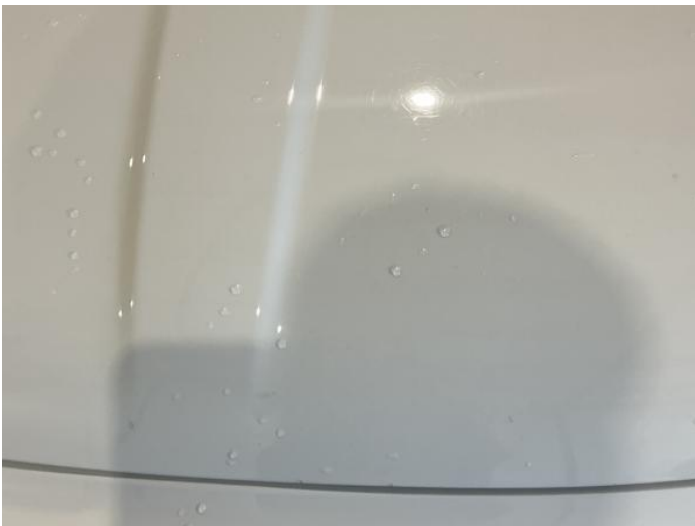
1: Bonnet
Chipped
1 To 5

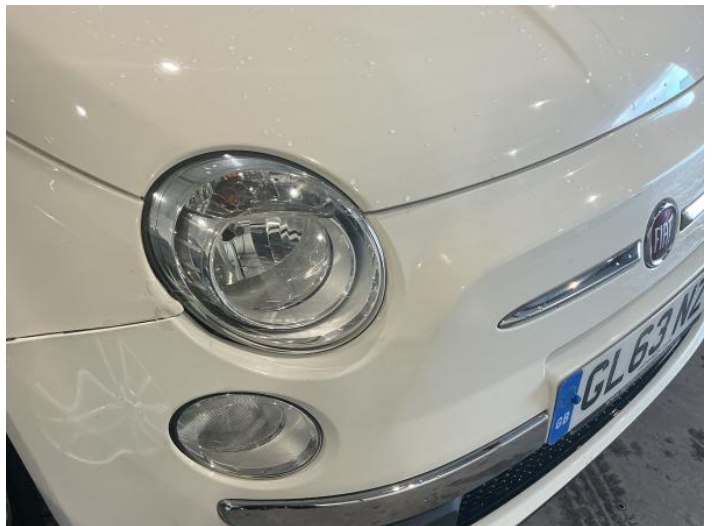
2: Bumper Front
Scratched
Over 100mm Thru Paint

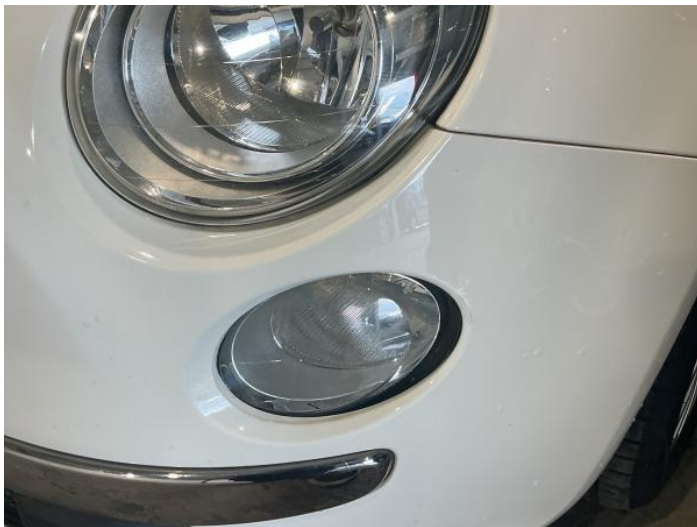
3: Fogdriving Lamp nsf
Broken
Replace

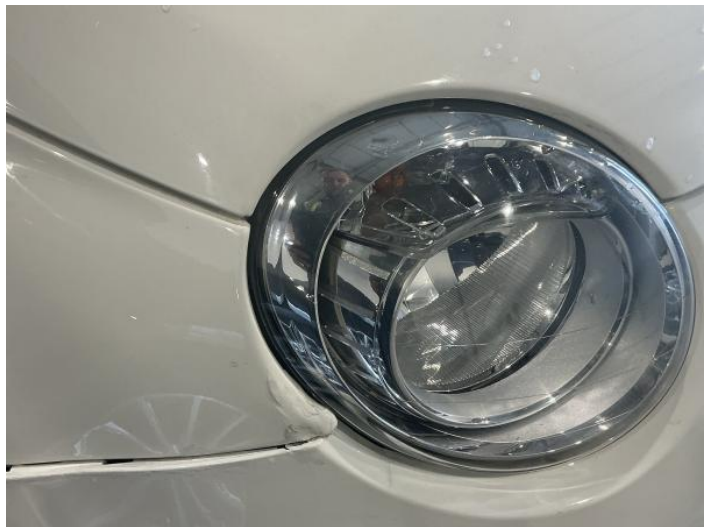
4: Wing osf
Dented
With Paint Damage

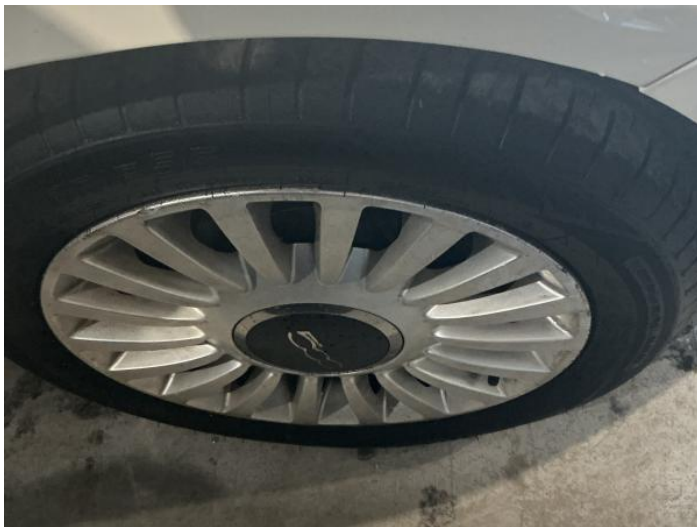
5: Wheel osf
Scratched
Over 50mm

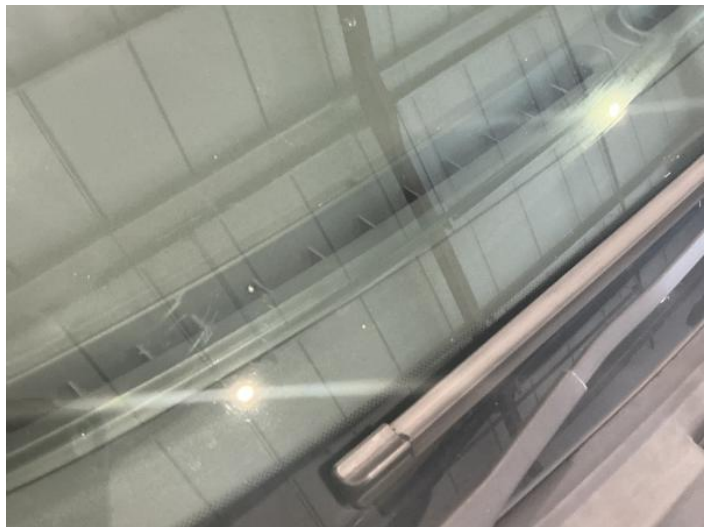
6: Screen Front
Chipped
UpTo 10mm

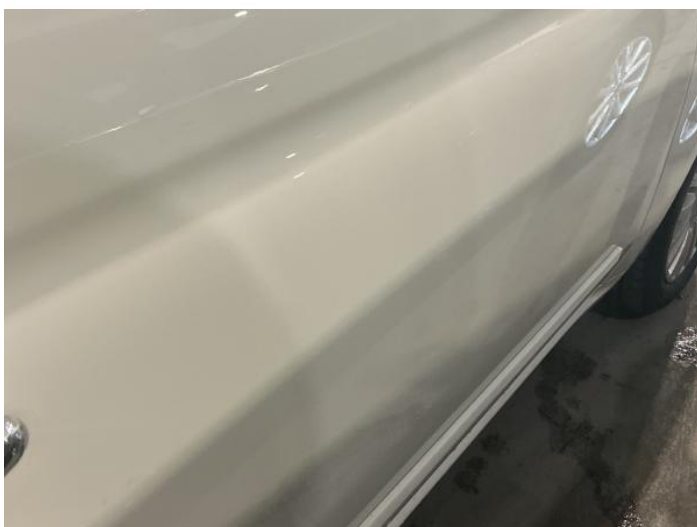
7: Door osf
Chipped
1 To 5

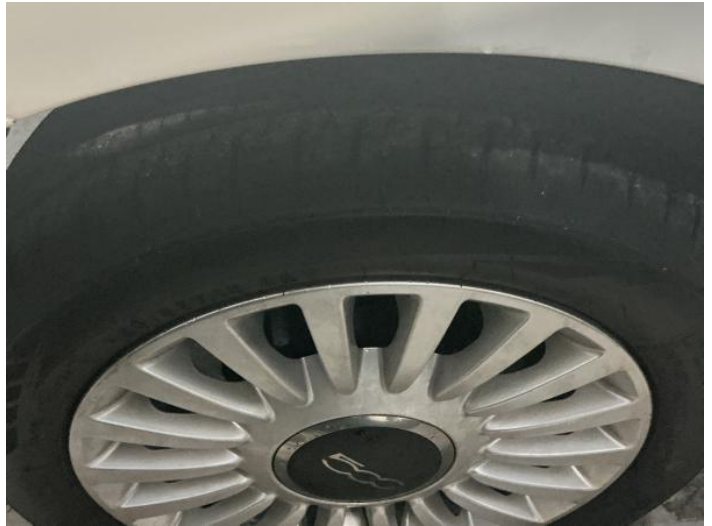
10: Wheel osr
Scratched
Over 50mm

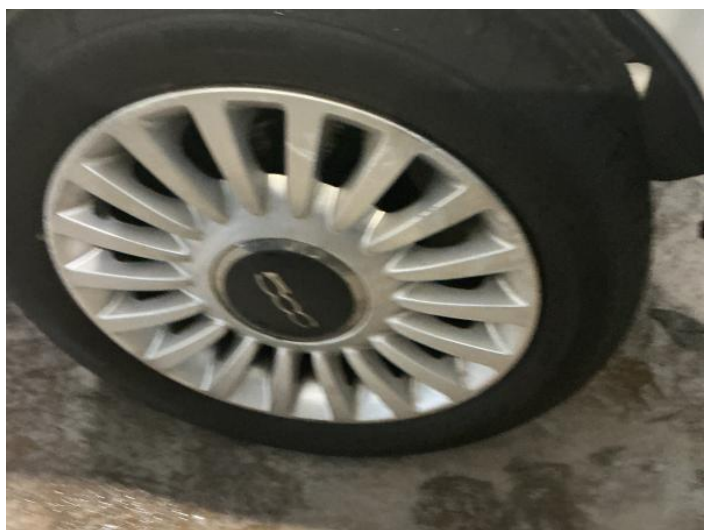
14: Wheel nsr
Scratched
Over 50mm

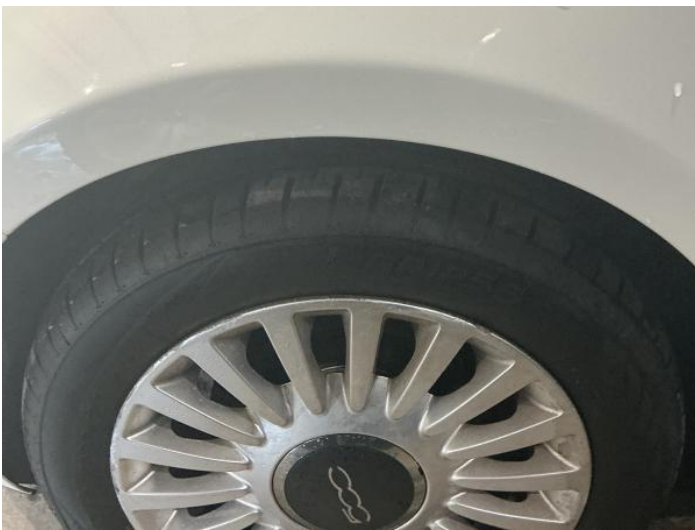
17: Wheel nsf
Scratched
Over 50mm
