VEHICLE INSPECTION REPORT

SW59GWP

Citroen C4 1.6HDi 16V VTR Plus [110] 5dr EGS

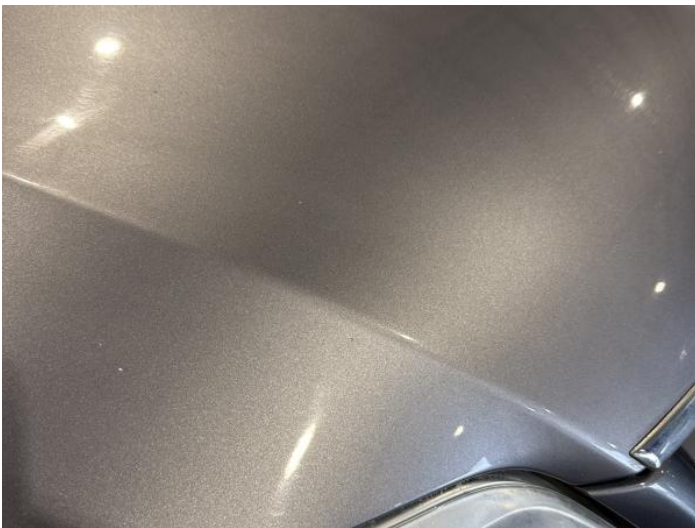
1: Bonnet
Chipped
Multiple Chips

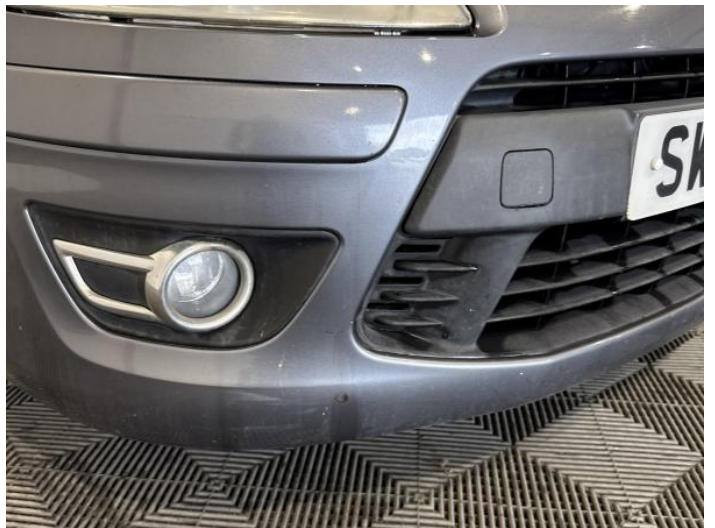
2: Bumper Front
Scratched
Over 100mm Thru Paint

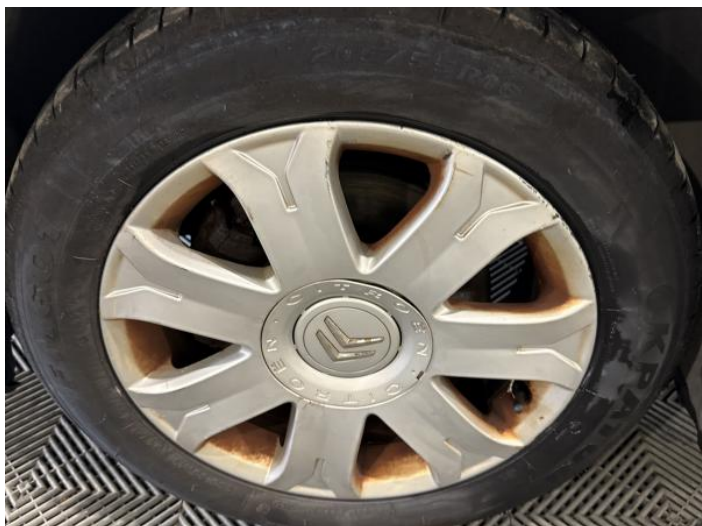
3: Wheel nsf
Scratched
Over 50mm

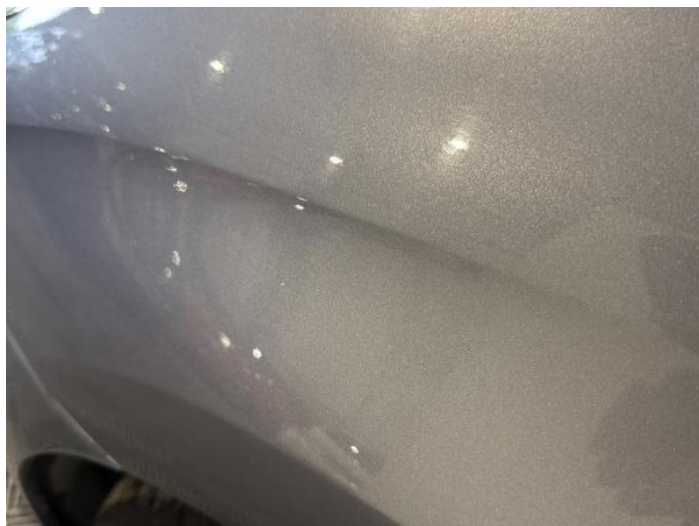
4: Wing nsf
Chipped
1 To 5

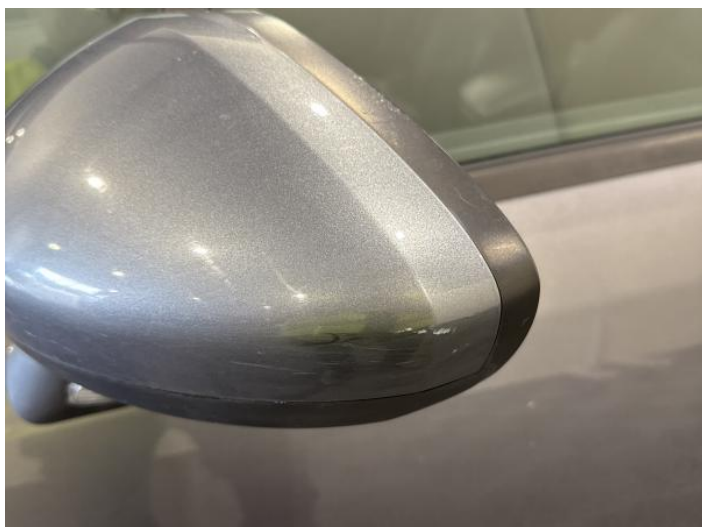
5: Door Mirror Assy nsf
Scratched (Painted)
UpTo 25mm Thru Paint

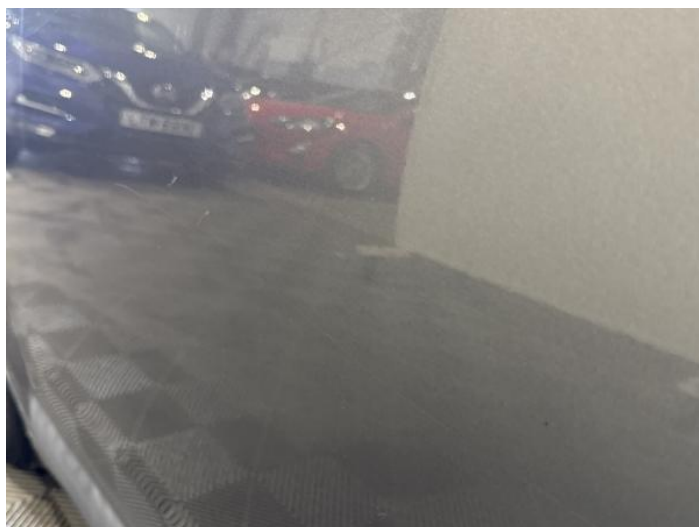
6: Door nsf
Scratched
Over 25mm Thru Paint

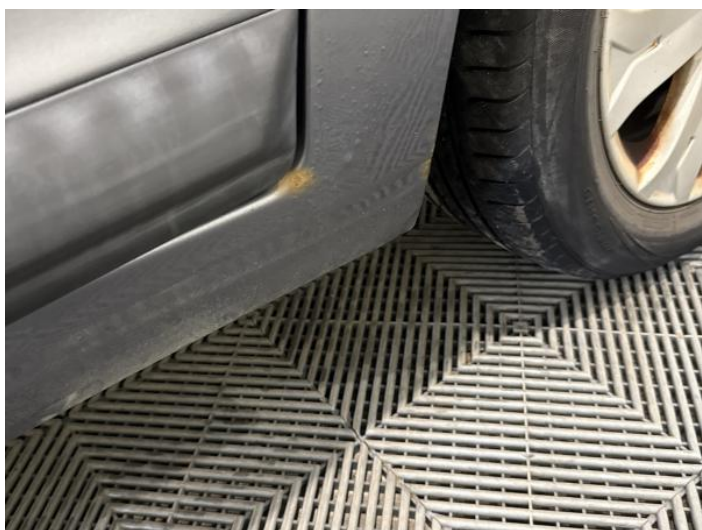
7: Sill ns
Rusted
Over 5mm

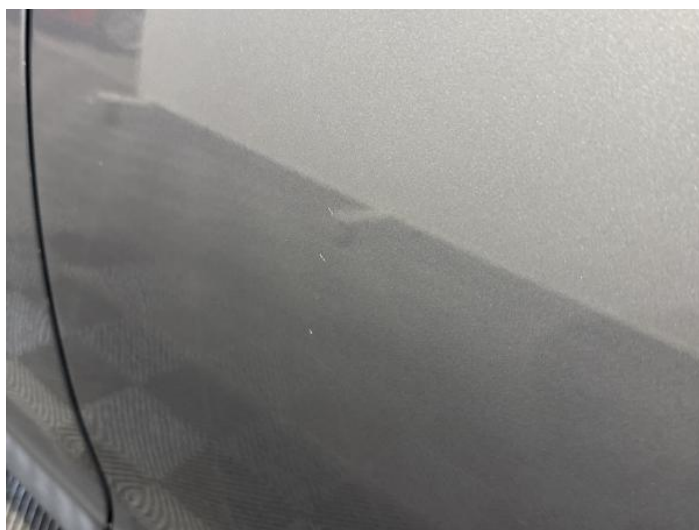
8: Door nsr
Scratched
UpTo 25mm Thru Paint

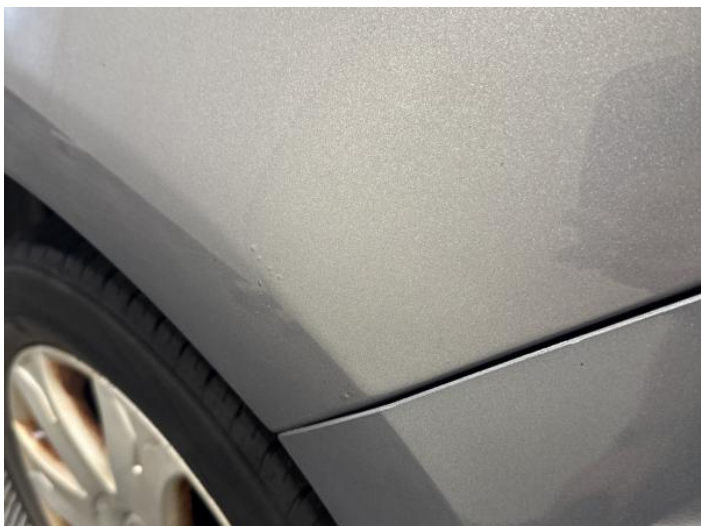
9: Qtr Panel nsr
Poor Previous Repair
Rippled UpTo 30%

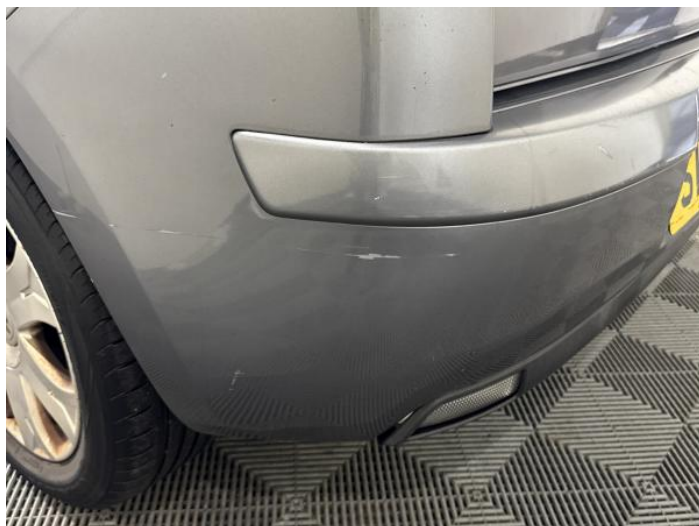
10: Bumper Rear
Scratched
Over 100mm Thru Paint

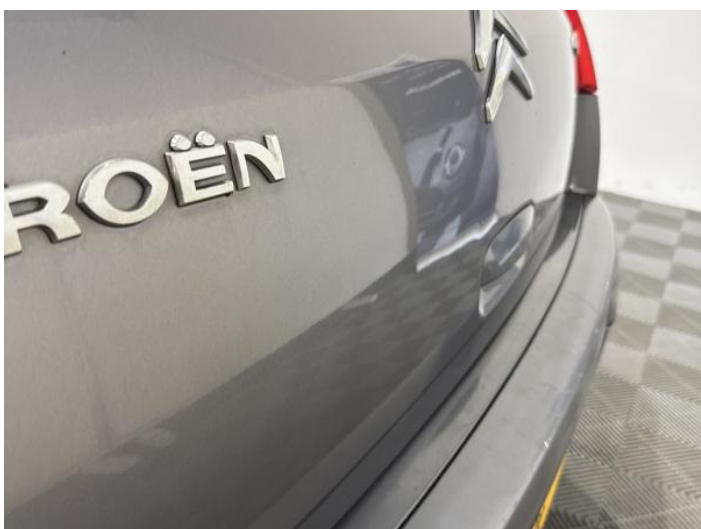
11: Tailgate
Poor Previous Repair
Rippled UpTo 30%

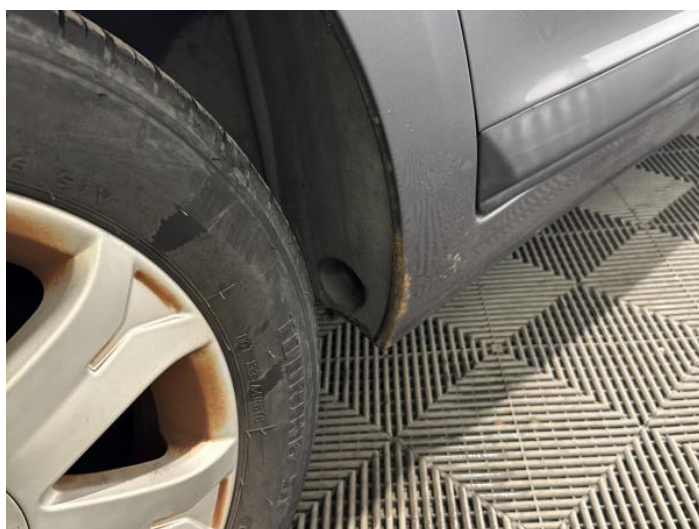
12: Qtr Panel osr
Rusted
Over 5mm

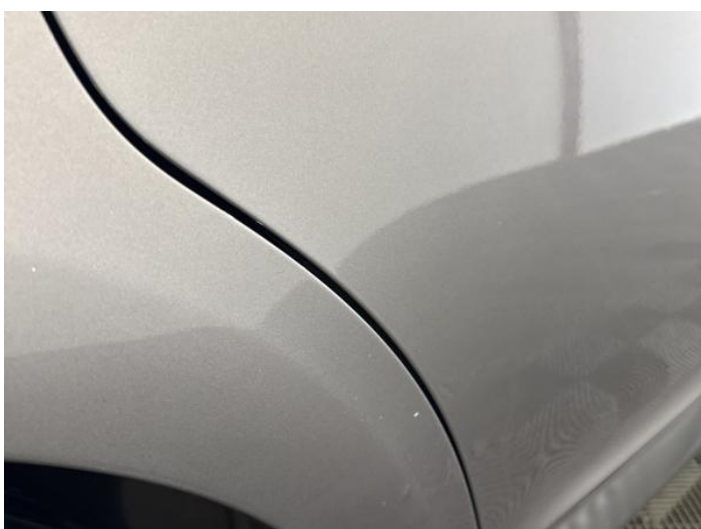
13: Door osr
Chipped
Edge Chip

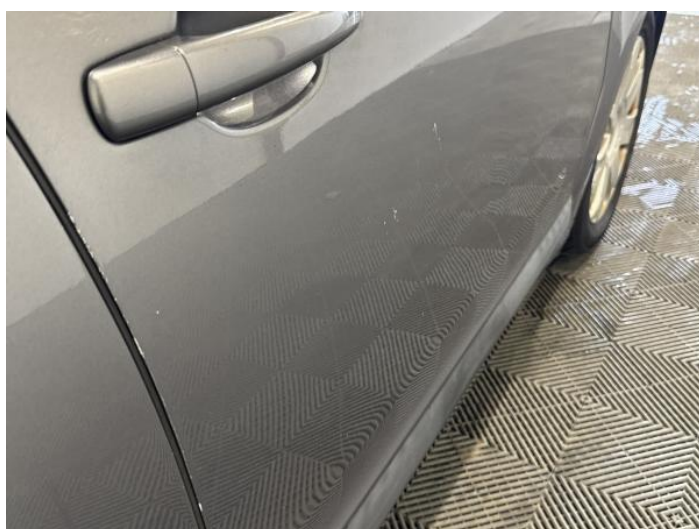
14: Door osf
Dented
Over 30mm

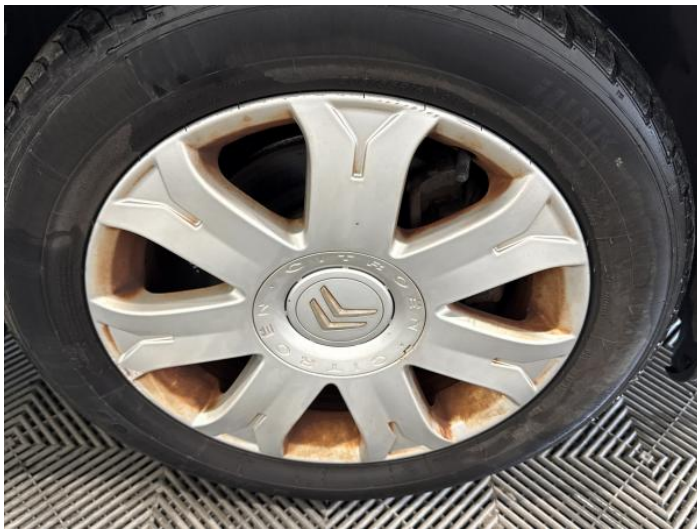
15: Wheel osf
Scratched
Over 50mm

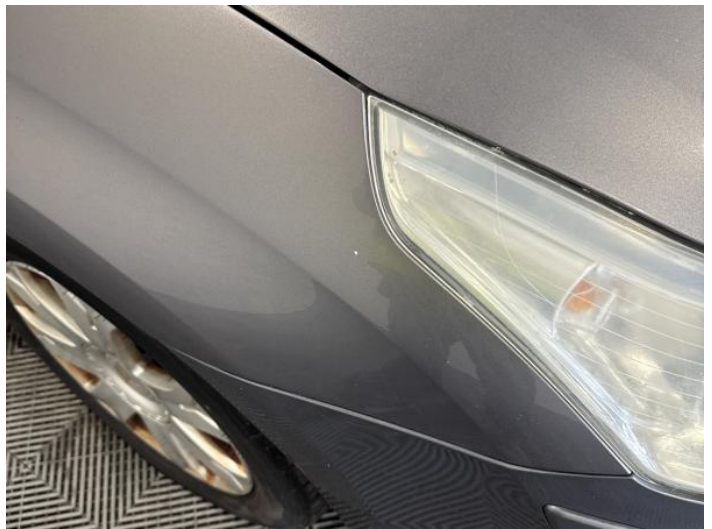
16: Wing osf
Chipped
Multiple Chips
