VEHICLE INSPECTION REPORT

GX21KVU

Mazda CX-30 2.0 e-Skyactiv G MHEV SE-L 5dr

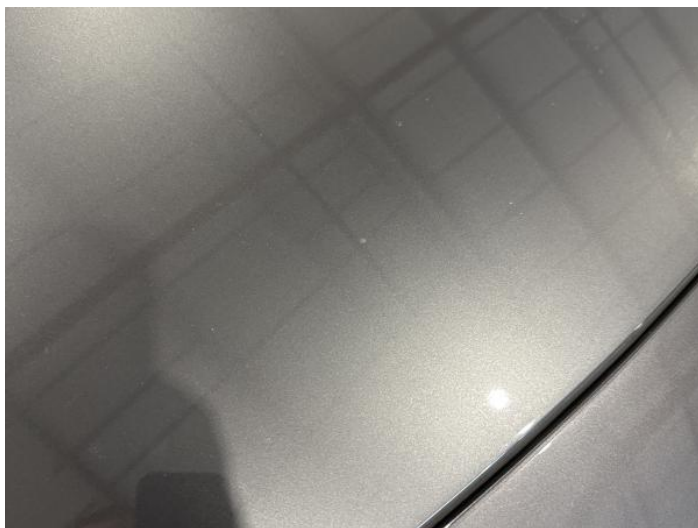
1: Bonnet
Chipped
1 To 5

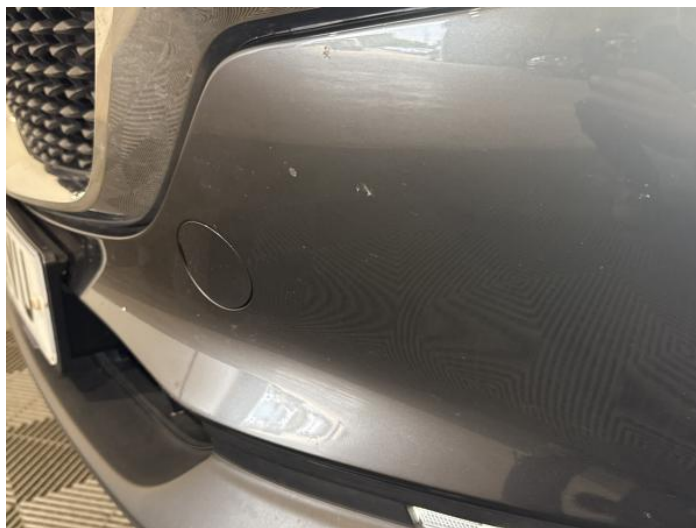
2: Bumper Front
Scratched
25 to 100mm Thru Paint

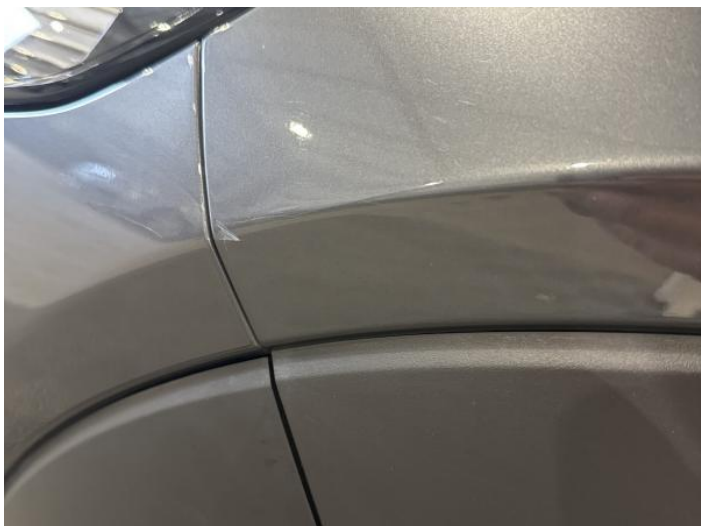
3: Wing nsf
Scratched
UpTo 25mm Thru Paint

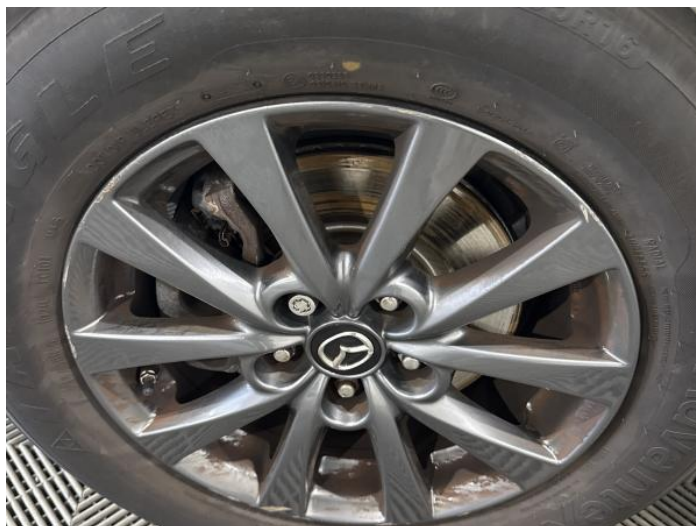
4: Wheel nsf
Scratched
Over 50mm

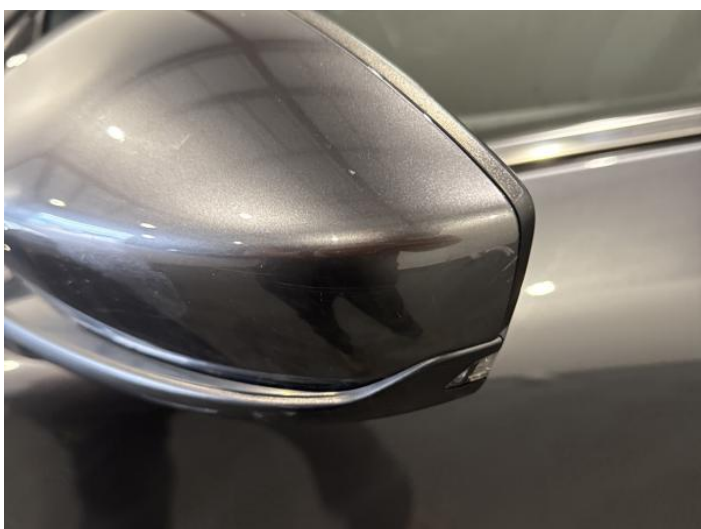
5: Door Mirror Assy nsf
Scratched (Painted)
UpTo 25mm Thru Paint

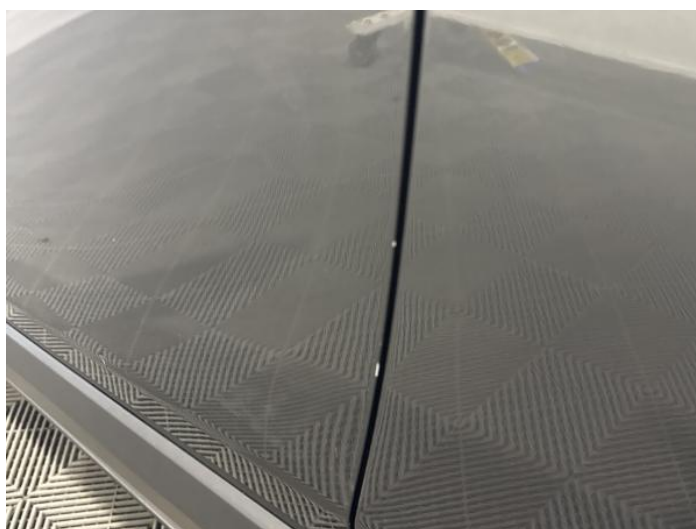
6: Door nsf
Chipped
Edge Chip

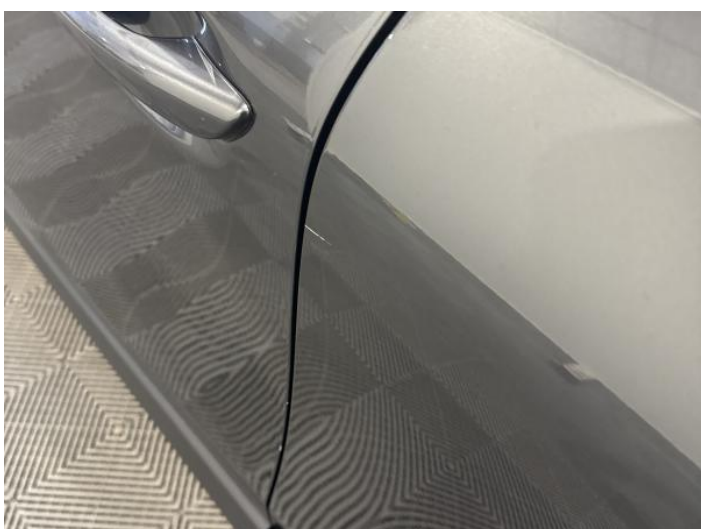
7: Door nsr
Scratched
UpTo 25mm Thru Paint

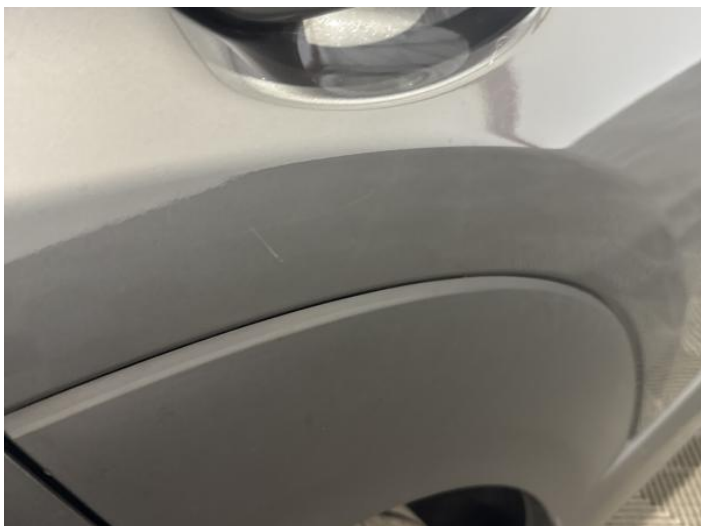
9: Door osr
Scratched
UpTo 25mm Thru Paint

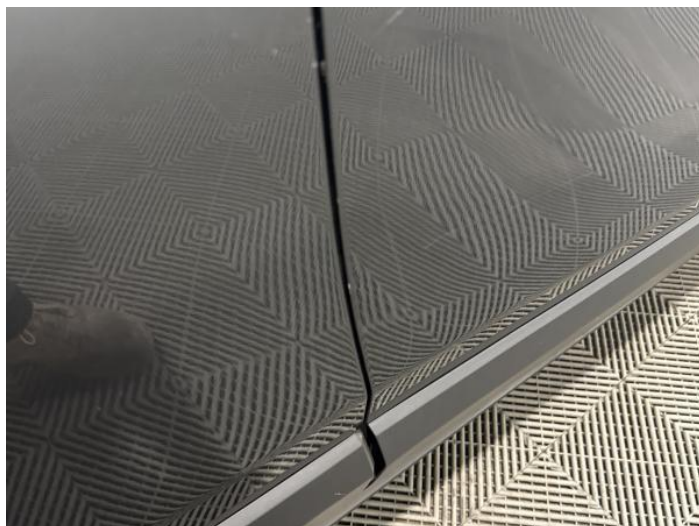
10: Door osf
Chipped
Edge Chip

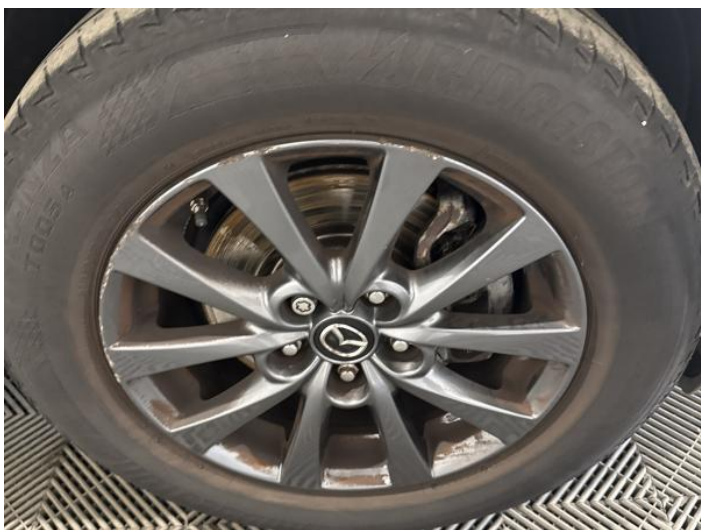
11: Wheel osf
Scratched
Over 50mm
