VEHICLE INSPECTION REPORT

BX17DNJ

BMW 2 Series 218i SE 5dr

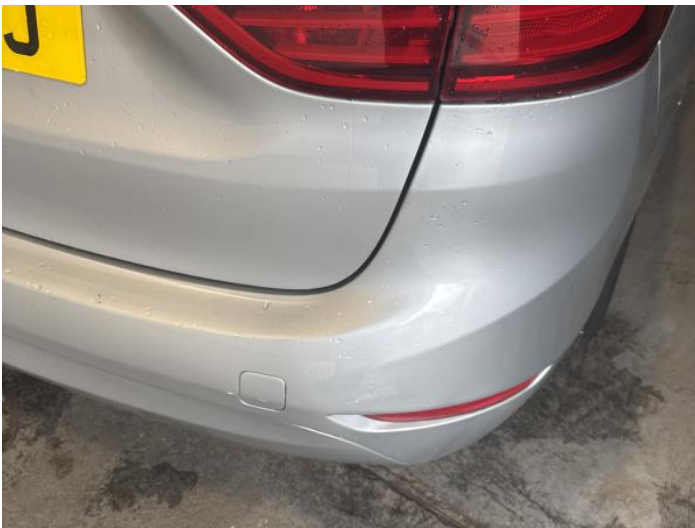
1: Bumper Rear
Poor Previous Repair
Poor Paint

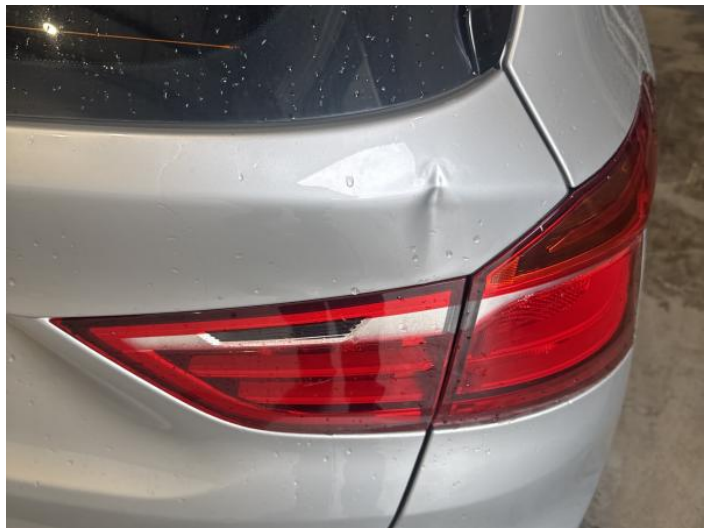
2: Boot Lid
Dented
Over 30mm

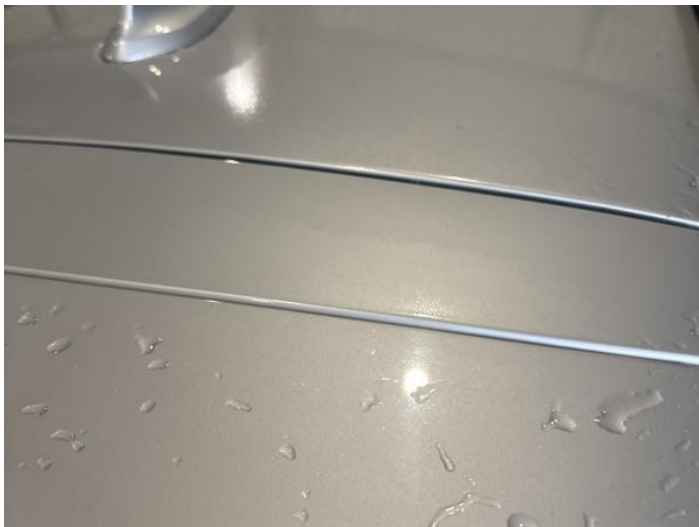
3: Roof
Dented
Over 30mm

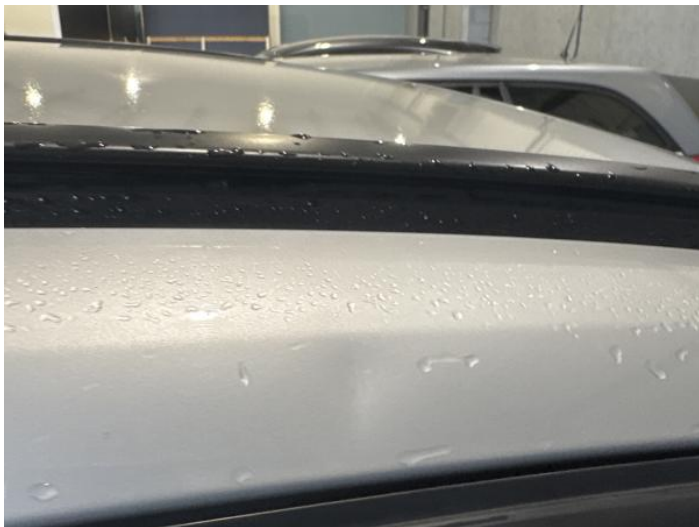
5: B Post os
Dented
Over 30mm

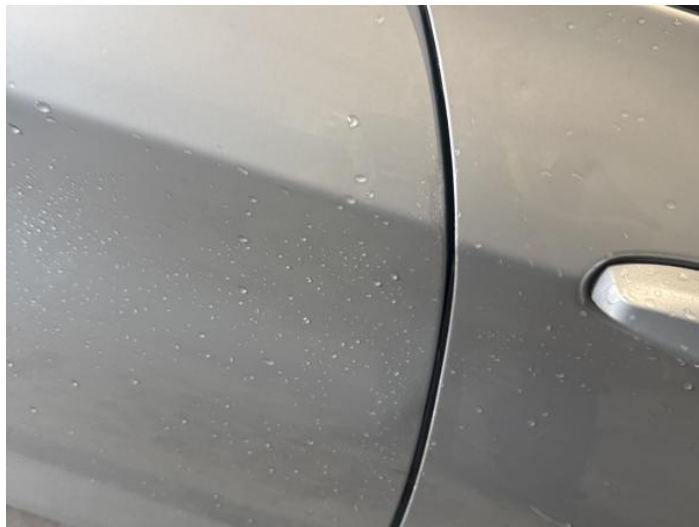
6: Door osr
Dented
Over 30mm

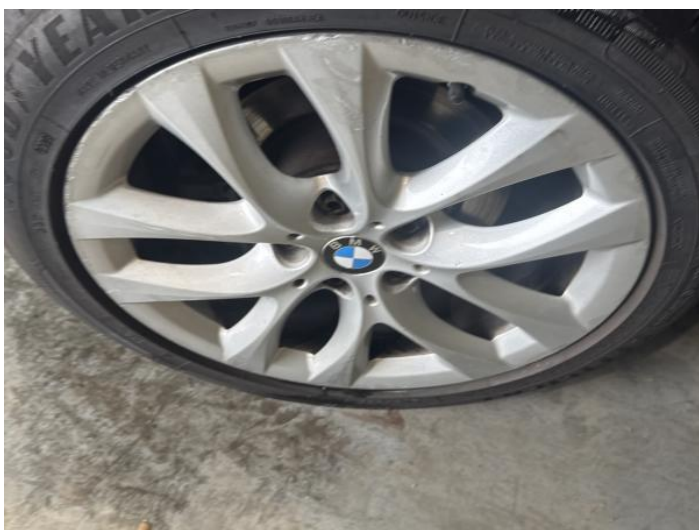
7: Wheel osr
Scratched
Over 50mm

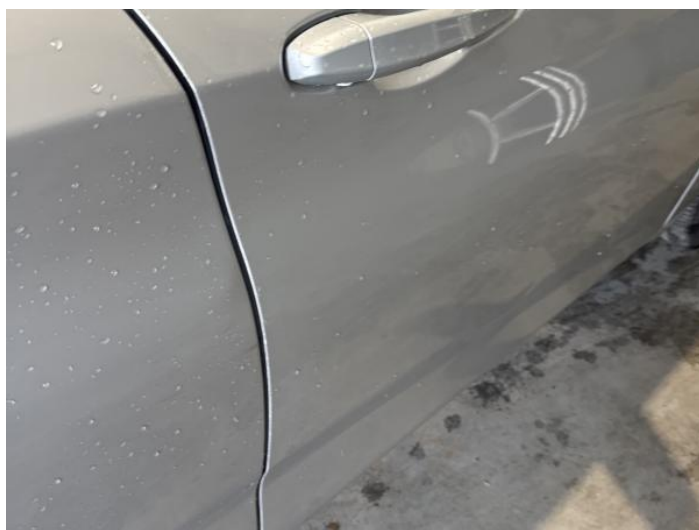
8: Door osf
Dented
Over 30mm

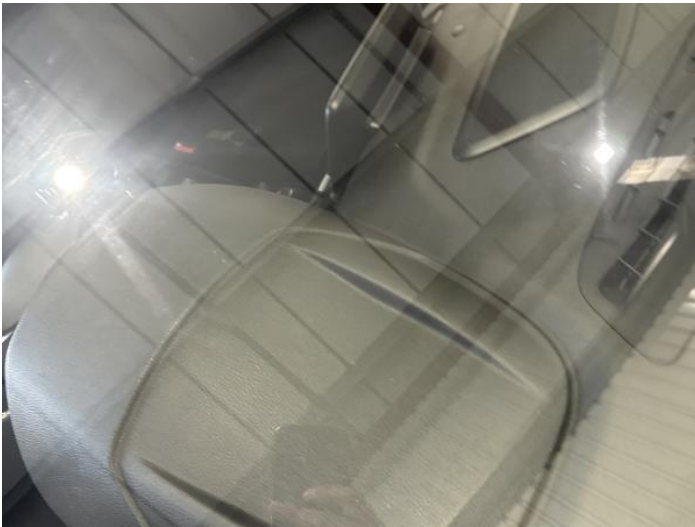
11: Screen Front
Chipped
UpTo 10mm

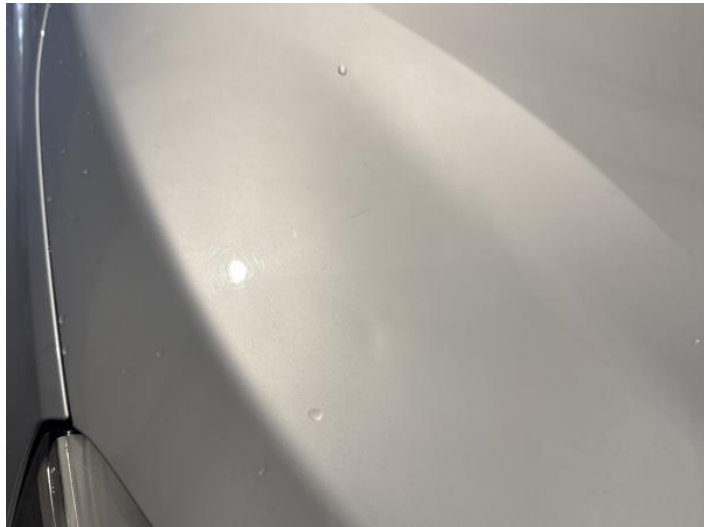
12: Bonnet
Dented
With Paint Damage

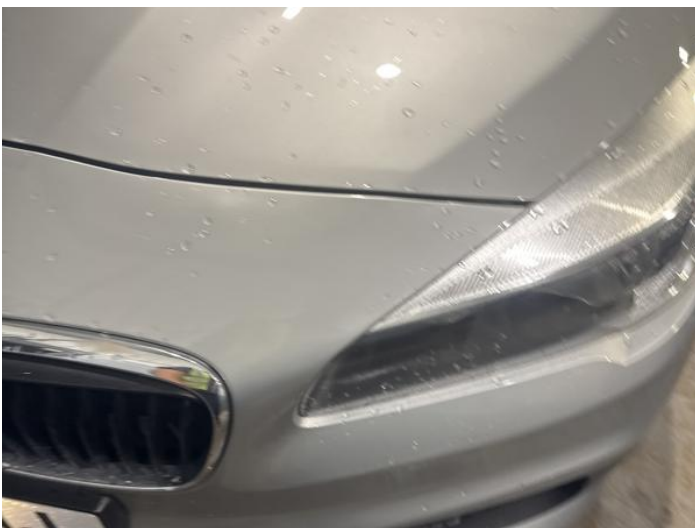
13: Bumper Front
Poor Previous Repair
Poor Paint

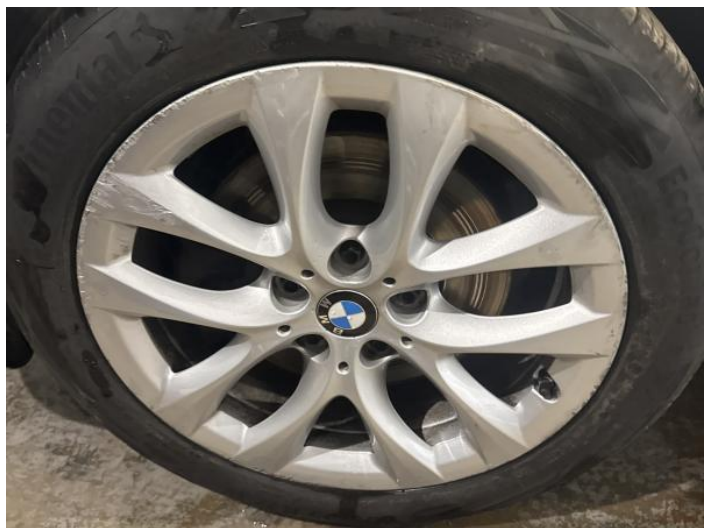
14: Wheel nsf
Scratched
Over 50mm

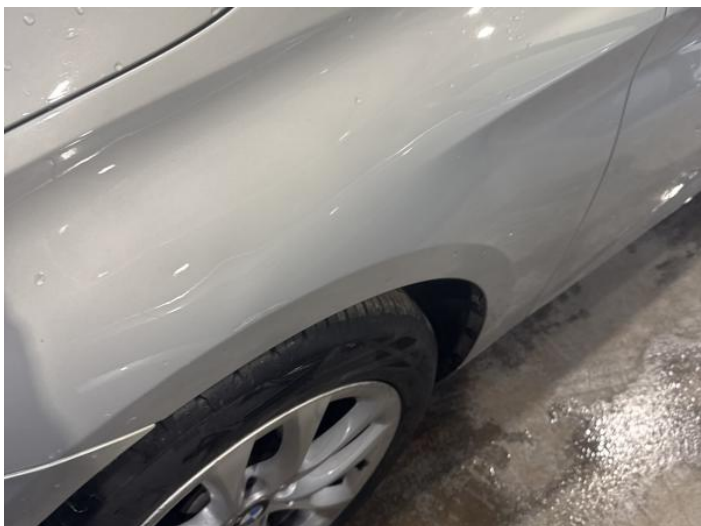
15: Wing nsf
Dented
With Paint Damage

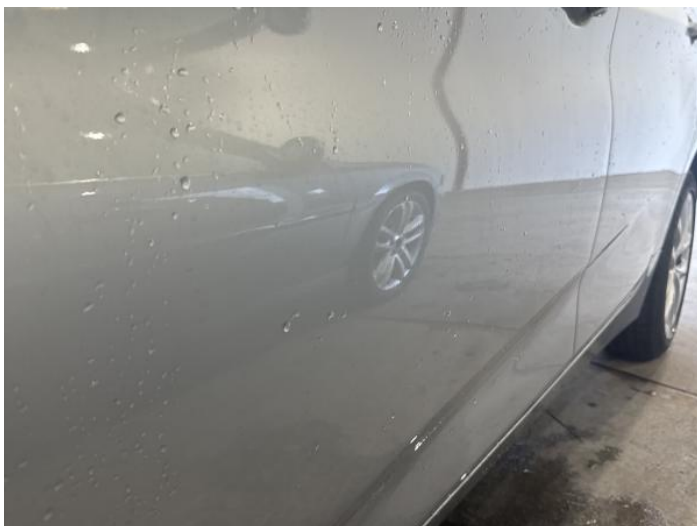
16: Door nsf
Dented
Over 2 UpTo 10mm

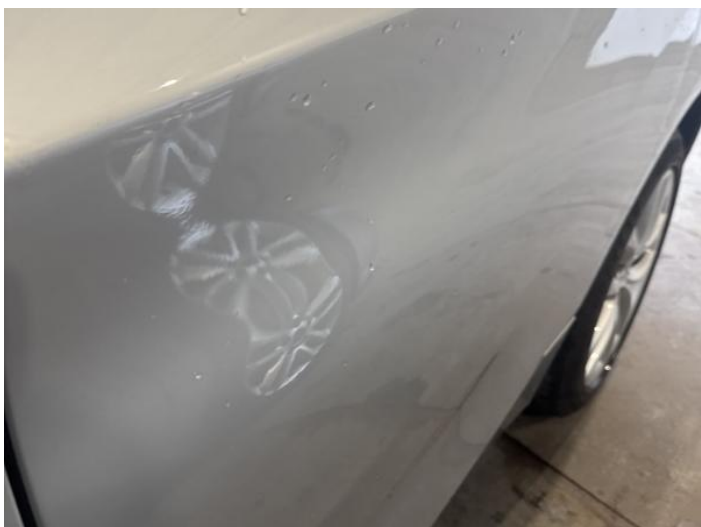
17: Door nsr
Dented
Over 30mm

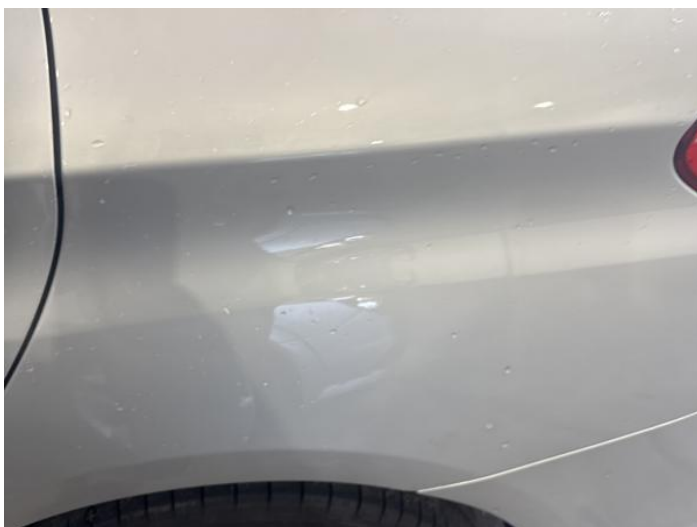
18: Qtr Panel nsr
Dented
Over 2 UpTo 10mm

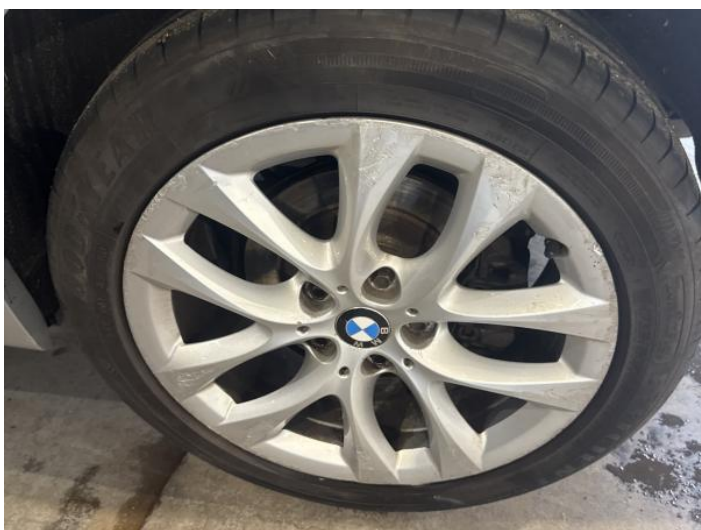
19: Wheel nsr
Scratched
Over 50mm
