VEHICLE INSPECTION REPORT

DA62UDG

Skoda Octavia 1.6 TDI CR SE 5dr

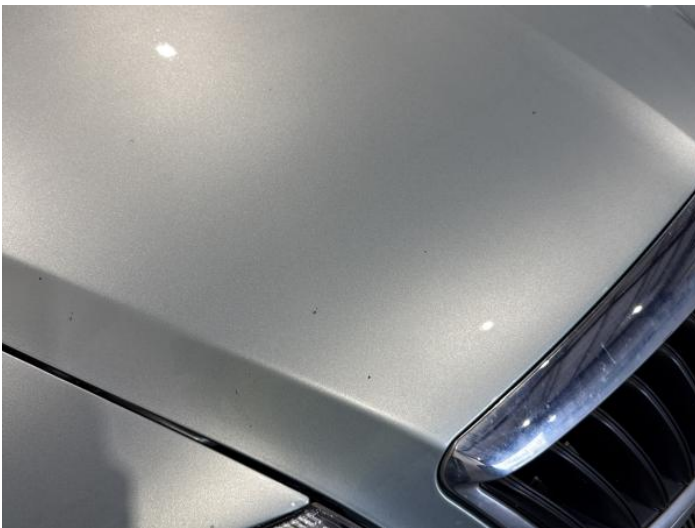
1: Bonnet
Chipped
Multiple Chips

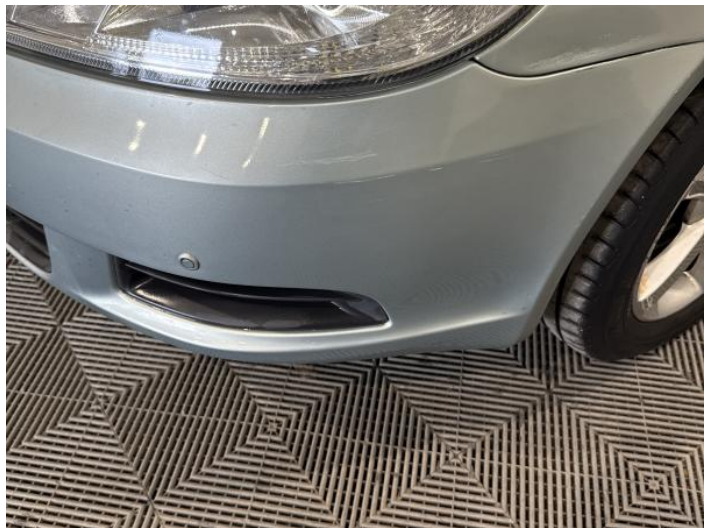
2: Bumper Front
Scratched
Over 100mm Thru Paint

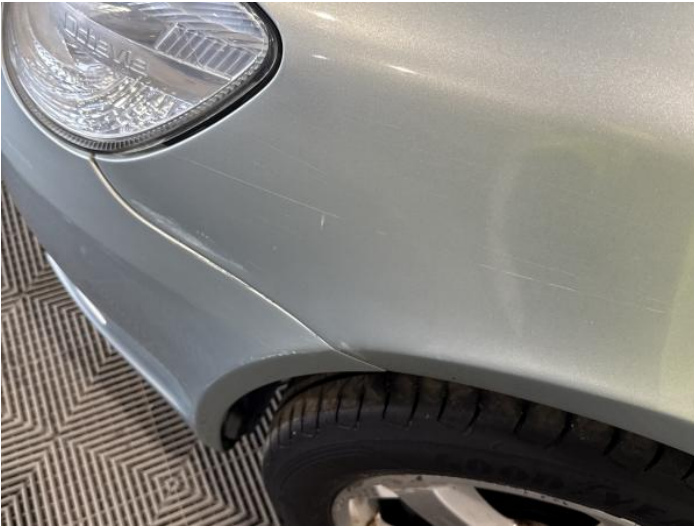
3: Wing nsf
Dented
With Paint Damage

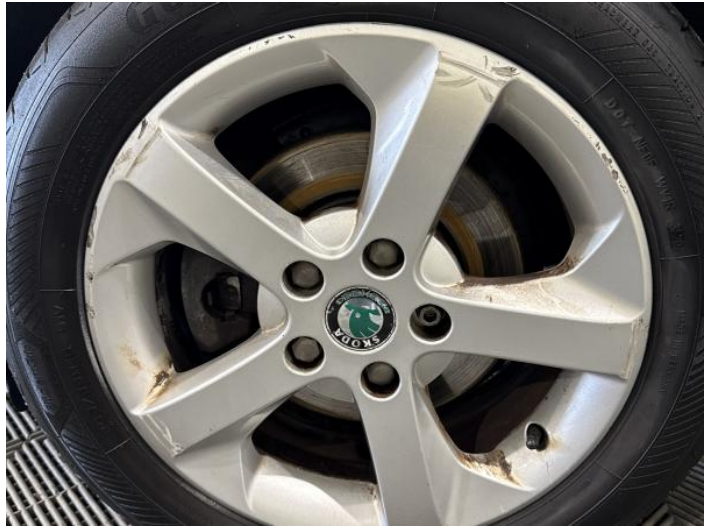
4: Wheel nsf
Scratched
Over 50mm

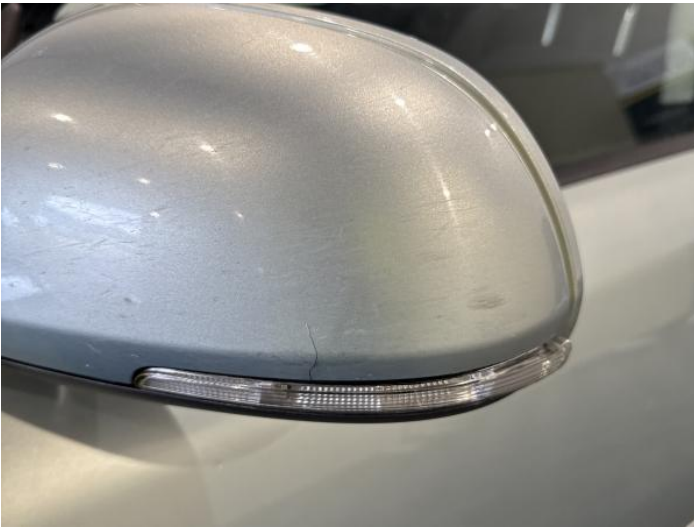
5: Door Mirror Assy nsf
Scratched (Painted)
UpTo 25mm Thru Paint

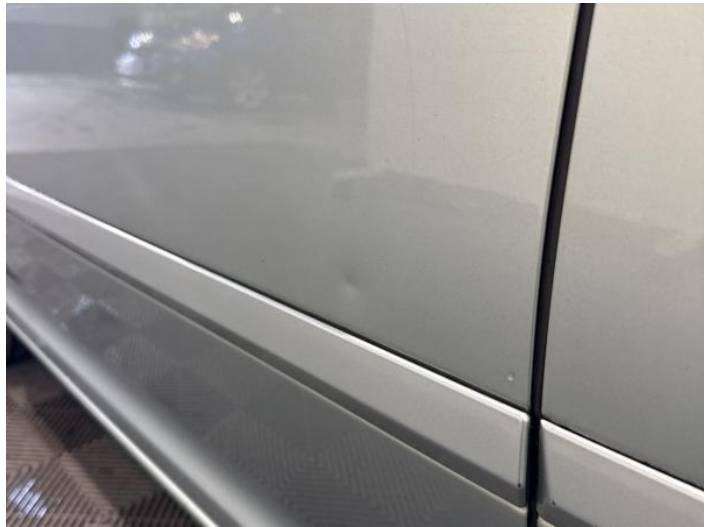
6: Door nsf
Dented
Between 10mm + 30mm

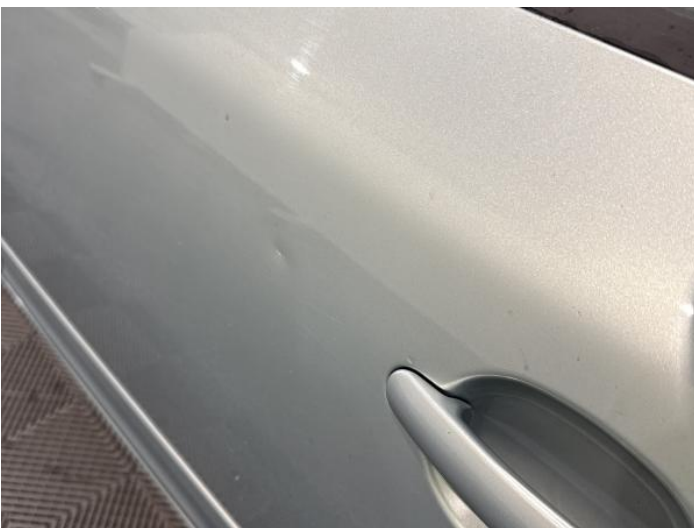
7: Door nsr
Dented
Between 10mm + 30mm

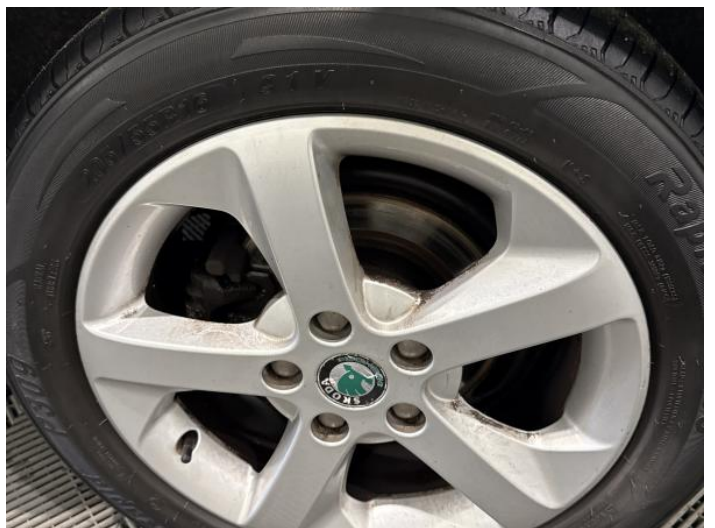
8: Wheel nsr
Scratched
Over 50mm

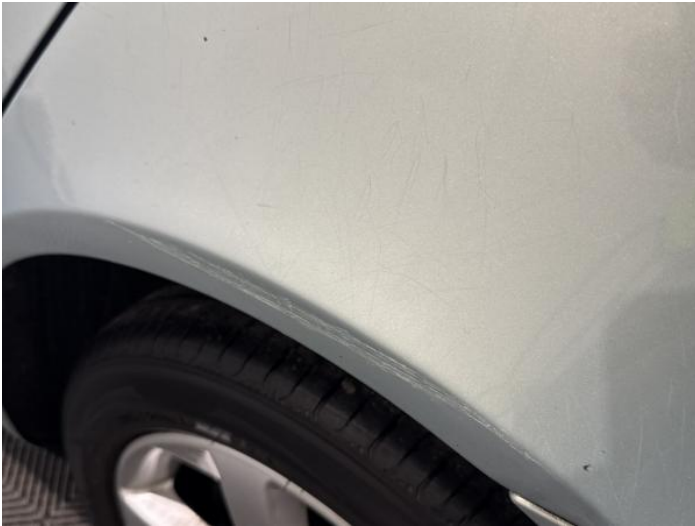
9: Qtr Panel nsr
Dented
With Paint Damage

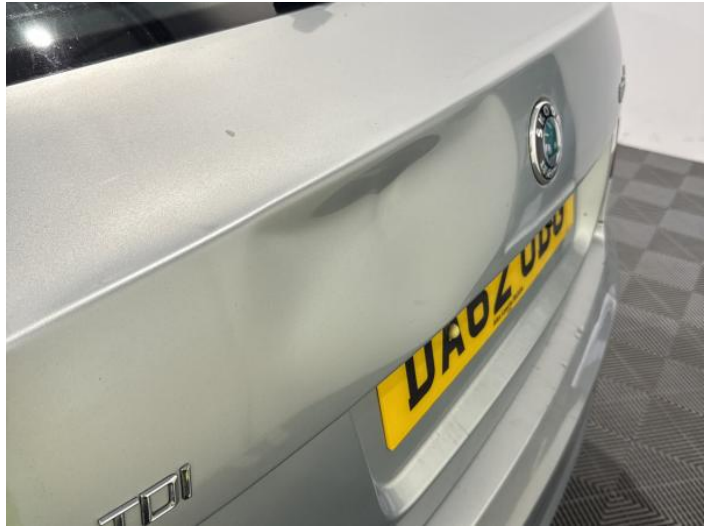
10: Tailgate
Dented
Over 30mm

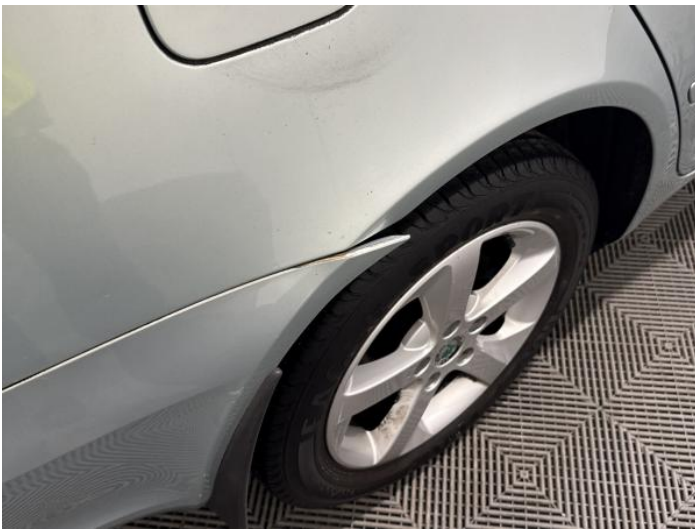
11: Bumper Rear
Dented
With Paint Damage

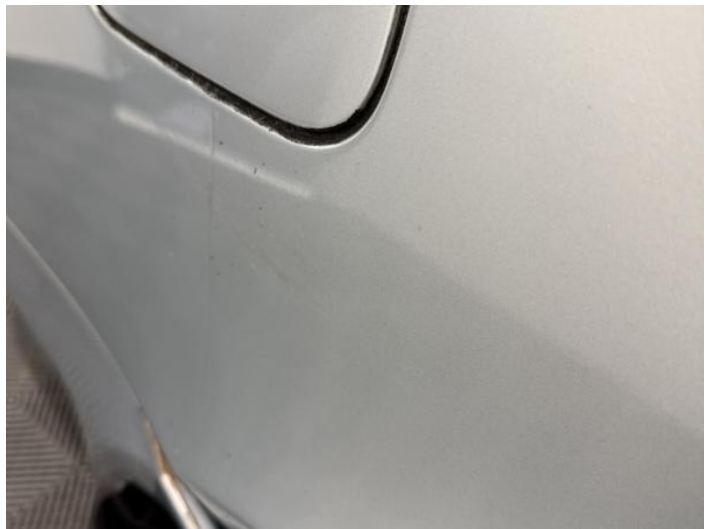
12: Qtr Panel osr
Scratched
Over 25mm Thru Paint

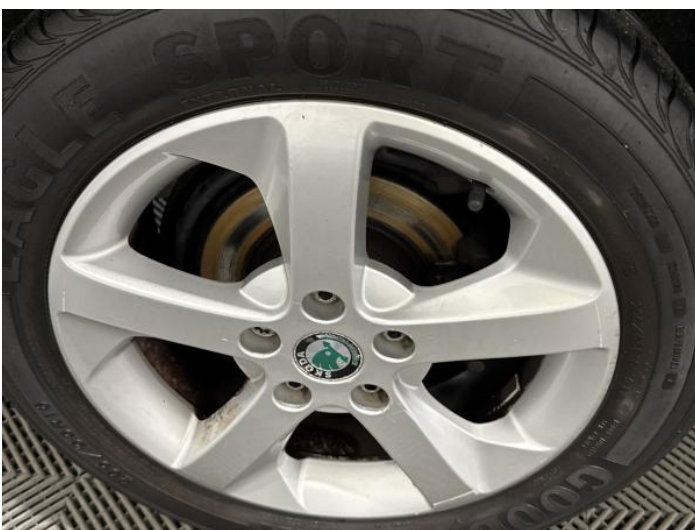
13: Wheel osr
Scratched
Over 50mm

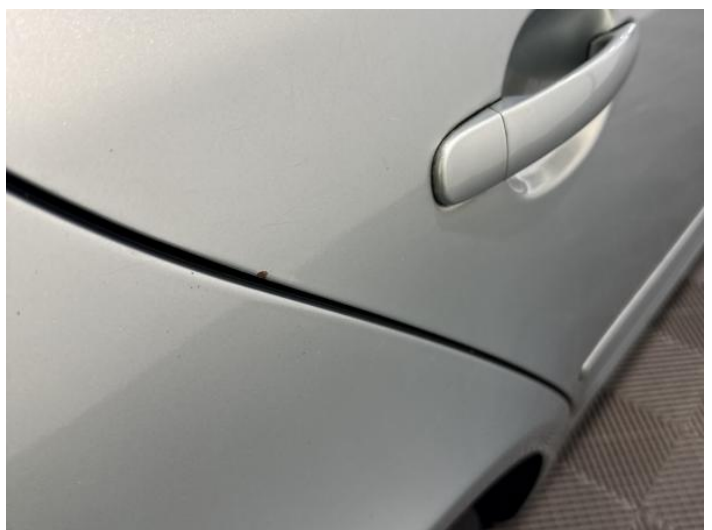
14: Door osr
Scratched
UpTo 25mm Thru Paint

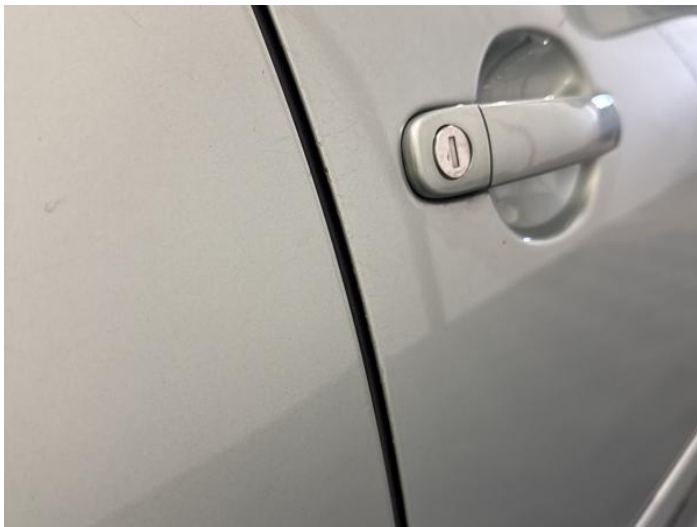
15: Door osf
Chipped
Edge Chip

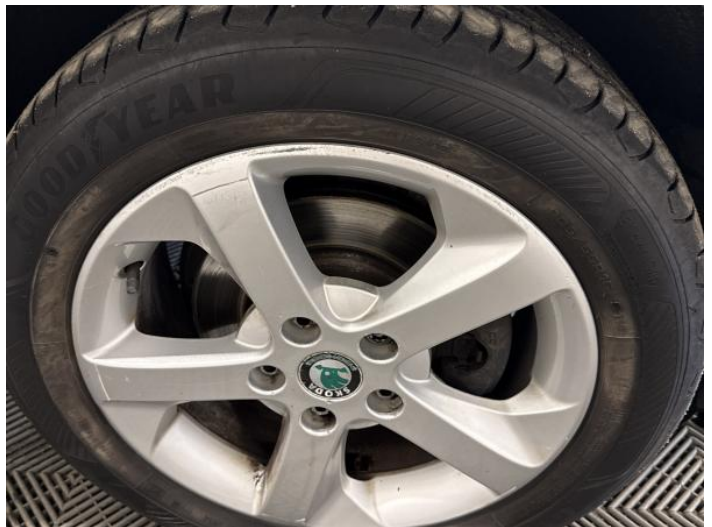
16: Wheel osf
Scratched
Over 50mm
