# VEHICLE INSPECTION REPORT

**YC59OKH**

## Mini Convertible 1.6 Cooper 2dr

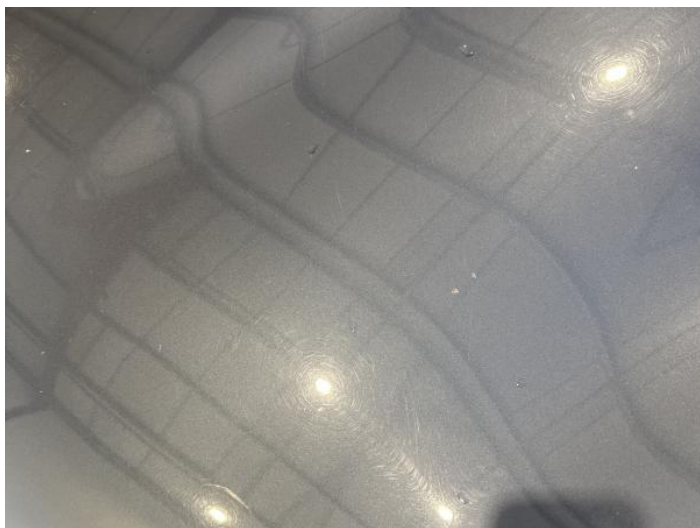
1: Bonnet  
Scratched  
Over 25mm Thru Paint

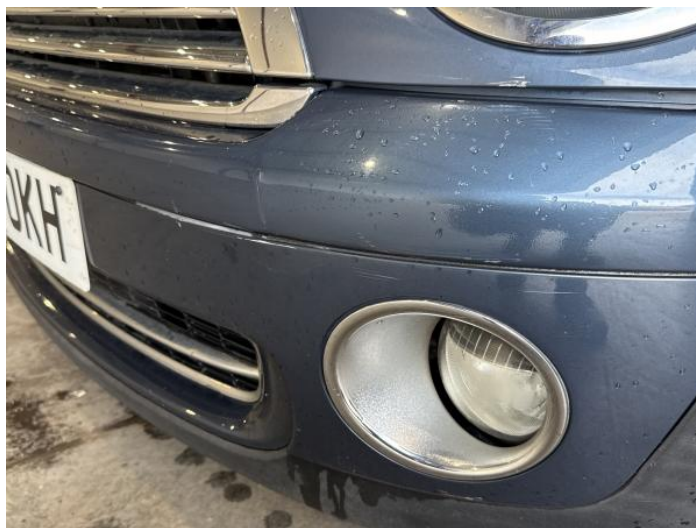
2: Bumper Front  
Scratched  
Over 100mm Thru Paint

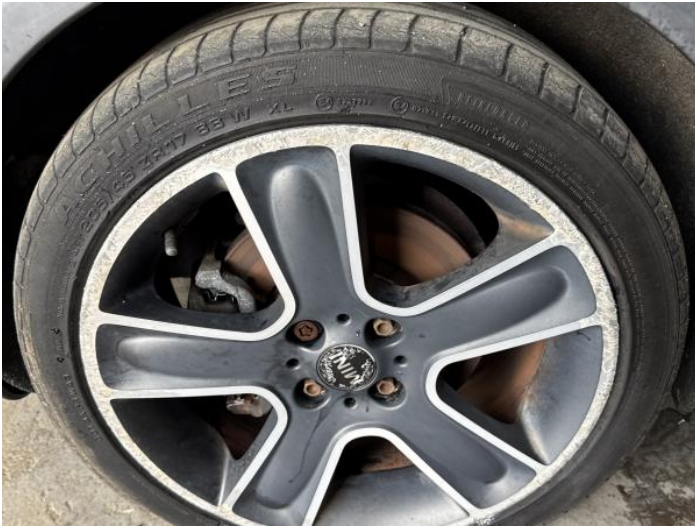
3: Wheel osf  
Scratched  
Over 50mm

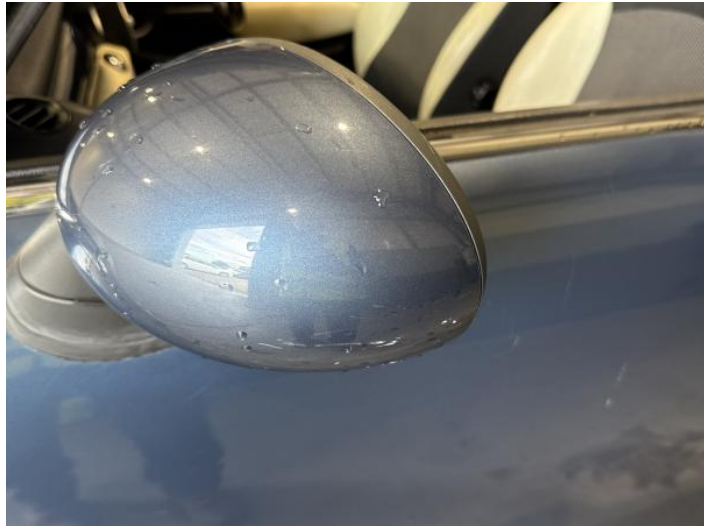
4: Door Mirror Assy nsf  
Scratched (Painted)  
Over 25mm Thru Paint

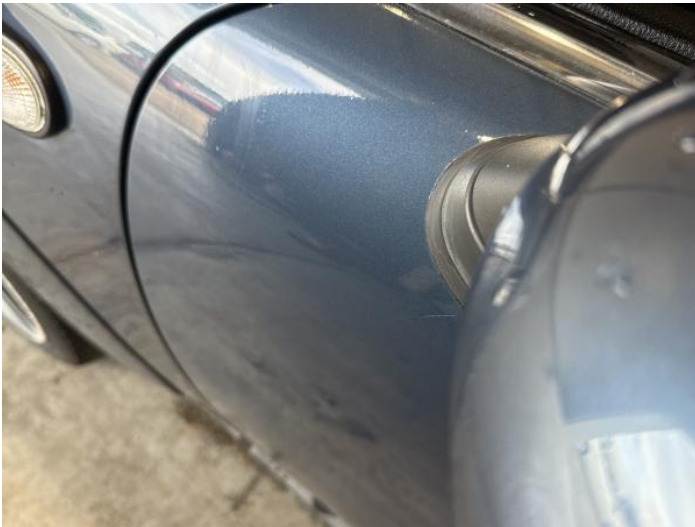
5: Door nsf  
Poor Previous Repair  
Poor Paint

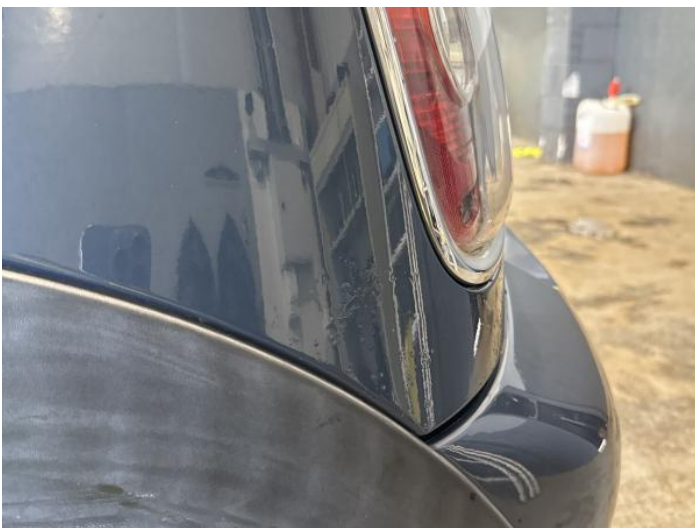
7: Qtr Panel nsr  
Poor Previous Repair  
Rippled UpTo 30%

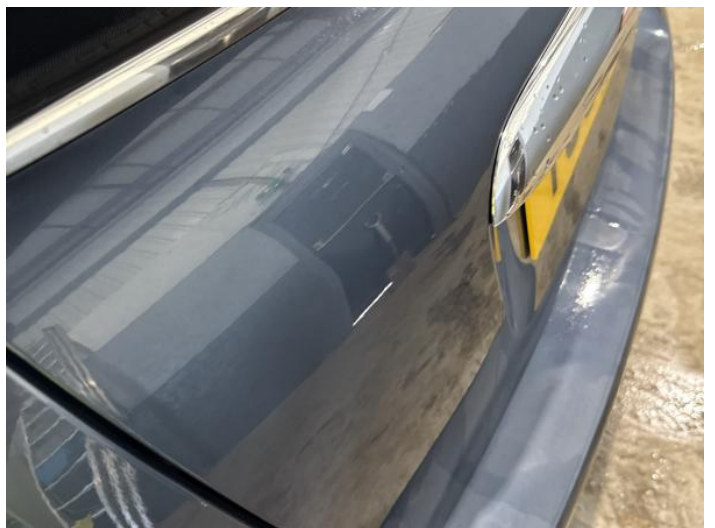
8: Boot Lid  
Dented  
Between 10mm + 30mm

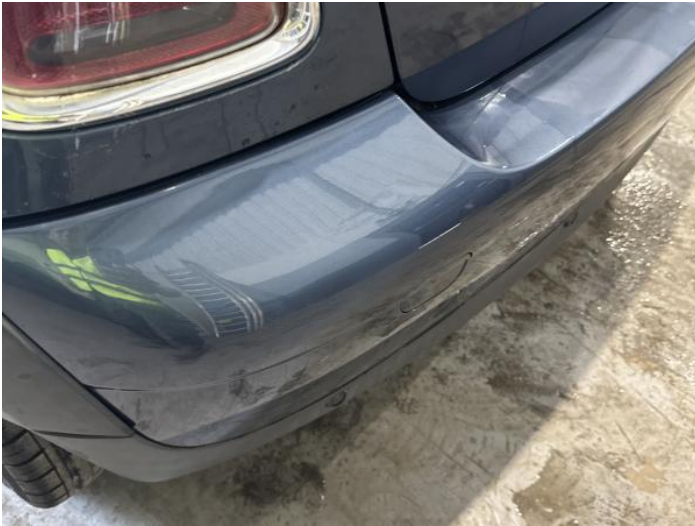
9: Bumper Rear  
Scratched  
Up To 25mm Thru Paint

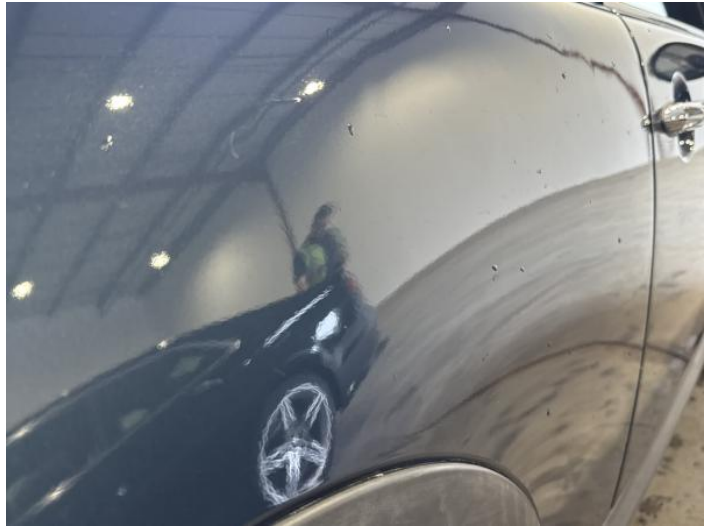
10: Qtr Panel osr  
Poor Previous Repair  
Rippled UpTo 30%

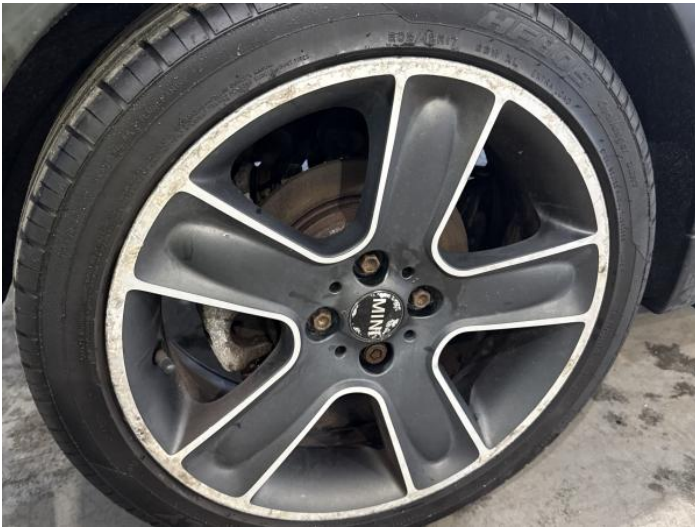
11: Wheel osr  
Scratched  
Over 50mm

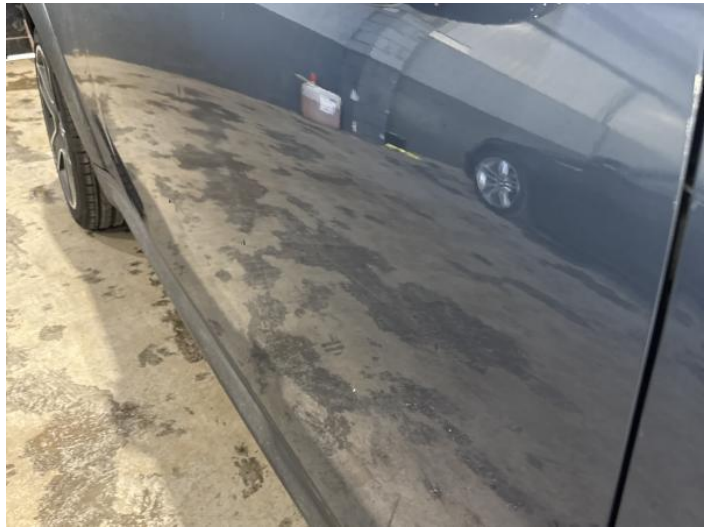
12: Door osf  
Poor Previous Repair  
Rippled UpTo 30%

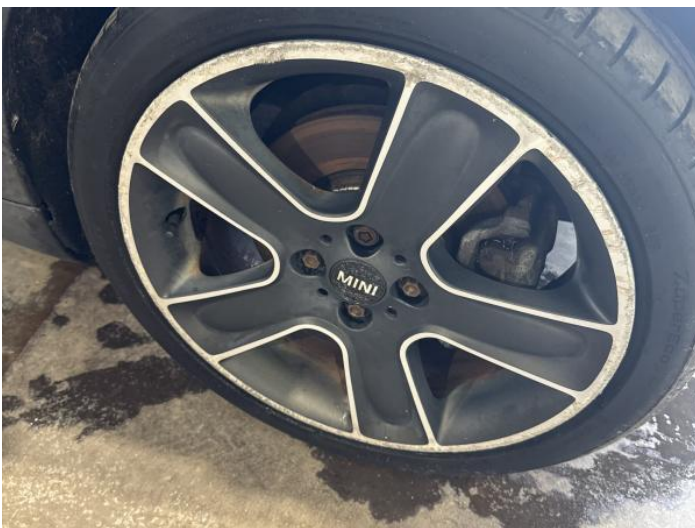
13: Wheel osf  
Scratched  
Over 50mm

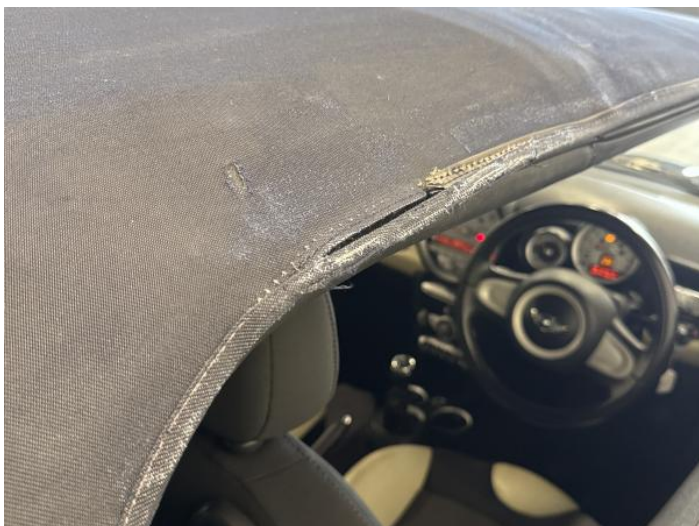
15: Roof Soft Top  
Scuffed  
Over 25mm

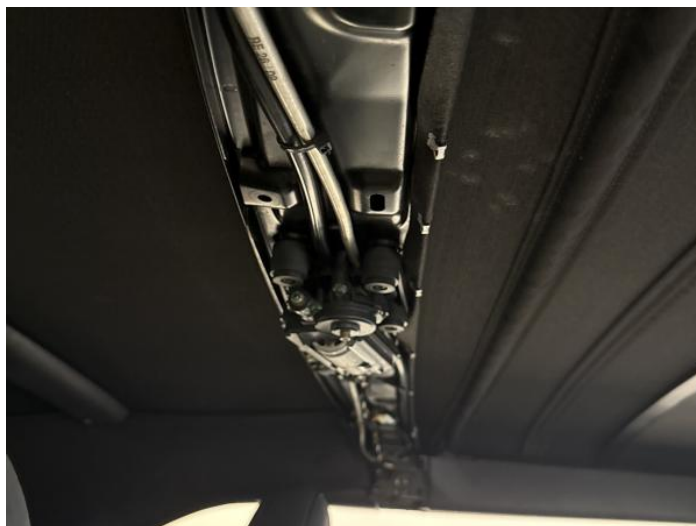
16: Fascia Panel  
Missing  
Replace
