VEHICLE INSPECTION REPORT

WV09MYM

Nissan Note 1.4 Acenta 5dr

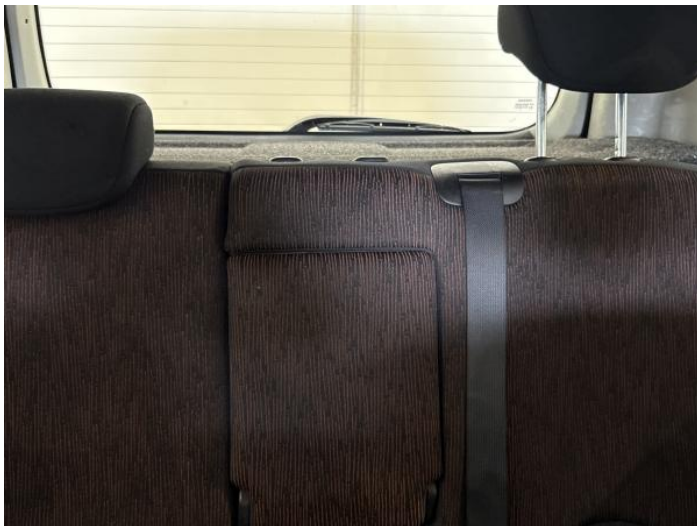
1: Headrest Assy Rear Seat Centr
Missing
Replace

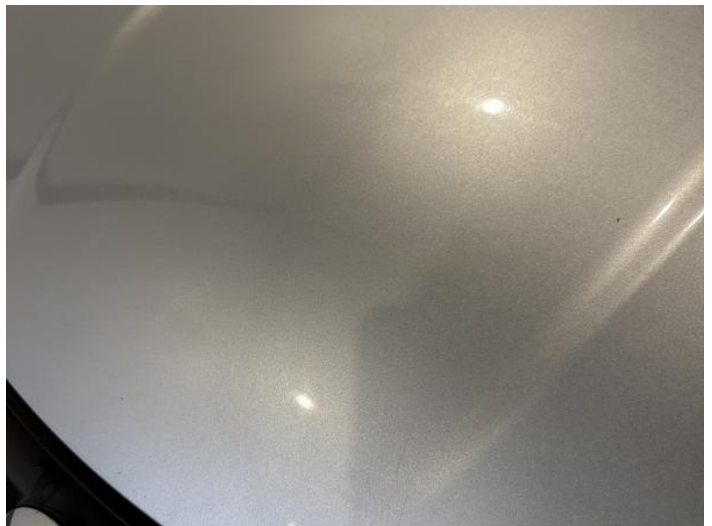
2: Bonnet
Dented
Over 30mm

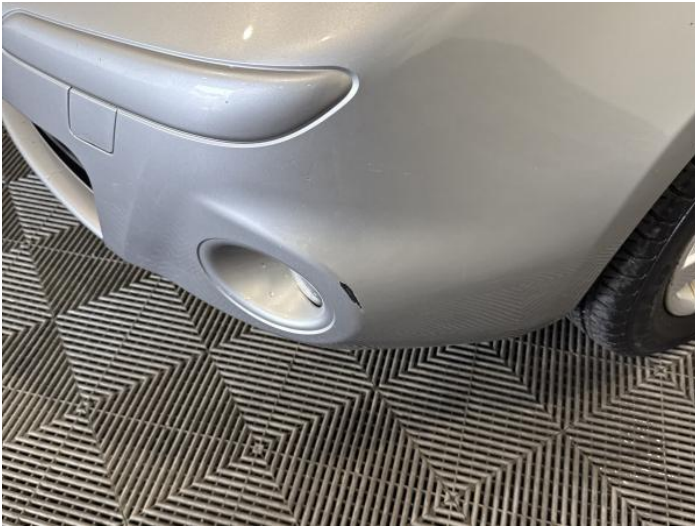
3: Bumper Front
Scratched
Over 100mm Thru Paint

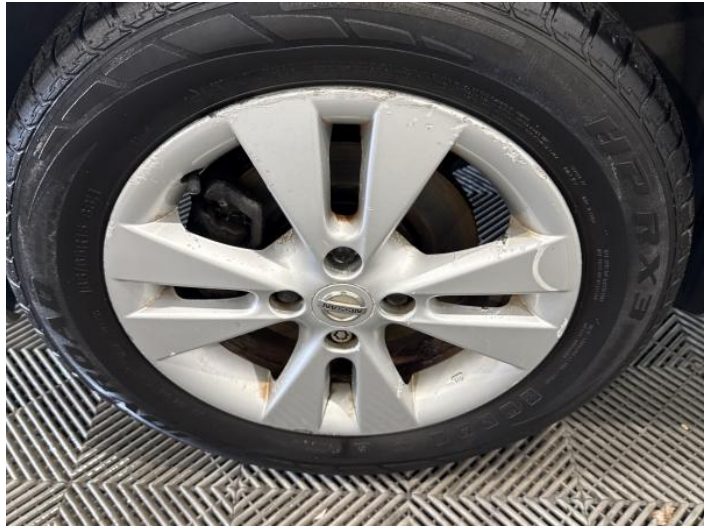
4: Wheel nsf
Scratched
Over 50mm

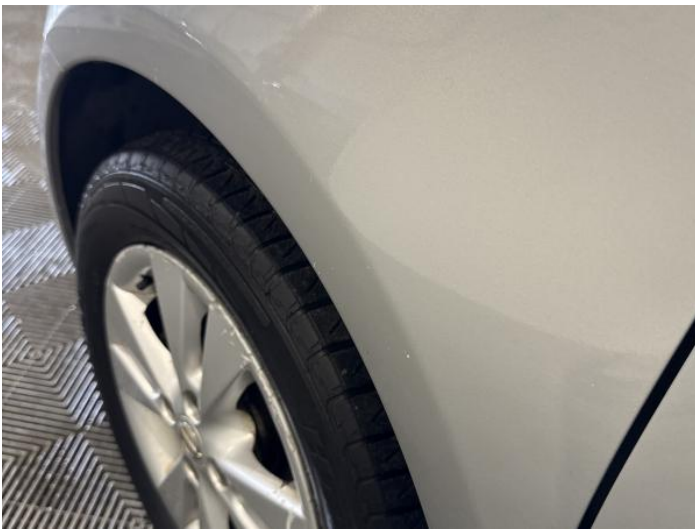
5: Wing nsf
Chipped
Multiple Chips

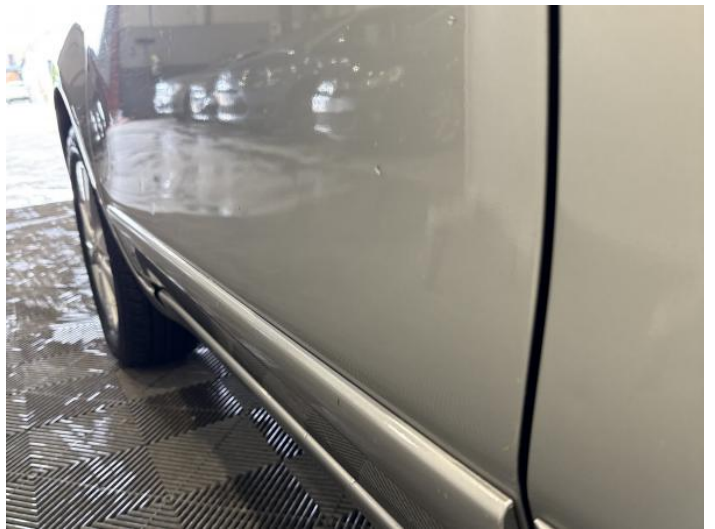
6: Door nsf
Dented
Over 30mm

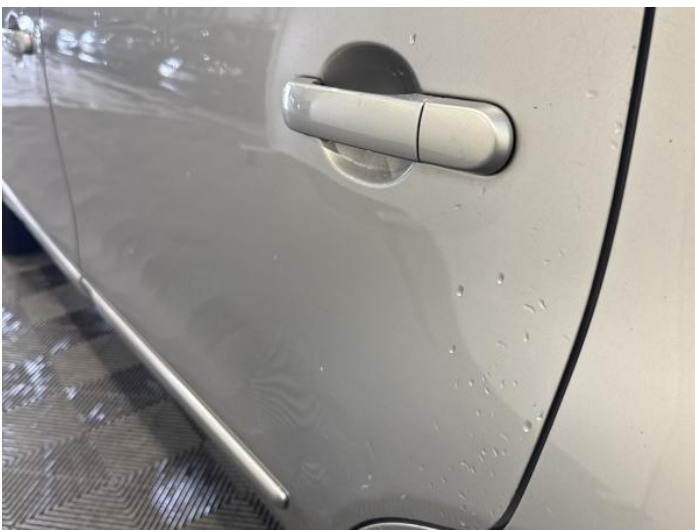
7: Door nsr
Dented
Over 30mm

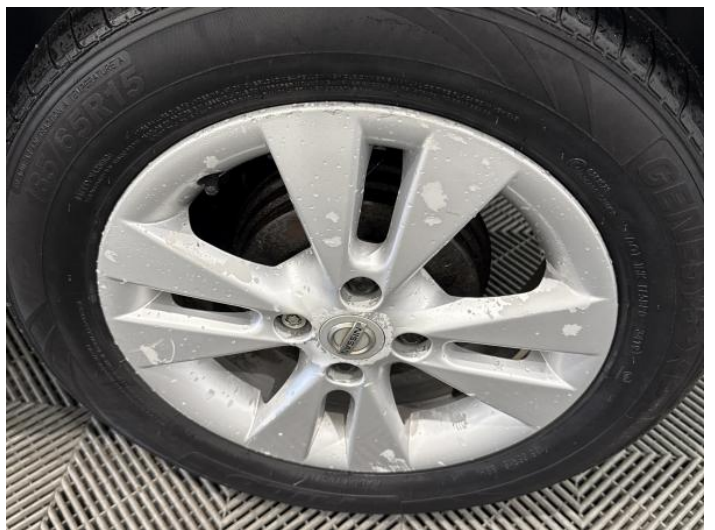
8: Wheel nsr
Scratched
Over 50mm

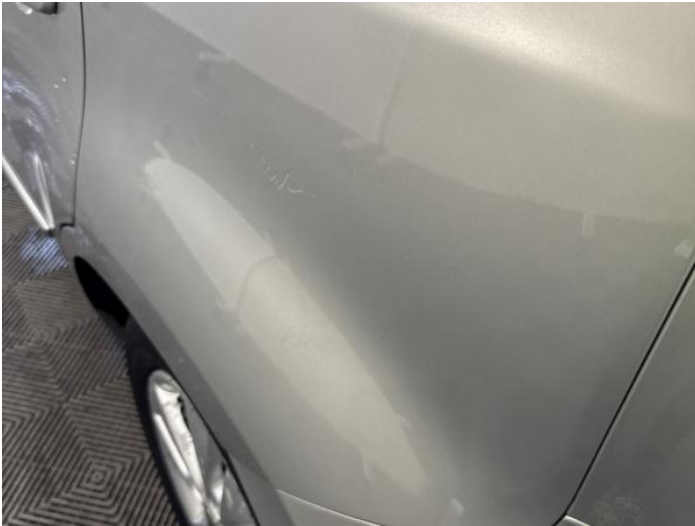
9: Qtr Panel nsr
Scratched
Over 25mm Thru Paint

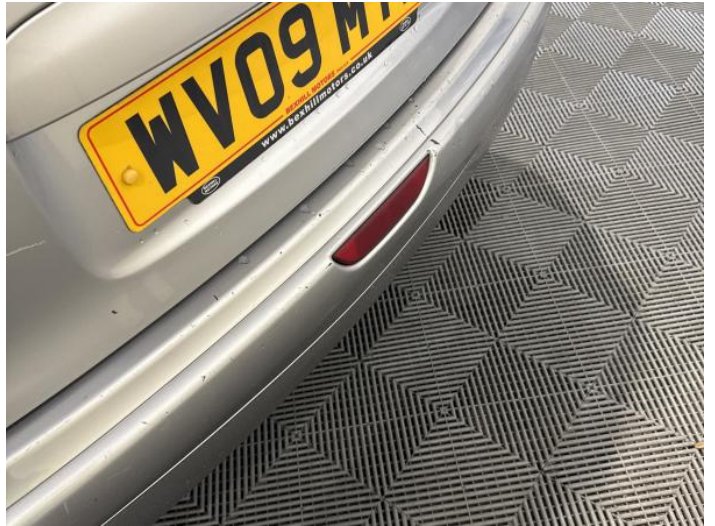
10: Bumper Rear
Dented
With Paint Damage

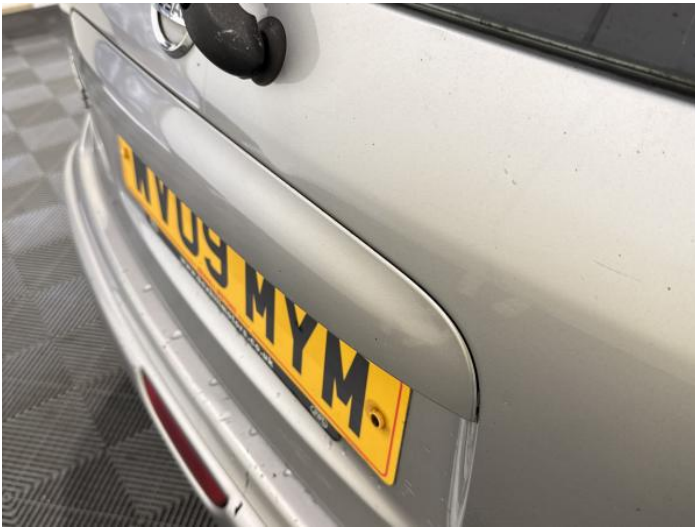
11: Tailgate
Dented
Over 30mm

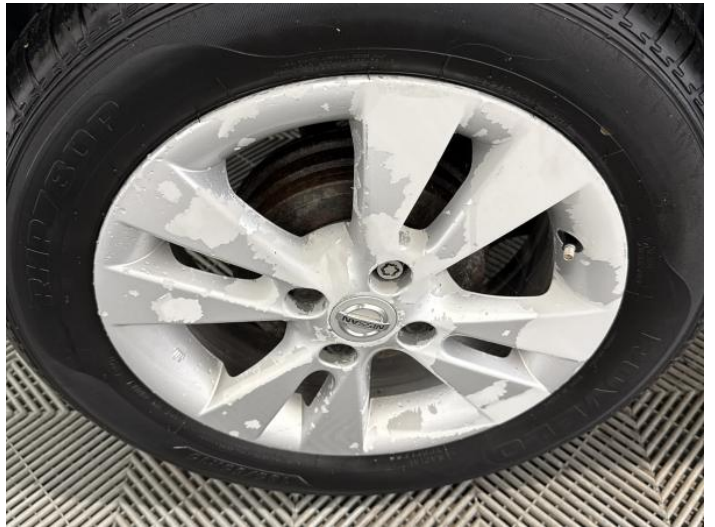
12: Wheel osr
Scratched
Over 50mm

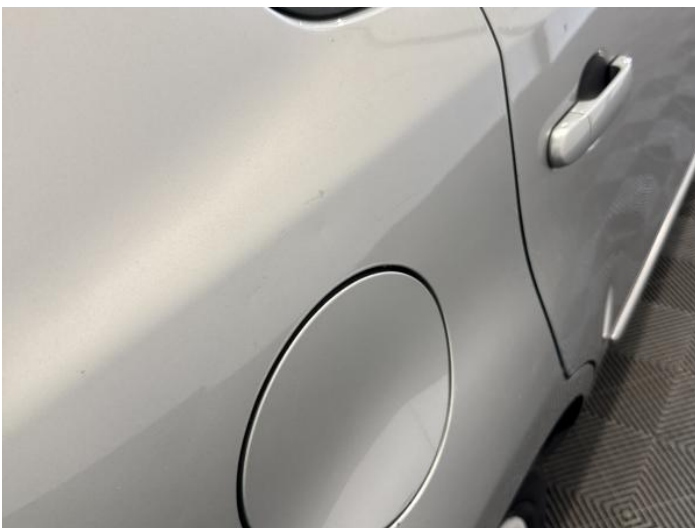
13: Qtr Panel osr
Dented
Between 10mm + 30mm

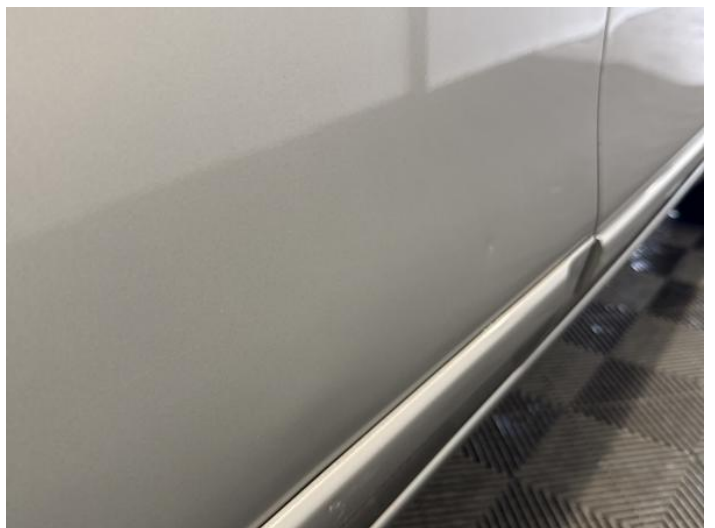
14: Door osr
Dented
Between 10mm + 30mm

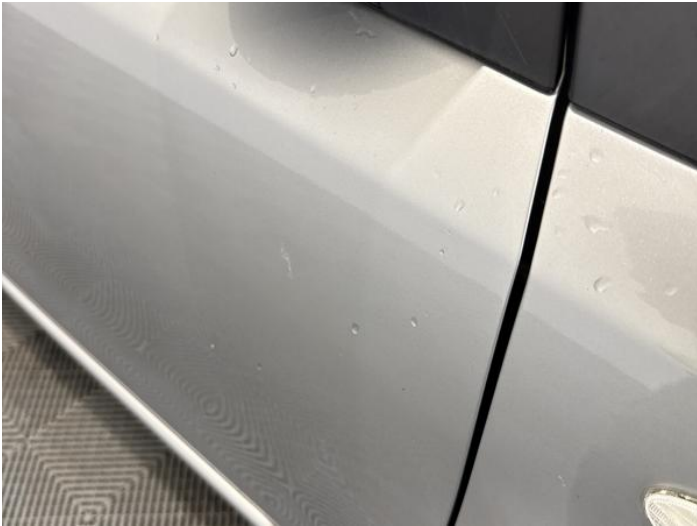
15: Door osf
Dented
Between 10mm + 30mm

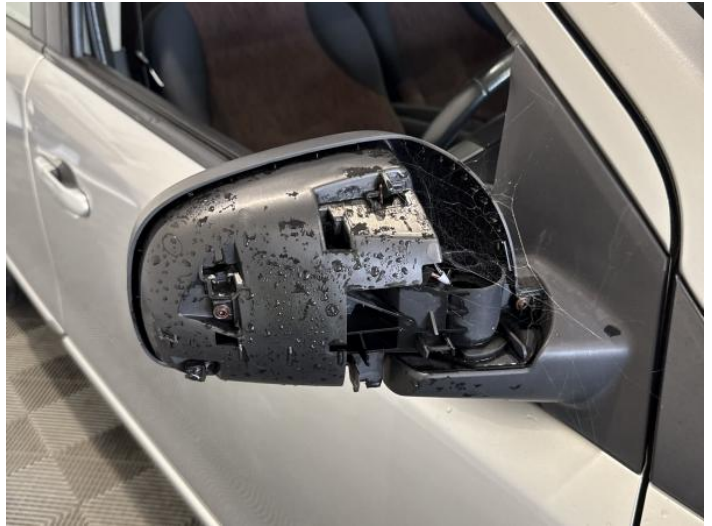
16: Door Mirror Assy osf
Missing
Replace

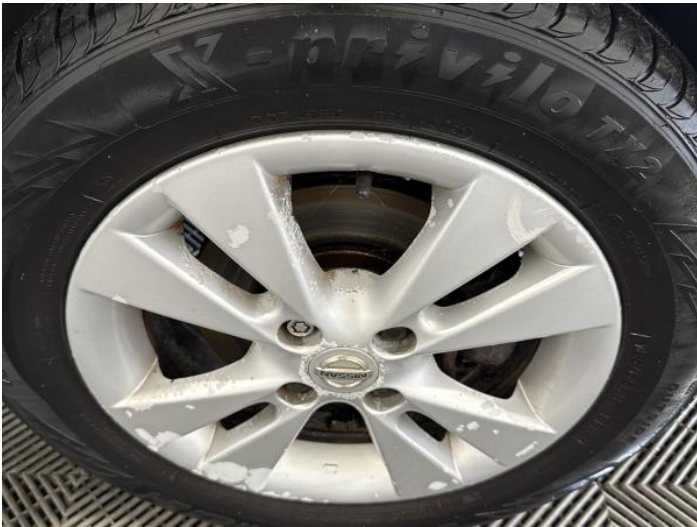
17: Wheel osf
Scratched
Over 50mm

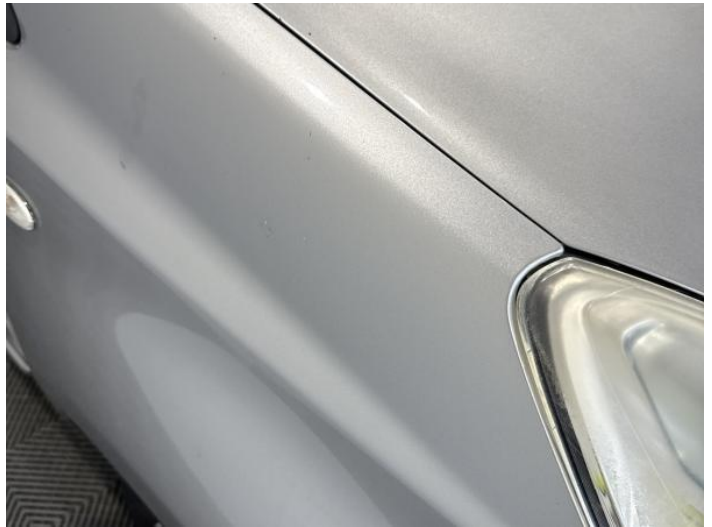
18: Wing osf
Chipped
1 To 5
