# VEHICLE INSPECTION REPORT

**KS11GYT**

## Peugeot 3008 1.6 HDi 112 Exclusive 5dr EGC

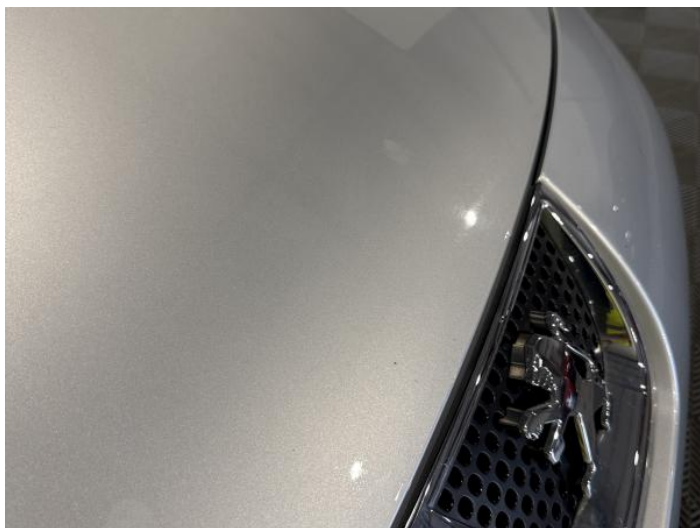
1: Bonnet  
Chipped  
1 To 5

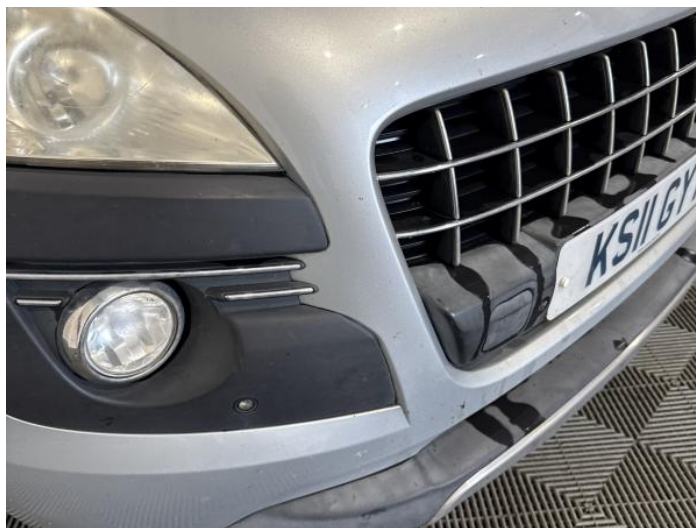
2: Bumper Front  
Scratched  
Over 100mm Thru Paint

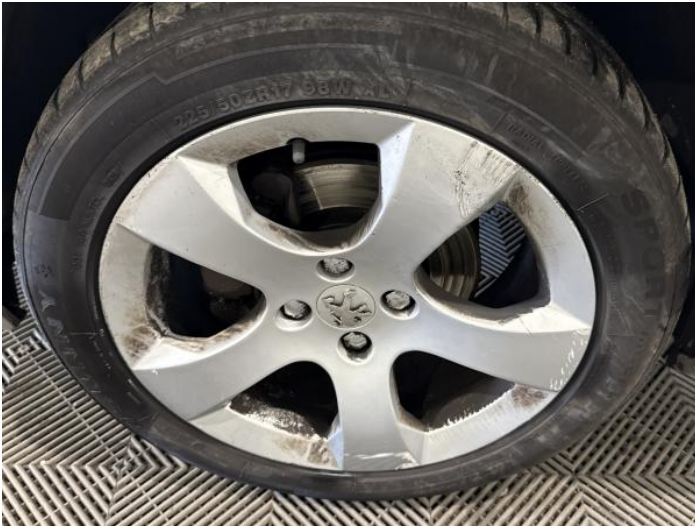
3: Wheel nsf  
Scratched  
Over 50mm

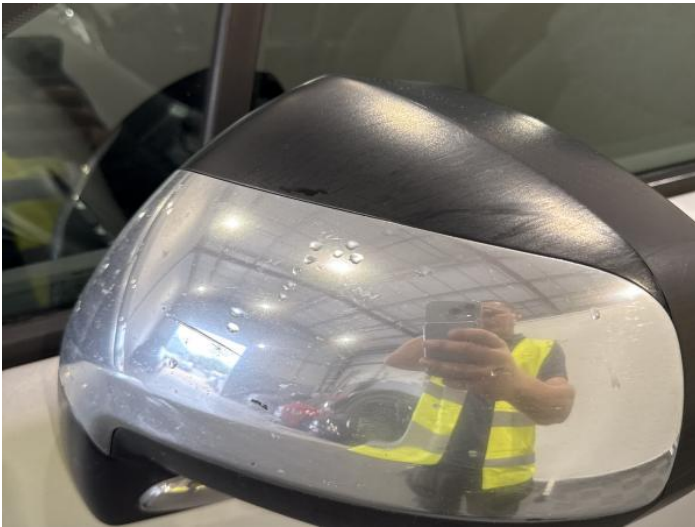
5: Door Mirror Assy nsf  
Scratched (Painted)  
Over 25mm Thru Paint

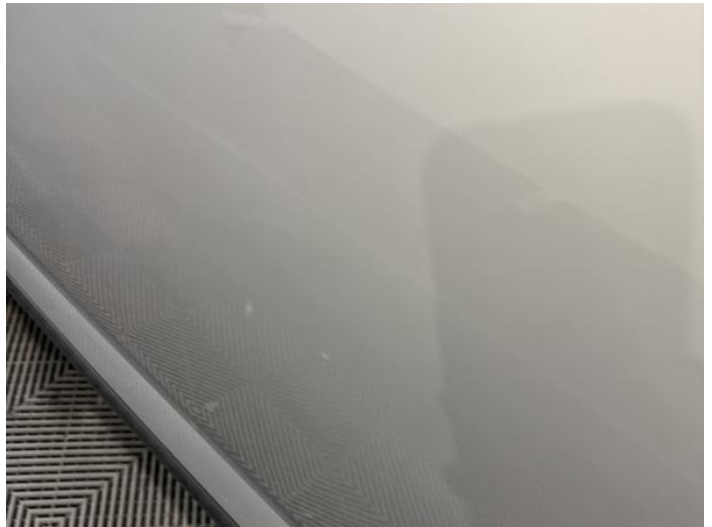
6: Door nsf  
Scratched  
UpTo 25mm Thru Paint

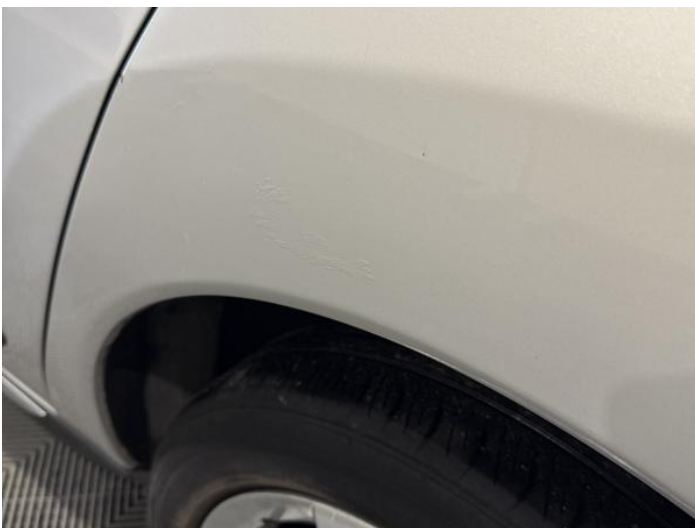
7: Qtr Panel nsr  
Poor Previous Repair  
Rippled UpTo 30%

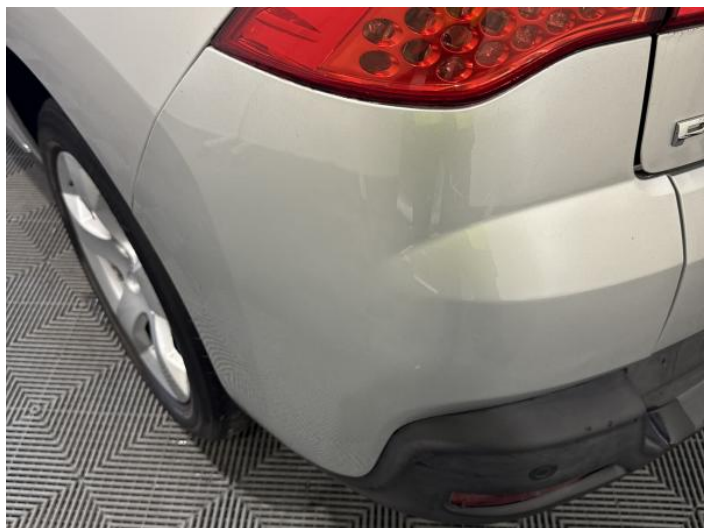
8: Bumper Rear  
Scratched  
Over 100mm Thru Paint

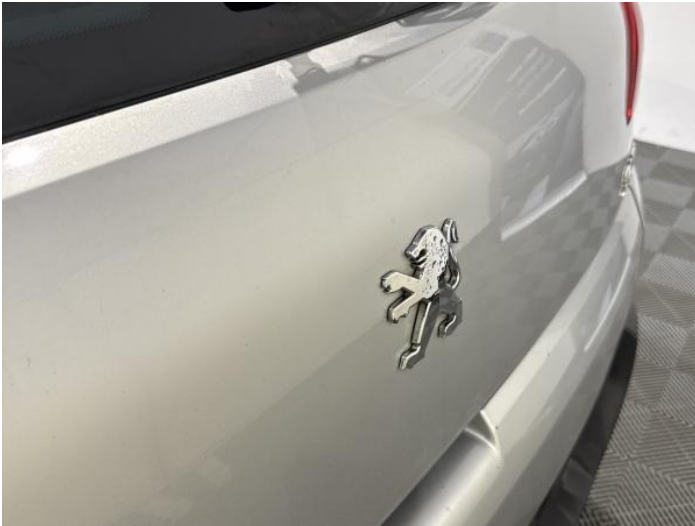
9: Tailgate  
Dented  
Between 10mm + 30mm

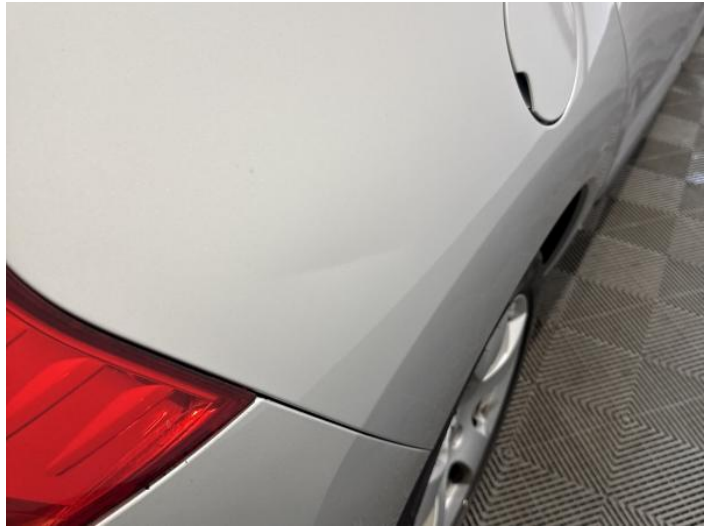
10: Qtr Panel osr  
Dented  
Over 30mm

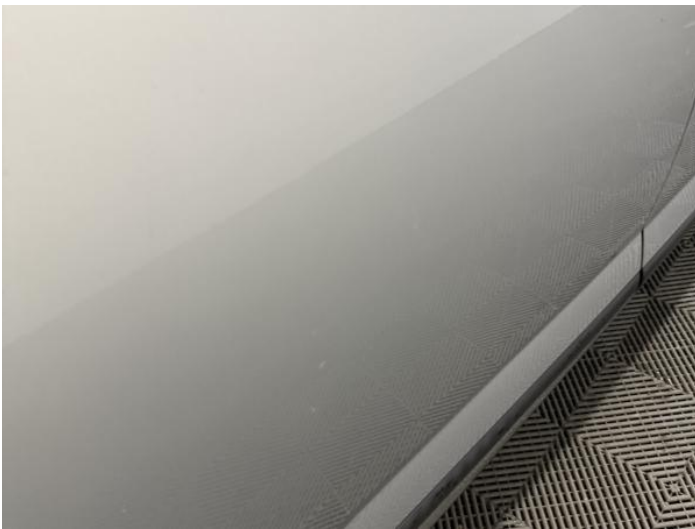
11: Door osr  
Scratched  
UpTo 25mm Thru Paint

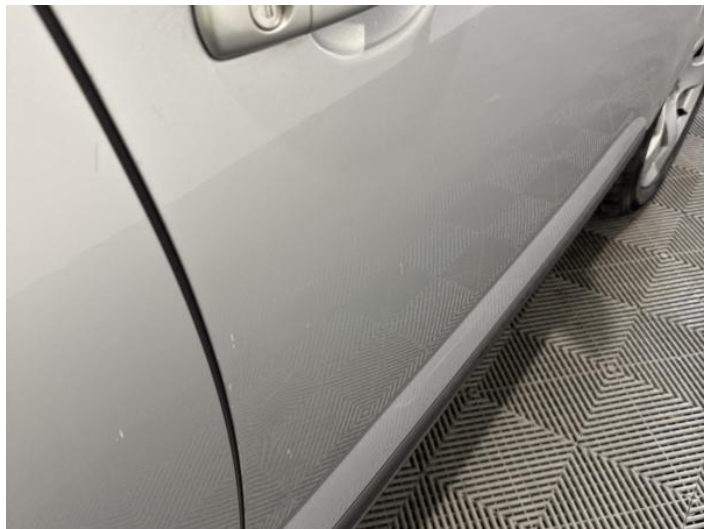
12: Door osf  
Scratched  
Over 25mm Thru Paint

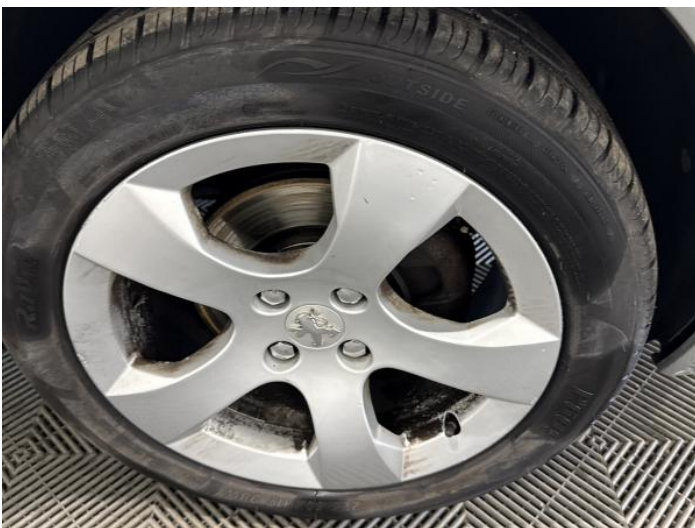
13: Wheel osf  
Scratched  
Over 50mm
