# VEHICLE INSPECTION REPORT

**GL10GHU**

## Volkswagen Golf 1.6 TDi 105 SE 5dr

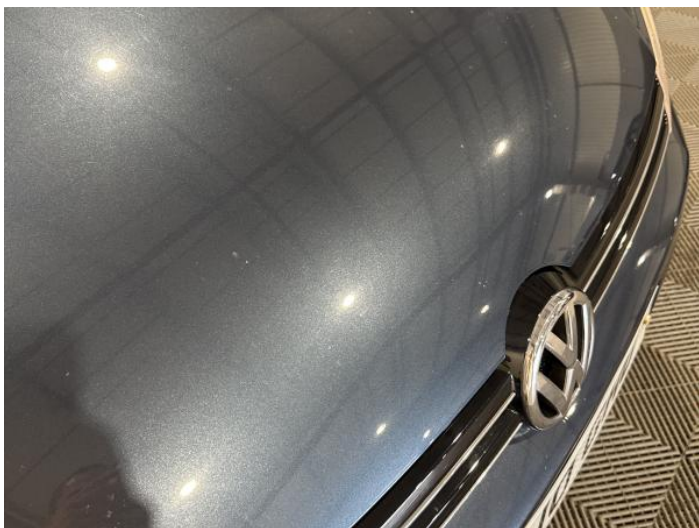
1: Bonnet  
Chipped  
Multiple Chips

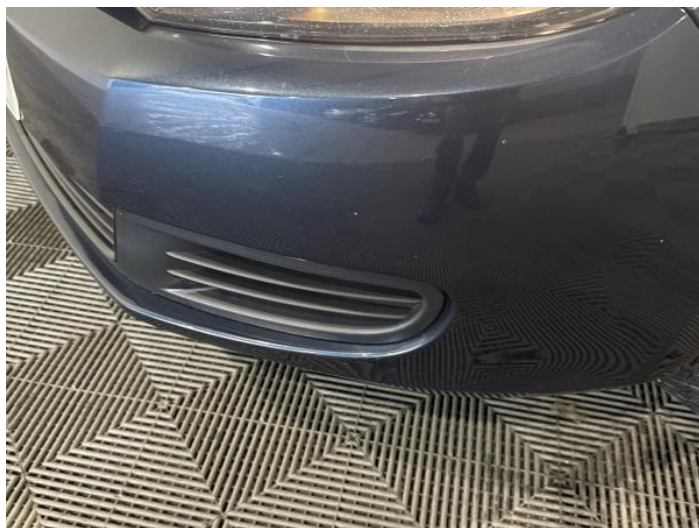
2: Bumper Front  
Chipped  
Multiple Chips

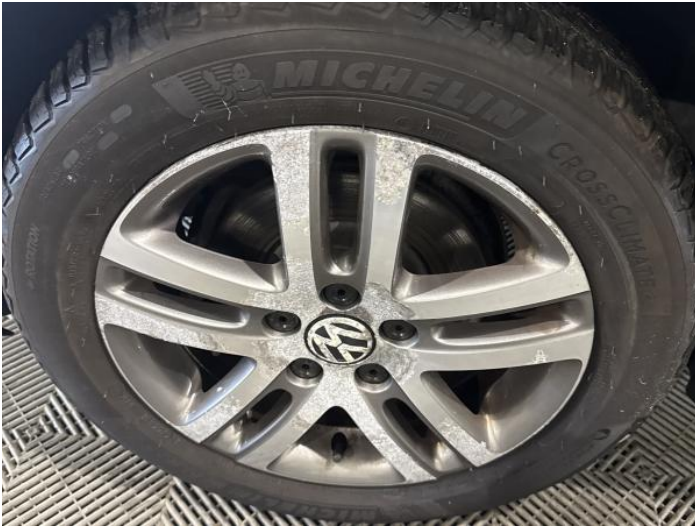
3: Wheel nsf  
Scratched  
Over 50mm

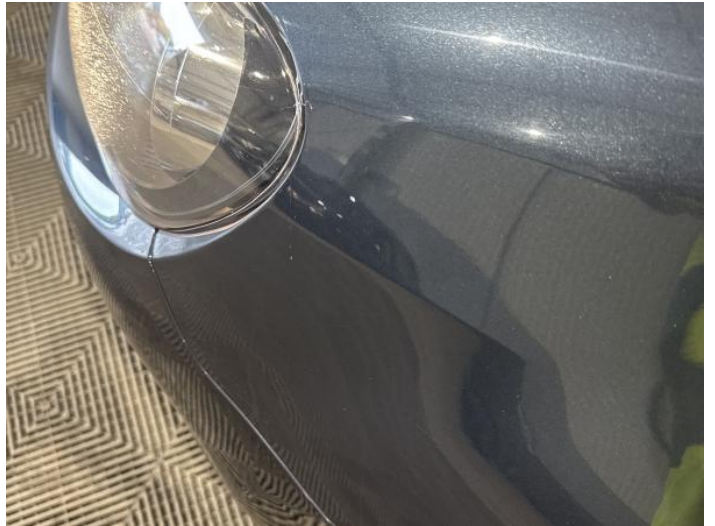
4: Wing nsf  
Chipped  
1 To 5

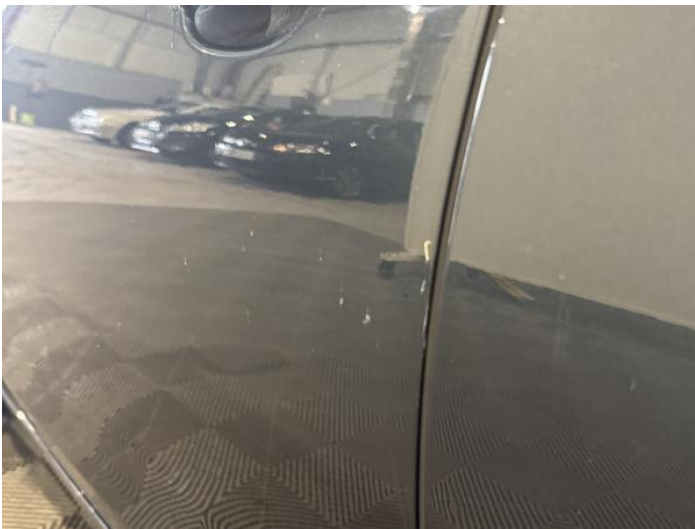
5: Door nsf  
Dented  
Between 10mm + 30mm

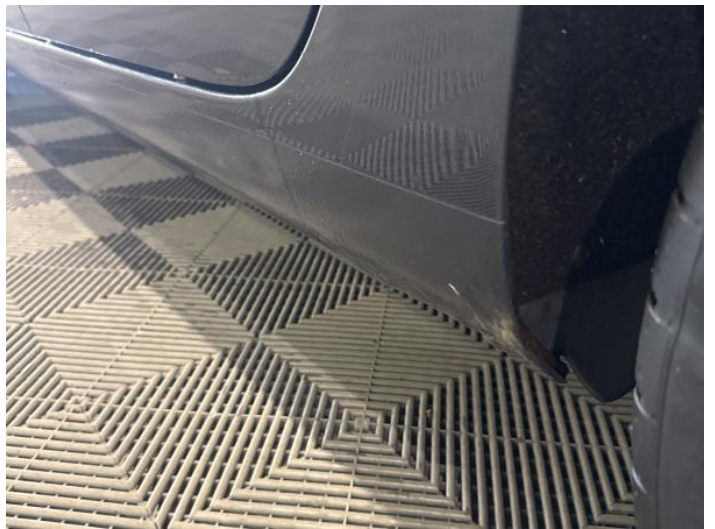
6: Sill ns  
Dented  
Over 30mm

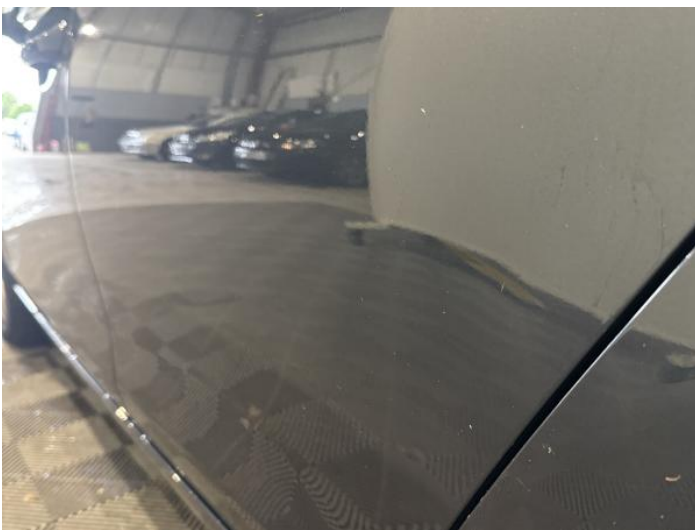
7: Door nsr  
Dented  
Over 30mm

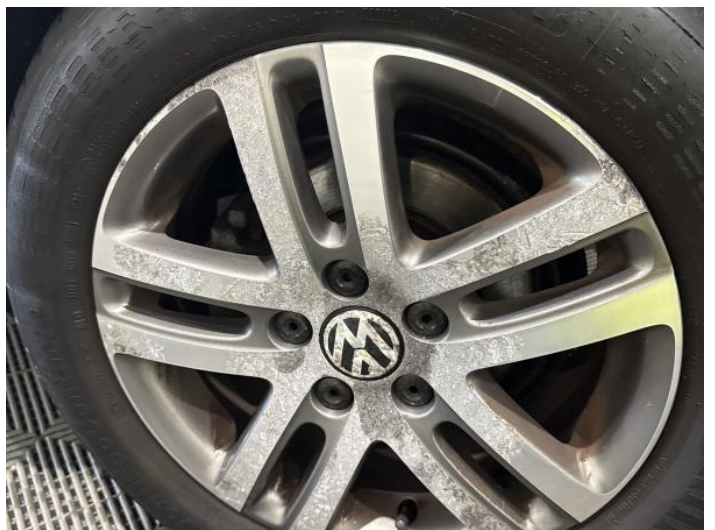
8: Wheel nsr  
Scratched  
Over 50mm

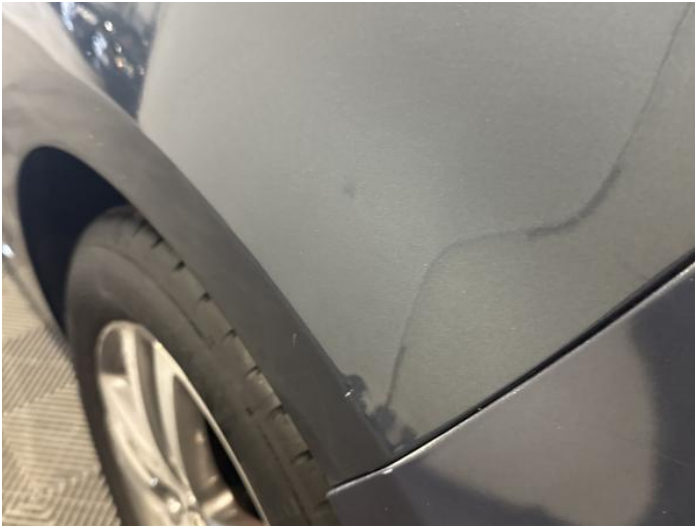
9: Qtr Panel nsr  
Dented  
Between 10mm + 30mm

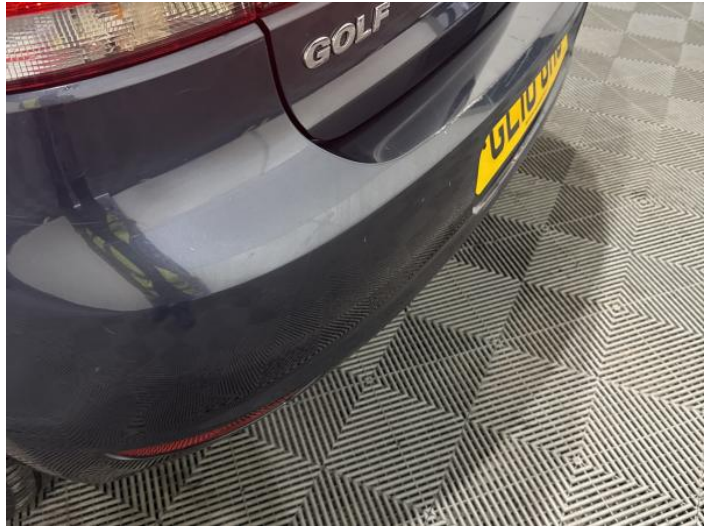
10: Bumper Rear  
Scratched  
Over 100mm Thru Paint

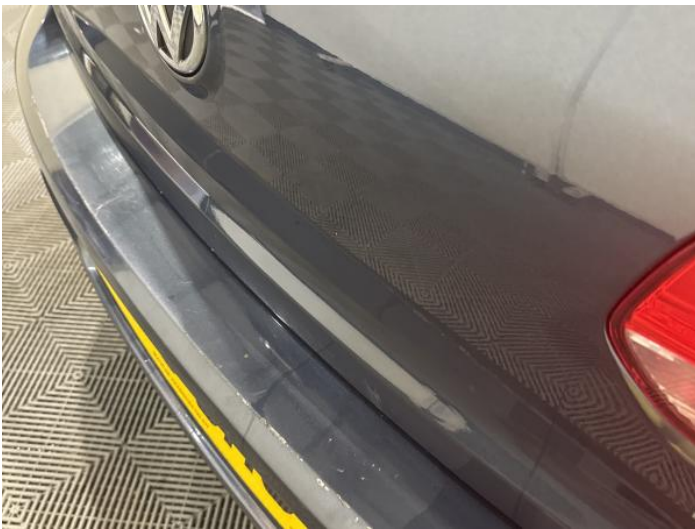
11: Tailgate  
Scratched  
Over 25mm Thru Paint

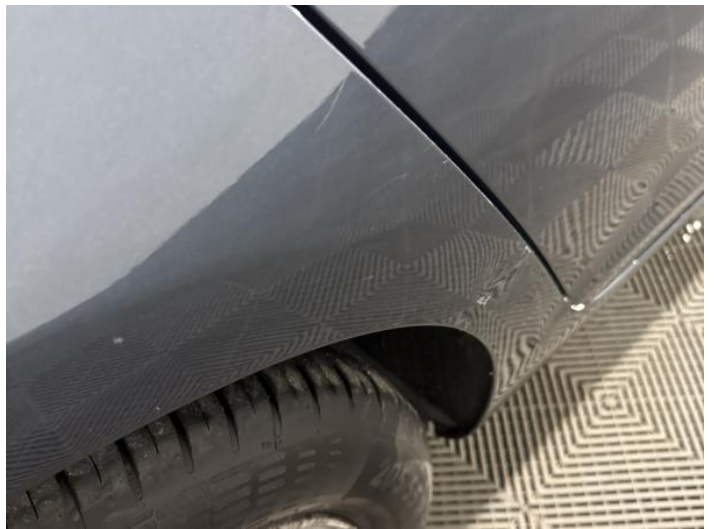
12: Qtr Panel osr  
Dented  
With Paint Damage

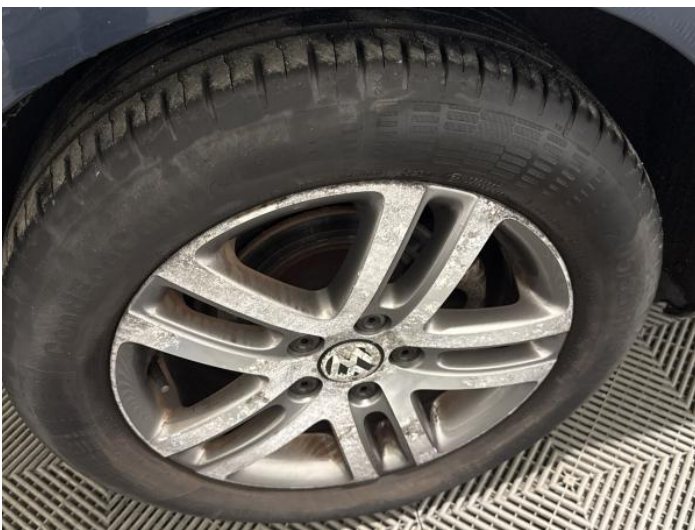
13: Wheel osr  
Scratched  
Over 50mm

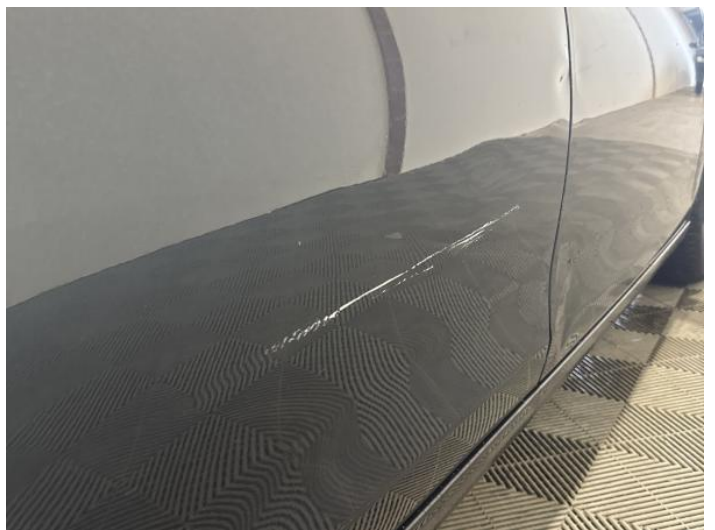
14: Door osr  
Dented  
With Paint Damage

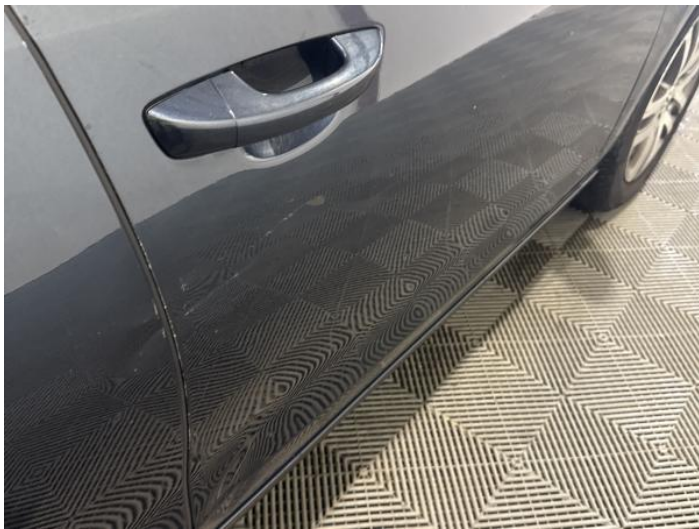
15: Door osf  
Dented  
Over 30mm

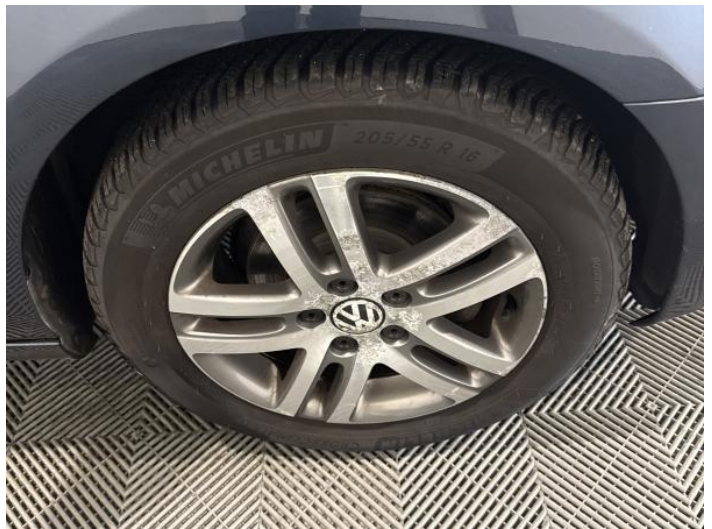
16: Wheel osf  
Scratched  
Over 50mm

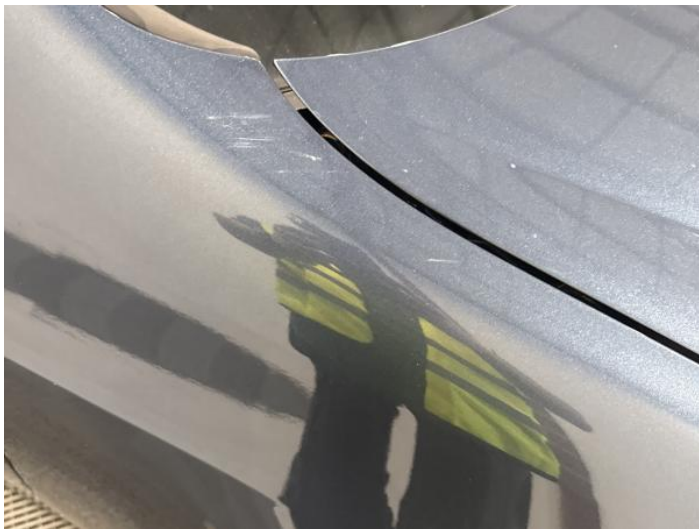
17: Wing osf  
Scratched  
Over 25mm Thru Paint

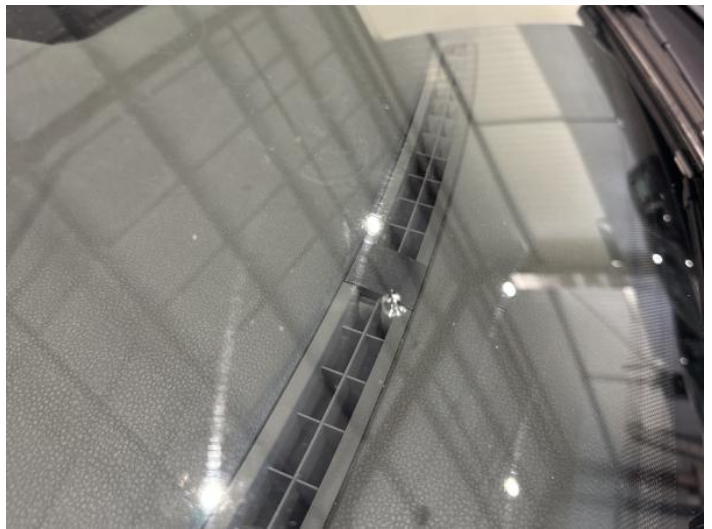
18: Screen Front  
Chipped  
UpTo 10mm
