VEHICLE INSPECTION REPORT

AP68KUS

Honda Civic 1.0 VTEC Turbo 126 Sport Line 5dr

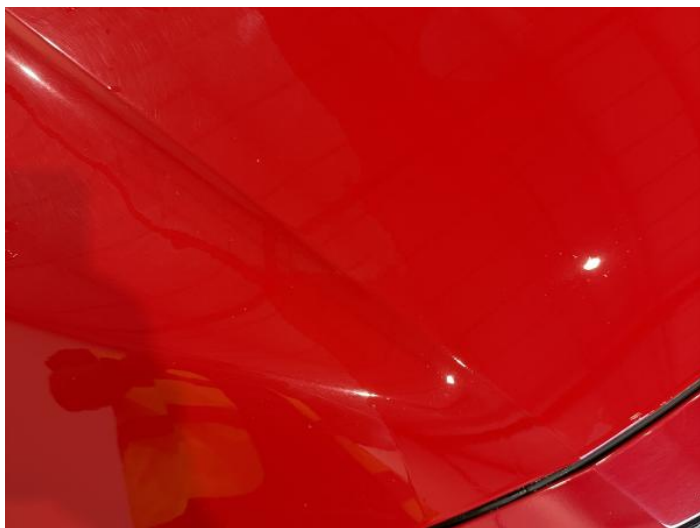
1: Bonnet
Chipped
1 To 5

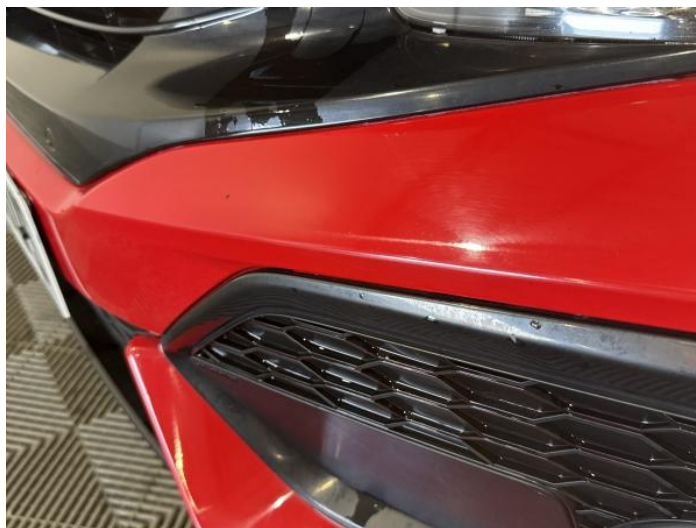
2: Bumper Front
Chipped
1 To 5

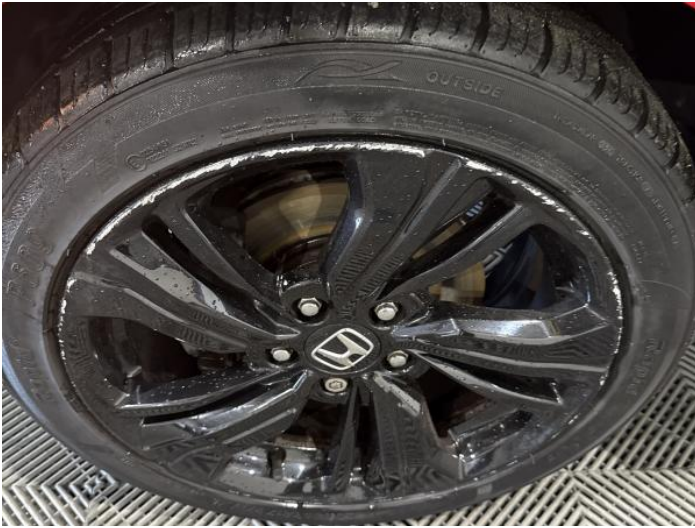
3: Wheel osf
Scratched
Over 50mm

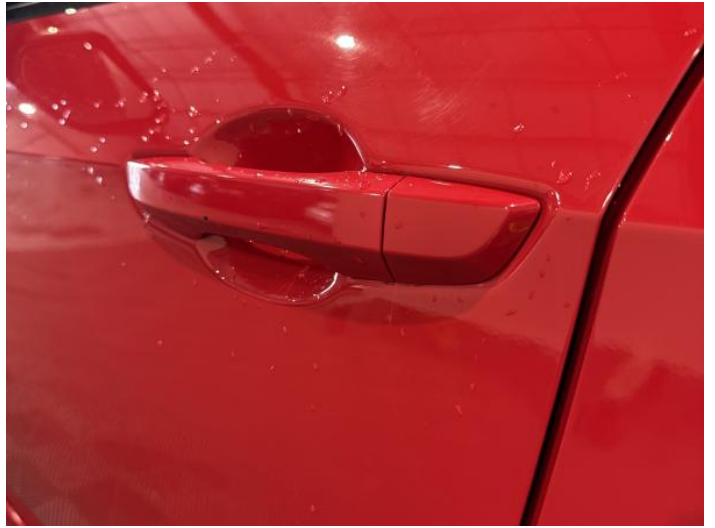
4: Handle Outer nsf
Scratched (Painted)
UpTo 25mm Thru Paint

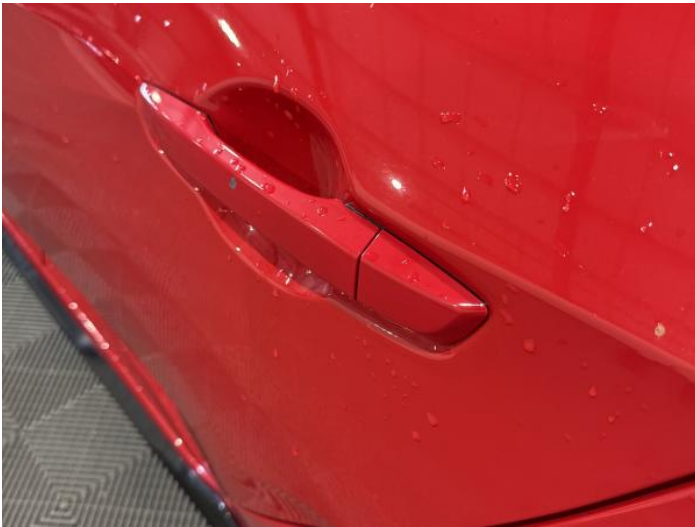
5: Handle Outer nsr
Scratched (Painted)
UpTo 25mm Thru Paint

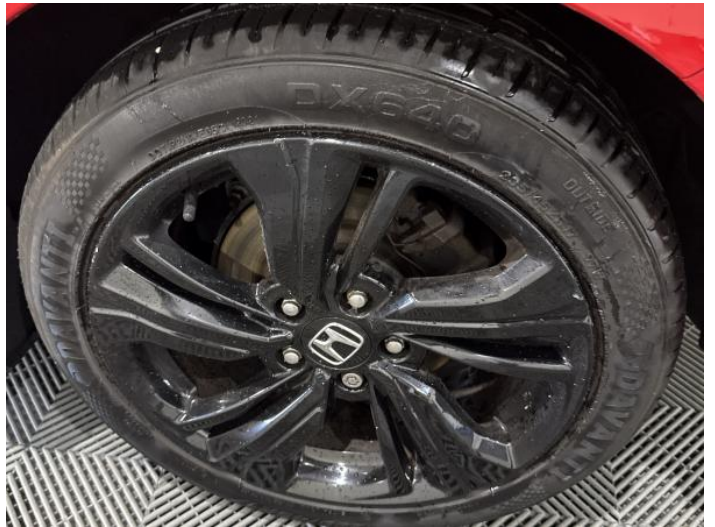
6: Wheel osr
Scratched
Over 50mm

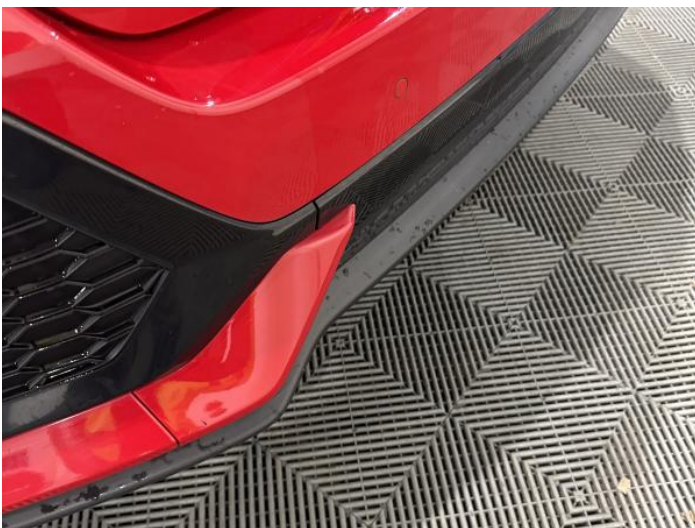
7: Bumper Rear
Scratched
25 to 100mm Thru Paint

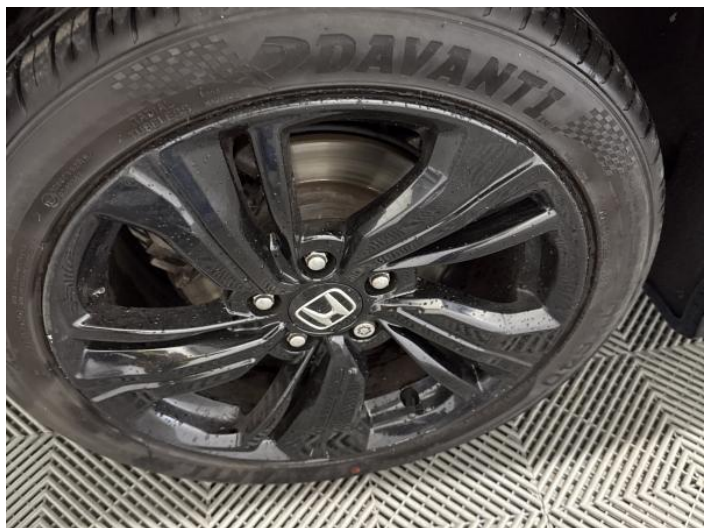
8: Wheel osr
Scratched
Over 50mm

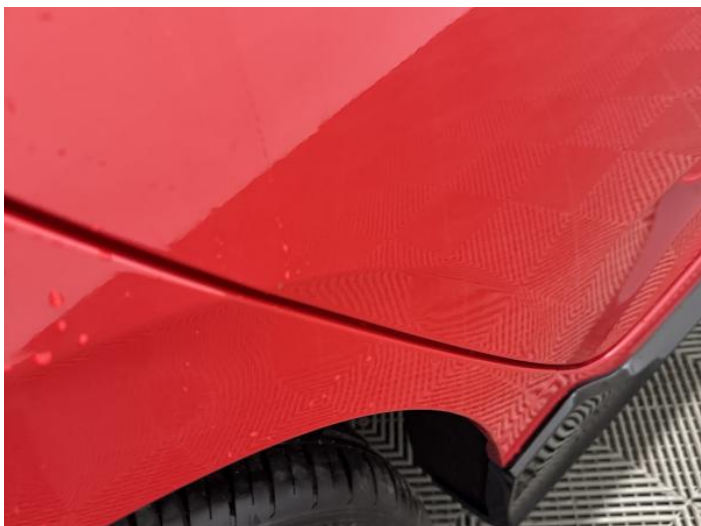
9: Door osr
Chipped
1 To 5

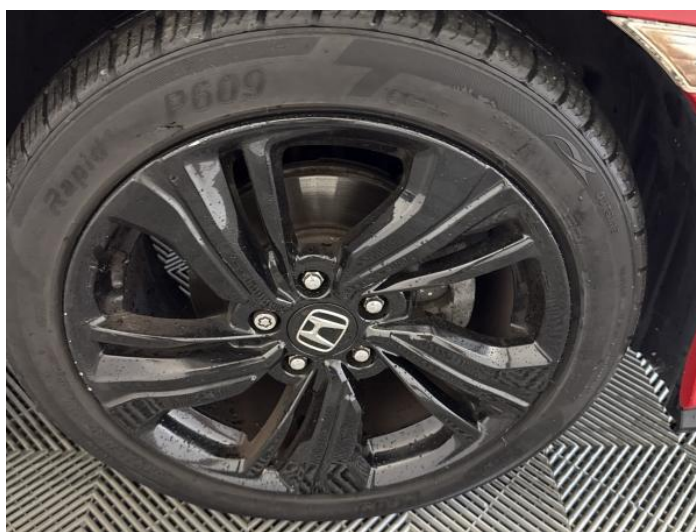
12: Wheel nsf
Scratched
Over 50mm

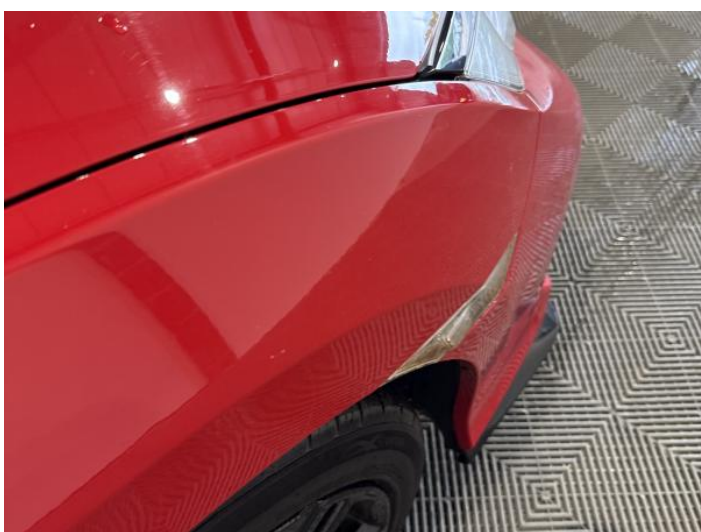
13: Wing osf
Chipped
1 To 5
