# VEHICLE INSPECTION REPORT

**NV58AVN**

## Kia Ceed 1.6 GS 5dr

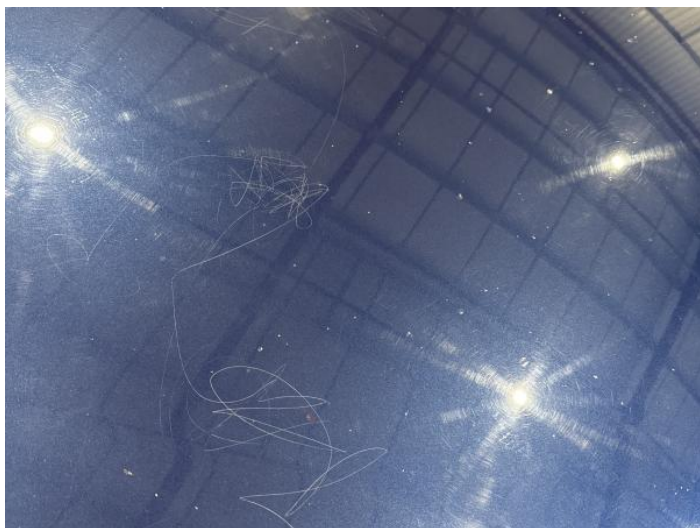
1: Bonnet  
Scratched  
Over 25mm Thru Paint

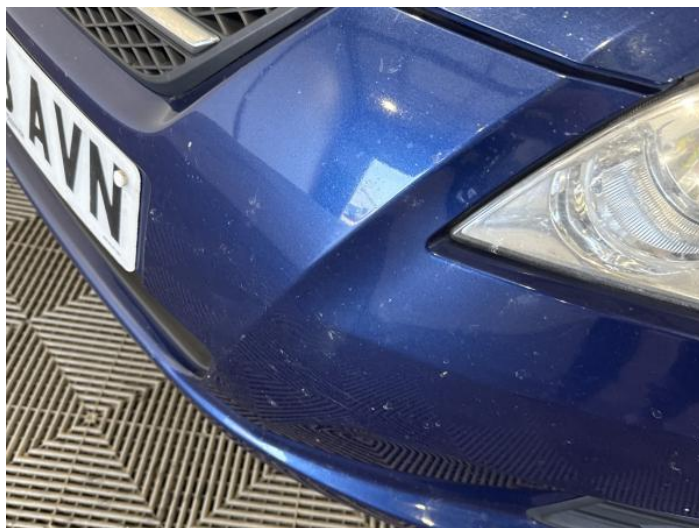
2: Bumper Front  
Scratched  
Over 100mm Thru Paint

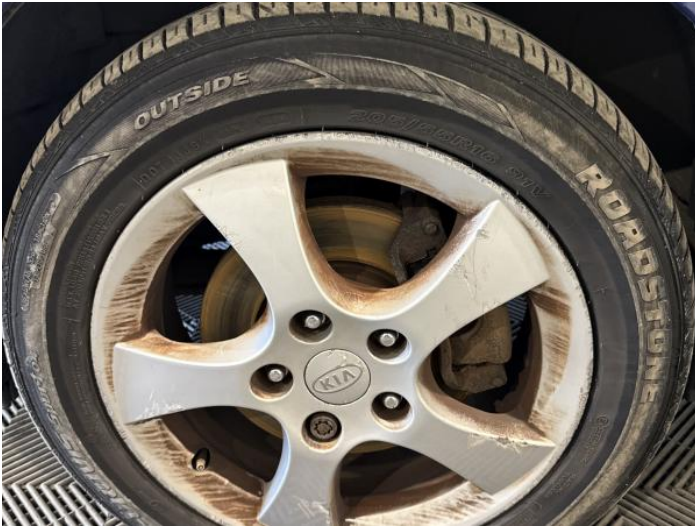
3: Wheel nsf  
Scratched  
Over 50mm

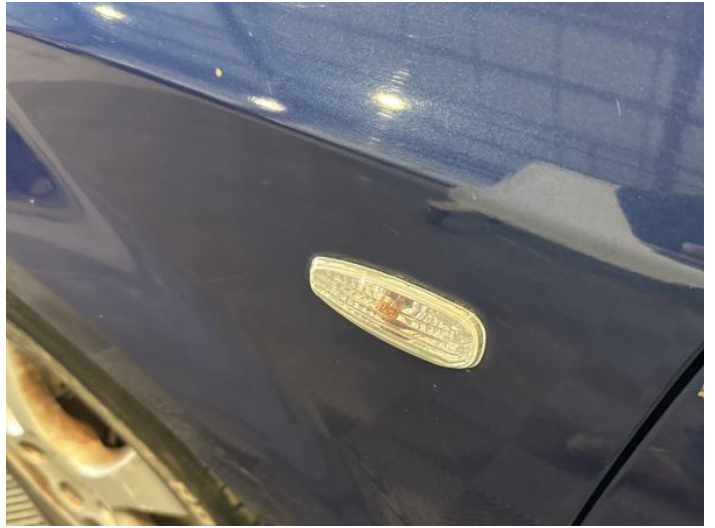
4: Wing nsf  
Chipped  
1 To 5

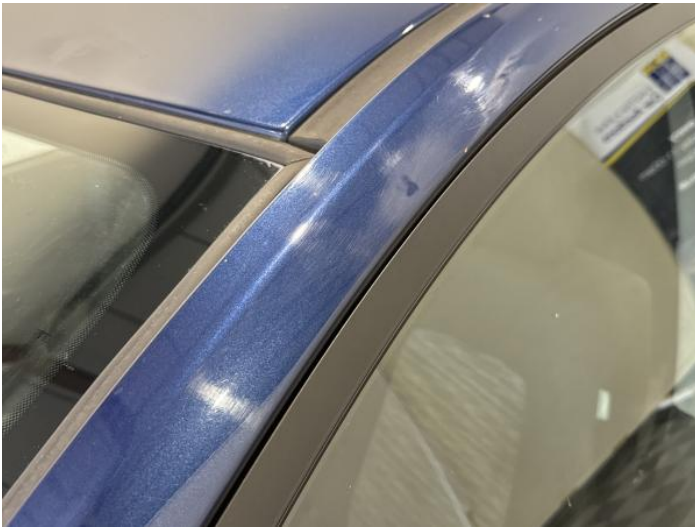
5: A Post ns  
Scratched  
Over 25mm Thru Paint

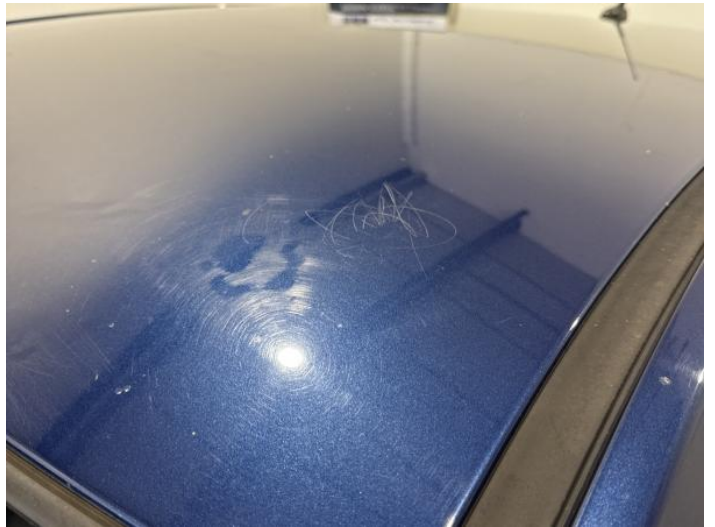
6: Roof  
Scratched  
Over 25mm Thru Paint

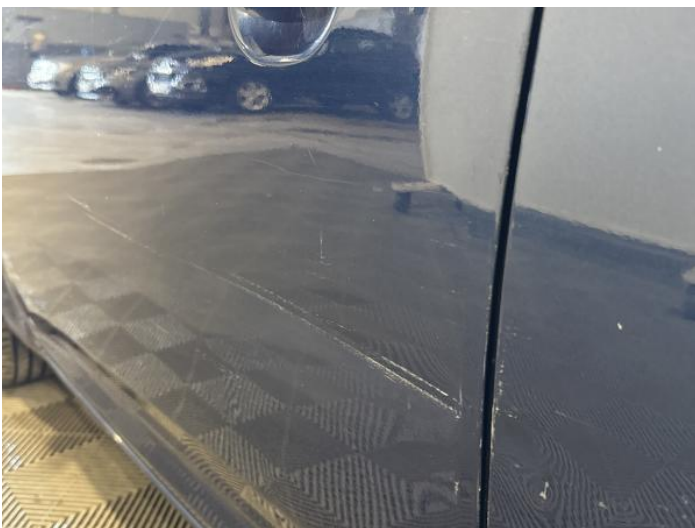
7: Door nsf  
Dented  
With Paint Damage

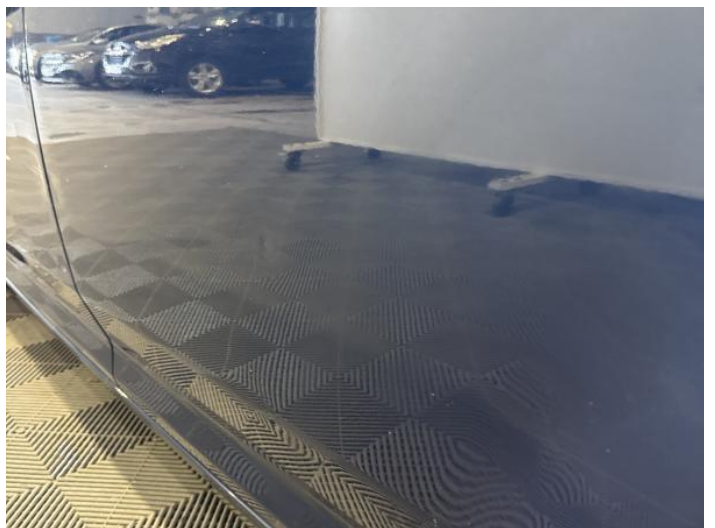
8: Door nsr  
Dented  
Over 30mm

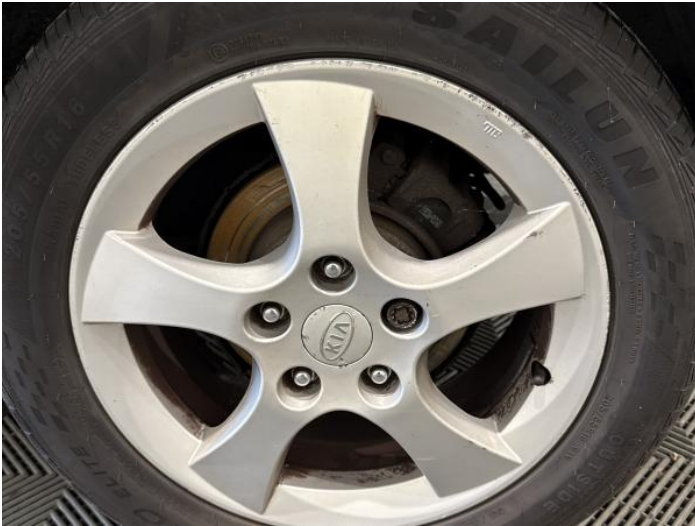
9: Wheel nsr  
Scratched  
Over 50mm

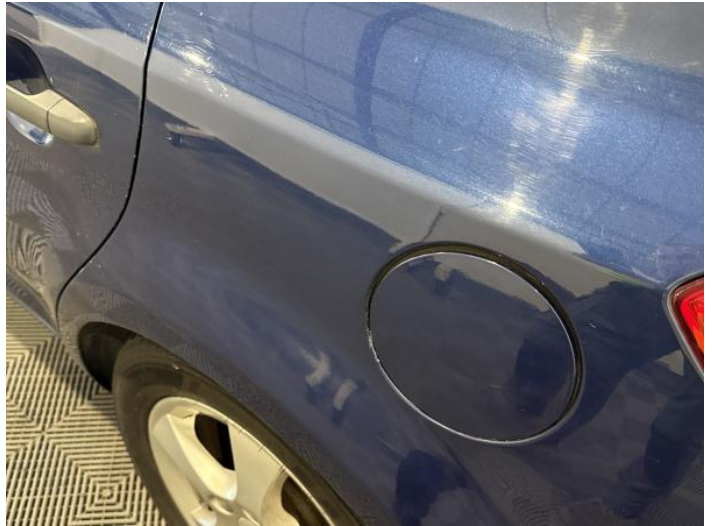
10: Qtr Panel nsr  
Dented  
With Paint Damage

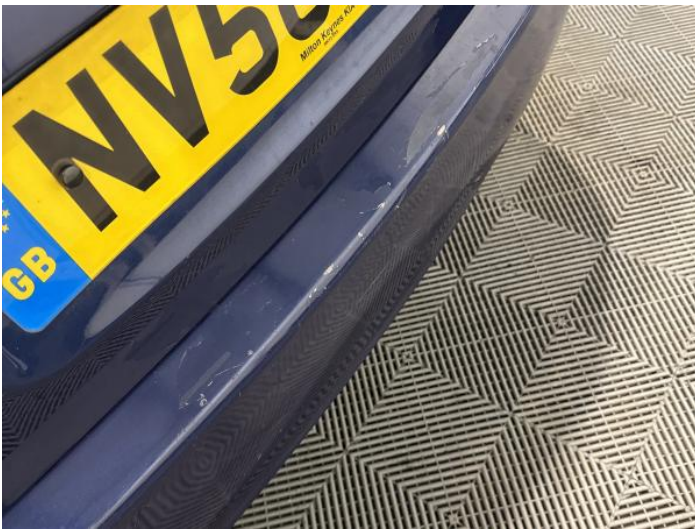
11: Bumper Rear  
Poor Previous Repair  
Paint Flake

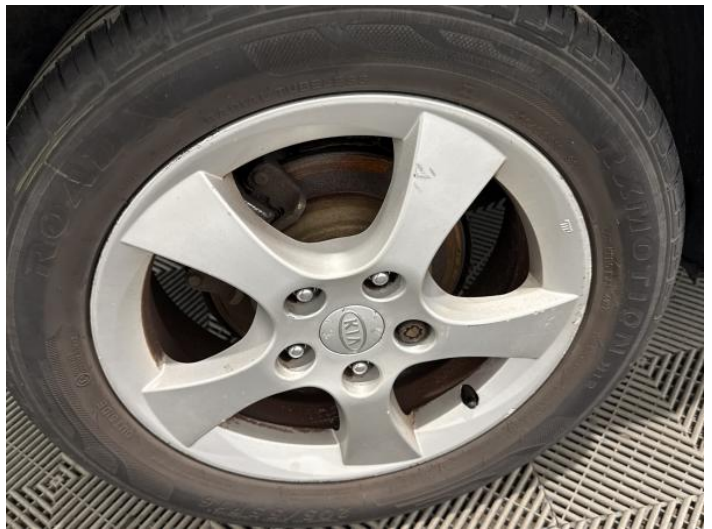
12: Wheel osr  
Scratched  
Over 50mm

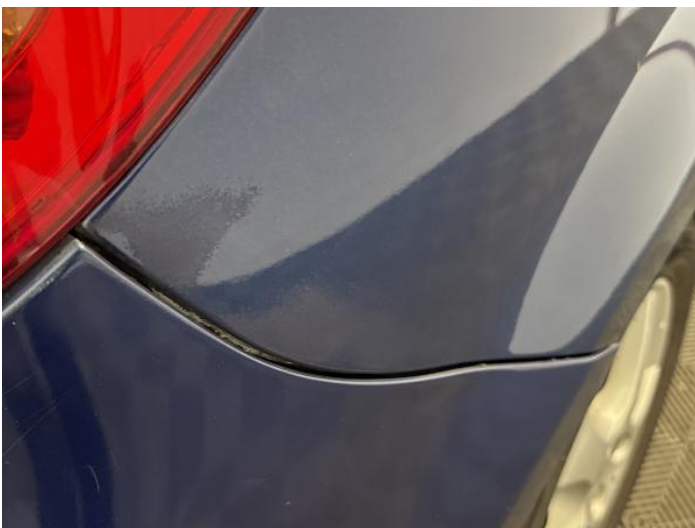
13: Qtr Panel osr  
Scratched  
Over 25mm Thru Paint

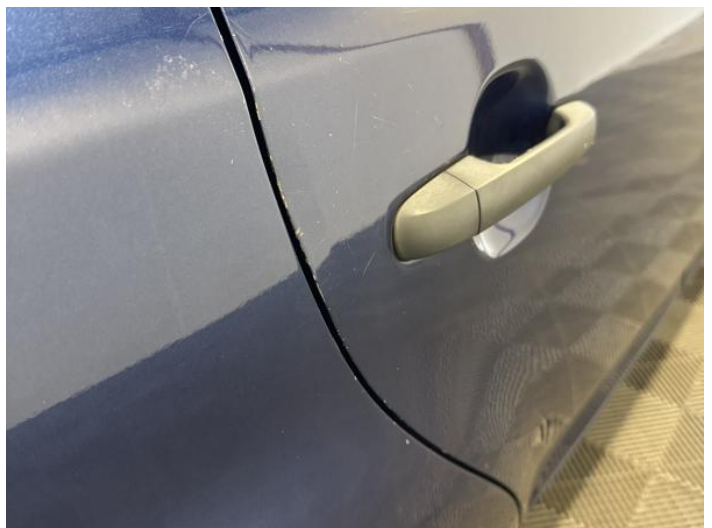
14: Door osr  
Scratched  
Over 25mm Thru Paint

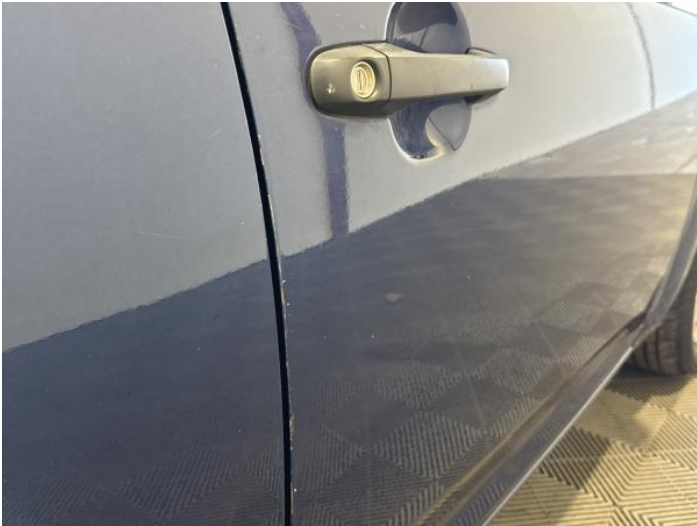
15: Door osf  
Scratched  
Over 25mm Thru Paint

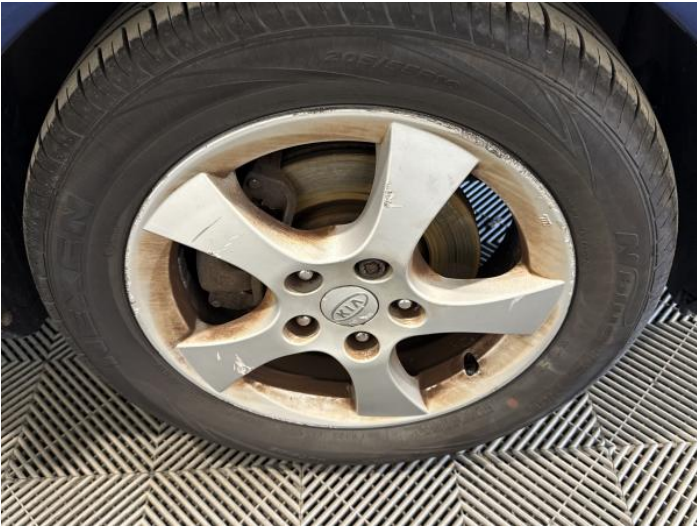
16: Wheel osf  
Scratched  
Over 50mm

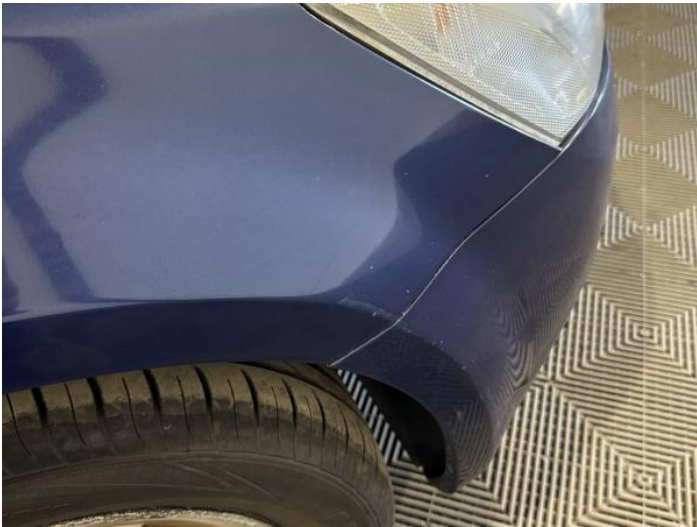
17: Wing osf  
Scratched  
Over 25mm Thru Paint
