VEHICLE INSPECTION REPORT

GV64LGO

Dacia Sandero Stepway 0.9 TCe Laureate 5dr

nama
GRADE
3

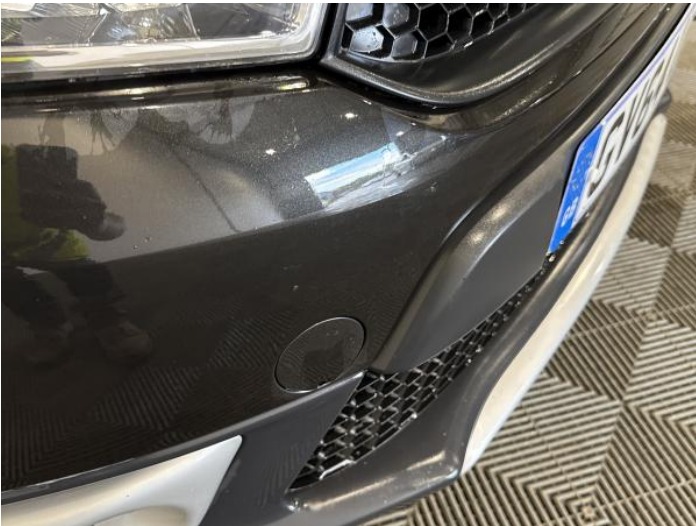
1: Bumper Front
Chipped
Multiple Chips

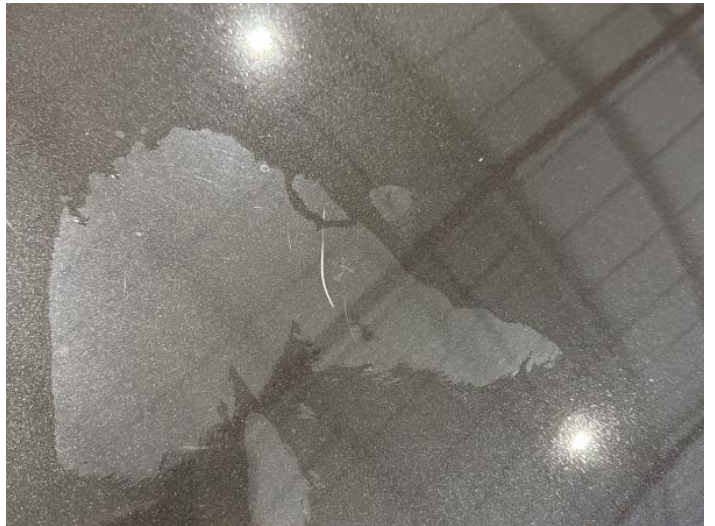
2: Bonnet
Scratched
Over 25mm Thru Paint

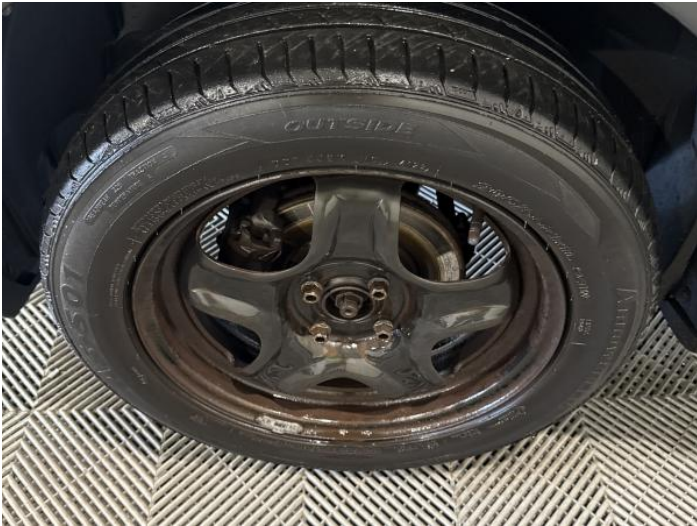
3: Wheel Trim nsf
Missing
Replace

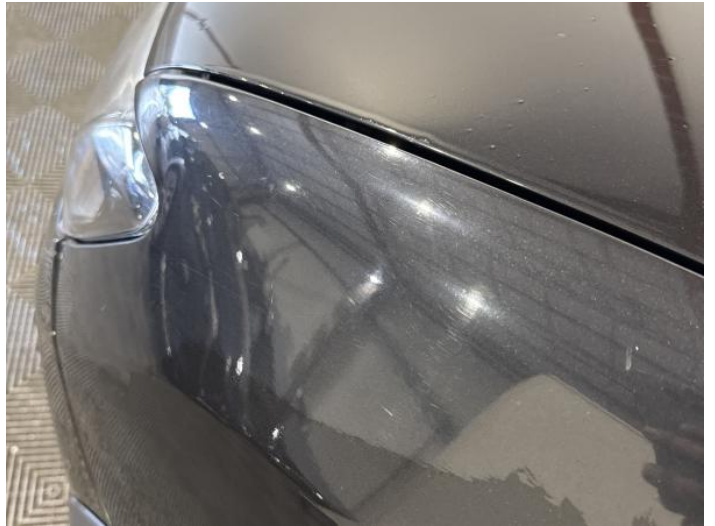
4: Wing nsf
Scratched
UpTo 25mm Thru Paint

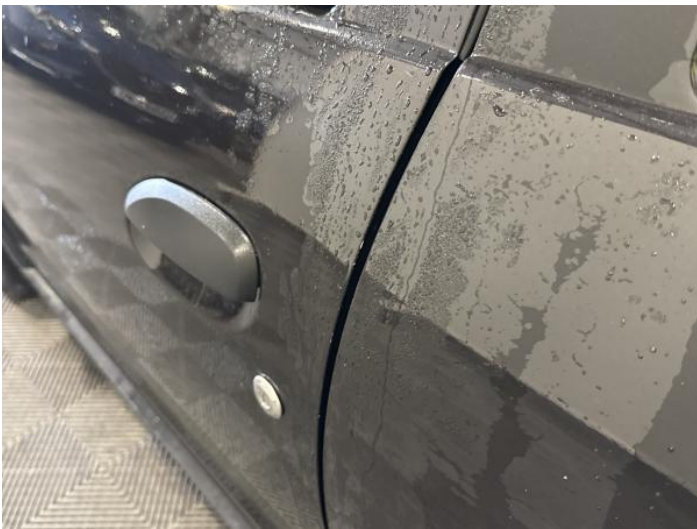
5: Door nsf
Chipped
Edge Chip

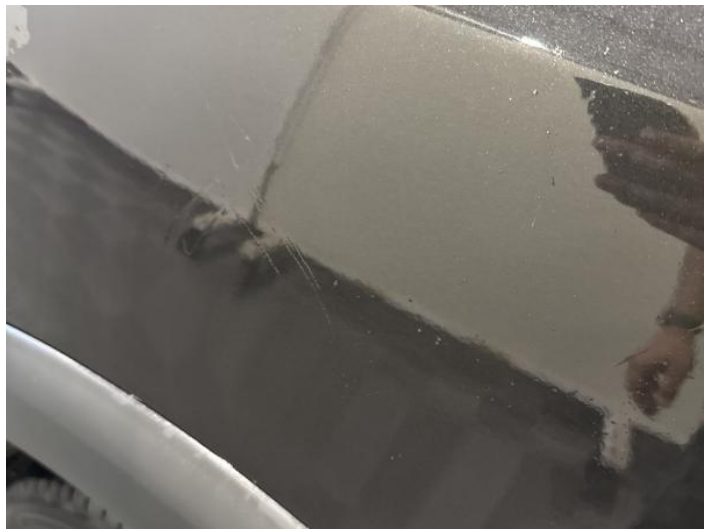
6: Qtr Panel nsr
Scratched
Over 25mm Thru Paint

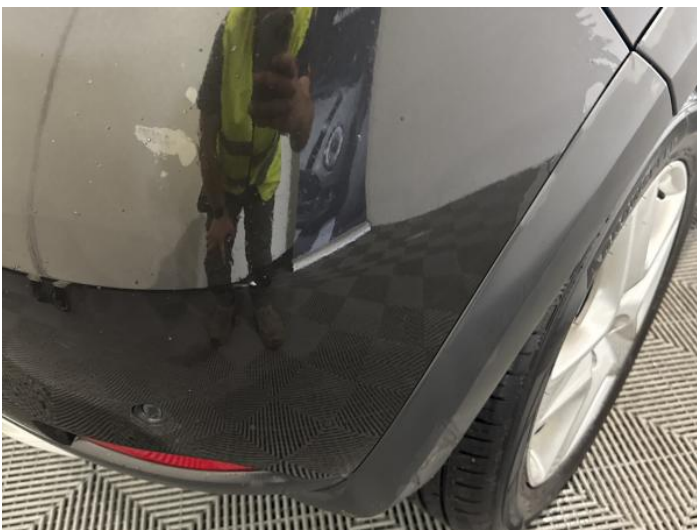
7: Bumper Rear
Scratched
25 to 100mm Thru Paint

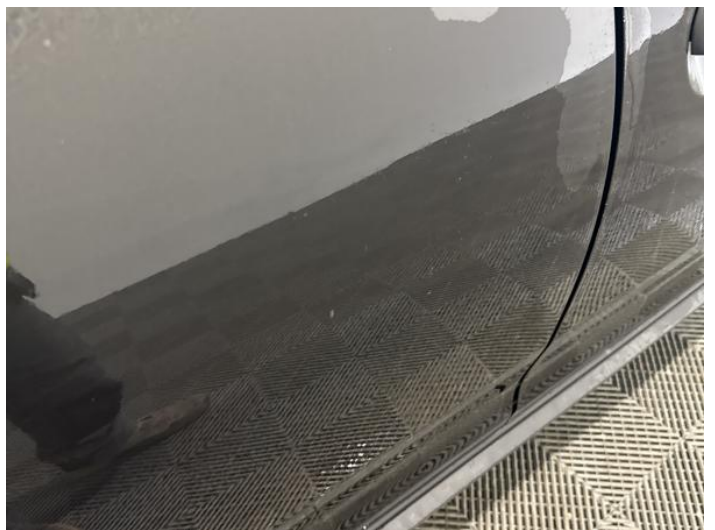
8: Door osr
Scratched
Over 25mm Thru Paint

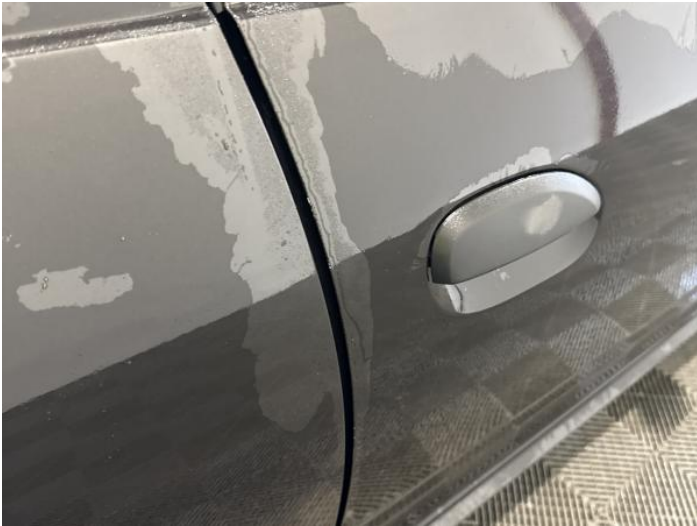
9: Door osf
Chipped
Edge Chip

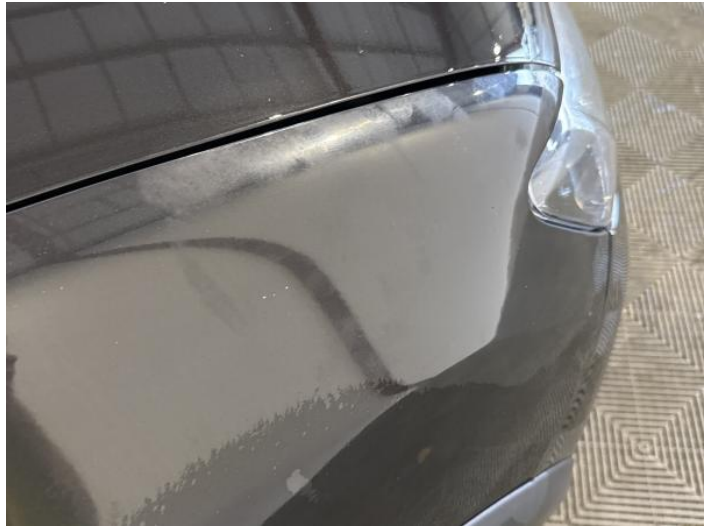
10: Wing osf
Scratched
Over 25mm Thru Paint

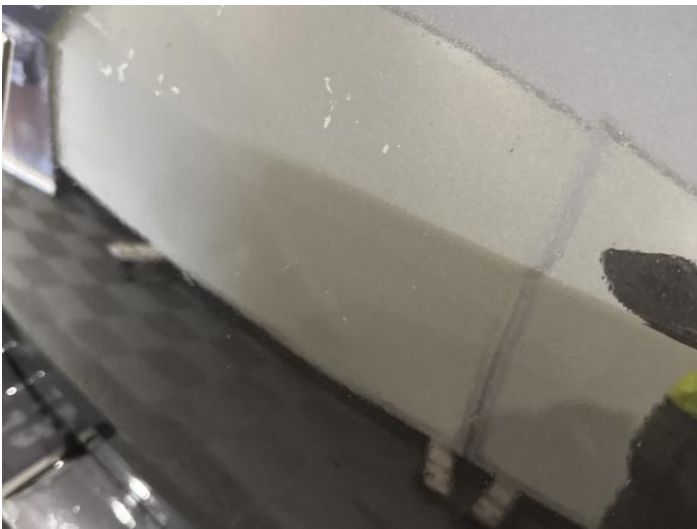
11: Tailgate
Dented
Between 10mm + 30mm
