VEHICLE INSPECTION REPORT

GU65WUA

Vauxhall Corsa 1.4 ecoFLEX Energy 3dr [AC]

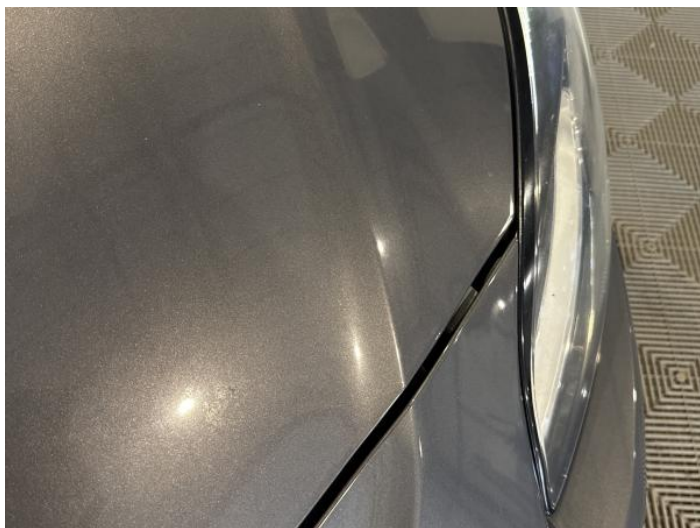
1: Bonnet
Dented
Over 30mm

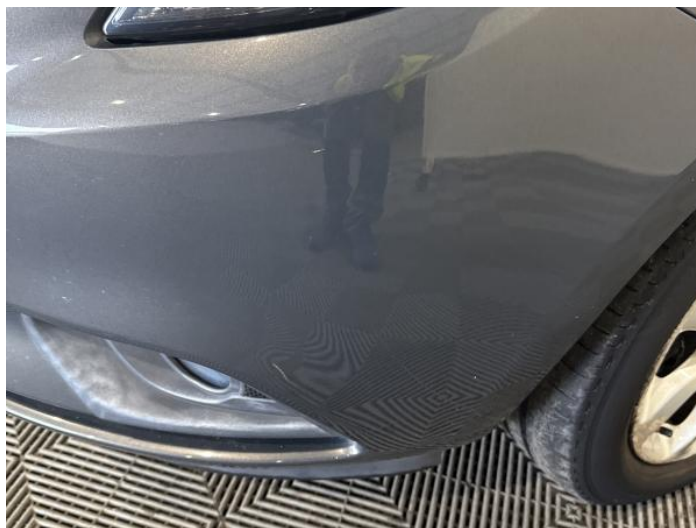
2: Bumper Front
Scratched
25 to 100mm Thru Paint

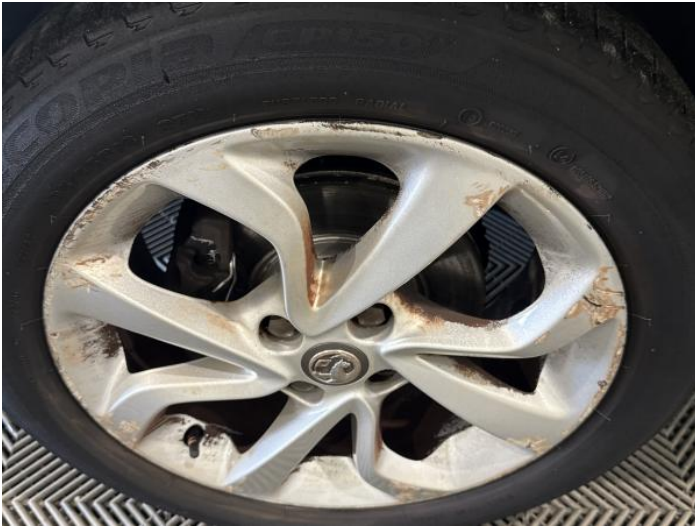
3: Wheel nsf
Scratched
Over 50mm

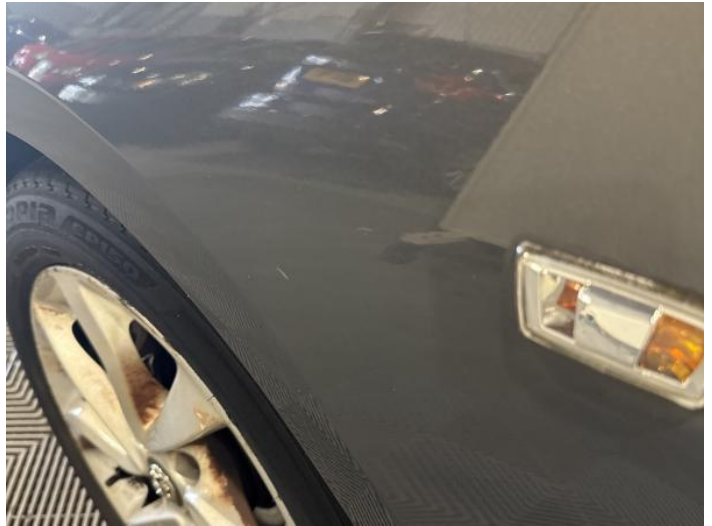
4: Wing nsf
Dented
Over 2 UpTo 10mm

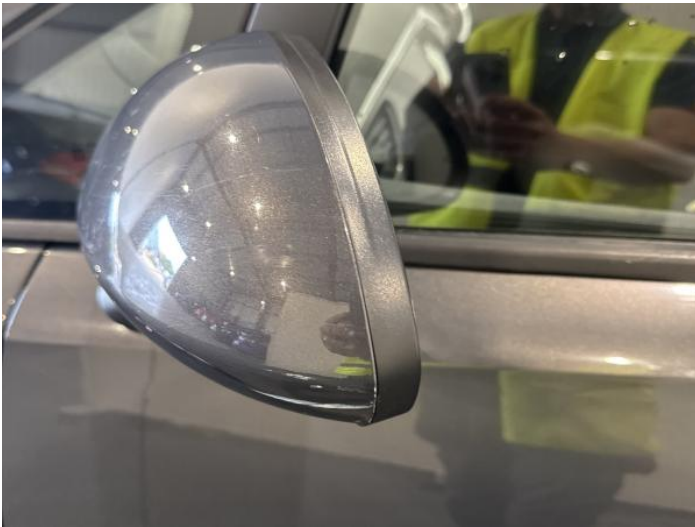
5: Door Mirror Assy nsf
Scratched (Painted)
UpTo 25mm Thru Paint

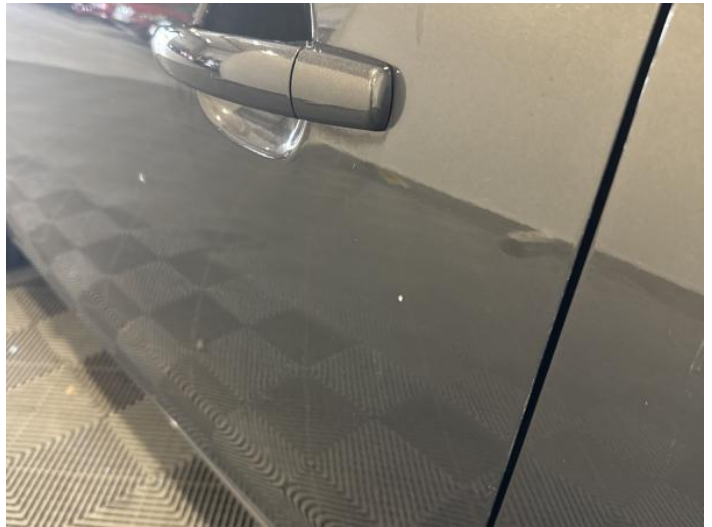
6: Door nsf
Dented
Over 30mm

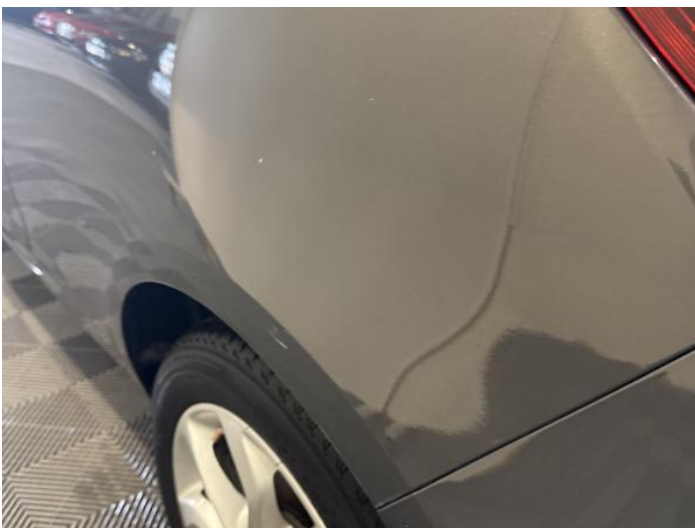
7: Qtr Panel nsr
Scratched
Over 25mm Thru Paint

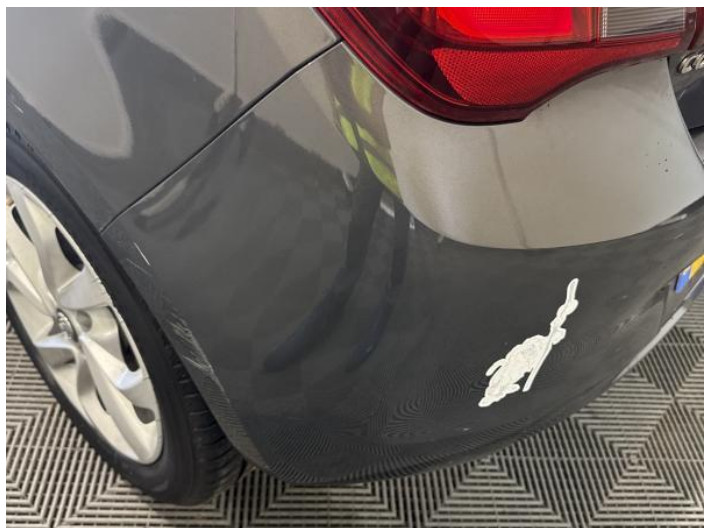
8: Bumper Rear
Scratched
Over 100mm Thru Paint

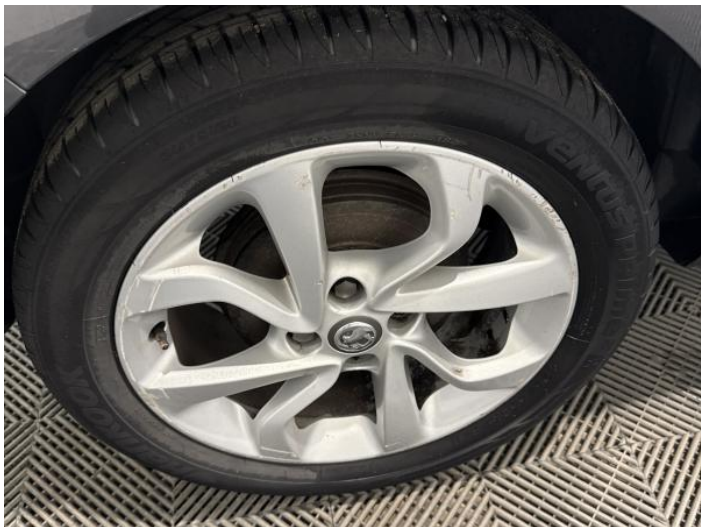
9: Wheel osr
Scratched
Over 50mm

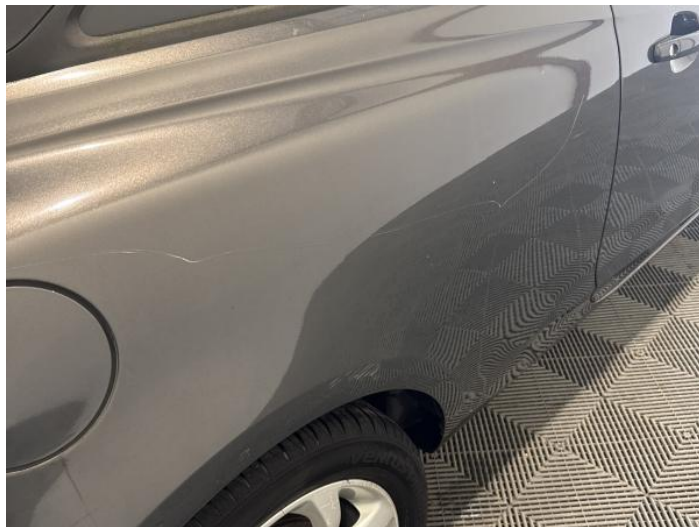
10: Qtr Panel osr
Dented
With Paint Damage

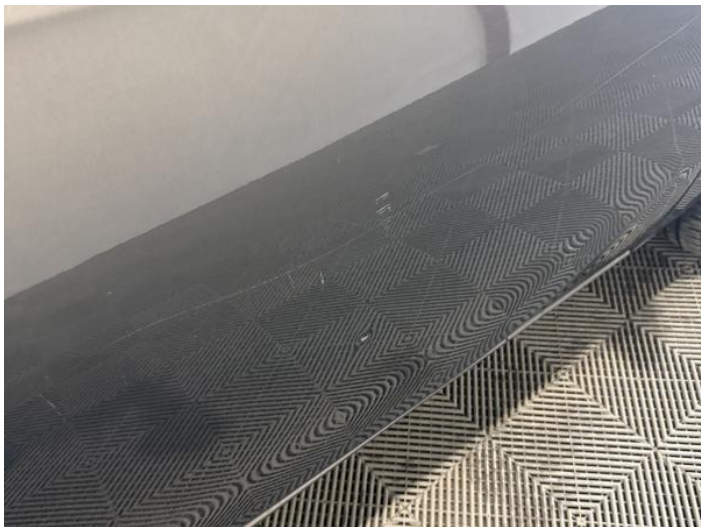
11: Door osf
Scratched
Over 25mm Thru Paint

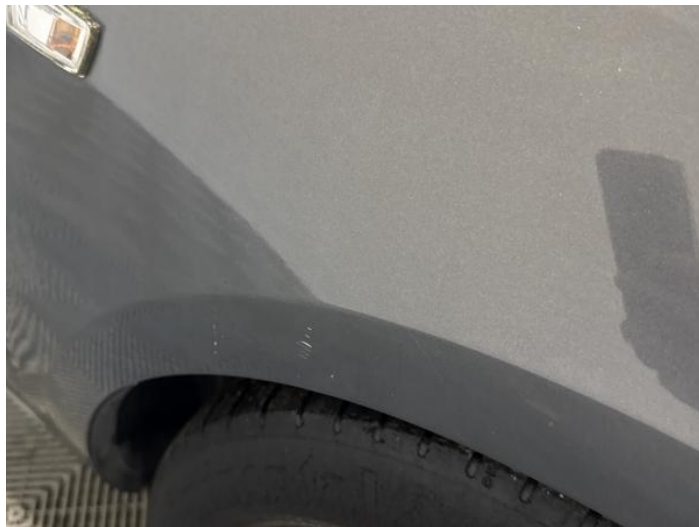
12: Wing osf
Scratched
UpTo 25mm Thru Paint

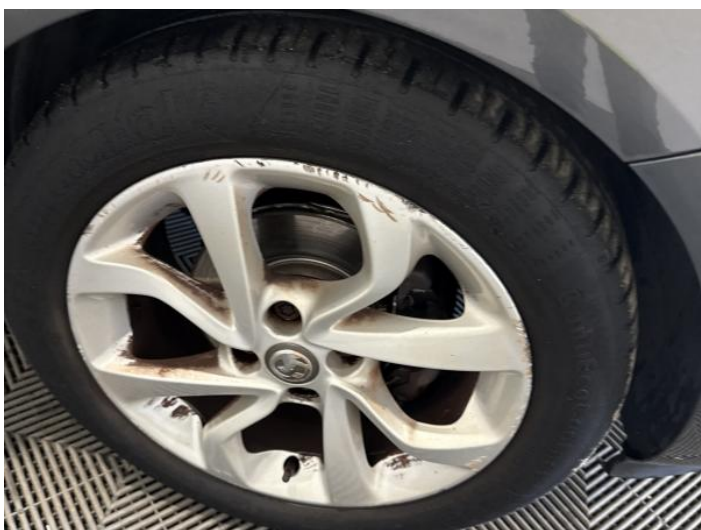
13: Wheel osf
Scratched
Over 50mm
