# VEHICLE INSPECTION REPORT

**GF23JGV**

## Volkswagen T-Roc 1.5 TSI Life 5dr

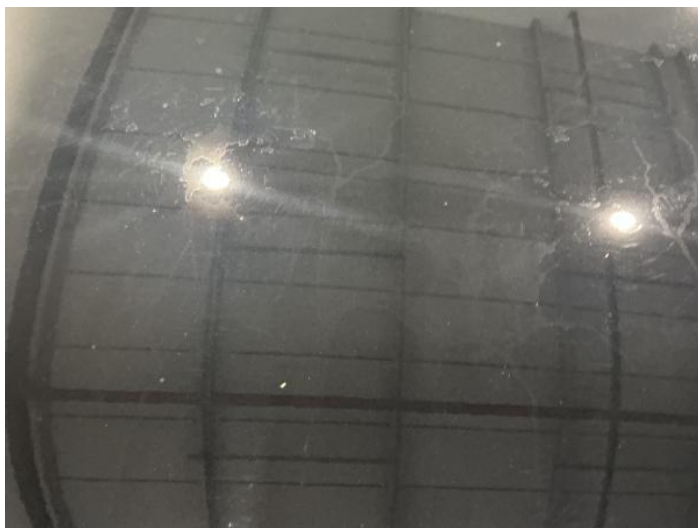
1: Bonnet  
Chipped  
1 To 5

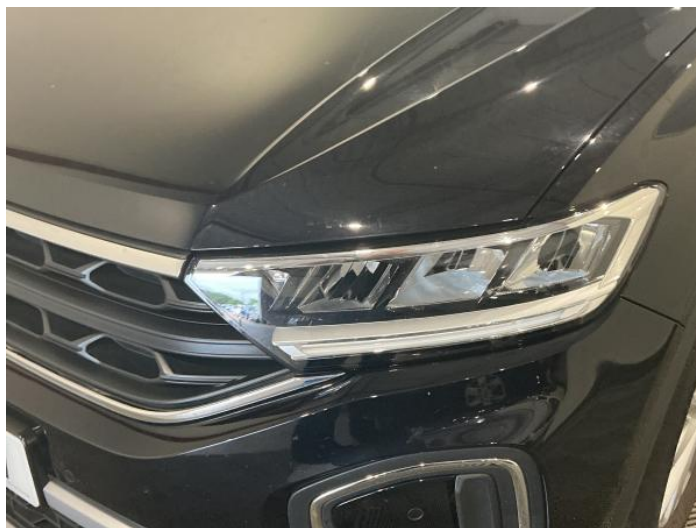
2: Bumper Front  
Chipped  
Multiple Chips

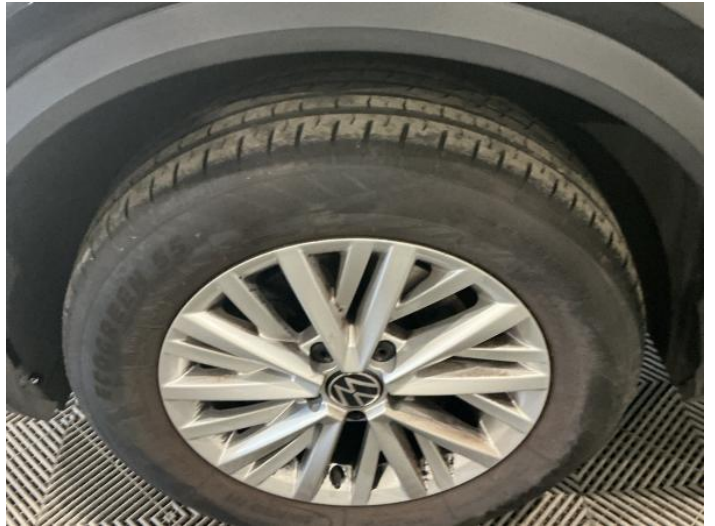
4: Wheel nsf  
Scratched  
Over 50mm

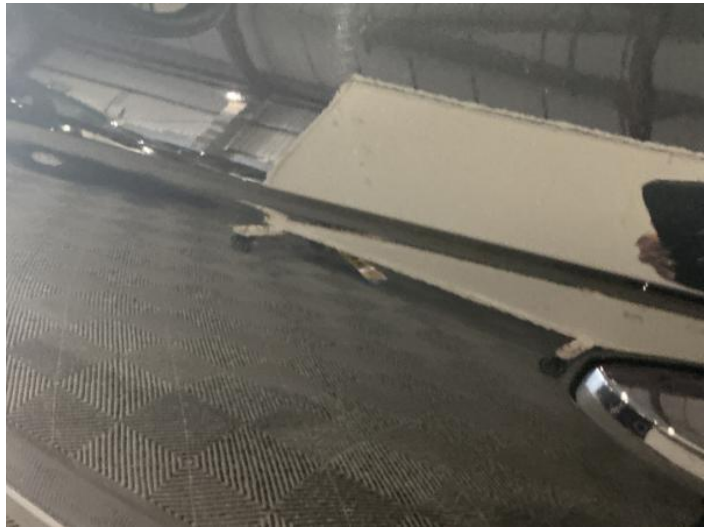
6: Door nsf  
Chipped  
1 To 5

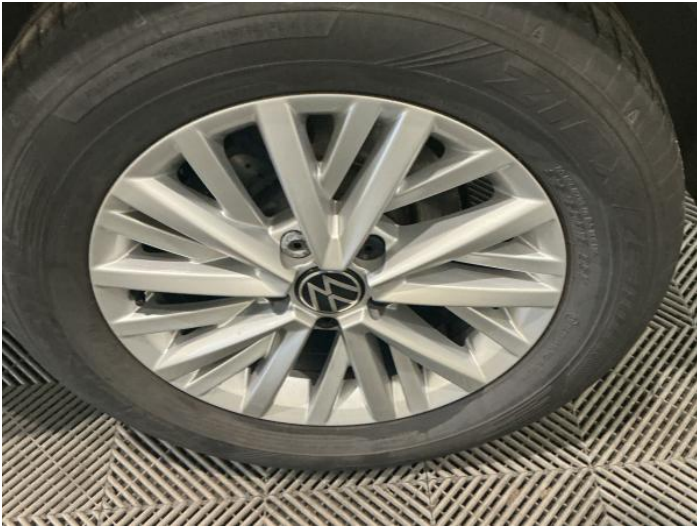
9: Wheel nsr  
Scratched  
Up To 50mm

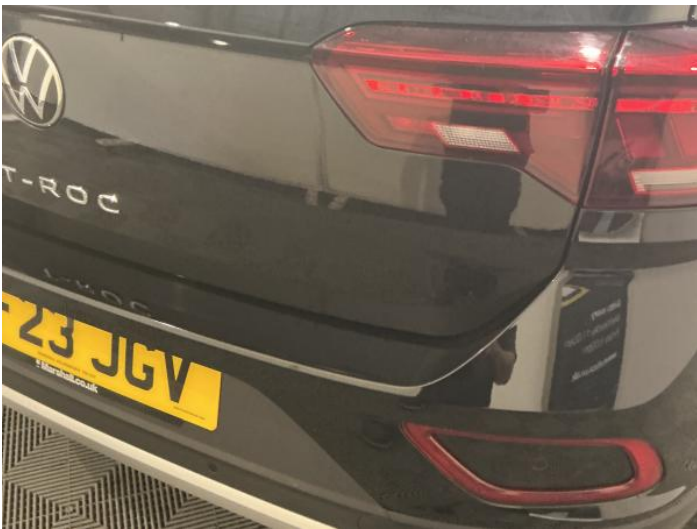
11: Bumper Rear  
Chipped  
Multiple Chips

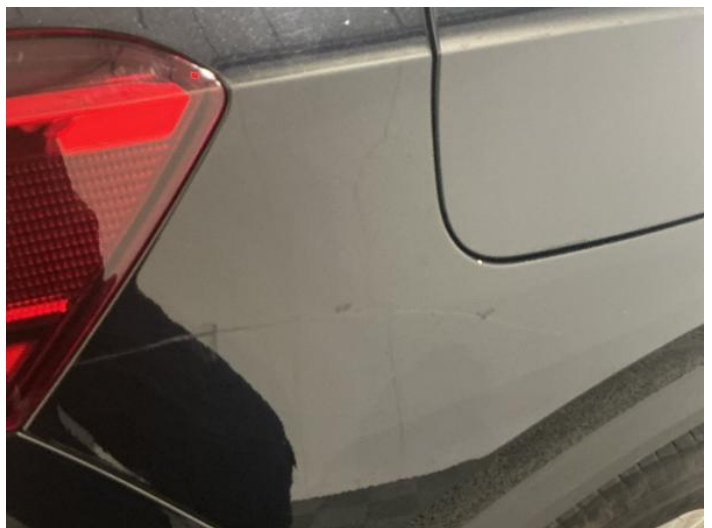
14: Qtr Panel osr  
Scratched  
Over 25mm Thru Paint

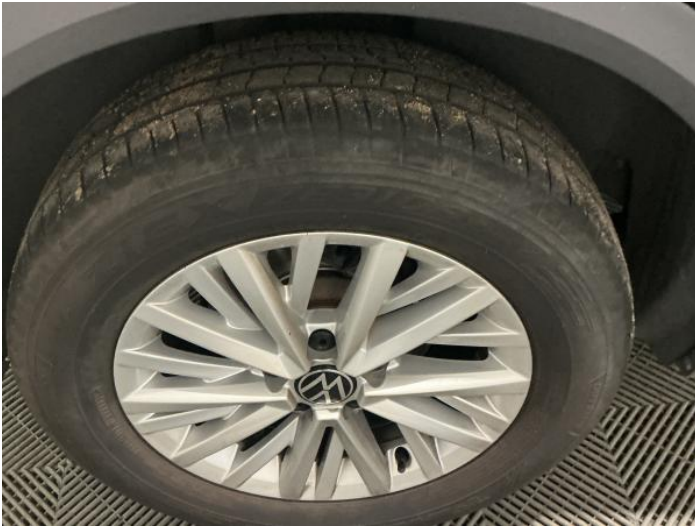
15: Wheel osr  
Scratched  
Over 50mm

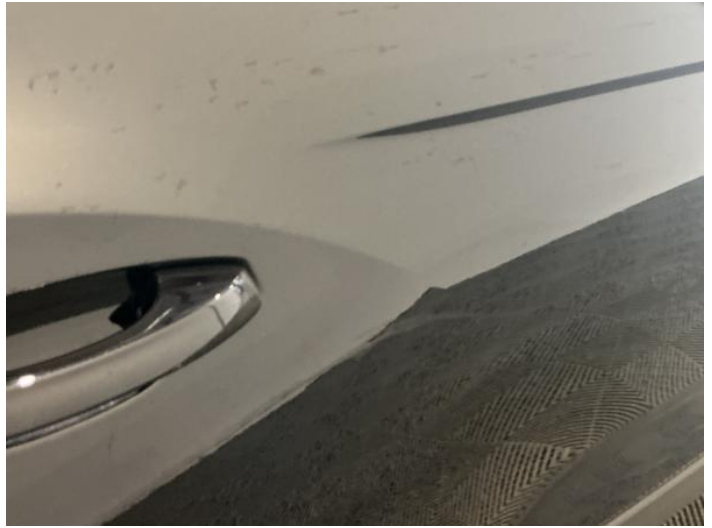
16: Door osr  
Scratched  
Over 25mm Thru Paint

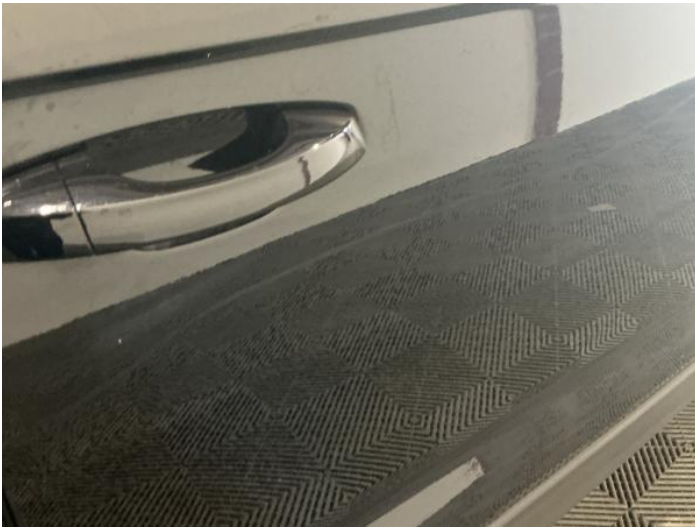
17: Door osf  
Scratched  
Over 25mm Thru Paint

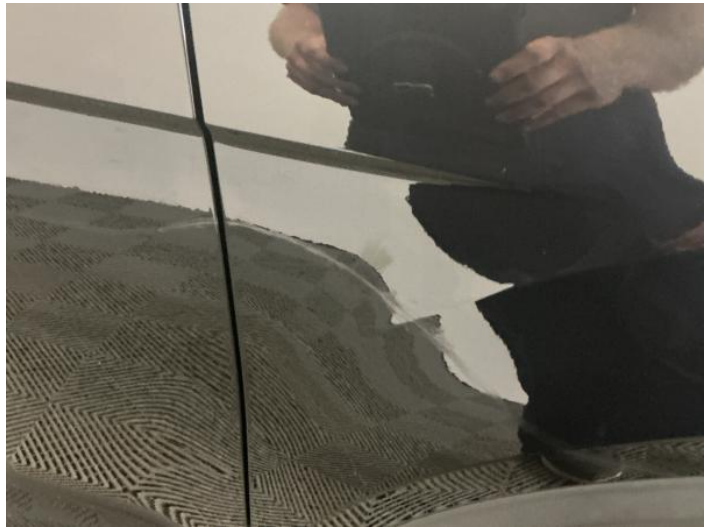
18: Wing osf  
Scratched  
Over 25mm Thru Paint

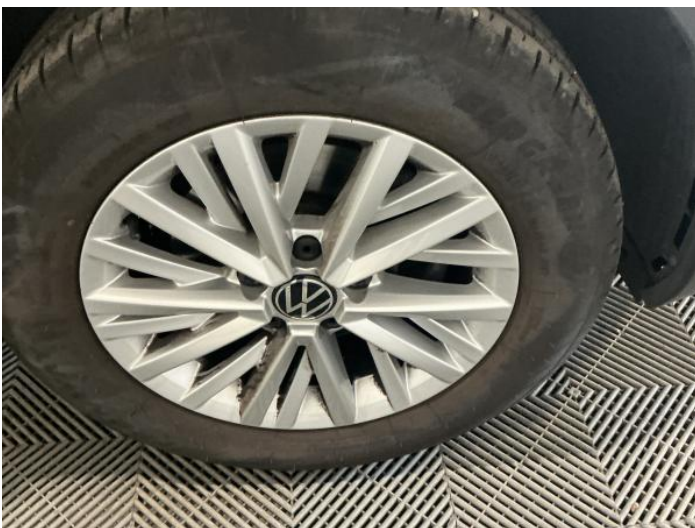
19: Wheel osf  
Scratched  
Up To 50mm
