# VEHICLE INSPECTION REPORT

**EF60XKT**

## Ford Focus 1.6 Titanium 5dr

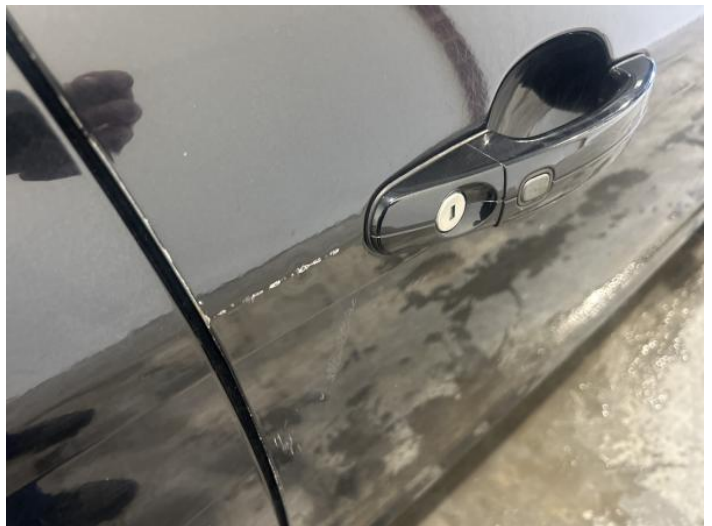
2: Door osf  
Scratched  
Over 25mm Thru Paint

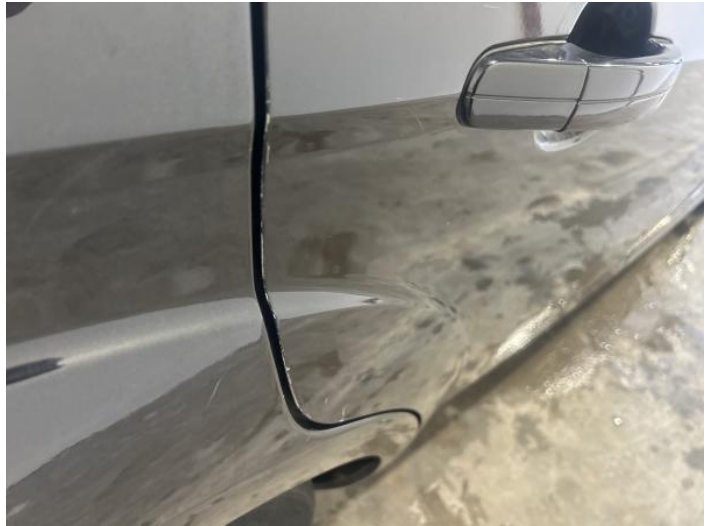
3: Door osr  
Scratched  
Over 25mm Not Thru Paint

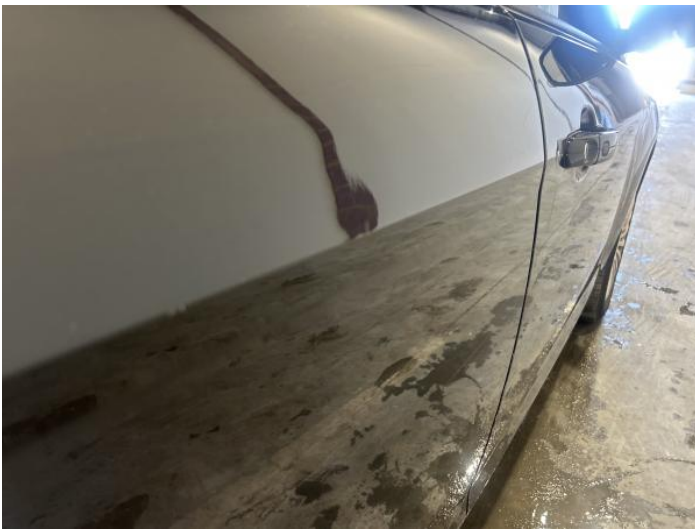
5: Door osr  
Dented  
2 Or Less UpTo 10mm

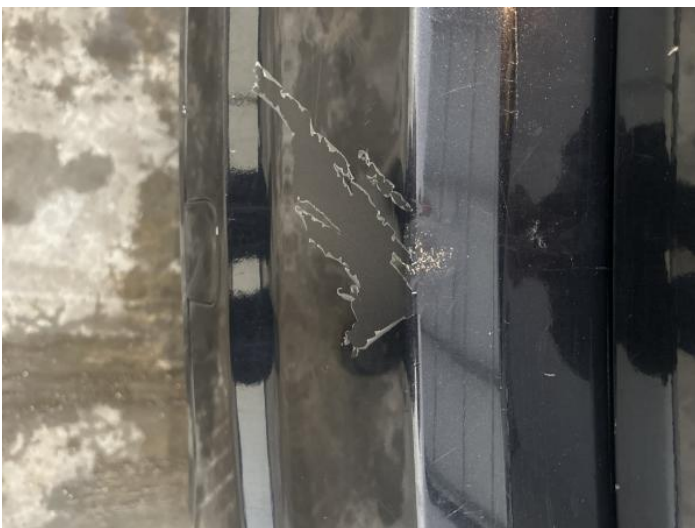
7: Bumper Rear  
Poor Previous Repair  
Paint Flake

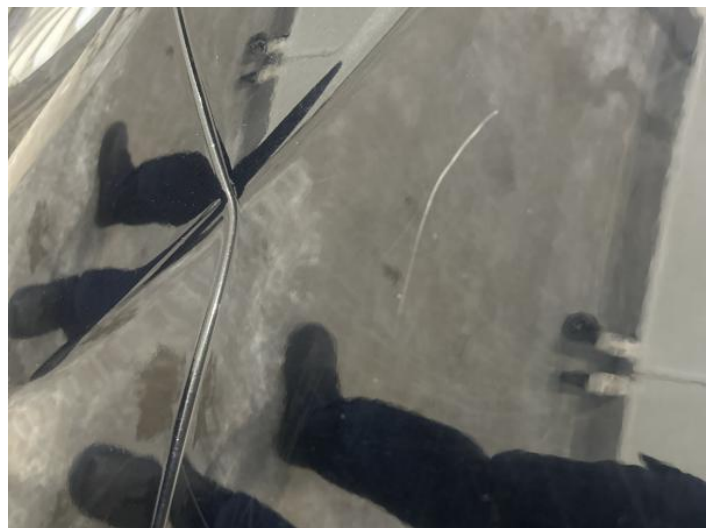
8: Qtr Panel nsr  
Scratched  
Over 25mm Thru Paint

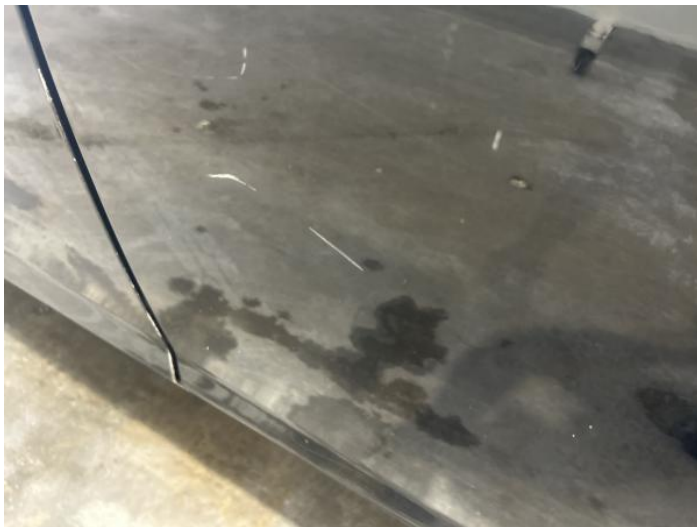
9: Door nsr  
Scratched  
Over 25mm Thru Paint

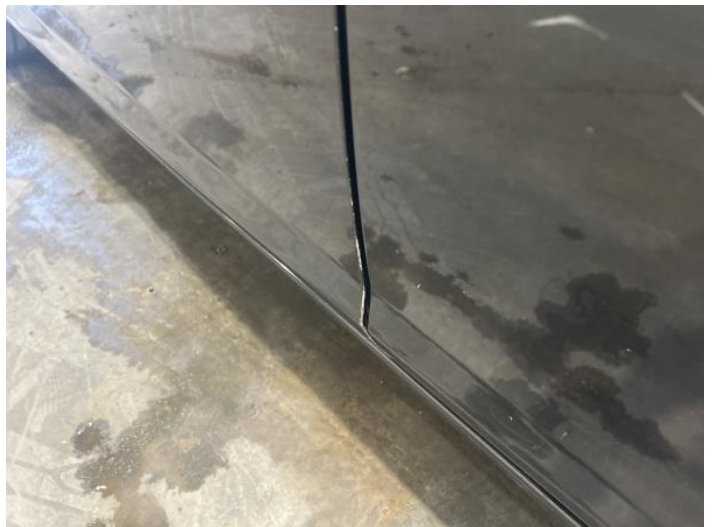
10: Door nsf  
Chipped  
Edge Chip

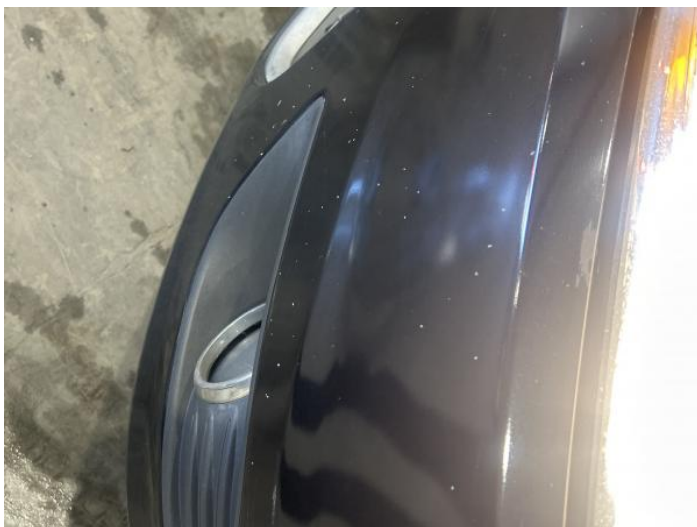
13: Bumper Front  
Poor Previous Repair  
Poor Paint

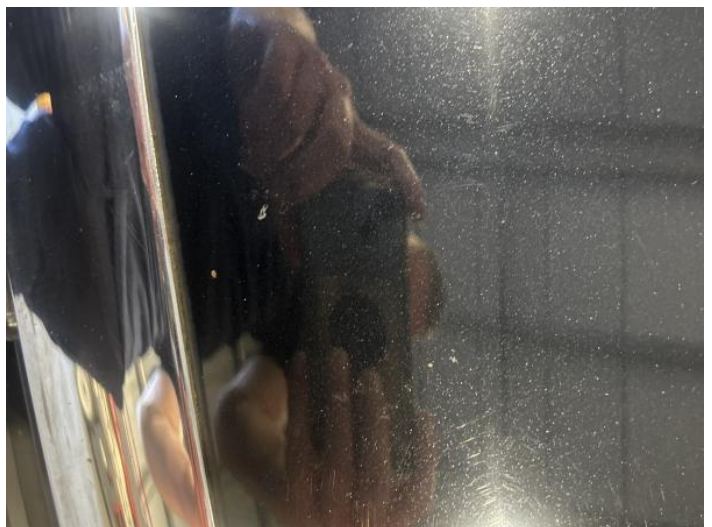
14: Bonnet  
Chipped  
1 To 5

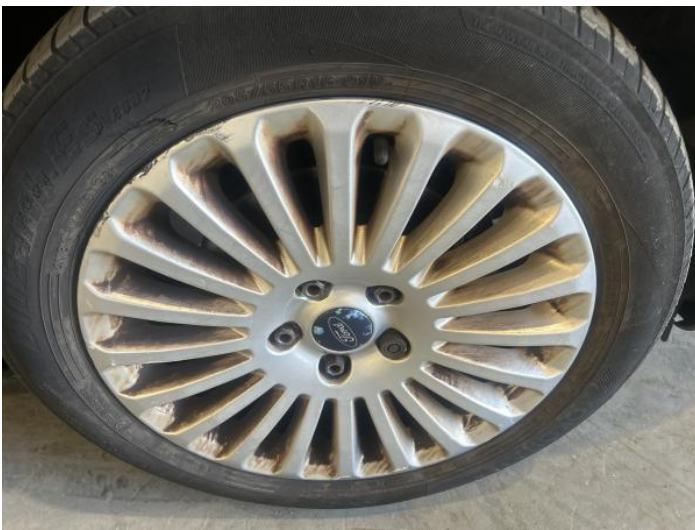
17: Wheel osf  
Scratched  
Over 50mm

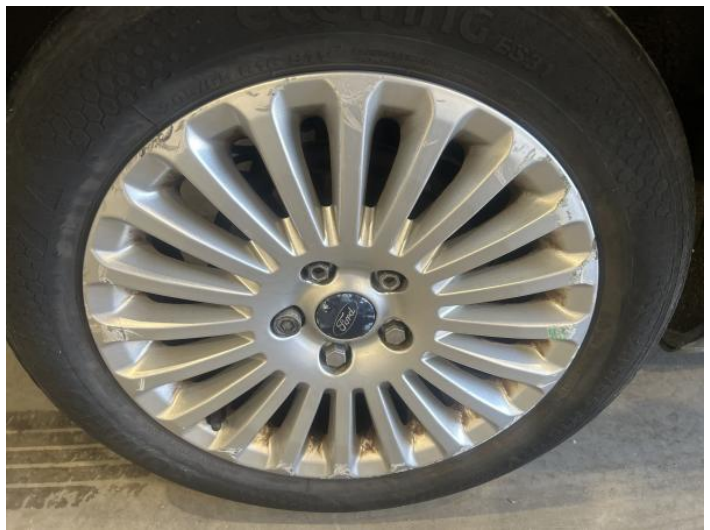
18: Wheel osr  
Scratched  
Over 50mm

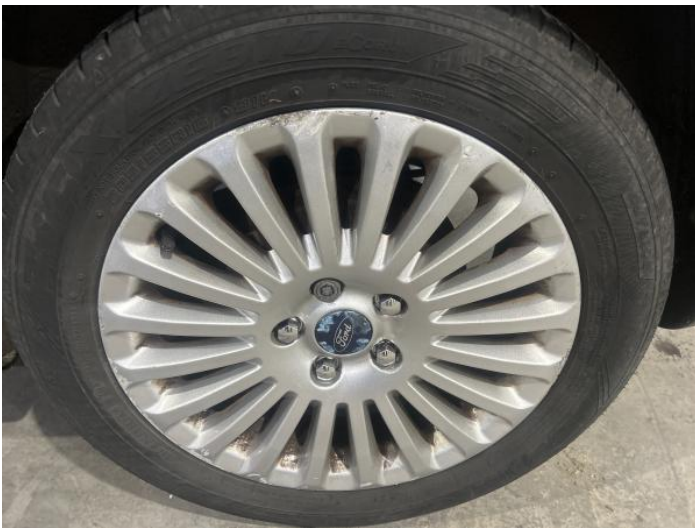
19: Wheel nsr  
Scratched  
Over 50mm

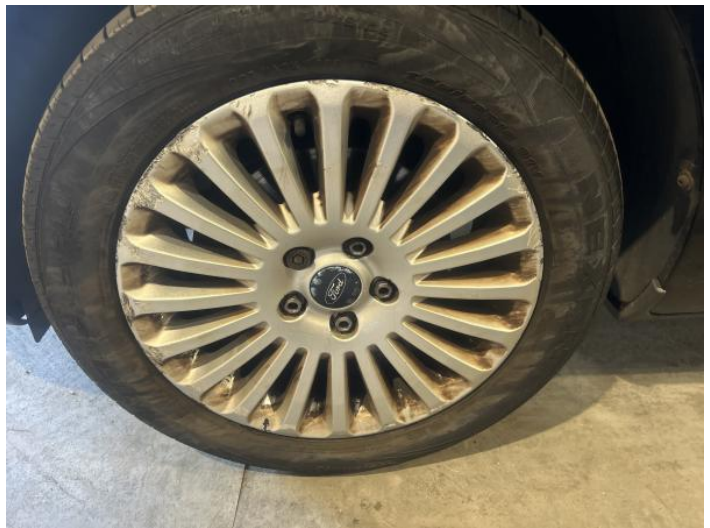
20: Wheel nsf  
Scratched  
Over 50mm

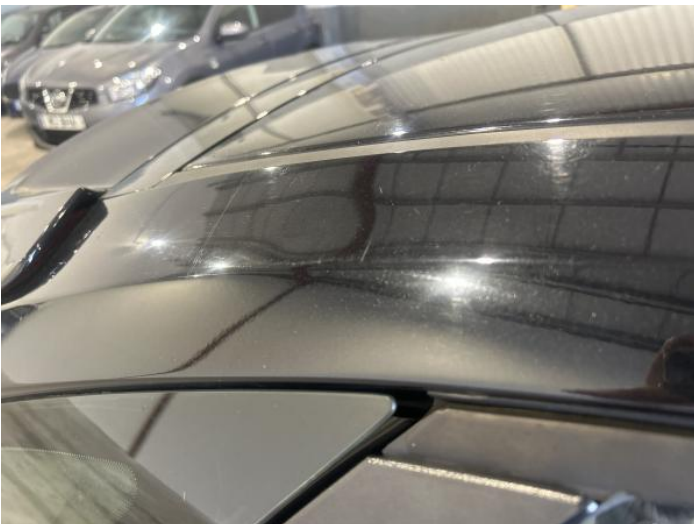
25: D Post os  
Dented  
Between 10mm + 30mm
