VEHICLE INSPECTION REPORT

GU64VRK

Skoda Fabia 1.2 TSI 105 Black Edition 5dr

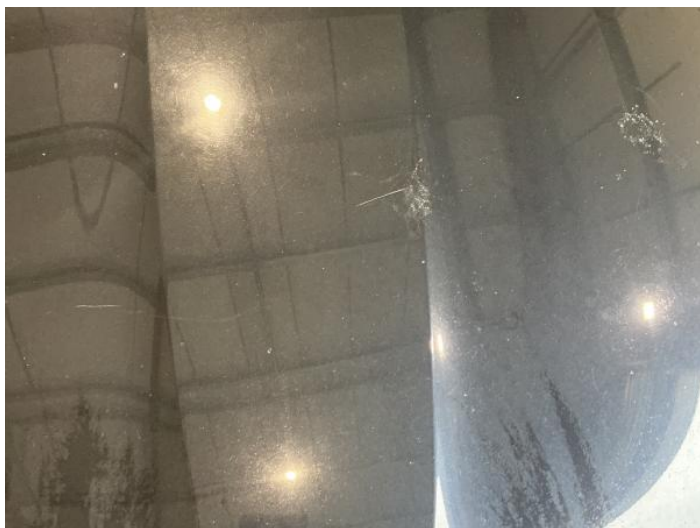
1: Bonnet
Chipped
Multiple Chips

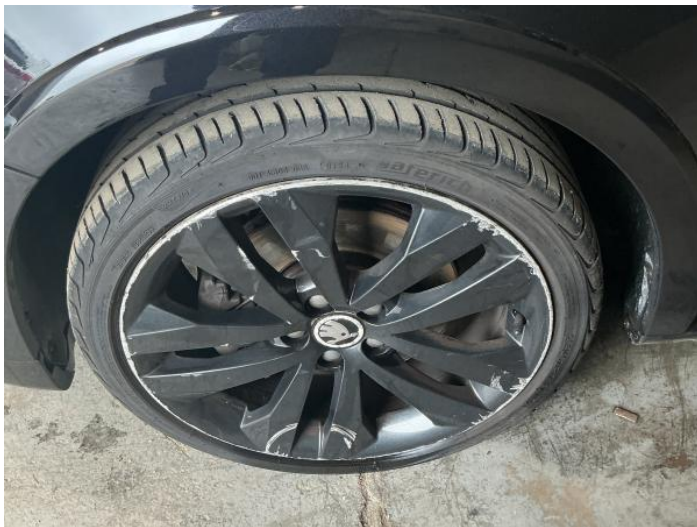
3: Wheel nsf
Scratched
Over 50mm

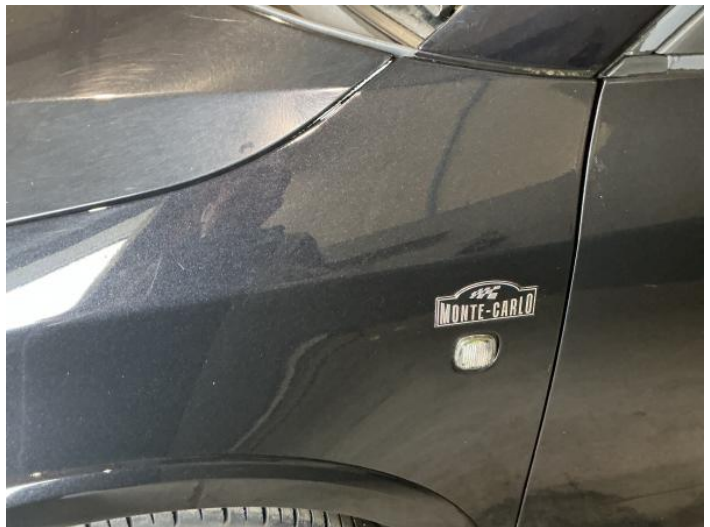
4: Wing nsf
Chipped
1 To 5

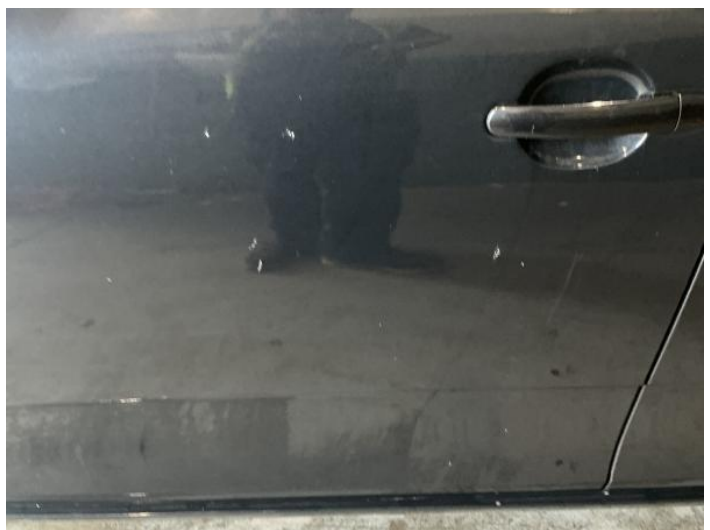
6: Door nsf
Chipped
Multiple Chips

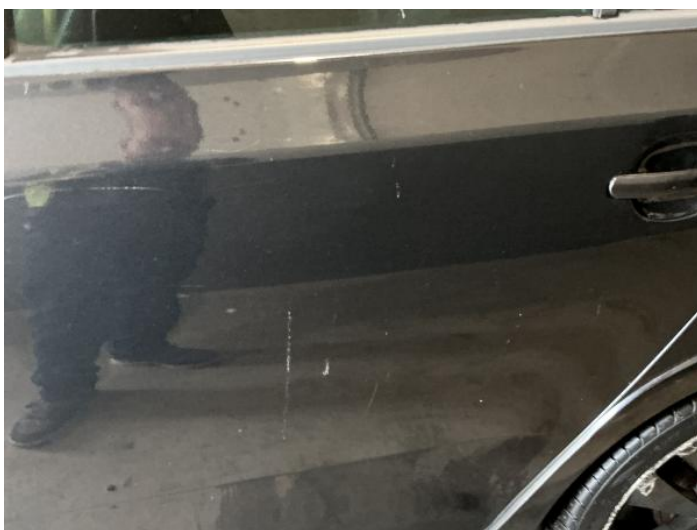
7: Door nsr
Chipped
Multiple Chips

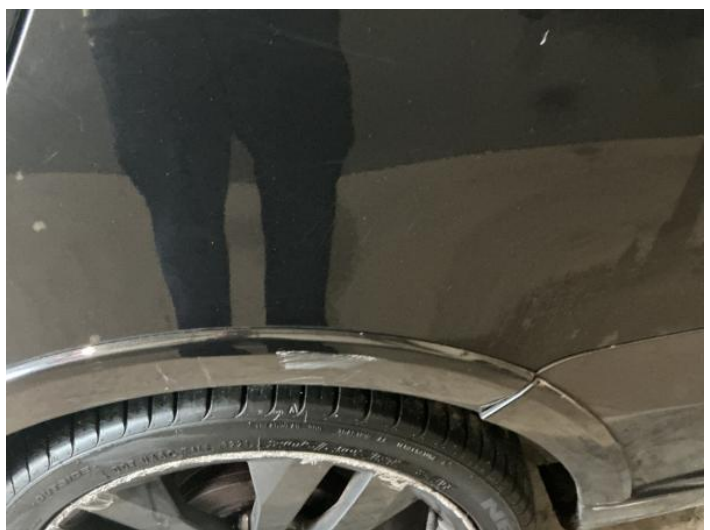
8: Qtr Panel Arch Extension ns
Scratched (Painted)
Over 25mm Thru Paint

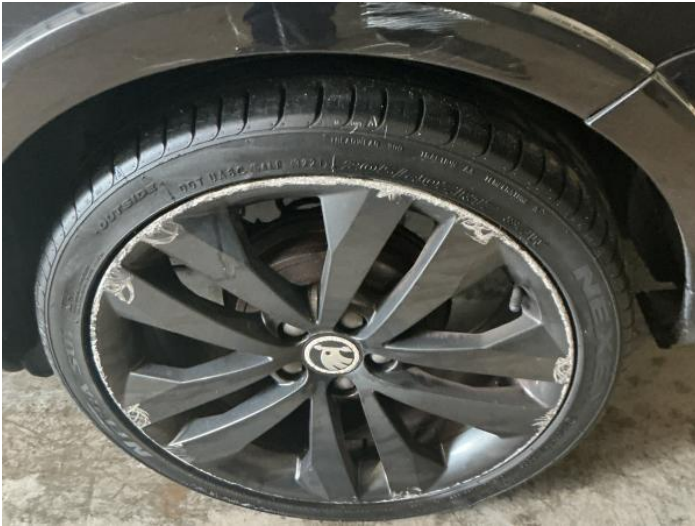
9: Wheel nsr
Scratched
Over 50mm

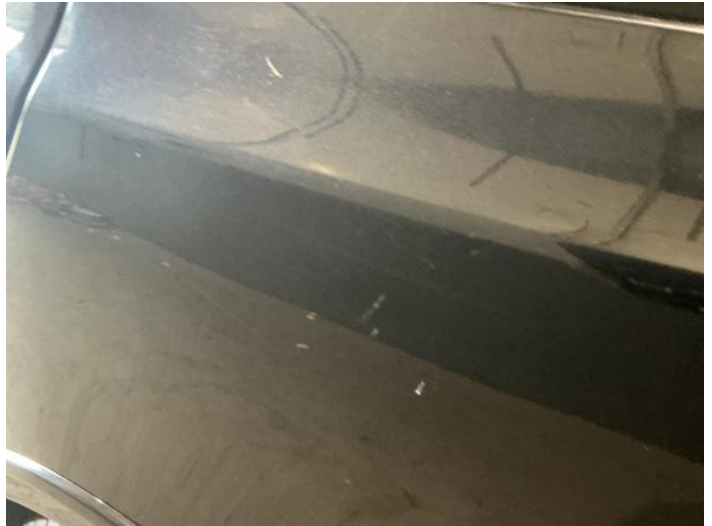
10: Qtr Panel nsr
Dented
Over 2 UpTo 10mm

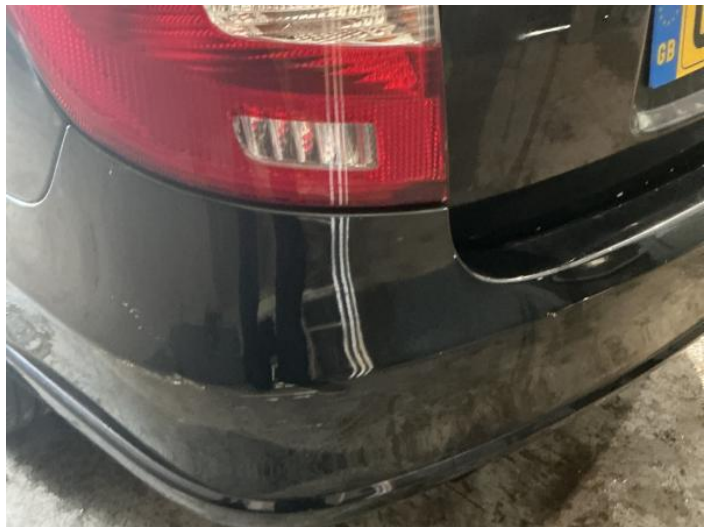
12: Bumper Rear
Scratched
Over 100mm Thru Paint

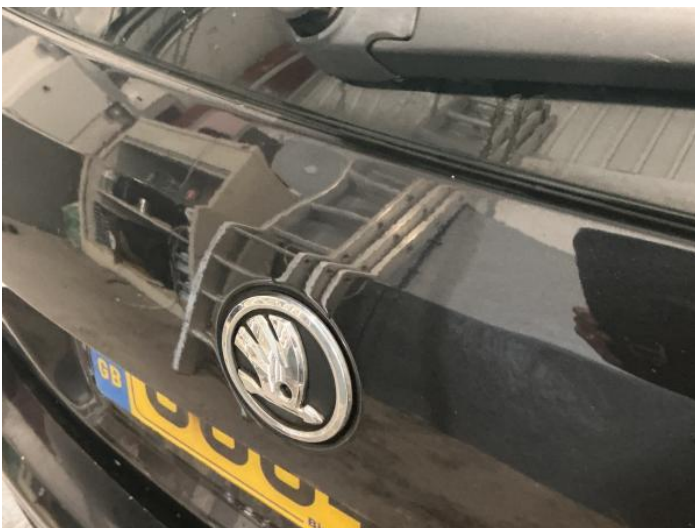
13: Boot Lid
Dented
Between 10mm + 30mm

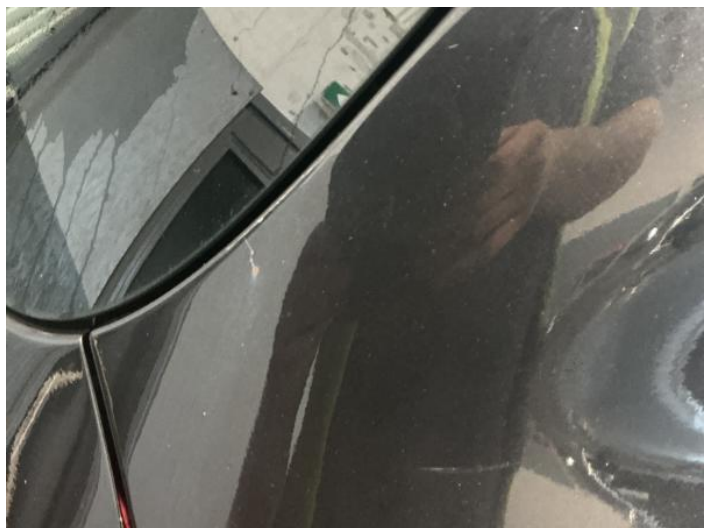
14: Qtr Panel osr
Rusted
UpTo 5mm

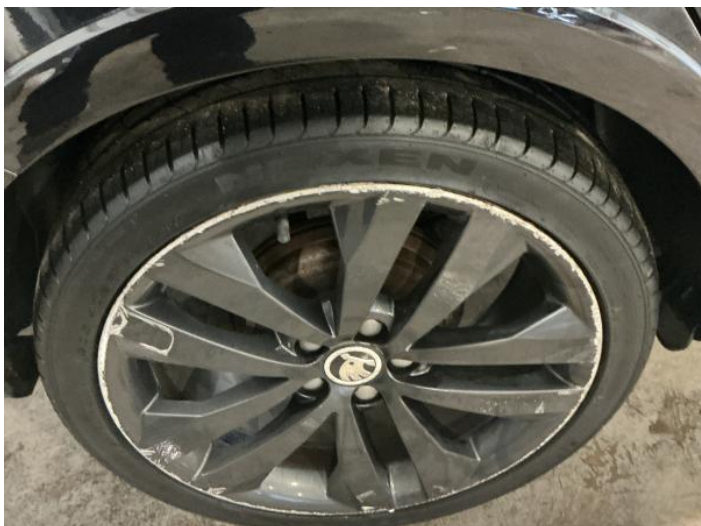
15: Wheel osr
Scratched
Over 50mm

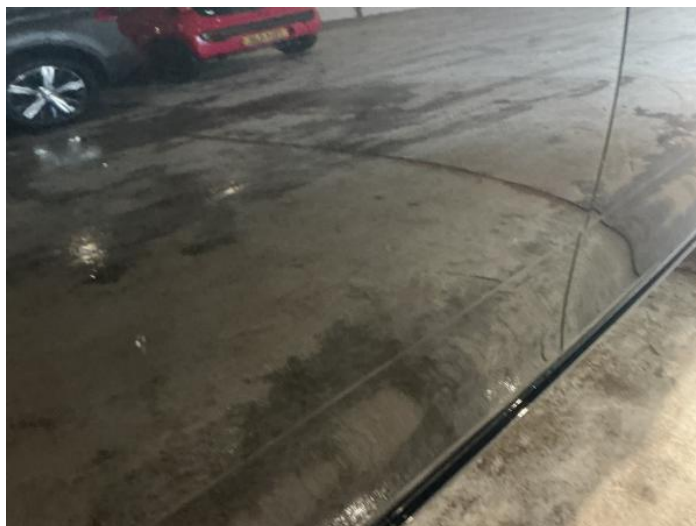
16: Door osr
Chipped
1 To 5

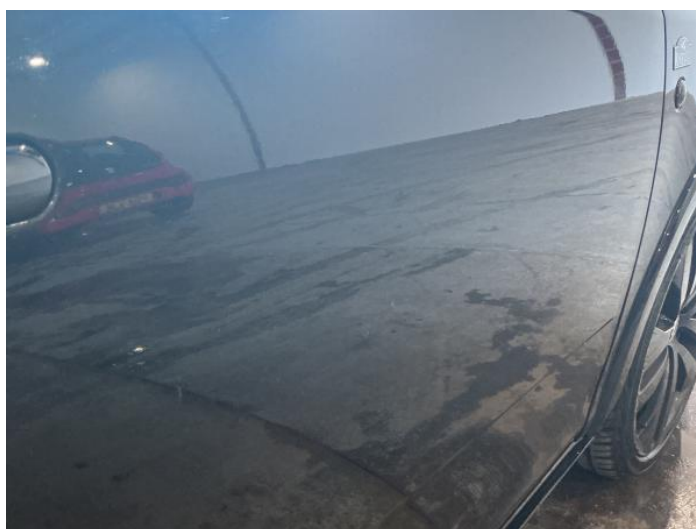
18: Door osf
Chipped
1 To 5

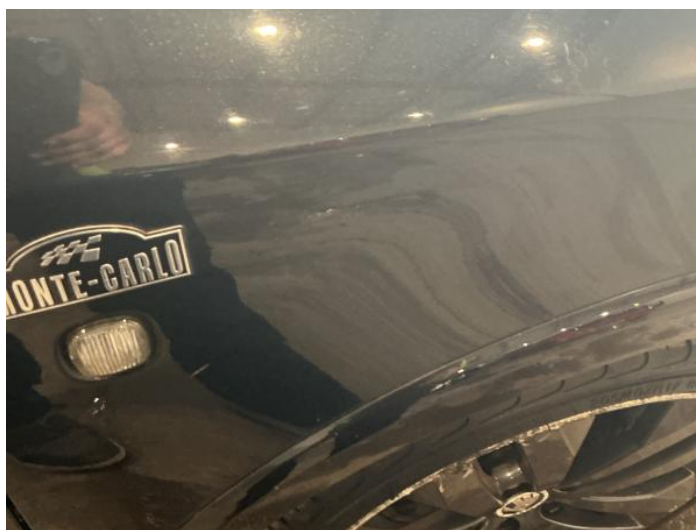
20: Wing osf
Scratched
UpTo 25mm Thru Paint

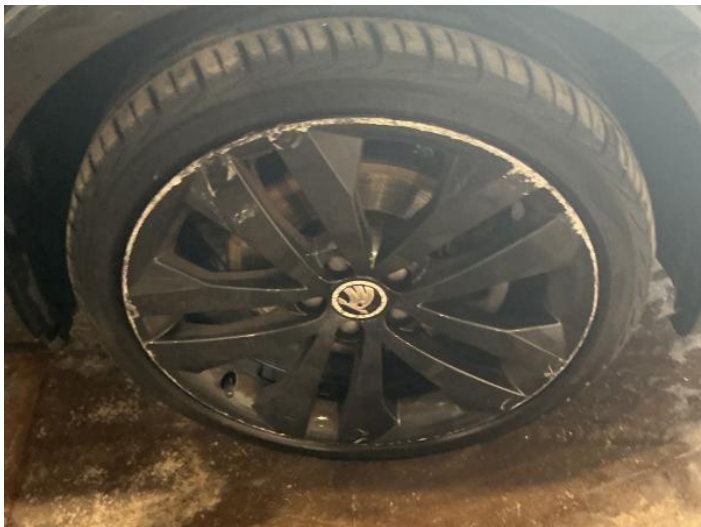
21: Wheel osf
Scratched
Over 50mm
