VEHICLE INSPECTION REPORT

YN13LBY

Volvo V40 D2 R DESIGN 5dr

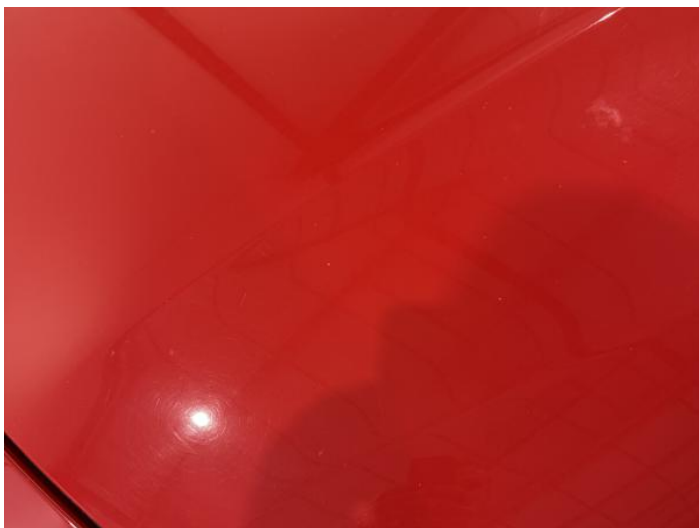
1: Bonnet
Chipped
Multiple Chips

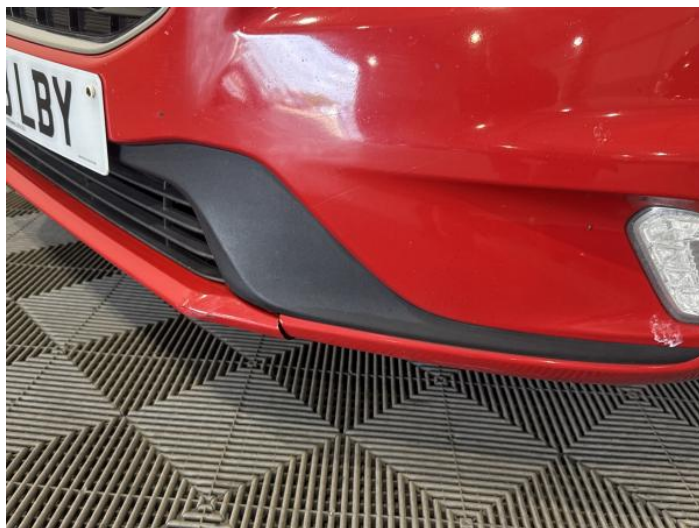
2: Bumper Front
Cracked
Over 25mm

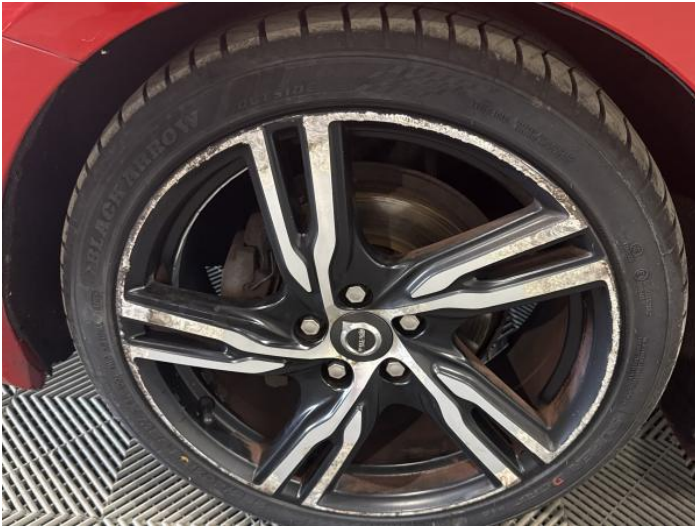
3: Wheel nsf
Scratched
Over 50mm

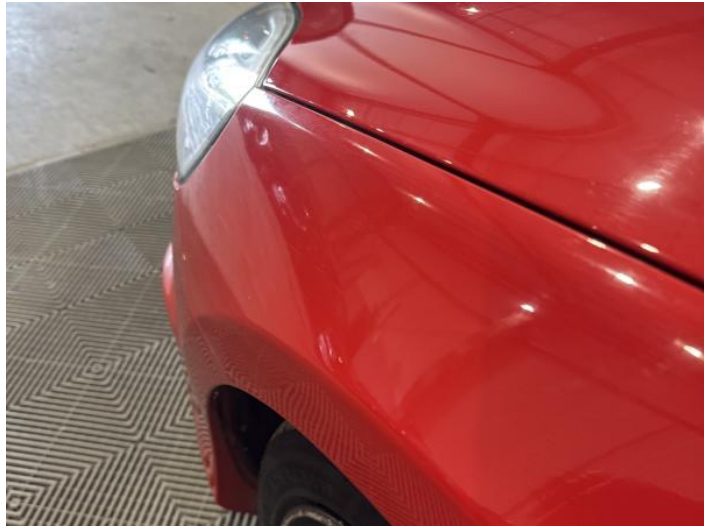
4: Wing nsf
Dented
Between 10mm + 30mm

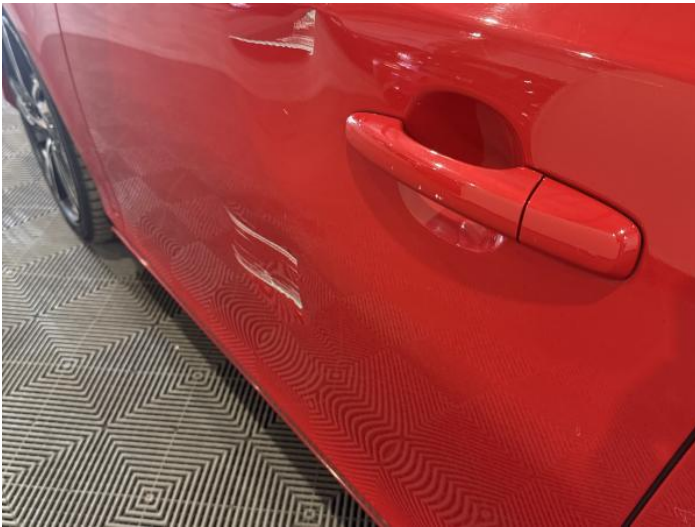
5: Door nsf
Dented
With Paint Damage

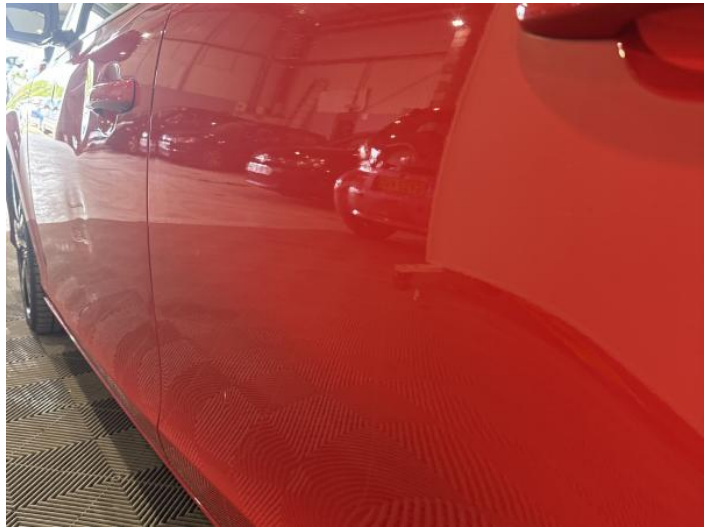
6: Door nsr
Dented
Over 30mm

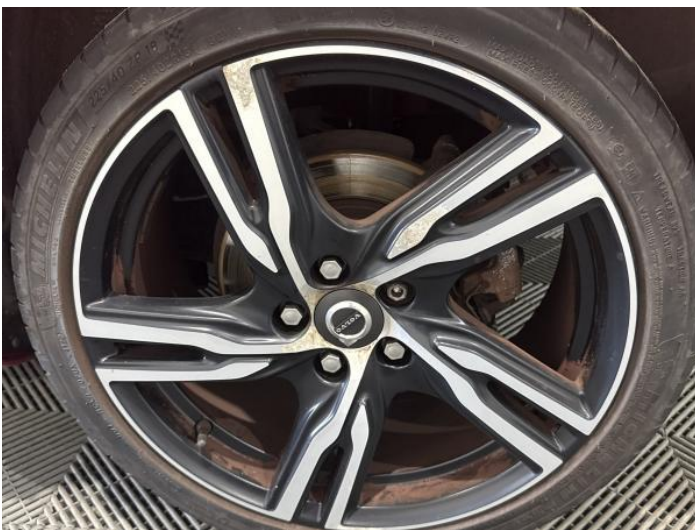
7: Wheel nsr
Scratched
Over 50mm

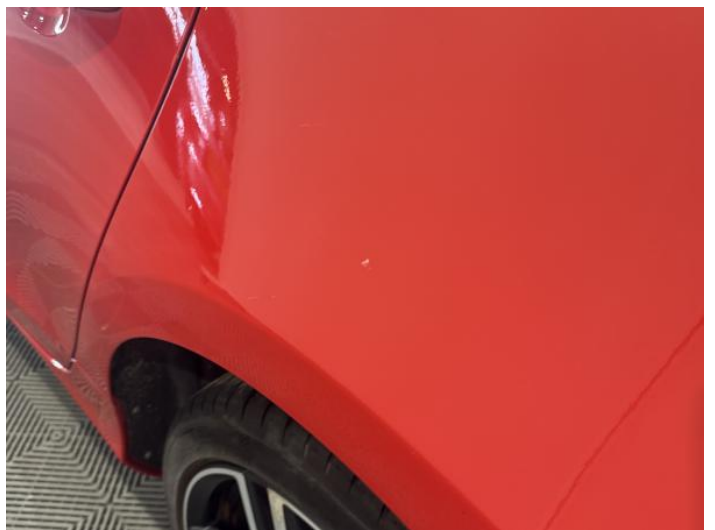
8: Qtr Panel nsr
Dented
Between 10mm + 30mm

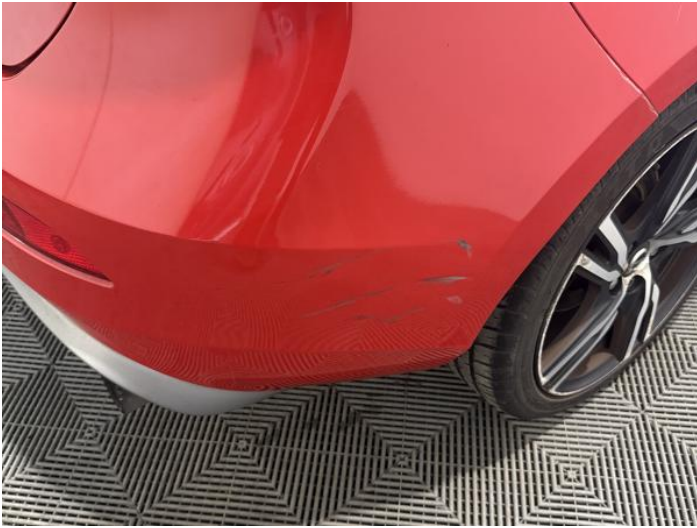
9: Bumper Rear
Scratched
Over 100mm Thru Paint

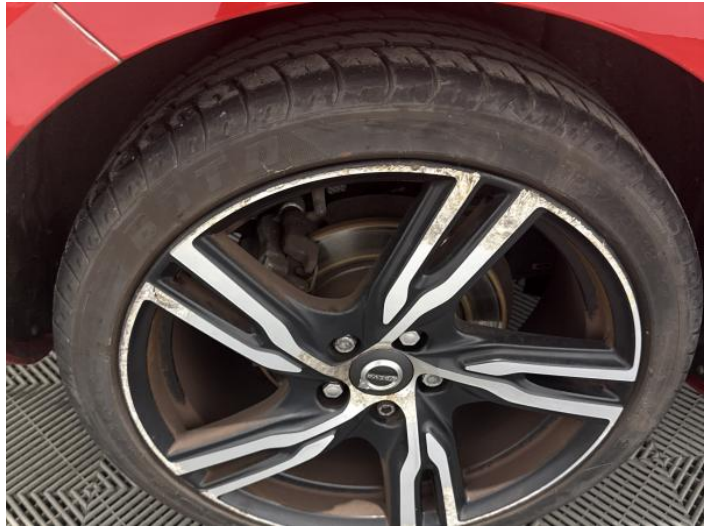
10: Wheel osr
Scratched
Over 50mm

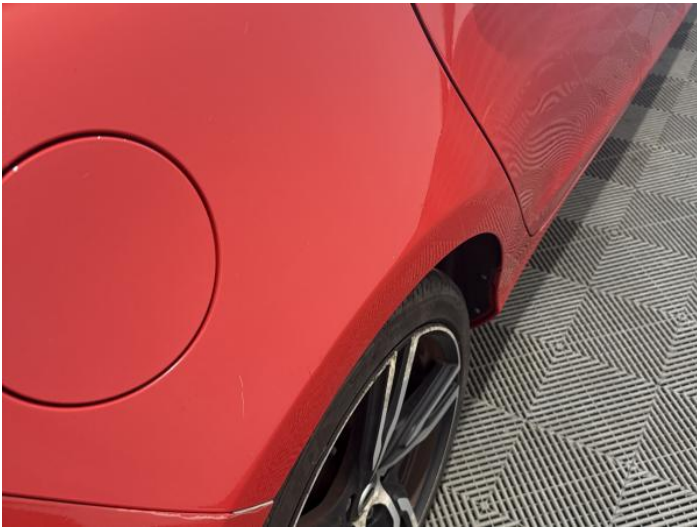
11: Qtr Panel osr
Scratched
Over 25mm Thru Paint

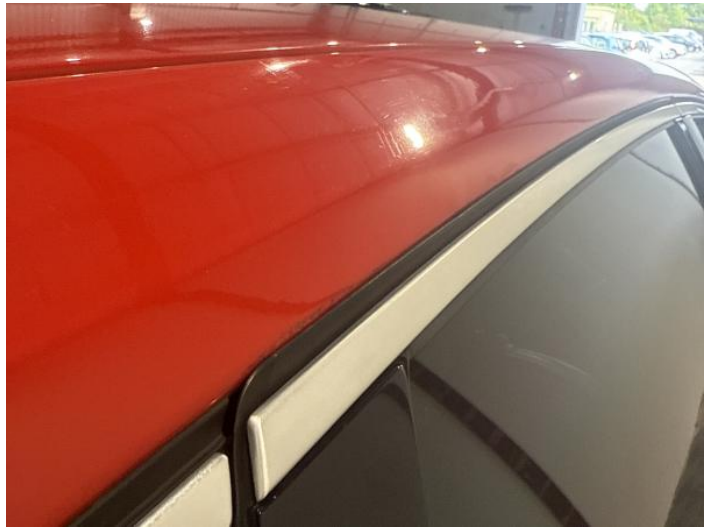
12: B Post os
Dented
Between 10mm + 30mm

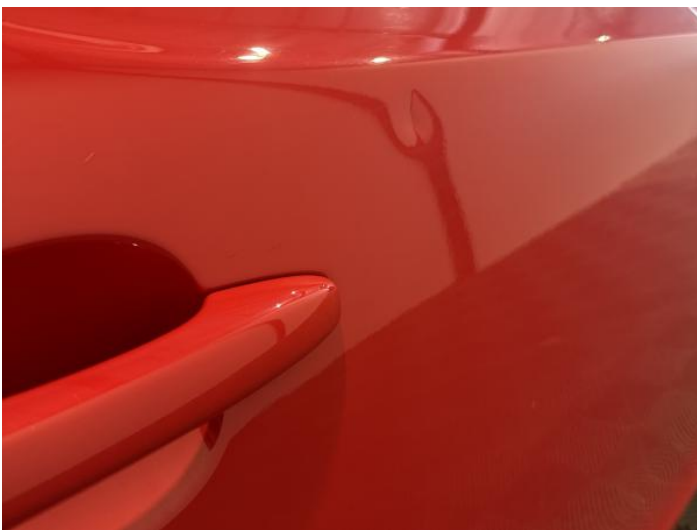
13: Door osr
Dented
Between 10mm + 30mm

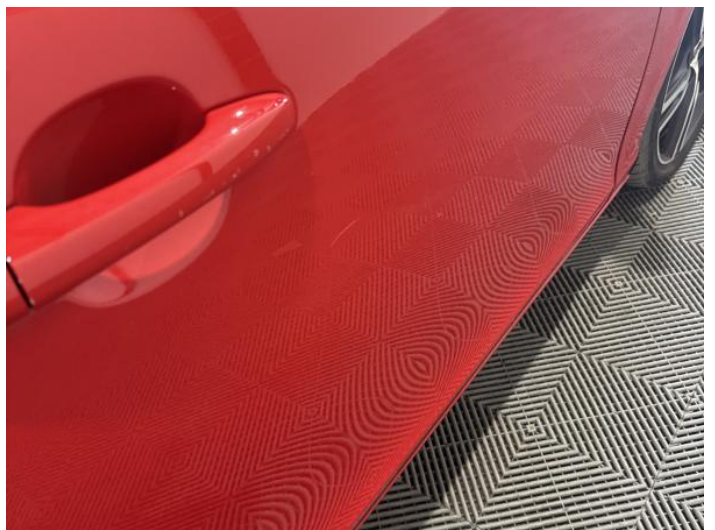
14: Door osf
Scratched
Over 25mm Thru Paint

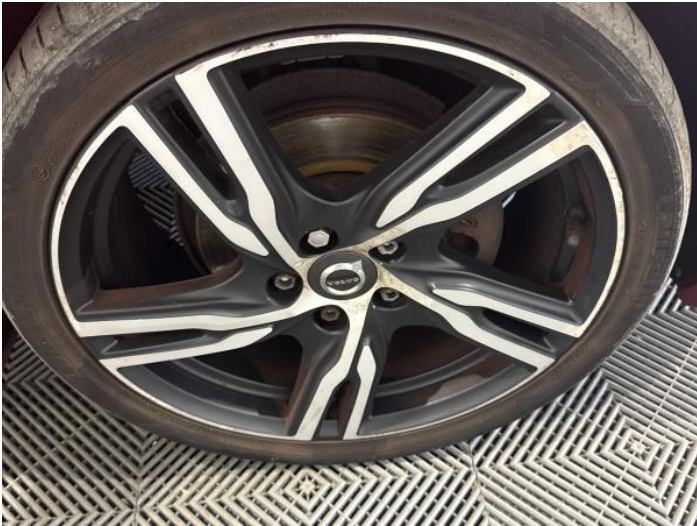
15: Wheel osf
Scratched
Over 50mm

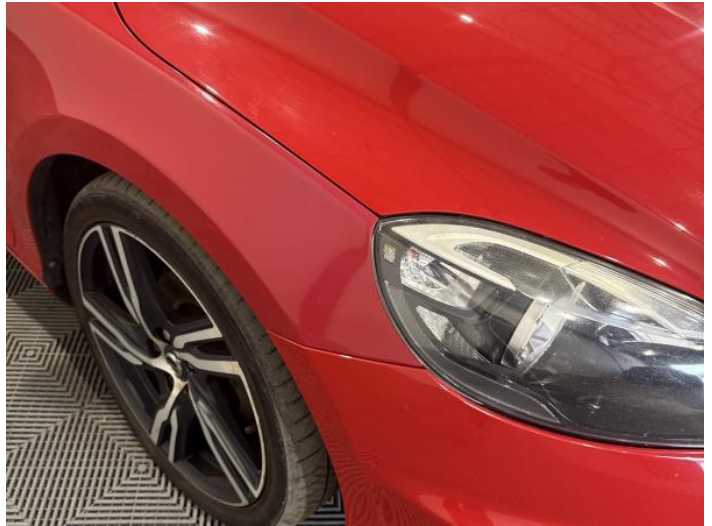
16: Wing osf
Poor Previous Repair
Poor Colour

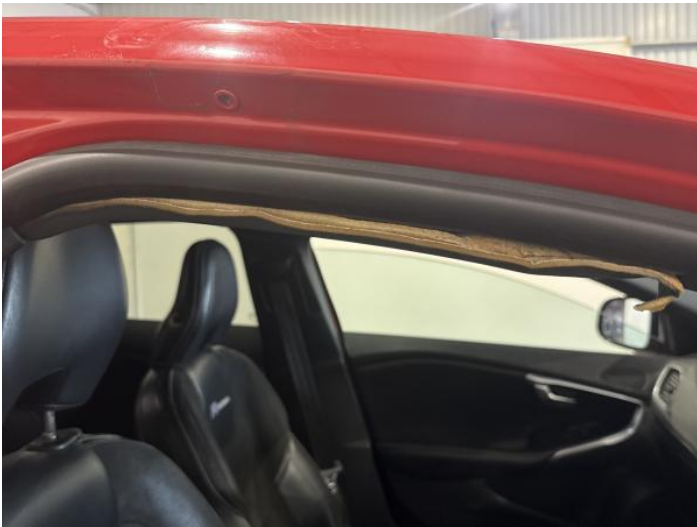
17: Roof Lining
Scuffed
Over 25mm

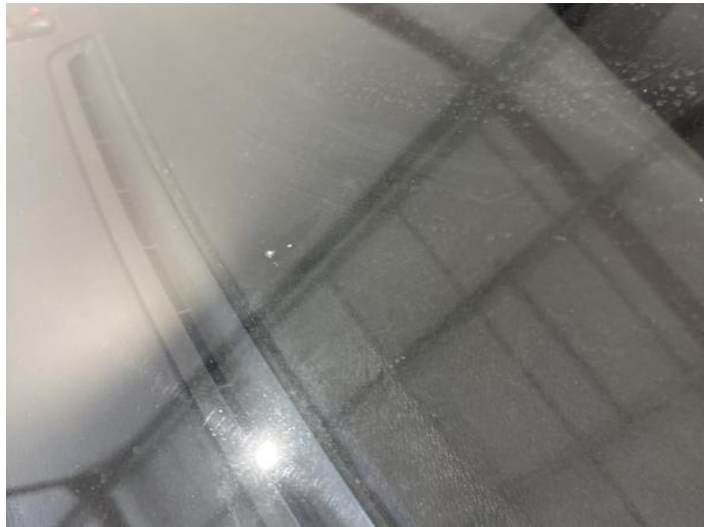
18: Screen Front
Chipped
UpTo 10mm
