VEHICLE INSPECTION REPORT

AJ09UEB

Peugeot 107 1.0 Verve 5dr

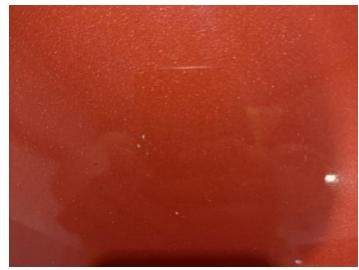
1: Bonnet Chipped 1 To 5

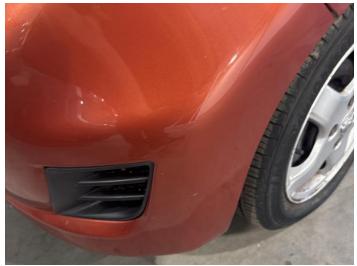
2: Bumper Front Scratched 25 to 100mm Thru Paint

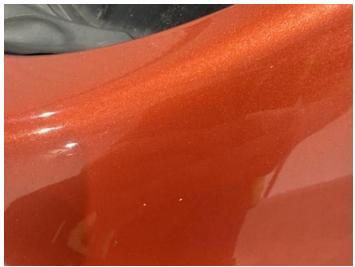
3: Wing nsf Chipped 1 To 5

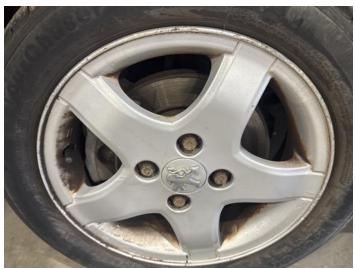
4: Wheel nsf Scratched Over 50mm

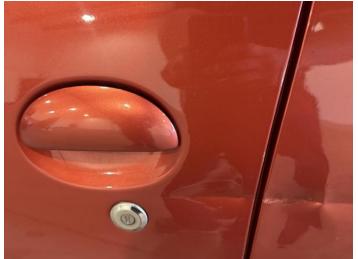
5: Door nsf Dented Over 30mm

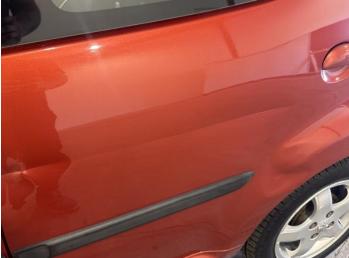
6: Door nsr Dented Over 30mm

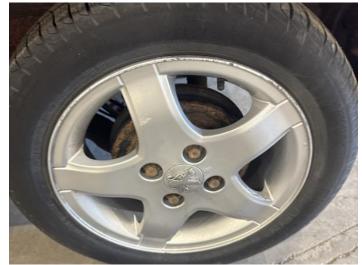
7: Wheel nsr Scratched Over 50mm

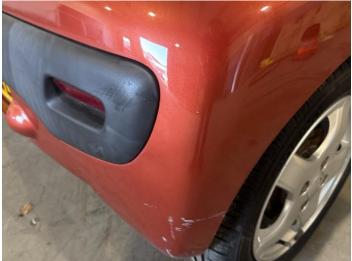
8: Bumper Rear Scratched Over 100mm Thru Paint

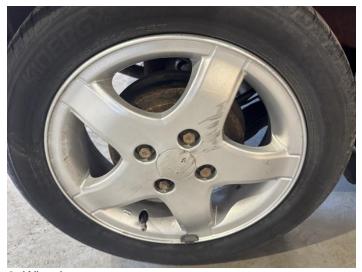
9: Wheel osr Scratched Over 50mm

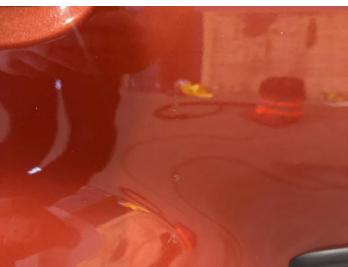
10: Door osr Chipped 1 To 5

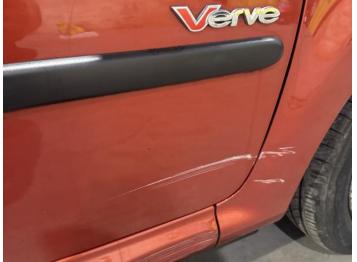
11: Door osf Scratched Over 25mm Thru Paint

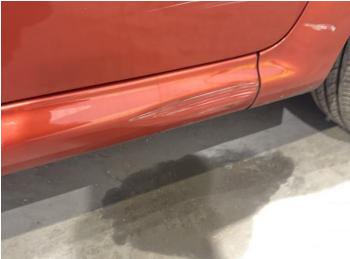
12: Sill os Dented With Paint Damage

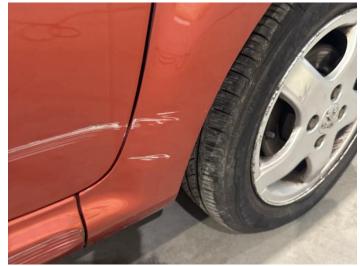
13: Wing osf Scratched Over 25mm Thru Paint

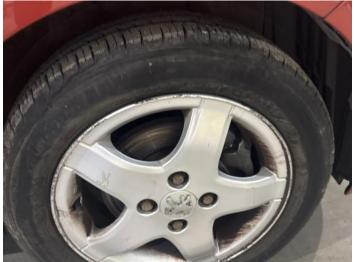
14: Wheel osf Scratched Over 50mm
